*NEW OFFICE BLOCK, BURY*

*PHASE 1 VALIDATION REPORT*

| Document Control Form | |
|---|---|
| REPORT NAME | REMEDIATION VALIDATION REPORT |
| REPORT REFERENCE | GRO-21438-5562 |

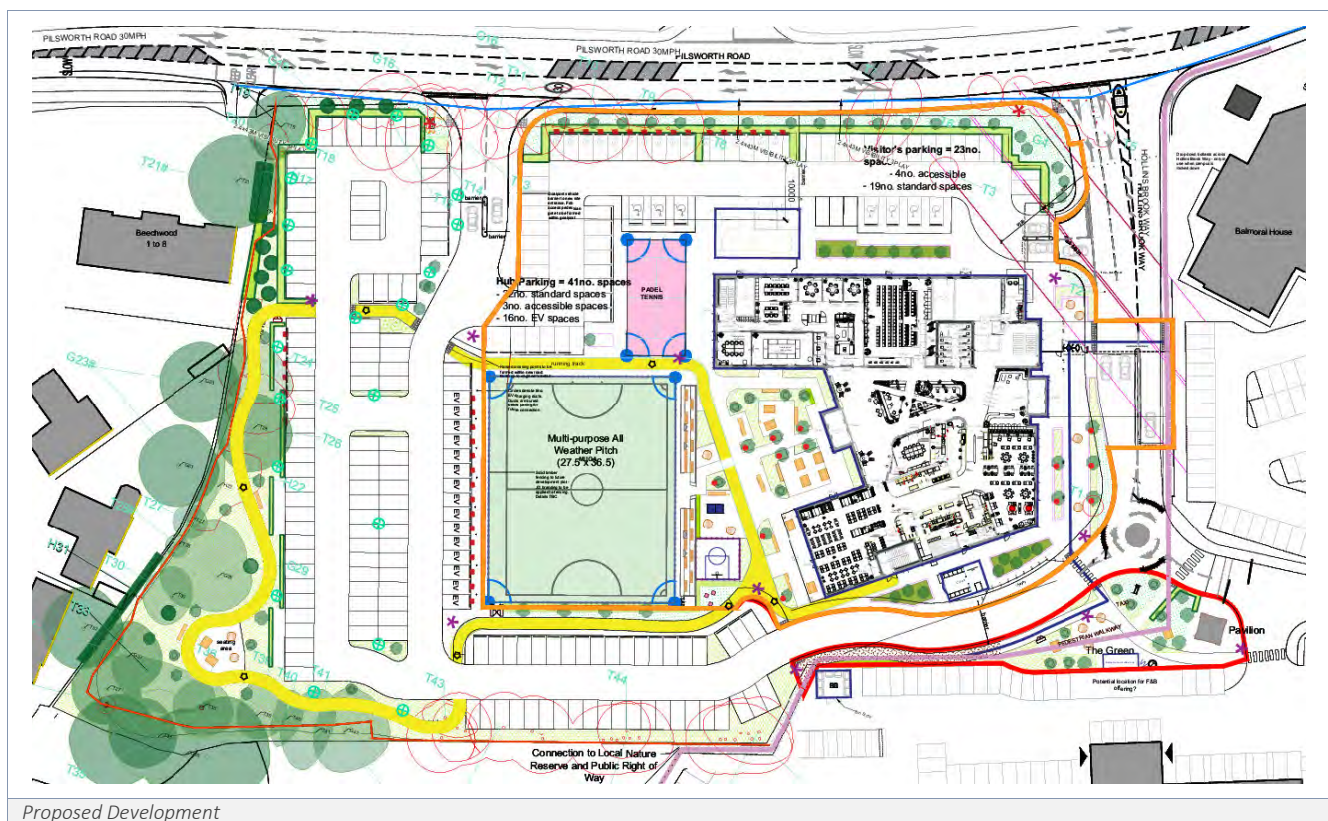
The proposed development is commercial end use comprising of a three-storey office block with associated staff welfare facilities including five-a-side football pitches and a Creche in the south west of the site, as shown on the 'Proposed Site Plan' Plan No. 13247-AEW-XX-SI-DR-A-1002 Rev P17 dated 7<sup>th</sup> November 2024. The Phase 1 area of the development is shown on Groundtech Plan *GRO-21438-P07* and comprises the access road and car park in the south and west of the site.

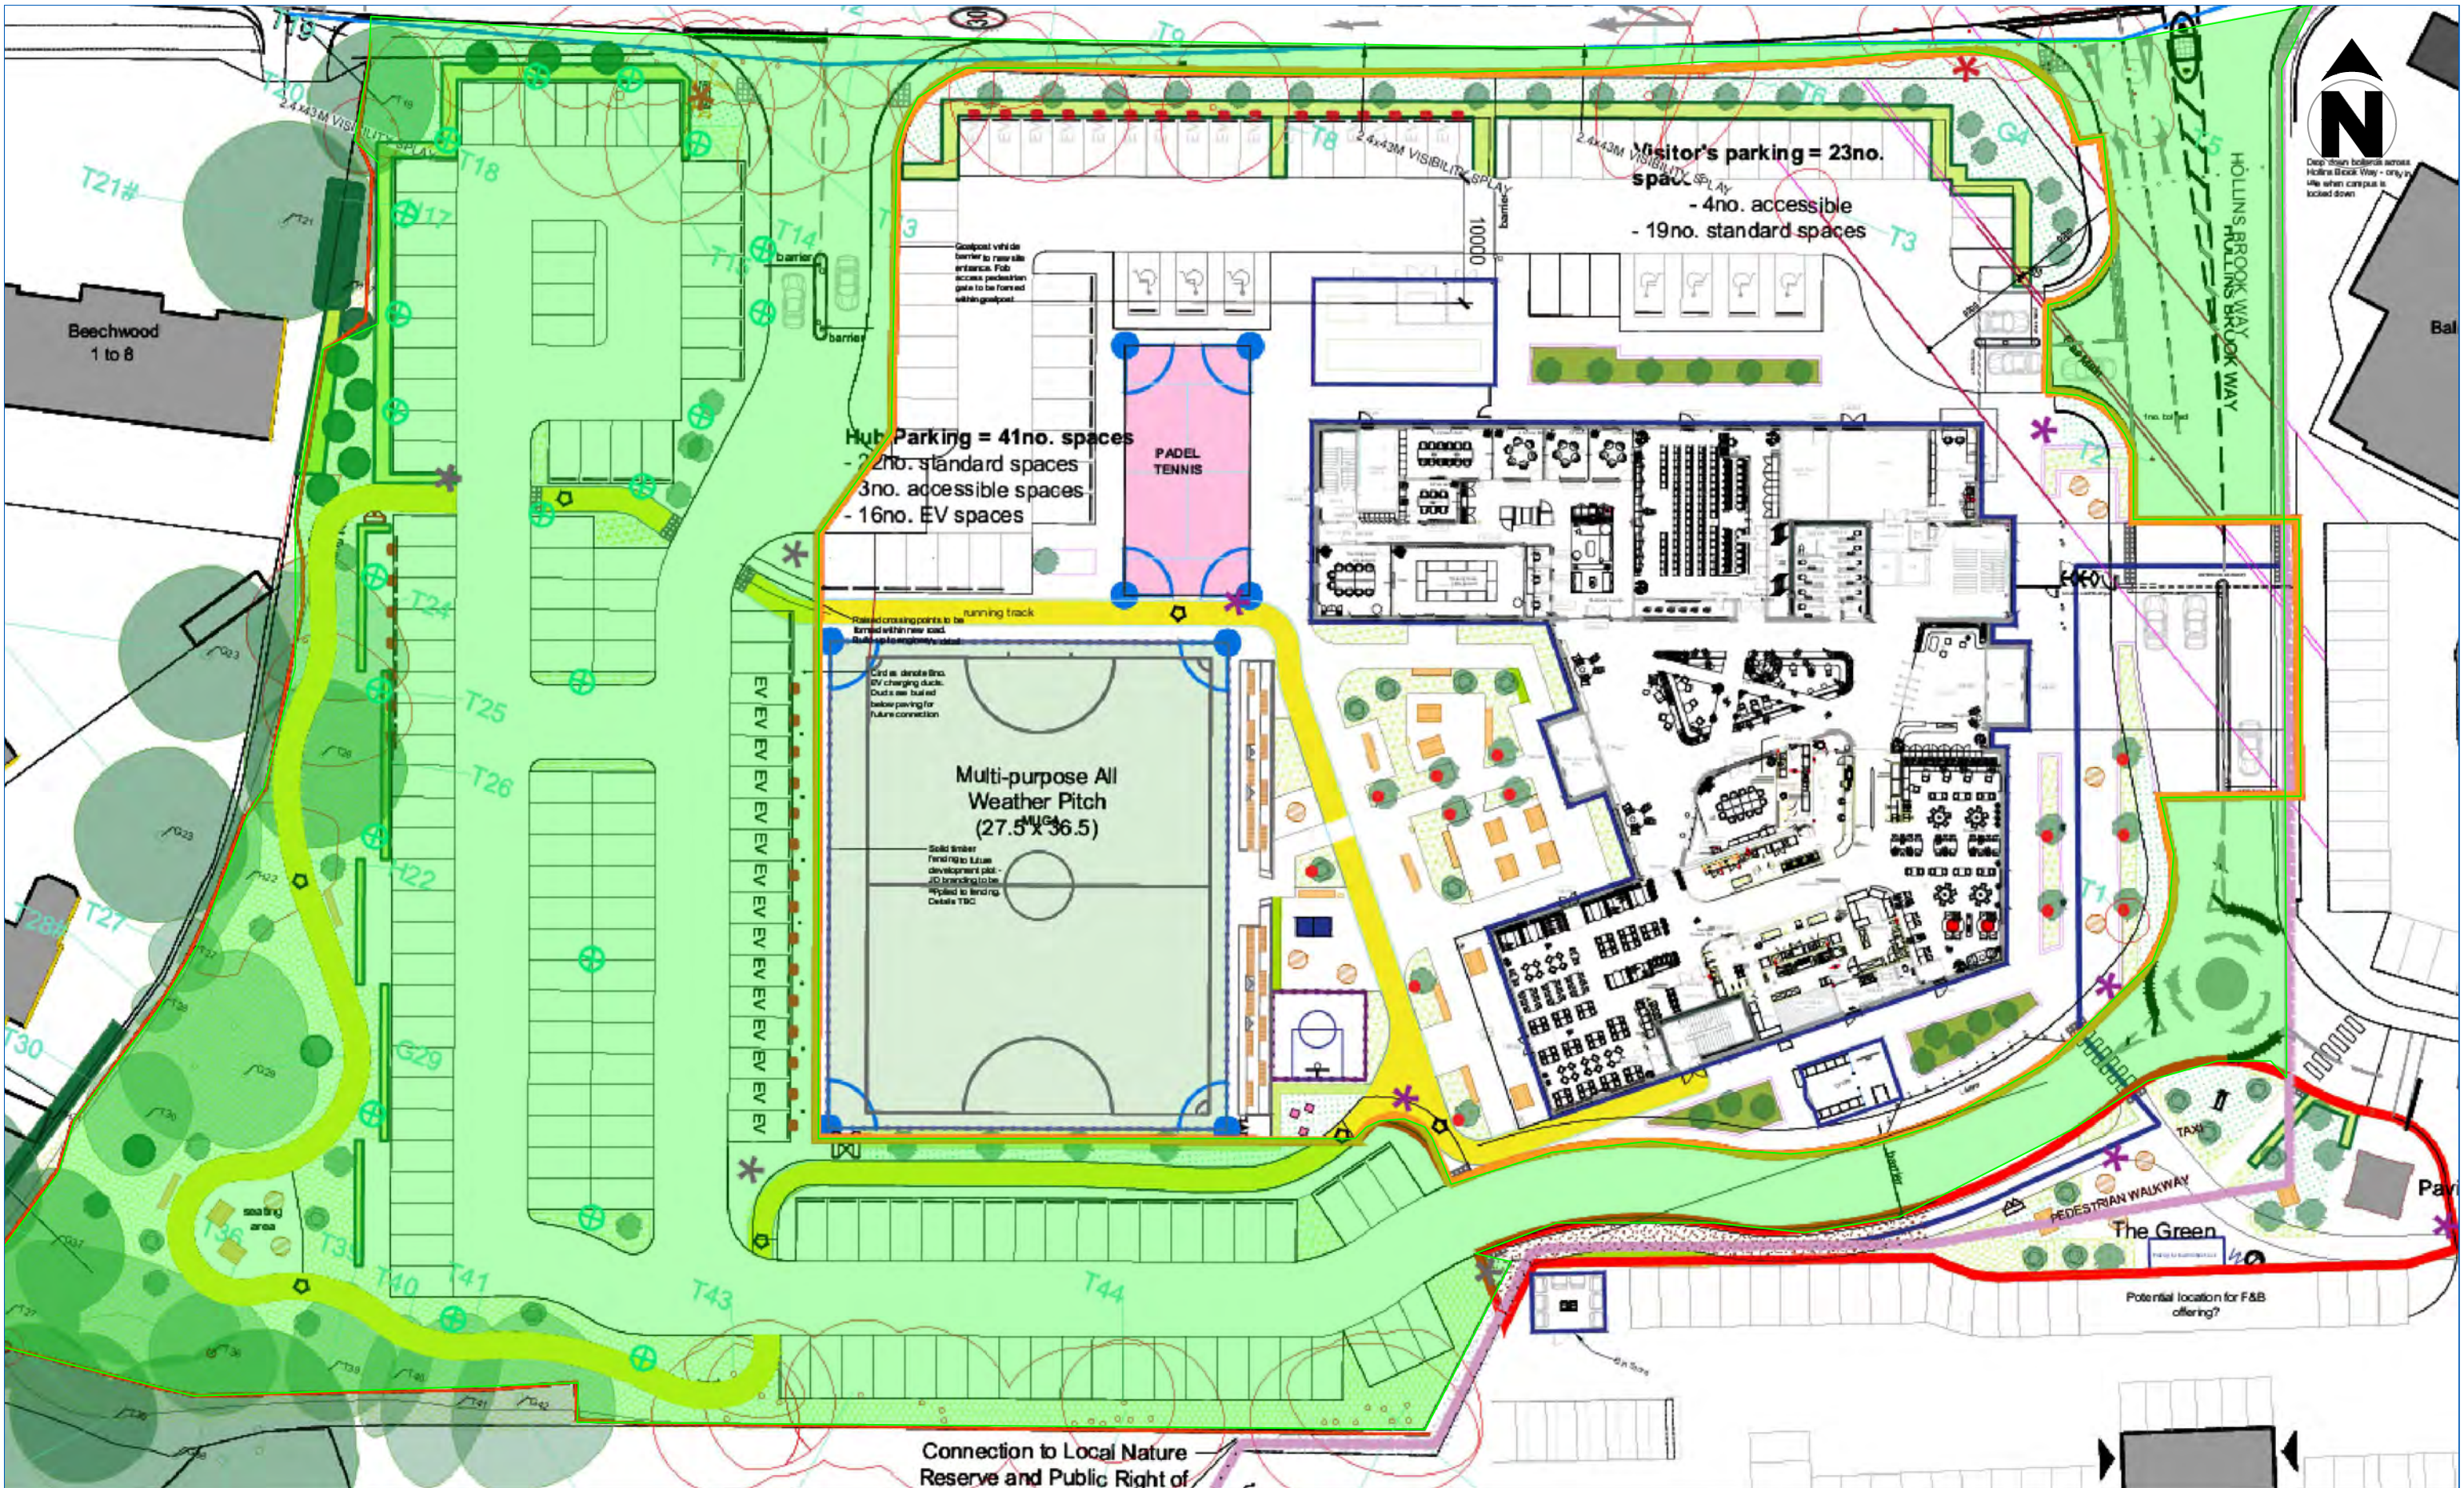
| | PHASING OF WORKS | GRO-21438-P07 | Rev. | Details | Date | Approved | | <div></div> |

All works undertaken and detailed below are for the Phase 1 area of the development only.

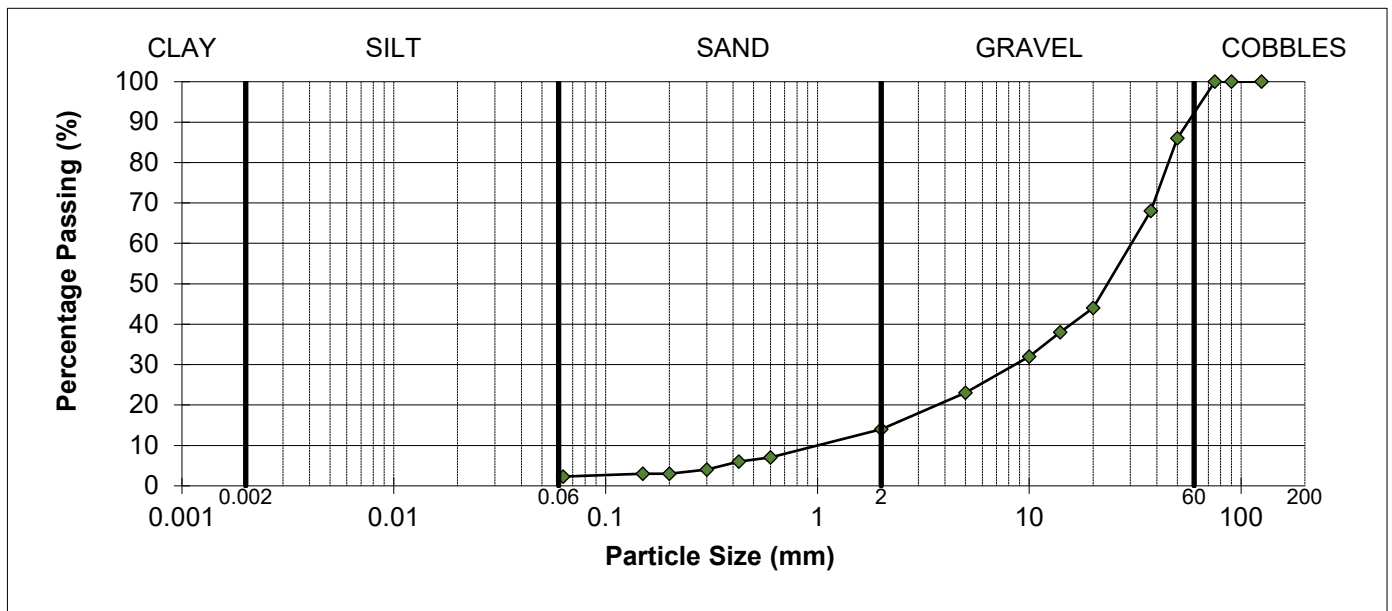
**TEST CERTIFICATE**  
**PARTICLE SIZE DISTRIBUTION**

Sample complies with the advised grading specification for a 6F2 material (SHW 2016)  
As received water content = 8.7%

Surplus material was stockpiled prior to removal from site, which is discussed in *Section 4.5* below. Gradings provided by the client for the site won crush material utilised throughout the works are presented in *Appendix 3*. The grading shows the material was crushed to 6F2 classification. Approximately 660m<sup>3</sup> of material was stockpiled and reused across the Phase 1 works.
