**Top 'OTh Brow,  
Two Brooks Lane, Hawkshaw, Bury,  
Greater Manchester.  
BL8 4LA**

**Survey & Assessment in Respect of Bat Species  
and Nesting Birds (including Barn Owl).**

**Echo Calls Bat Surveys**

**14<sup>th</sup> September 2021**

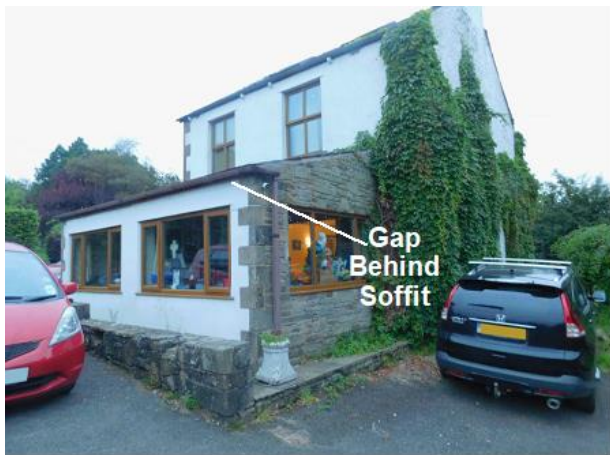
**PHOTO 1**  
**South-eastern Corner of House & Elevation**

- There was a small gap behind the soffit at the south-eastern corner of the extension, however a close inspection of the interior of the gap using an endoscope, and a visible check of the wall and floor beneath it, found neither bat droppings, prey remains, urine staining, nor fur staining were found, and it was deemed therefore, that bats were not using the gap for roosting or access purpose, (refer to **figs 4 and 5** and **photo 1**).
- The eastern elevation of the extension was also partially covered in the same mat of climbing plants as the main part of the house, and where possible the mat was carefully searched, but again no bat droppings, urine stains or prey remains were found to suggest that bats use any part of the ivy for roosting purposes, (refer to **figs 4 and 5** and **photos 1 and 12**).

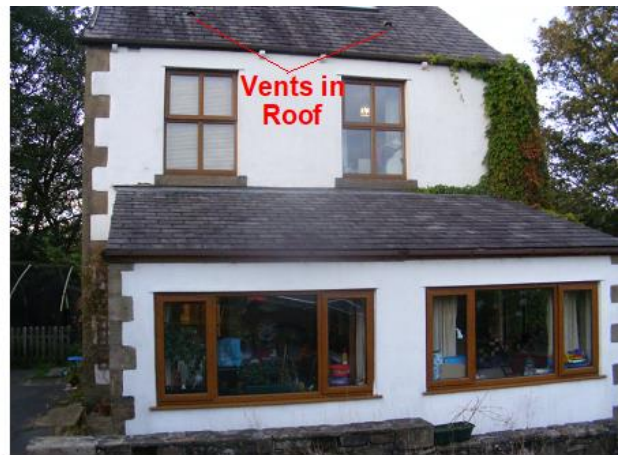
**PHOTO 2**  
**Southern Elevation of House & Extension**

- The eastern elevation was partially covered in a mat of climbing plants, and these can be considered to have a low, but significant, bat roost potential. Where possible, the plant network was carefully searched, but there were no bat droppings found, or any other signs to suggest that bats use any part of the plants for roosting purposes, nor were any signs of bird nesting observed anywhere within the plant, (refer to **figs 4 and 5** and **photos 1, 2, and 9 to 12**).
- There were several roof vents positioned in the southern pitch of the roof, but close inspection of these using close-focus binoculars, found them to be internally covered in mesh, and therefore offered negligible bat roosting potential, (refer to **figs 4 and 5** and **photo 2**).

There was a single-story extension attached both internally and externally along the entire southern elevation, and this had a sloping roof covered in slate and no roof void. The extension was also built from stone, and with its southern and western elevations being covered in white render. The extension and its roof also appeared to be in a good, well maintained overall condition, (refer to **figs 4 and 5** and **photos 1 to 3 and 12**).

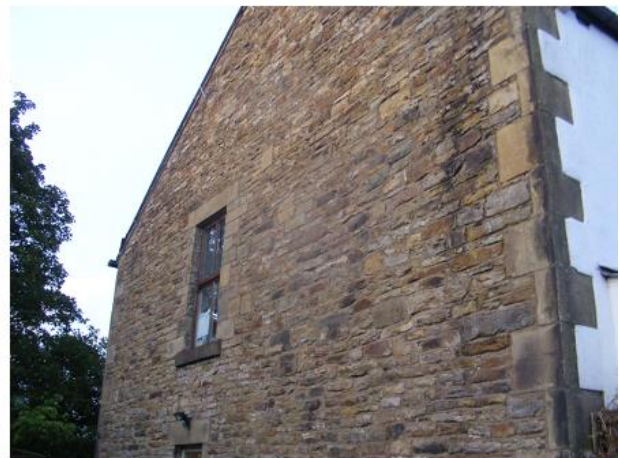
**PHOTO 4**  
**Western Elevation of House**

The house was located centrally within the site close to the northern boundary, and it was a tall two-story building constructed from stone, with both the northern and southern elevations being covered in a white render coating. It had a pitched roof of underlined slate containing two rectangular roof lights positioned in the southern pitch. Internally however, the majority of the first floor ceiling followed the contour of the roof, leaving only two small triangular roof voids to be searched. One was along the northern edge of the roof and the second was along the southern edge of the roof, and both were insulated and well-sealed. The house, its gables, roof, soffits and render coating, were all in good condition, and in the other elevations, the stones appeared to be well-pointed, (refer to **figs 3 and 4** and **photos 1 to 5, and 8 to 12**).

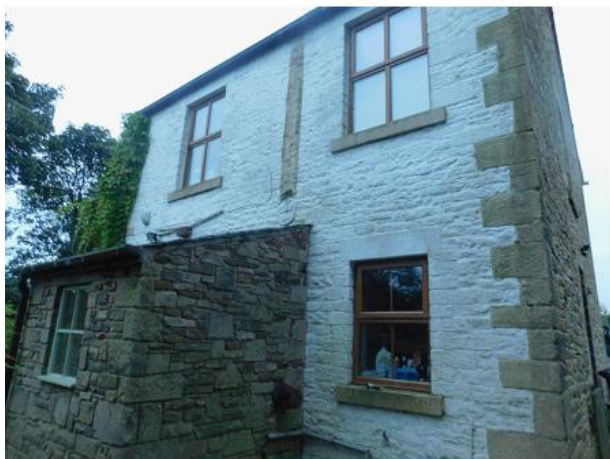
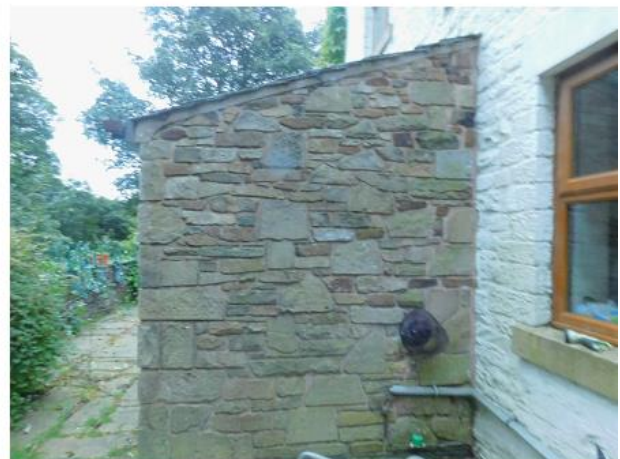
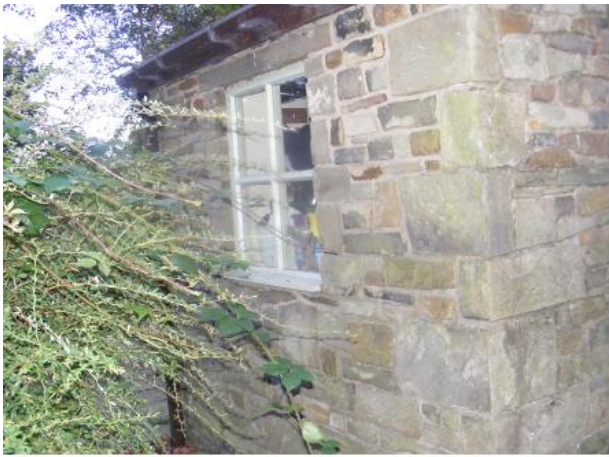
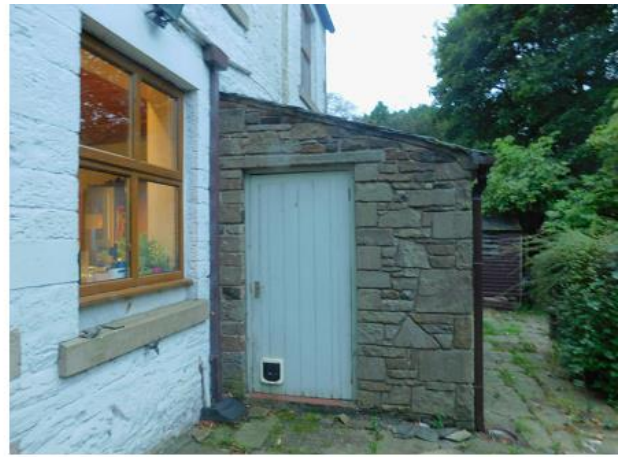
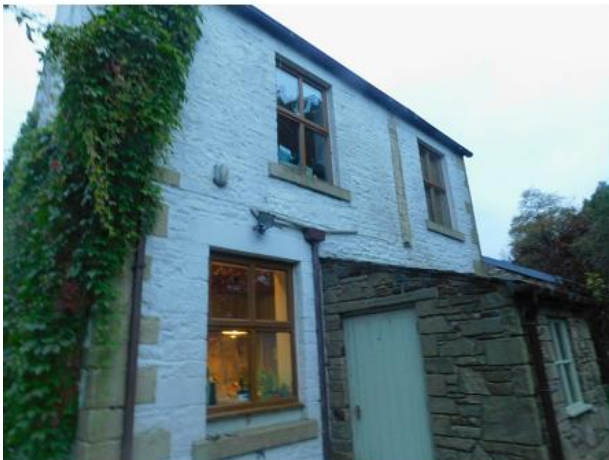
Attached centrally along the northern elevation of the dwelling, and connected to it internally was a small single-storied kitchen extension. This was built from unrendered stone, and had a sloping roof covered in slate, but with no searchable roof void. Like the rest of the house, the extension, and its roof, were in excellent condition, (refer to **figs 4 and 5** and **photos 5 to 9**).

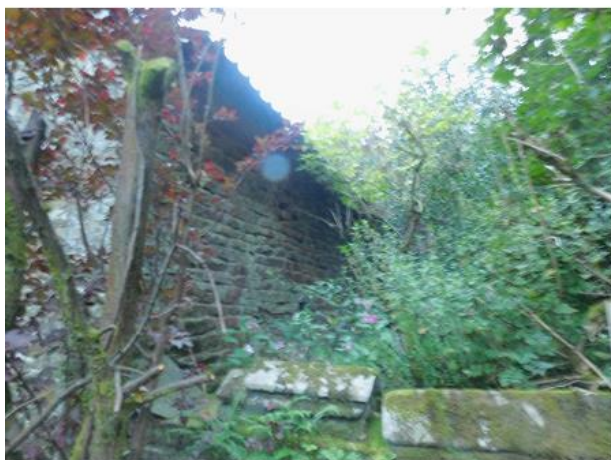
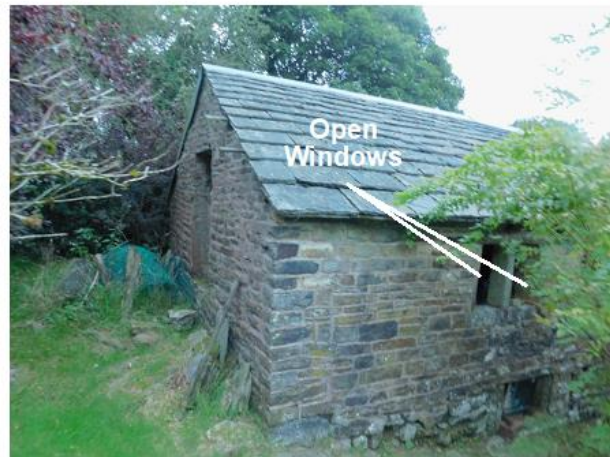
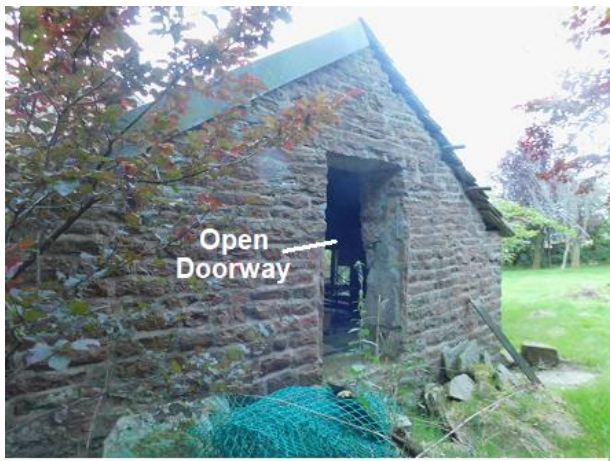
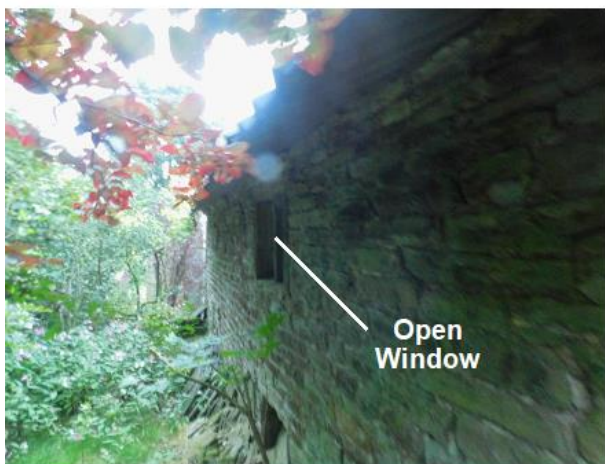
- There was no glass in the window frames in both the southern and northern elevations, and also, there was no actual door in the doorframe within the western elevation, all of which resulted in openings large enough to allow both birds and bats to enter both the cellar and the barn interior. All the areas around these openings, both internally and externally, were searched, as was the interior of all parts of the building, but neither bat droppings, staining, prey remains, nor bats themselves were found. It was also thought that copious amounts of daylight would enter the building through these openings, thus further reducing internal roosting potential. The search also found no sign to suggest that birds had used any part of the barn for nesting purposes, (refer to **figs 4 and 5**, and **photos 15 to 19 and 21**).

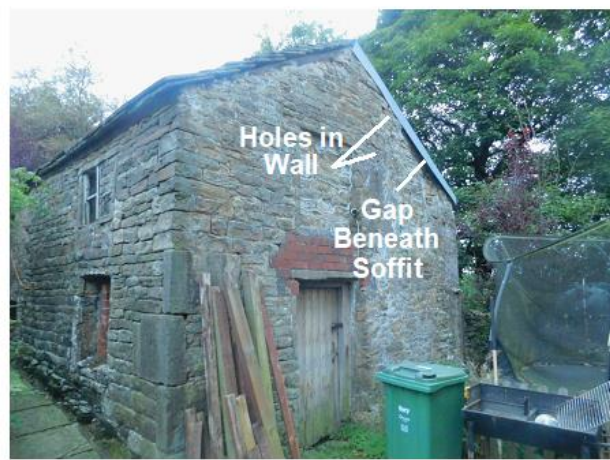
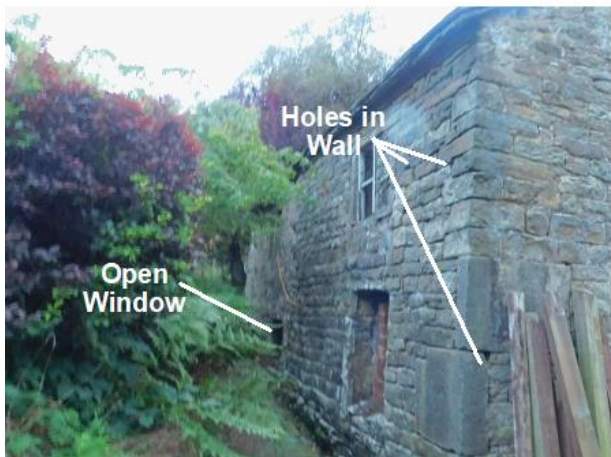
- There was a gap beneath the soffit close to the eastern gable, also several holes in the eastern elevation walls, and further holes in the southern elevation. All of these were carefully searched using the endoscope, for signs of bat occupation. The walls and floors beneath these holes and gaps and opening were also searched, but as no evidence was found, they were all deemed to offer negligible potential for roosting bats, (refer to **figs 4 and 5** and **photos 16 and 17**).

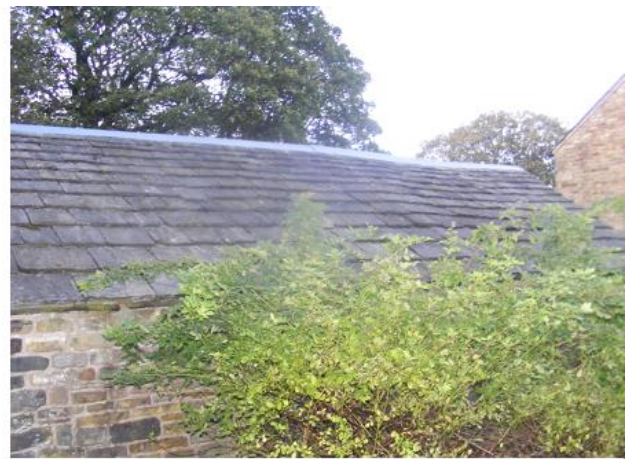
**PHOTO 20**  
**Northern Elevation of Barn**

The barn ran in an east to west orientation, and was located to the west of the house in the north-western corner of the site. It was a rectangular single-storied, stone-built building, and as it was positioned on a slope, as a result, the western half of the building had a cellar beneath it, whilst the eastern half did not. The barn had an uninsulated pitched roof, with a southern pitch still covered in the original slate, however during recent times, the northern pitch of the roof had been worked on, resulting in it being covered in steel corrugated sheeting, but there was no roof void. The barn was split into two halves and both parts of the barn were currently used for storage, however the overall structure was still fairly sound and in reasonable condition, (refer to **figs 4 and 5** and **photos 15 to 24**).

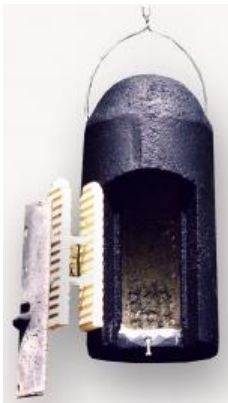
### Schwegler 1FD Bat Box

This Schwegler 1FD bat box has been developed specifically for smaller bats. The interior and the type and size of the entrance hole match the requirements of smaller species. It features a special layout inside the domed roof, an increased interior height, and two grooved internal wooden front panels with precise spacing between them.
