Preliminary Ecological Appraisal Report

Willow Street, Bury

Reference: 80-819-R1-1

Date: September 2022

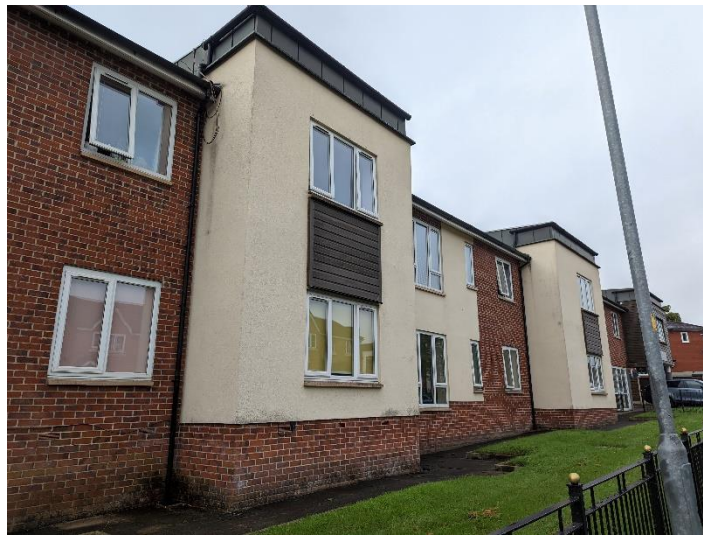
PLATE 1      SHOWING B1

Three buildings, Building 1 – Building 3 (B1 – B3) were located on-site. B1 comprised residential units. B2 and B3 were on a disused section of the site and comprised a garage previously used for storage and a commercial unit. A description of the buildings can be found in Appendix II.

B1, B2, and B3 were assessed as having **Low** roosting potential therefore it is recommended that one Nocturnal Bat Survey is required between May and August (inclusive) on B1, B2 and B3.

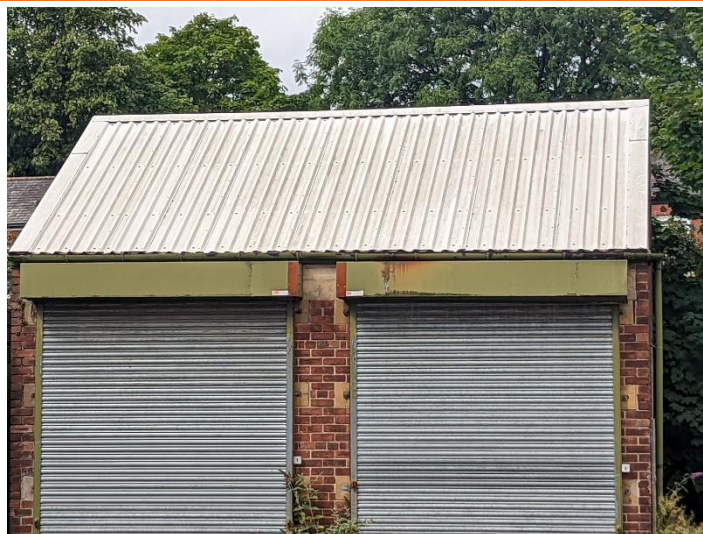
PLATE 2      SHOWING B2

Internal access to B1 and B2 was not possible at the time of the survey. B1 was a residential unit used to house young people as such a detailed external inspection was deemed sufficient. Access to B2 was not possible due to damage to the roller door on the eastern aspect. This has been taken into consideration during the assessment.

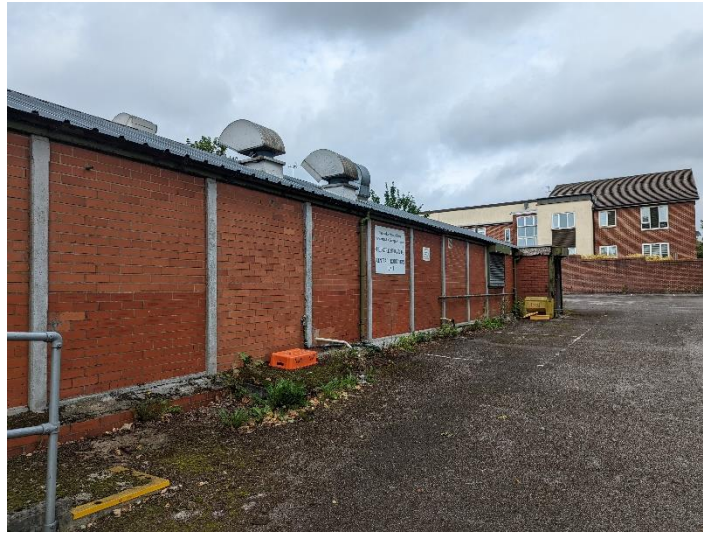
PLATE 3      SHOWING B3

A loft void was present in B3, access was not possible via one of the loft hatches due to health and safety reasons. A detailed inspection of the southern aspect of the loft void was possible from the additional loft hatch. This has been taken into consideration during the assessment.

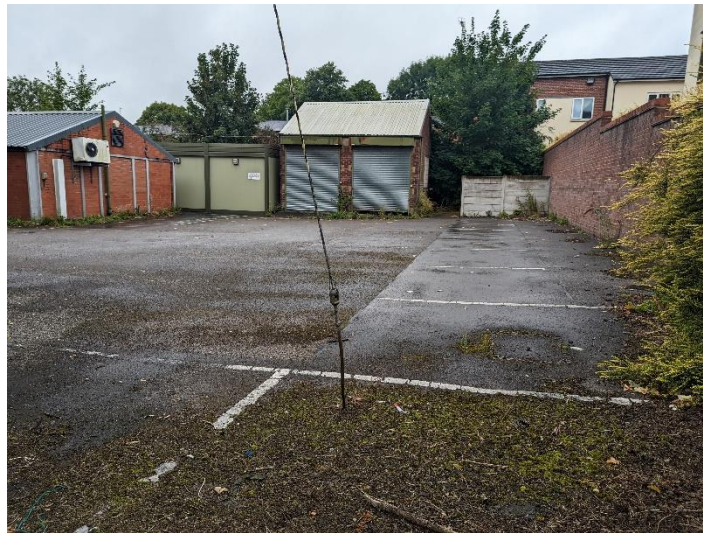
PLATE 4      SHOWING HARDSTANDING CARPARK

Concrete hardstanding car parks were associated with the on-site buildings. The hardstanding had been colonised at its edges by butterfly-bush (*Buddleja davidii*), herb-Robert (*Geranium robertianum*), dandelion (*Taraxacum officinale* agg.), bramble (*Rubus fruticosus*), ivy (*Hedera helix*) and rosebay willowherb (*Chamaenerion angustifolium*). Field horsetail (*Equisetum arvense*) was present within the hardstanding in the centre of the site adjacent to B3.

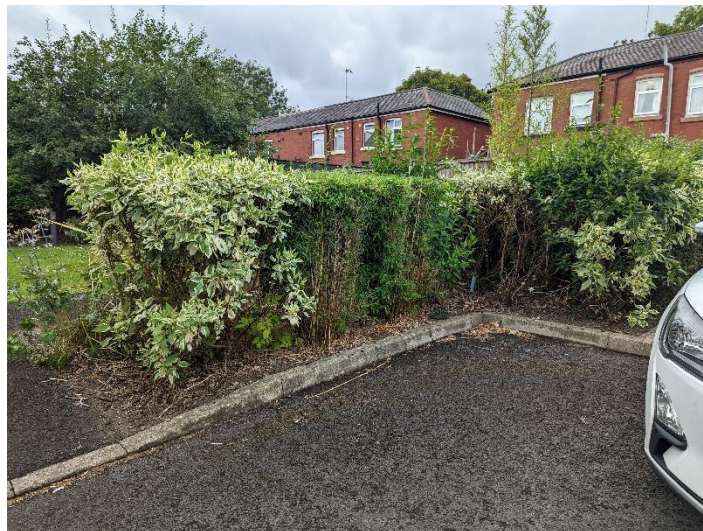
PLATE 6      INTRODUCED SHRUB

Stands of introduced shrub were present within the western boundary, south-west corner and centre of the site. Species present included Wilson's honeysuckle (*Lonicera nitida*), white dogwood (*Cornus alba*), orange day-lily (*Hemerocallis fulva*), ninebark (*Physocarpus opulifolius*), shrubby cinquefoil (*Dasiphora fruticosa*), Chinese silver grass (*Miscanthus sinensis*), red escallonia (*Escallonia rubra*), bamboo species (*Phyllostachys* spp.), New Zealand flax (*Phormium tenax*), Japanese pieris (*Pieris japonica*), and Lavender species (*Lavandula* spp.).

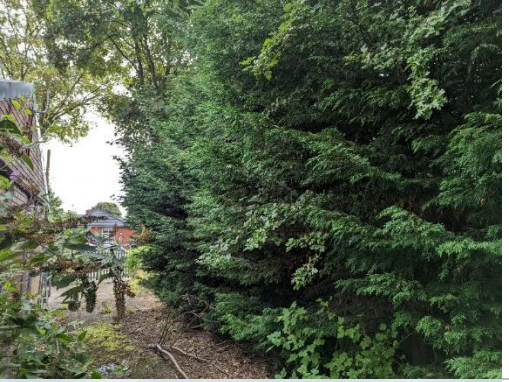
| REF. | DESCRIPTION | PHOTOGRAPH |
|---|---|---|
| H1 | H1 was present adjacent to the hardstanding car park adjacent to the eastern boundary. H1 was approximately 10 m long, 5 m tall and 1 m wide and comprised Lawson's cypress ( <i>Cupressus lawsoniana</i> ). | |

It is recommended that, where possible, trees and hedgerows are retained and protected through development. It is anticipated that some trees, and hedgerows may require removal to facilitate development, and where this is needed, new landscape planting will be introduced to mitigate the loss. Where hedgerows require removal, replacement hedgerow planting is to be undertaken as soon as practicable to mitigate the loss and to maintain the commuting feature through the site. A mix of native woody species is to be utilised to create a species-rich hedgerow, increasing the value of the hedgerows currently on-site.

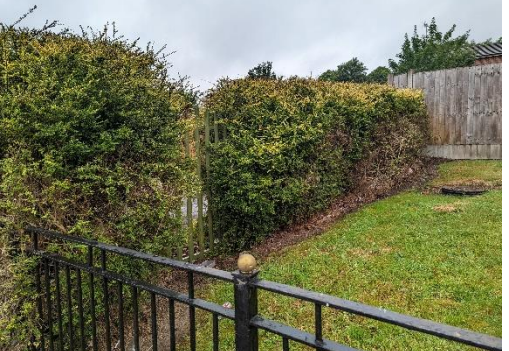
| REF. | DESCRIPTION | PHOTOGRAPH |
|---|---|---|
| H2 | H2 was present adjacent to the southern site boundary. H2 was approximately 5 m long, 2 m tall and 0.5 m wide. H1 comprised Wilson's honeysuckle. | |

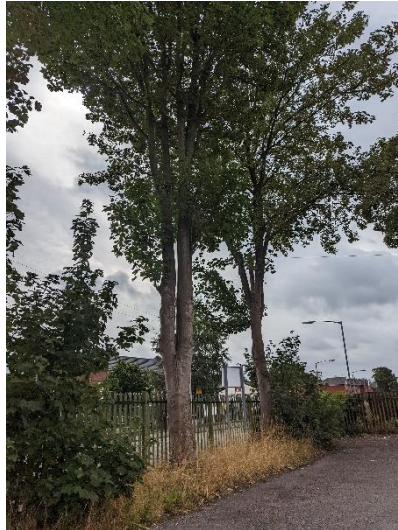
PLATE 7      SHOWING SCATTERED TREES

Scattered trees were present adjacent to the western, eastern, and southern site boundaries and within the centre of the site. Species included sycamore (*Acer pseudoplatanus*), cherry species (*Prunus sp.*), ash and goat willow (*Salix caprea*).

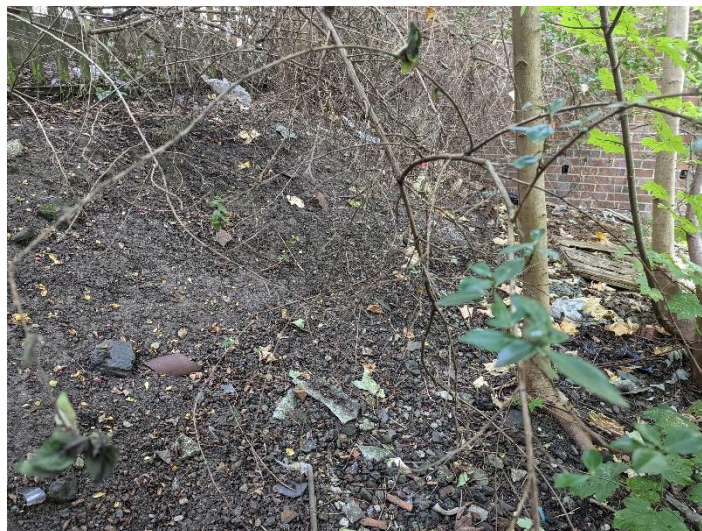
PLATE 8      BARE GROUND

Bare ground was present within the centre of the site. Colonising species present included butterfly bush, field horsetail, sycamore saplings, common nettle, bramble, rosebay willowherb and false oat grass.

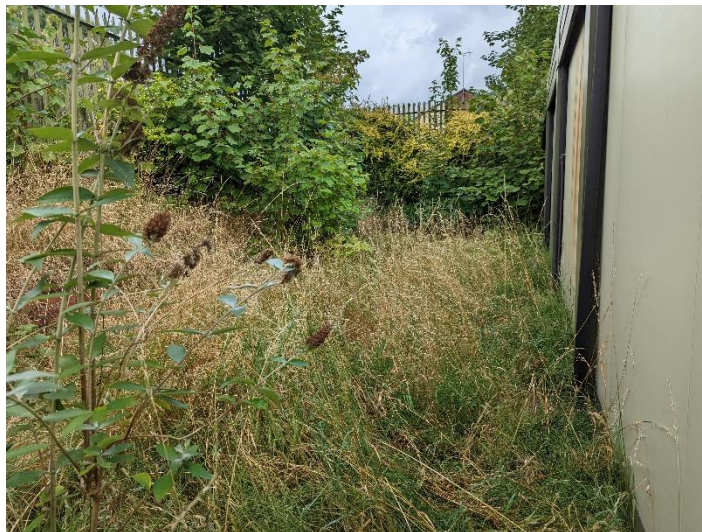
PLATE 9 POOR SEMI-IMPROVED GRASSLAND

Poor semi-improved grassland was present within the centre of the site. Species present included dandelion, false oat-grass (*Arrhenatherum elatius*), rosebay willowherb, ash saplings (*Fraxinus excelsior*), field horsetail, common nettle, and sycamore saplings (*Acer pseudoplatanus*).

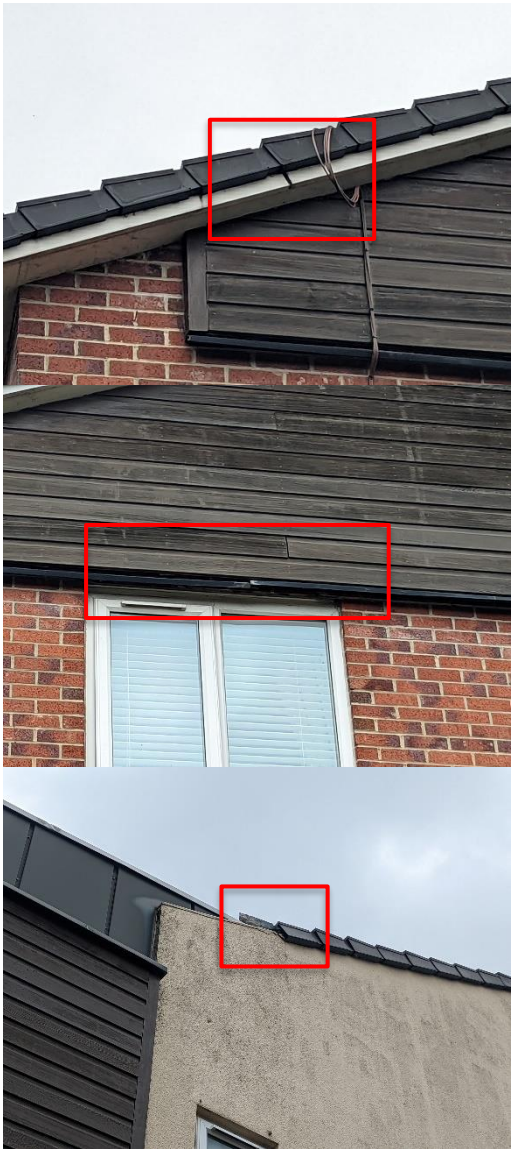
| REF. | DESCRIPTION | PHOTOGRAPH |
|---|---|---|
| B1 | <p>Building 1 comprised a residential unit containing self-contained apartments. The building comprised red brick walls. The wooden cladding was present under several windows on all aspects of the building. The roof comprised tiles with lead flashing and end dry verges.</p> <p>The building was in fairly good condition on all aspects, one gap was present within two pieces of the soffit on the eastern aspect. This gap could provide roosting opportunities for a small number of crevice-dwelling bats on an occasional basis.</p> <p>The wooden cladding on the northern, eastern, and western aspects had lifted sections along the bottom of the feature. This created a crevice between the brickwork and wooden cladding. The crevice could support a small number of bats on an occasional basis.</p> <p>The dry-end verges on the roof on the eastern and western aspects contained gaps where the verges end. These small gaps could support a small number of crevice-dwelling bats on an occasional basis.</p> <p>B1 was assessed as having roosting potential for a small number of crevice-dwelling bats on an occasional basis within a small gap within the soffit, crevices present between the wooden cladding and brickwork and gaps at the end of the dry end verges. As such, B1 was assessed as having <b>Low</b> bat roosting potential.</p> | |

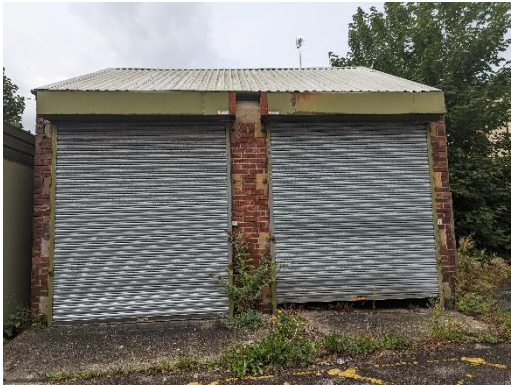
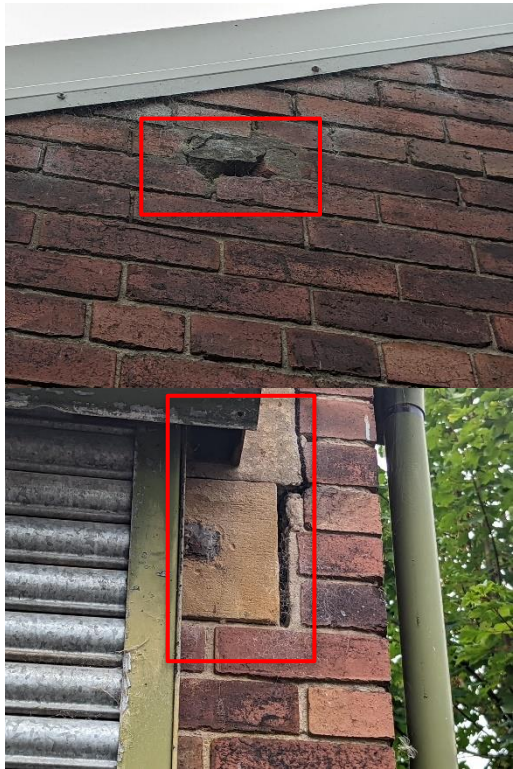
| REF. | DESCRIPTION | PHOTOGRAPH |
|---|---|---|
| B2 | <p>Building 2 comprised a double roller door garage previously used for storage. The walls comprised red brick walls with quions present adjacent to the doorways. The roof comprised corrugated metal with metal bargeboards.</p> <p>The majority of the brickwork was well sealed however, one brickwork crevice was present along the northern aspect. The brickwork crevice could provide a small number of crevice-dwelling bat species roosting opportunities on an occasional basis.</p> <p>Crevices were present around the quions on the eastern aspect of the building, these</p> | |

| REF. | DESCRIPTION | PHOTOGRAPH |
|---|---|---|
| | <p>crevices could support a roost containing a small number of crevice-dwelling bats on an occasional basis.</p> <p>B2 was assessed as having roosting potential for a small number of crevice-dwelling bats on an occasional basis within an area of damaged brickwork and services present around the quions. As such, B2 was assessed as having <b>Low</b> bat roosting potential.</p> | |

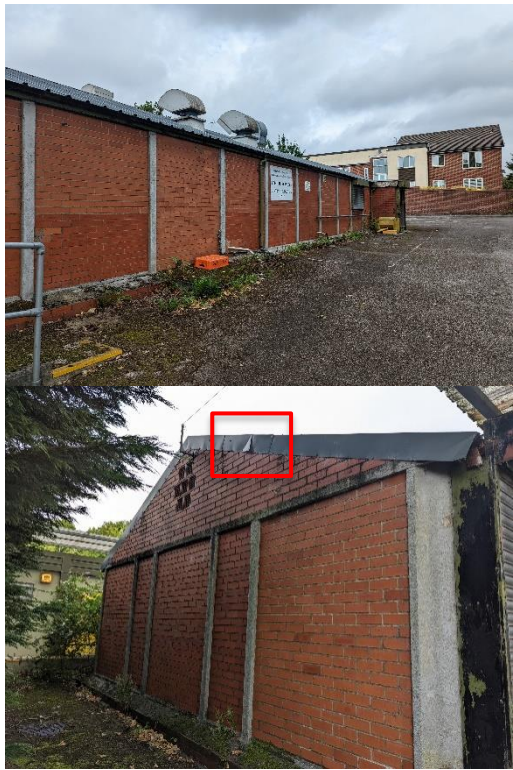
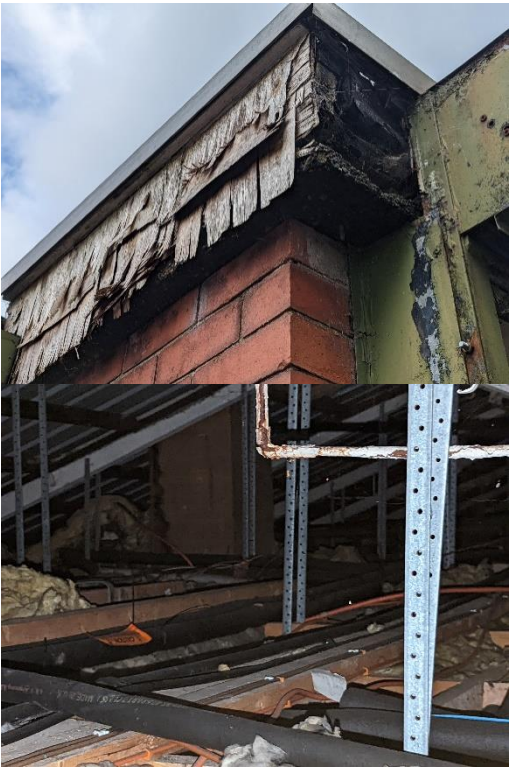
| REF. | DESCRIPTION | PHOTOGRAPH |
|---|---|---|
| <b>B3</b> | <p>Building 3 comprised red brickwork walls with a corrugated metal roof on the eastern aspect. The western aspect of the building comprised metal sheeting walls, barge board and a corrugated metal roof.</p> <p>Externally, B3 featured a lifted section of bargeboard along the southern aspect of the building. This could provide internal access to the loft void within the building. The area of lifting could provide a crevice that could support a small number of crevice-dwelling bats on an occasional basis.</p> <p>The main entrance to B3 featured plywood bargeboards that were damaged and contained lifted sections. The damage and lifted sections of boarding could provide roosting opportunities for a small number of crevice-dwelling bats on an occasional basis.</p> <p>Internally, the building comprised several refrigerated rooms with food preparation and office space. Internal access for bats to B3 was possible via the lifted metal bargeboard along the southern aspect. The access point provided access to the building's loft void.</p> | |

| REF. | DESCRIPTION | PHOTOGRAPH |
|---|---|---|
| | <p>The loft void comprised a corrugated metal roof with open beams and insulation. Also present were thin metal supporting beams. The brickwork was present at each gable end and featured sections of peeling paintwork. The paintwork was thin and as such did not provide any potential roosting features. The internal brickwork was well sealed and did not contain any crevices that could provide a roosting feature. As the internal loft void did not contain any potential roosting features, the building could not support a larger number of bats on a more regular basis.</p> <p>B3 was assessed as having roosting potential for a small number of crevice-dwelling bats on an occasional basis within a crevice behind a section of lifted metal bargeboard and damaged and lifted sections of plywood bargeboard. As such, B3 was assessed as having <b>Low</b> bat roosting potential.</p> | |

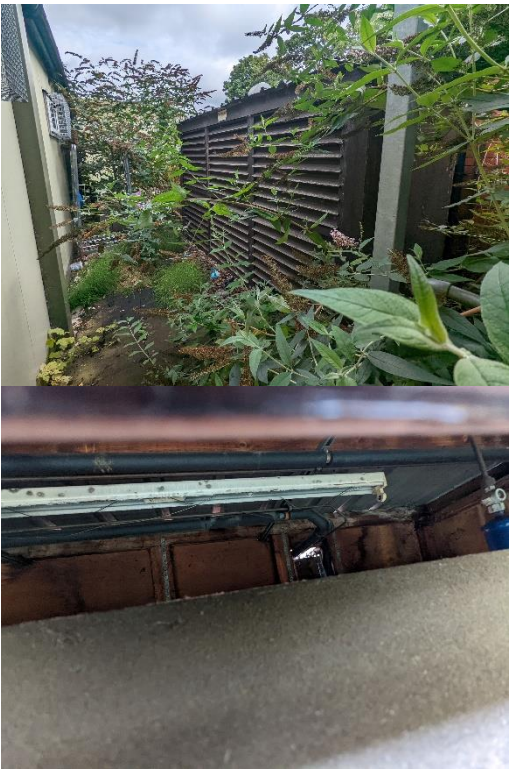
| REF. | DESCRIPTION | PHOTOGRAPH |
|---|---|---|
| S1 | <p>Structure 1 comprised a small substation located between the two sections of B3. The gaps created by the vents could provide internal access to S1. However, no potential bat roosting features were present within the structure.</p> <p>S1 was assessed as having no potential roosting features and as such, assessed as having <b>Negligible</b> bat roosting potential.</p> | |

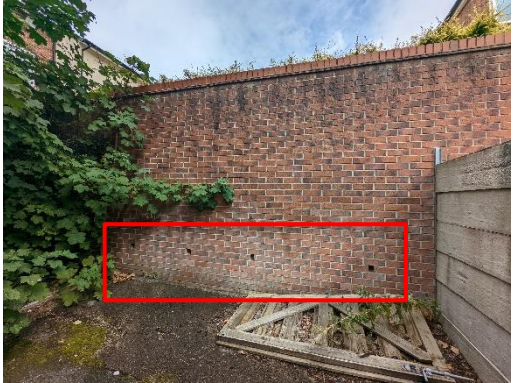
| REF. | DESCRIPTION | PHOTOGRAPH |
|---|---|---|
| W1 | <p>Wall 1 comprised a red brick wall approximately 1.5 m in height.</p> <p>The brickwork of the wall was well sealed with no brickwork crevices present. Some small holes were present along the bottom of the wall. However, these were discounted as having bat roosting potential due to the distance from the ground.</p> <p>W1 was assessed as having no potential roosting features and as such, assessed as having <b>Negligible</b> bat roosting potential.</p> | |
