**This Record sheet is only applicable to block and beam floor slabs for Characteristic Situation 2 gas protection systems**

Plot No.: 14 ..... Inspection Stage - Stage 2 - Floor Stage

**For Residential Development at New Church Street, Radcliffe.**

## Gas Protection - Validation Record Sheet

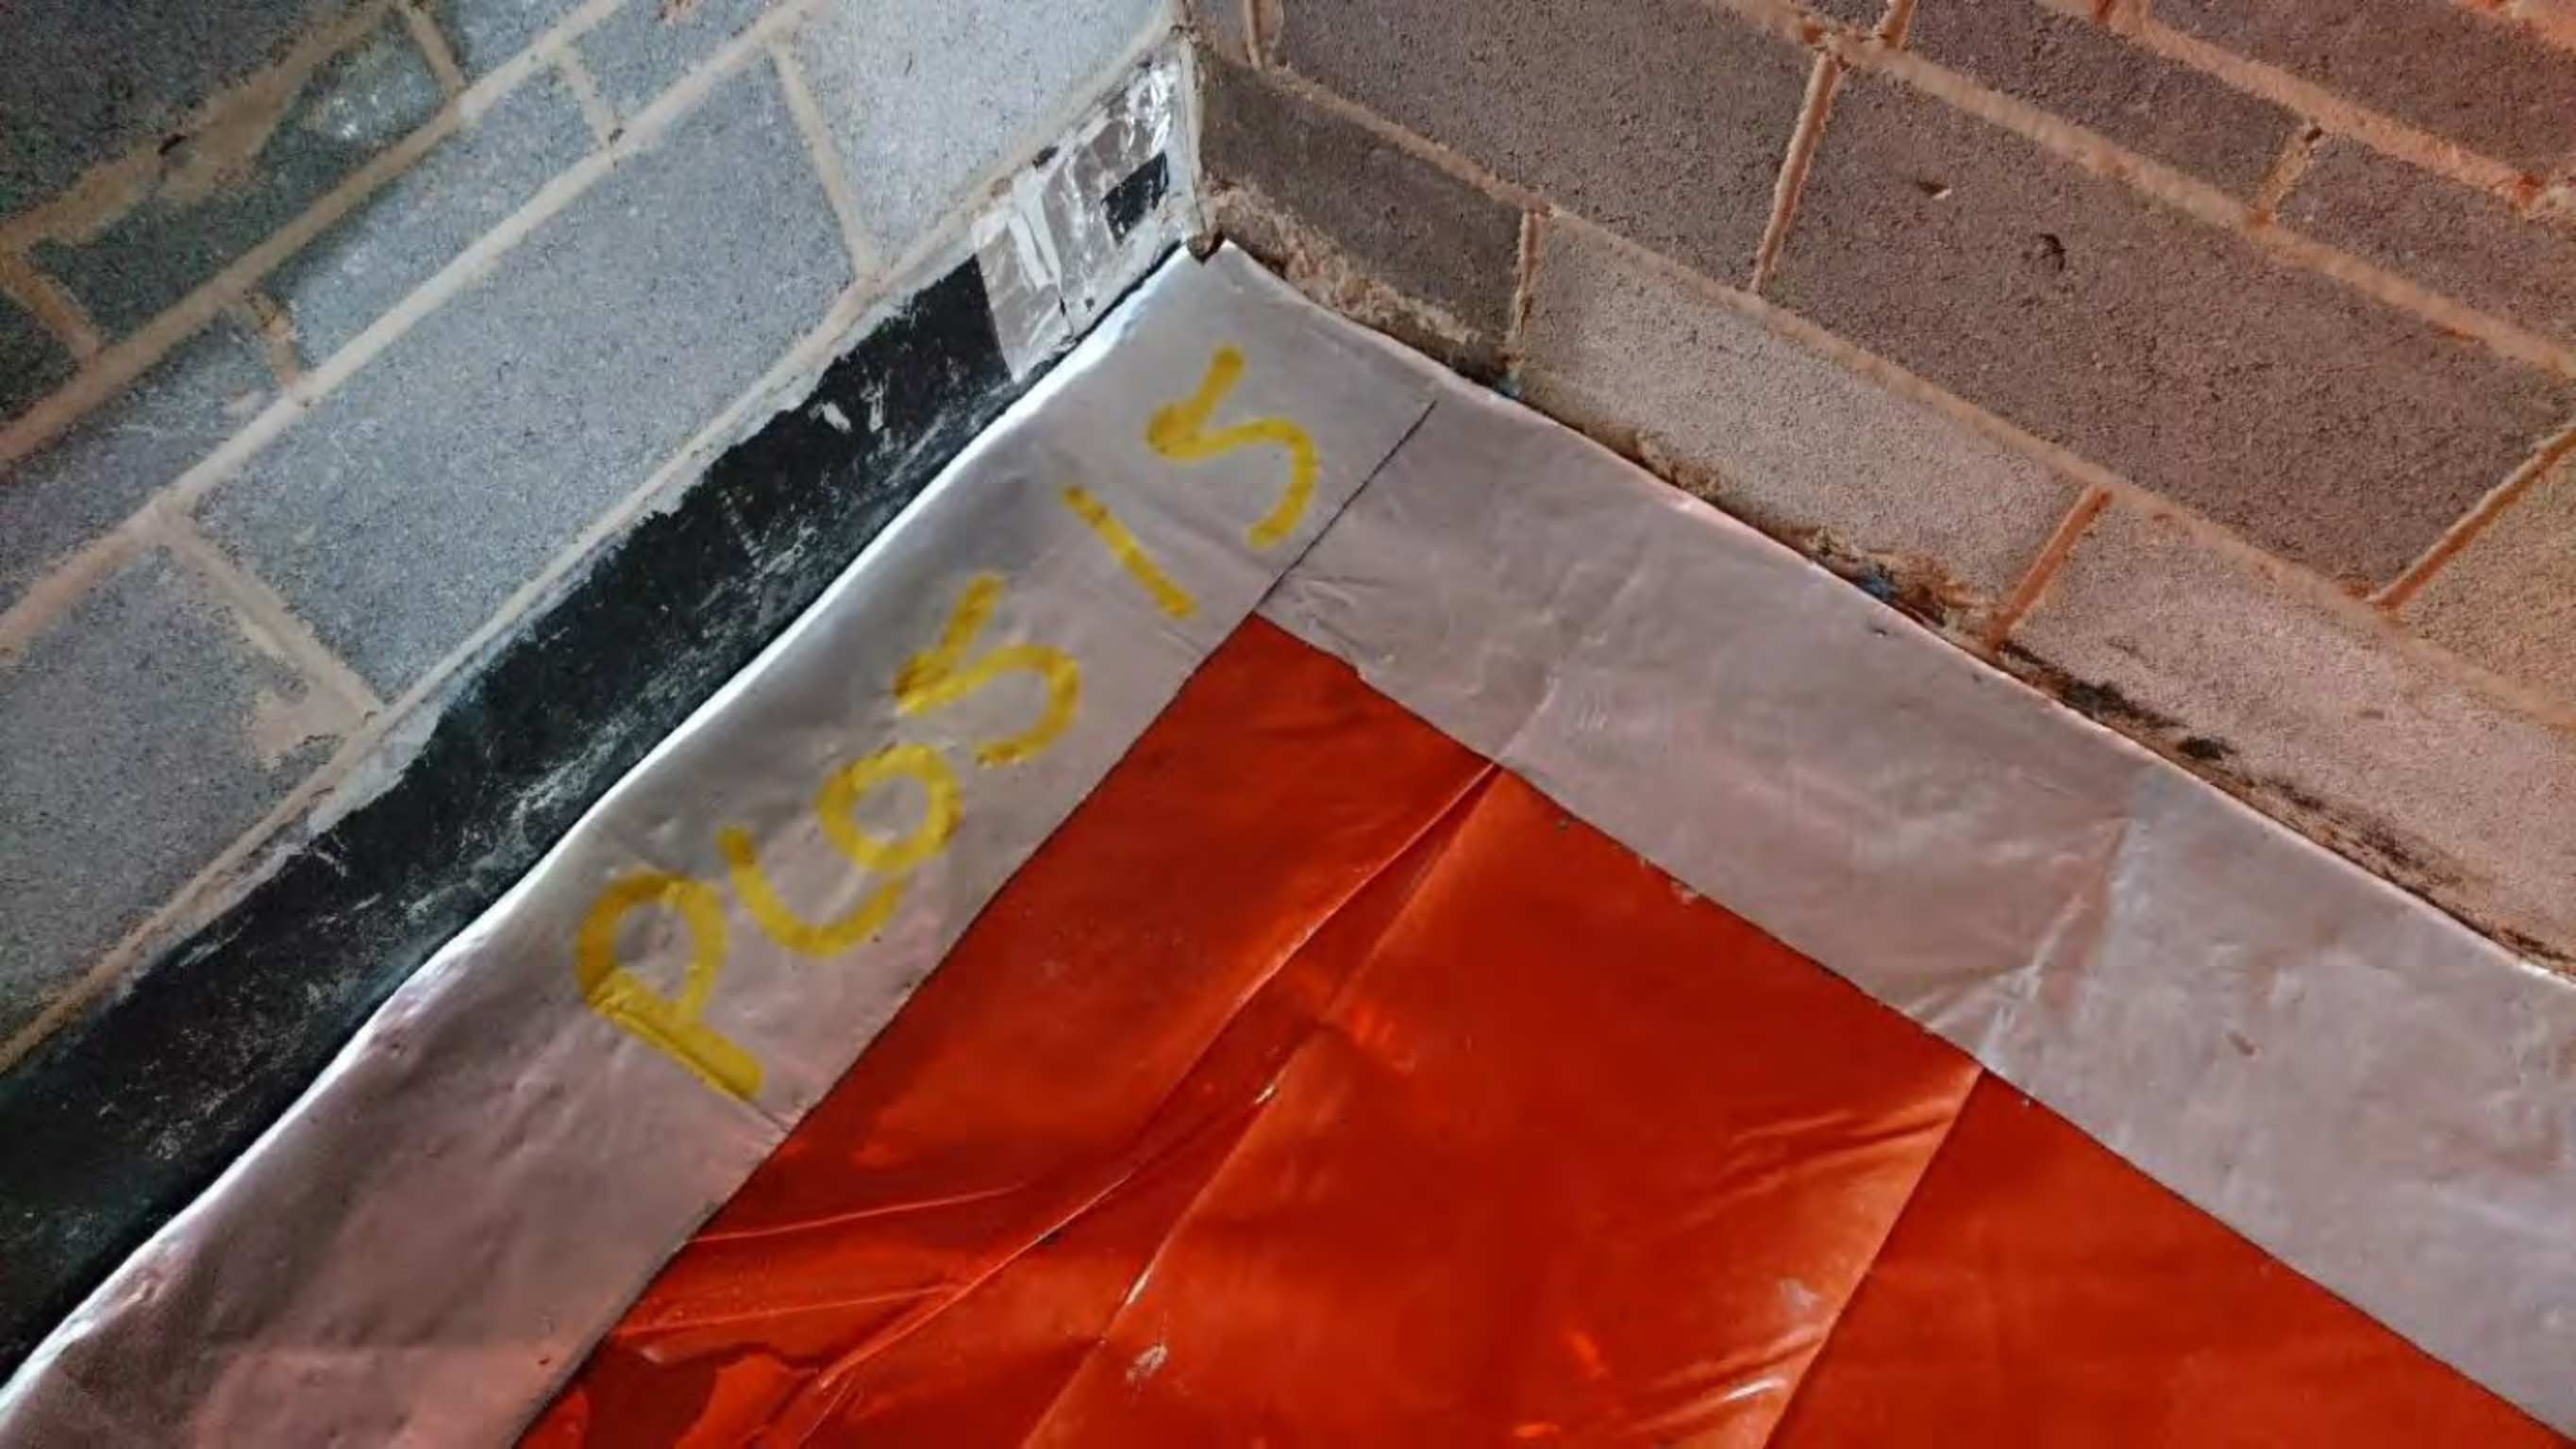
PLOT 15

| 2.1 | Condition of sub-grade & underside of gas membrane | <u>PLOT SWEEP + SNOTS REMOVED. FLOOR LEVEL + FLAT. NO RIPS OR TEARS VISIBLE.</u> | | | | | |
| 2.3 | Gas membrane condition and coverage | <u>PRIMER APPLIED, MEMBRANE CLEANED. NEAT + TIDY, SEALED TO STAGE 1 AGAINST WALL CAVITY</u> | | | | | |
| 2.6 | Condition of joints/seals | <u>CREASINE PRESENT, SO 300mm RADBAR DETAILING TAPE APPLIED ON FULL PERIMETER.</u> | | | | | |
| 2.7 | Number and condition of service entry seals | <u>TWO, 1 TOPHAT – PREFORMED</u> | | | | | |
| 2.8 | Membrane steps/corner seals | <u>ALL GOOD, SQUARE WITH CORNERS SEALED WELL. TAPE VISIBLE.</u> | | | | | |

| 2.9 | Repairs or Corrections: | <u>AS PER PHOTOS, ADDITIONAL 300mm RADBAR DETAILING TAPE USED AS SHOWN</u> | | | | | |

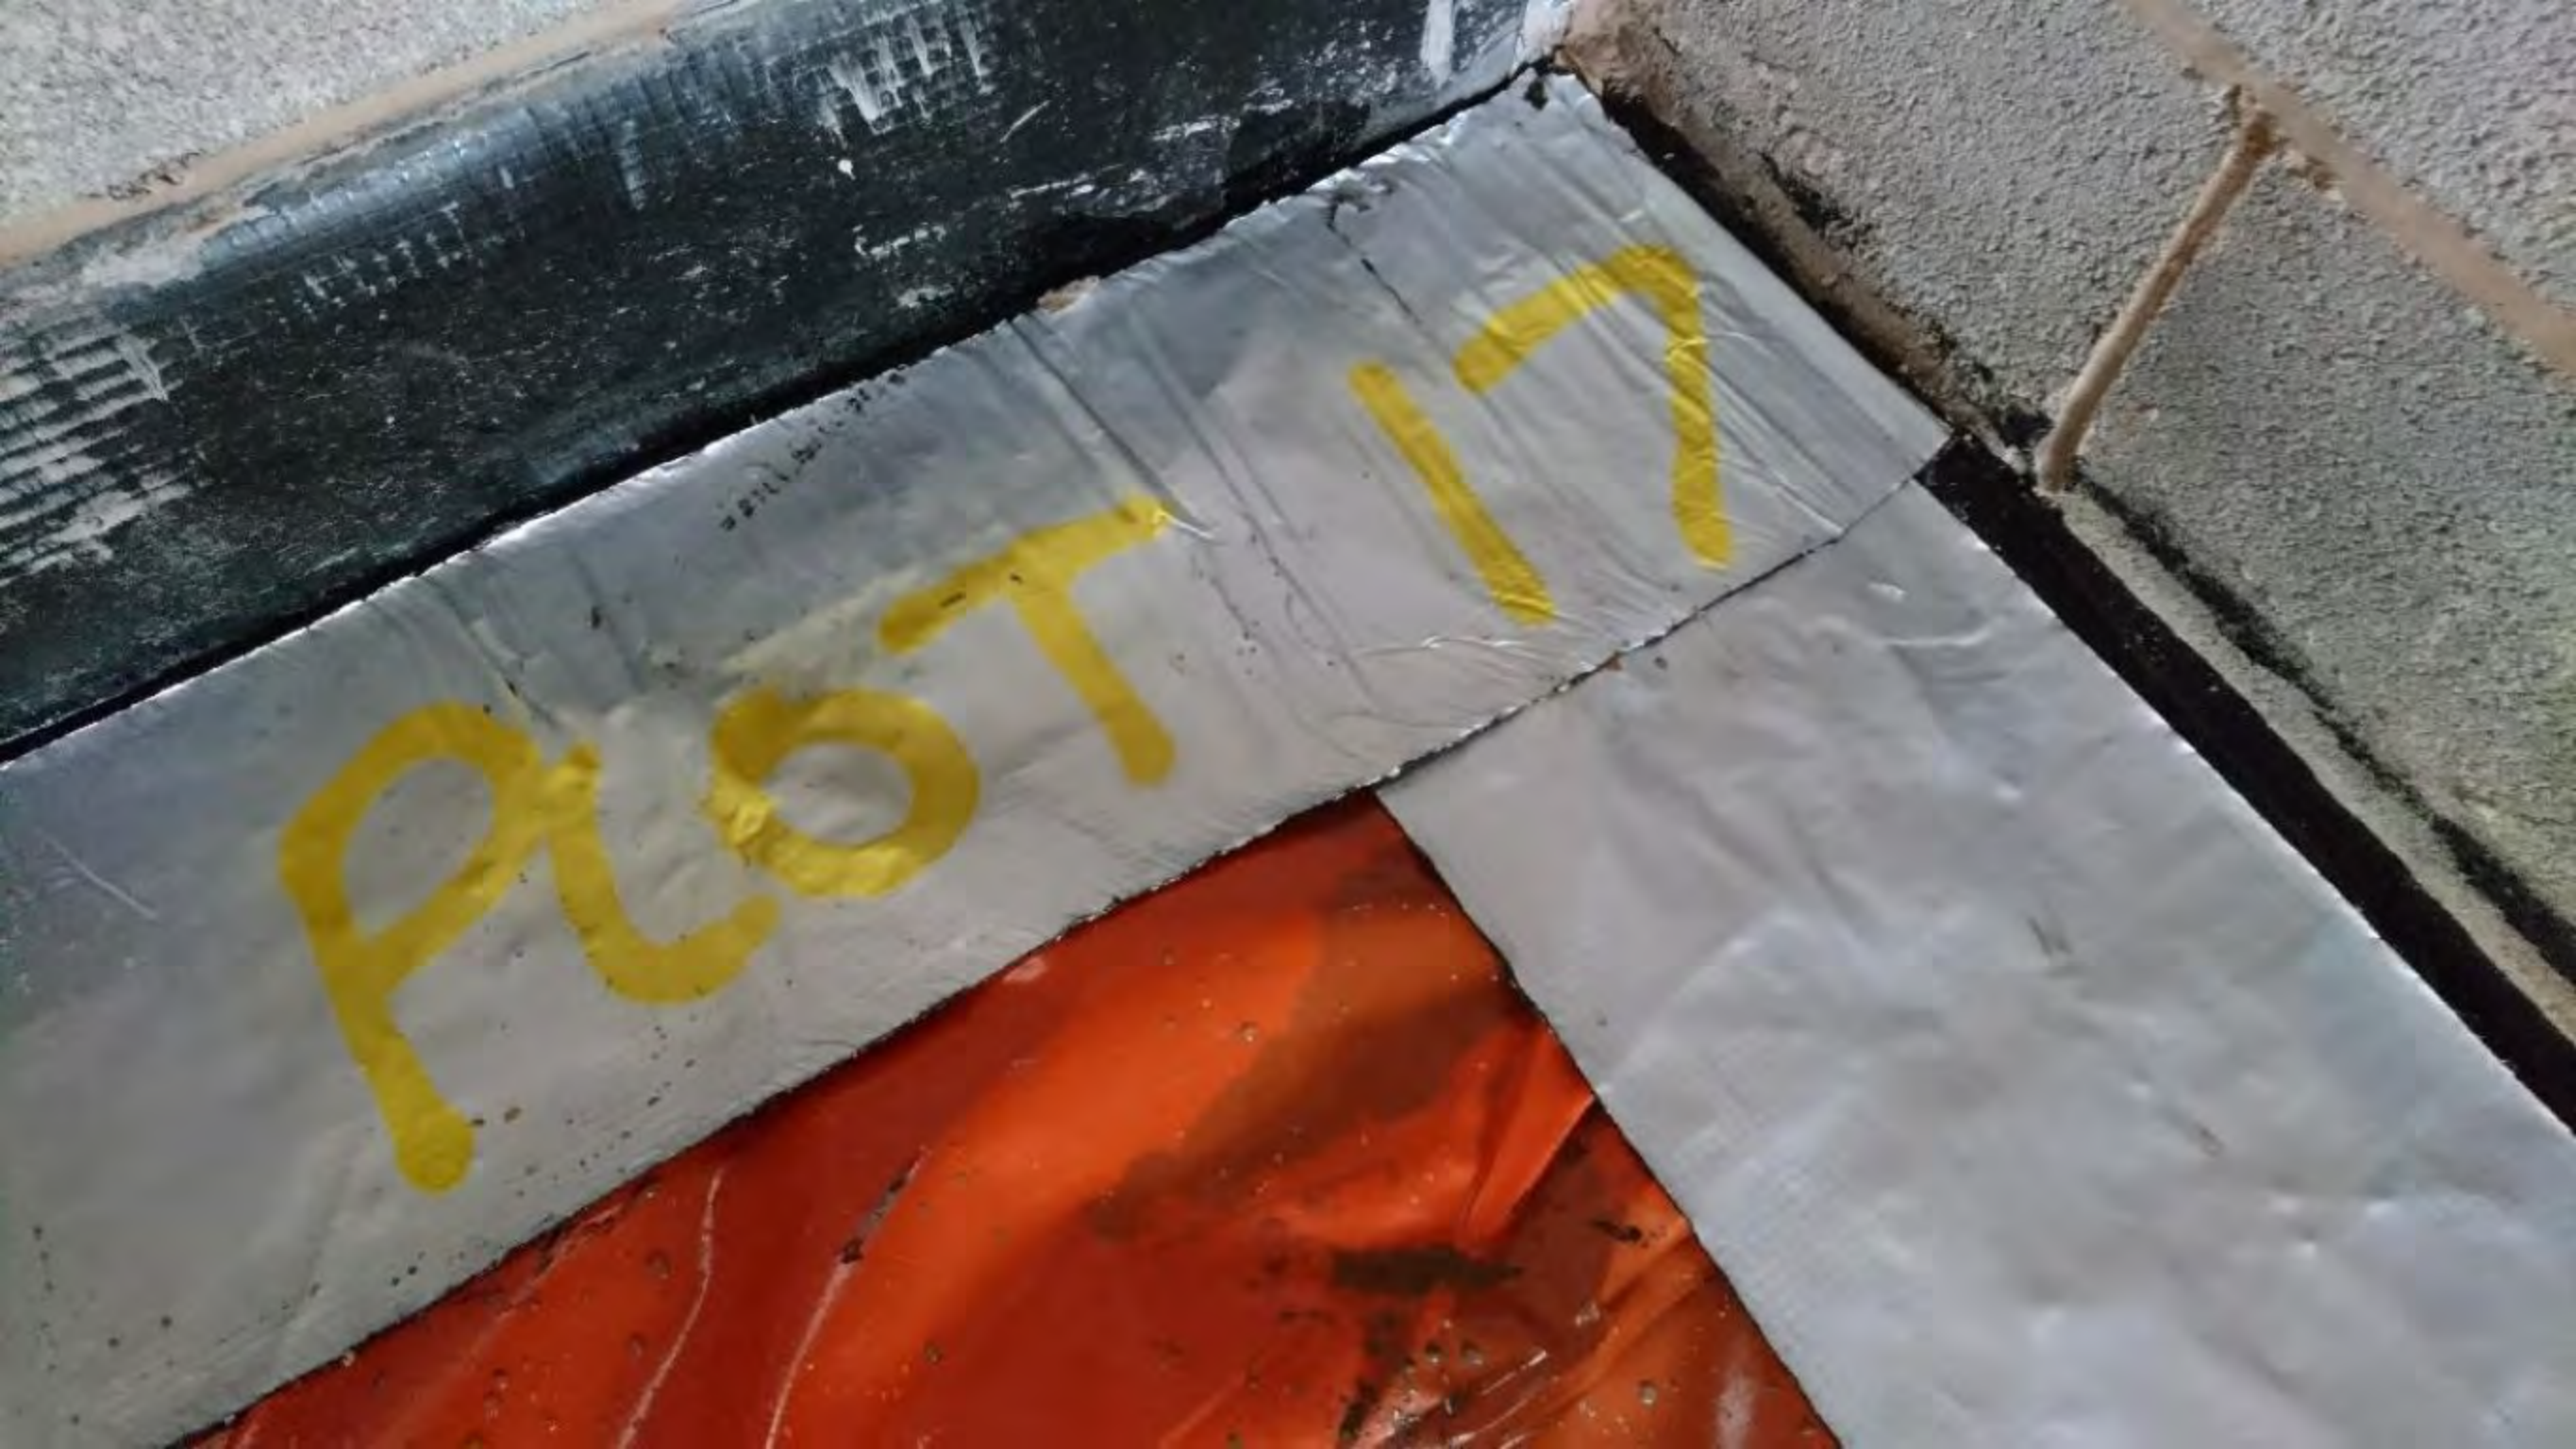
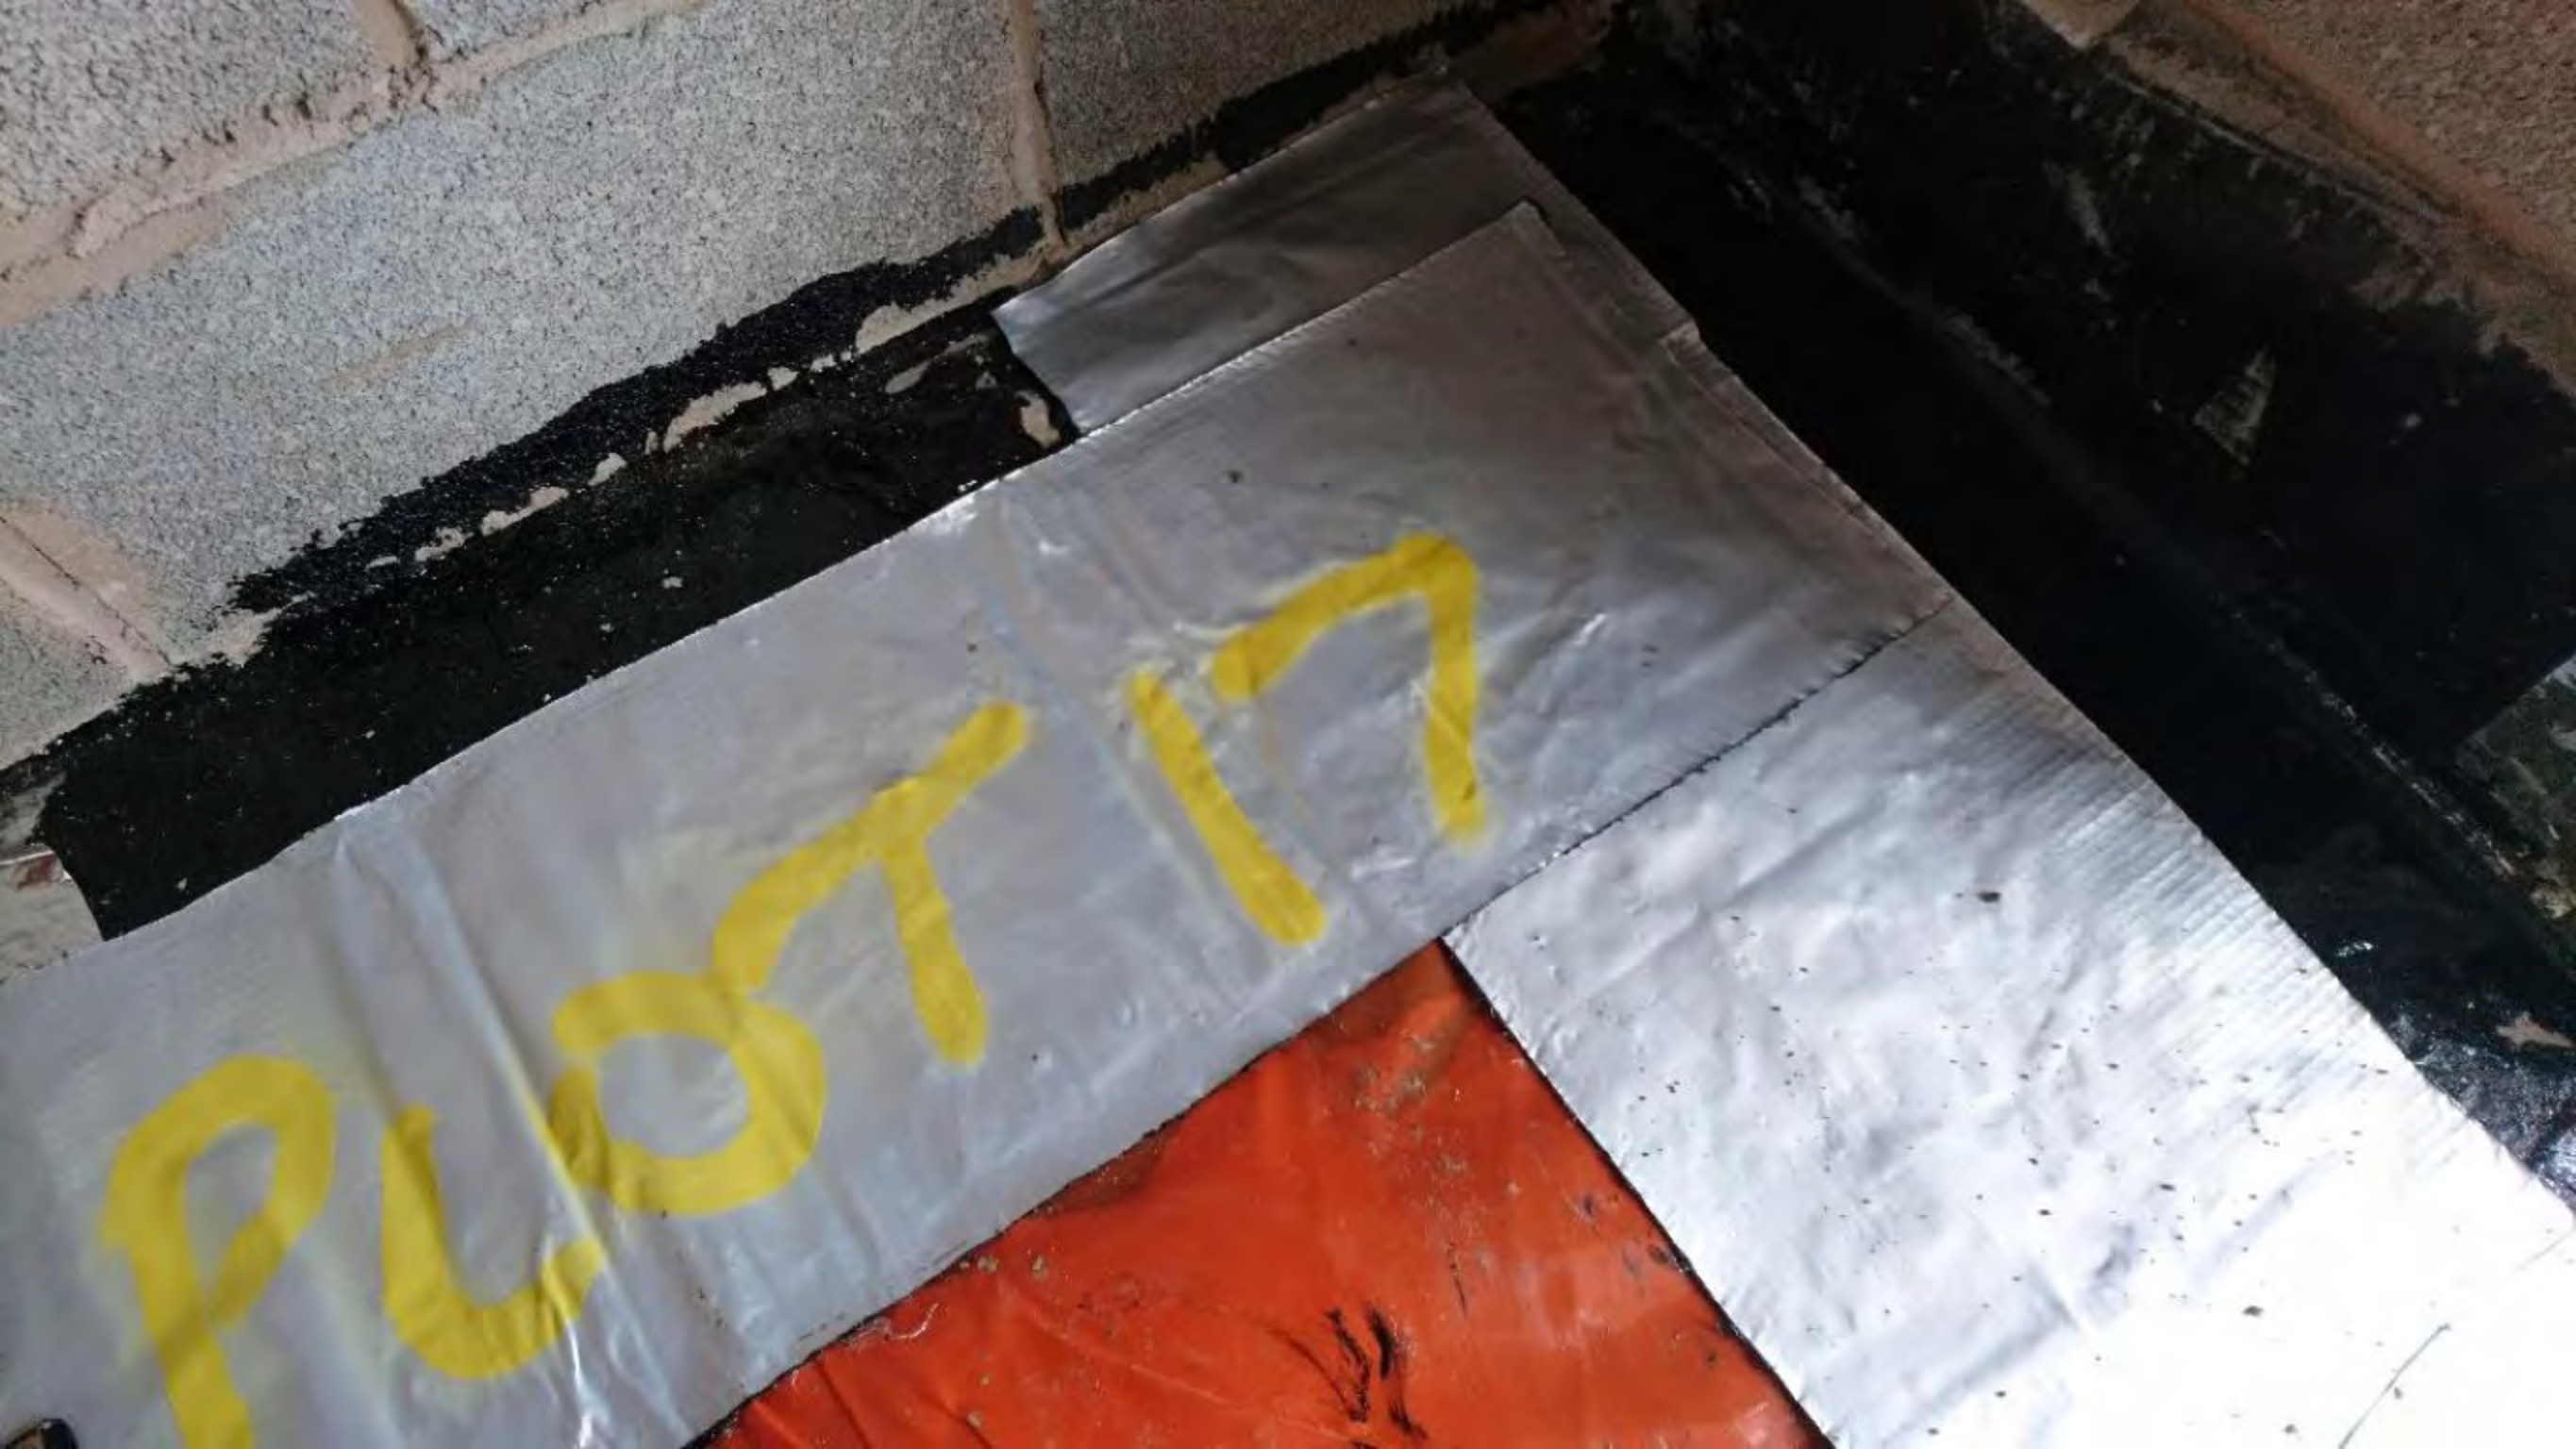
PLOT 17

| 2.1 | Condition of sub-grade & underside of gas membrane | LEVEL + FLAT - FLOT SWEEP OUT. NO FOREIGN OBJECTS UNDER MEMBRANE. NO RISERS. | | | | | |
| 2.3 | Gas membrane condition and coverage | PRIMER APPLIED, SEALED TO STAGE 1 AGAINST WALL CAVITY. CLEAN, NEAT + TIDY. | | | | | |
| 2.6 | Condition of joints/seals | CREASING, SO 300mm RADBAR TAPE APPLIED ON FULL PERIMETER TO PREVENT LEAKAGE. | | | | | |
| 2.7 | Number and condition of service entry seals | TWO IN TOTAL, 1 TOPHAT - PERFORMED. | | | | | |
| 2.8 | Membrane steps/corner seals | ALL GOOD, LAPS AS PER RECOMMENDATIONS, SQUARE WITH TAPE VISIBLE. | | | | | |

| 2.9 | Repairs or Corrections: | AS PER PHOTOS, EXTRA TAPE AROUND TOPHAT. 300mm RADBAR DETAILING TAPE | | | | | |
