**This Record sheet is only applicable to block and beam floor slabs for Characteristic Situation 2 gas protection systems**

Plot No.: 14 ..... Inspection Stage - Stage 2 - Floor Stage

**For Residential Development at New Church Street, Radcliffe.**

## Gas Protection - Validation Record Sheet

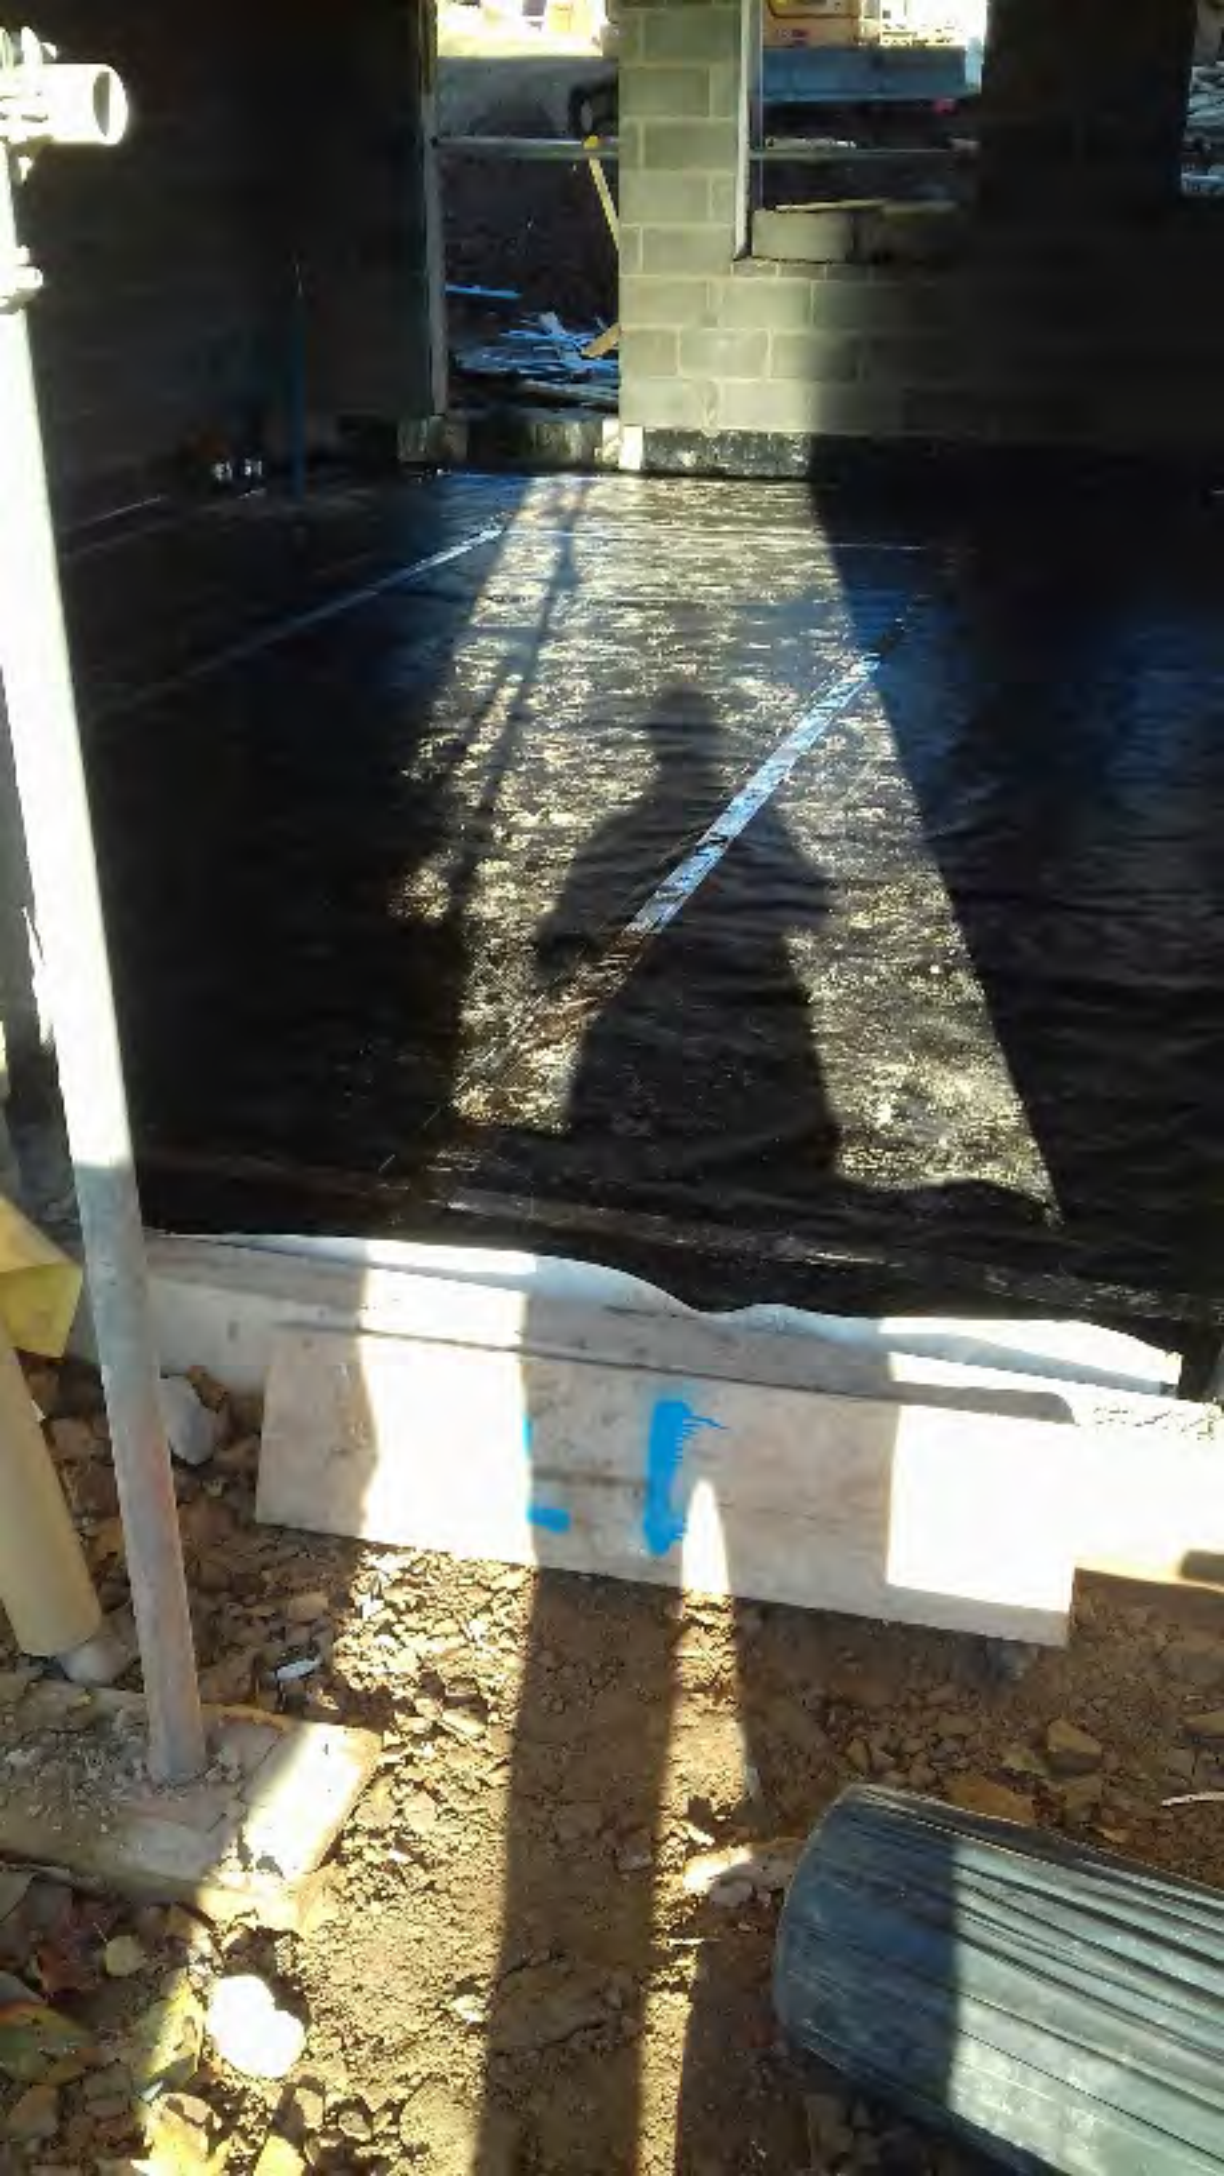
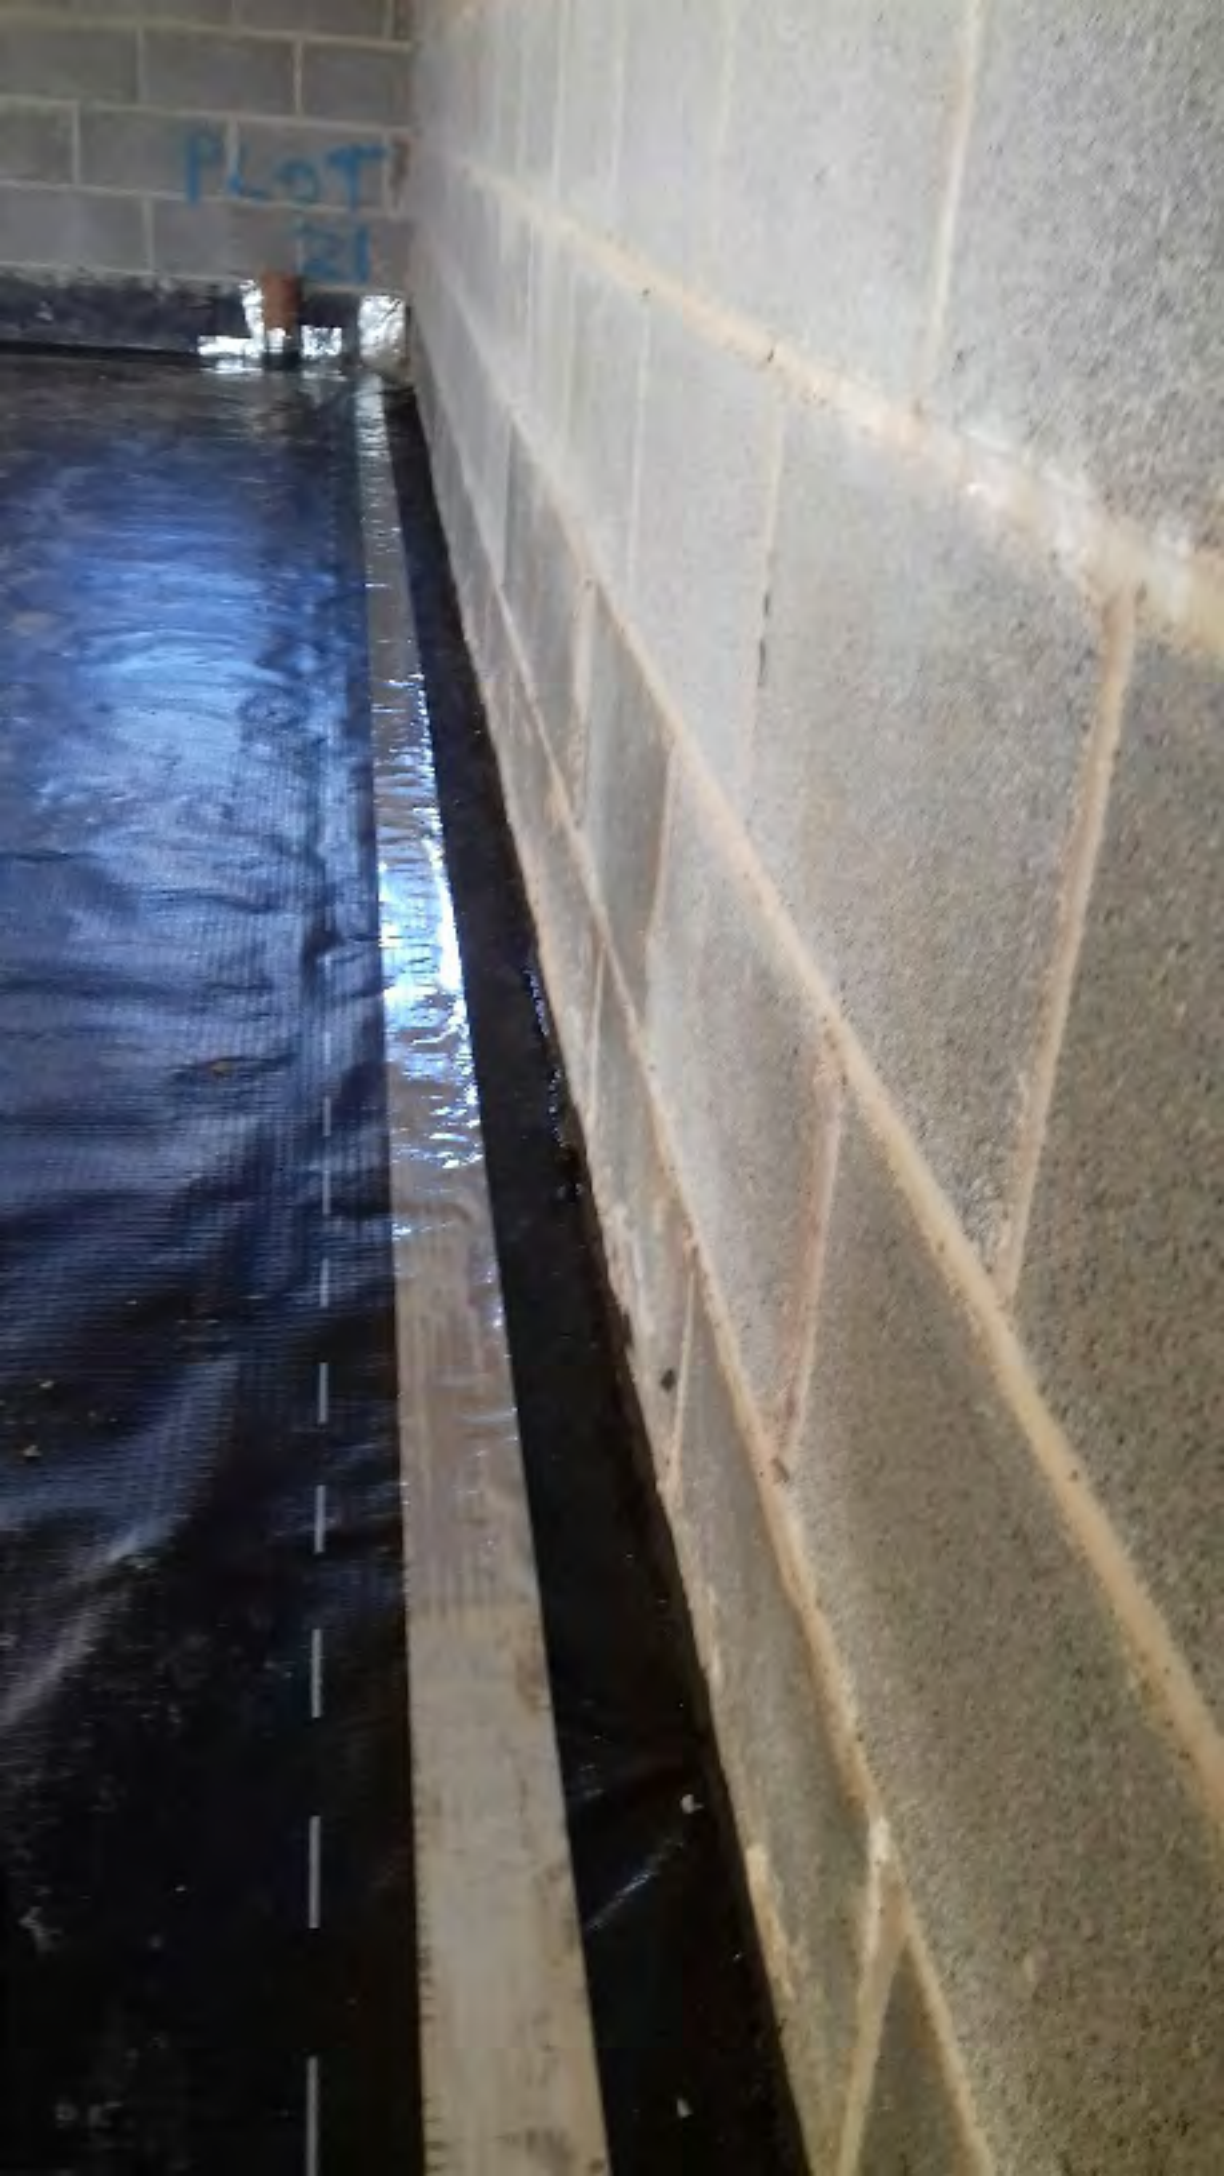
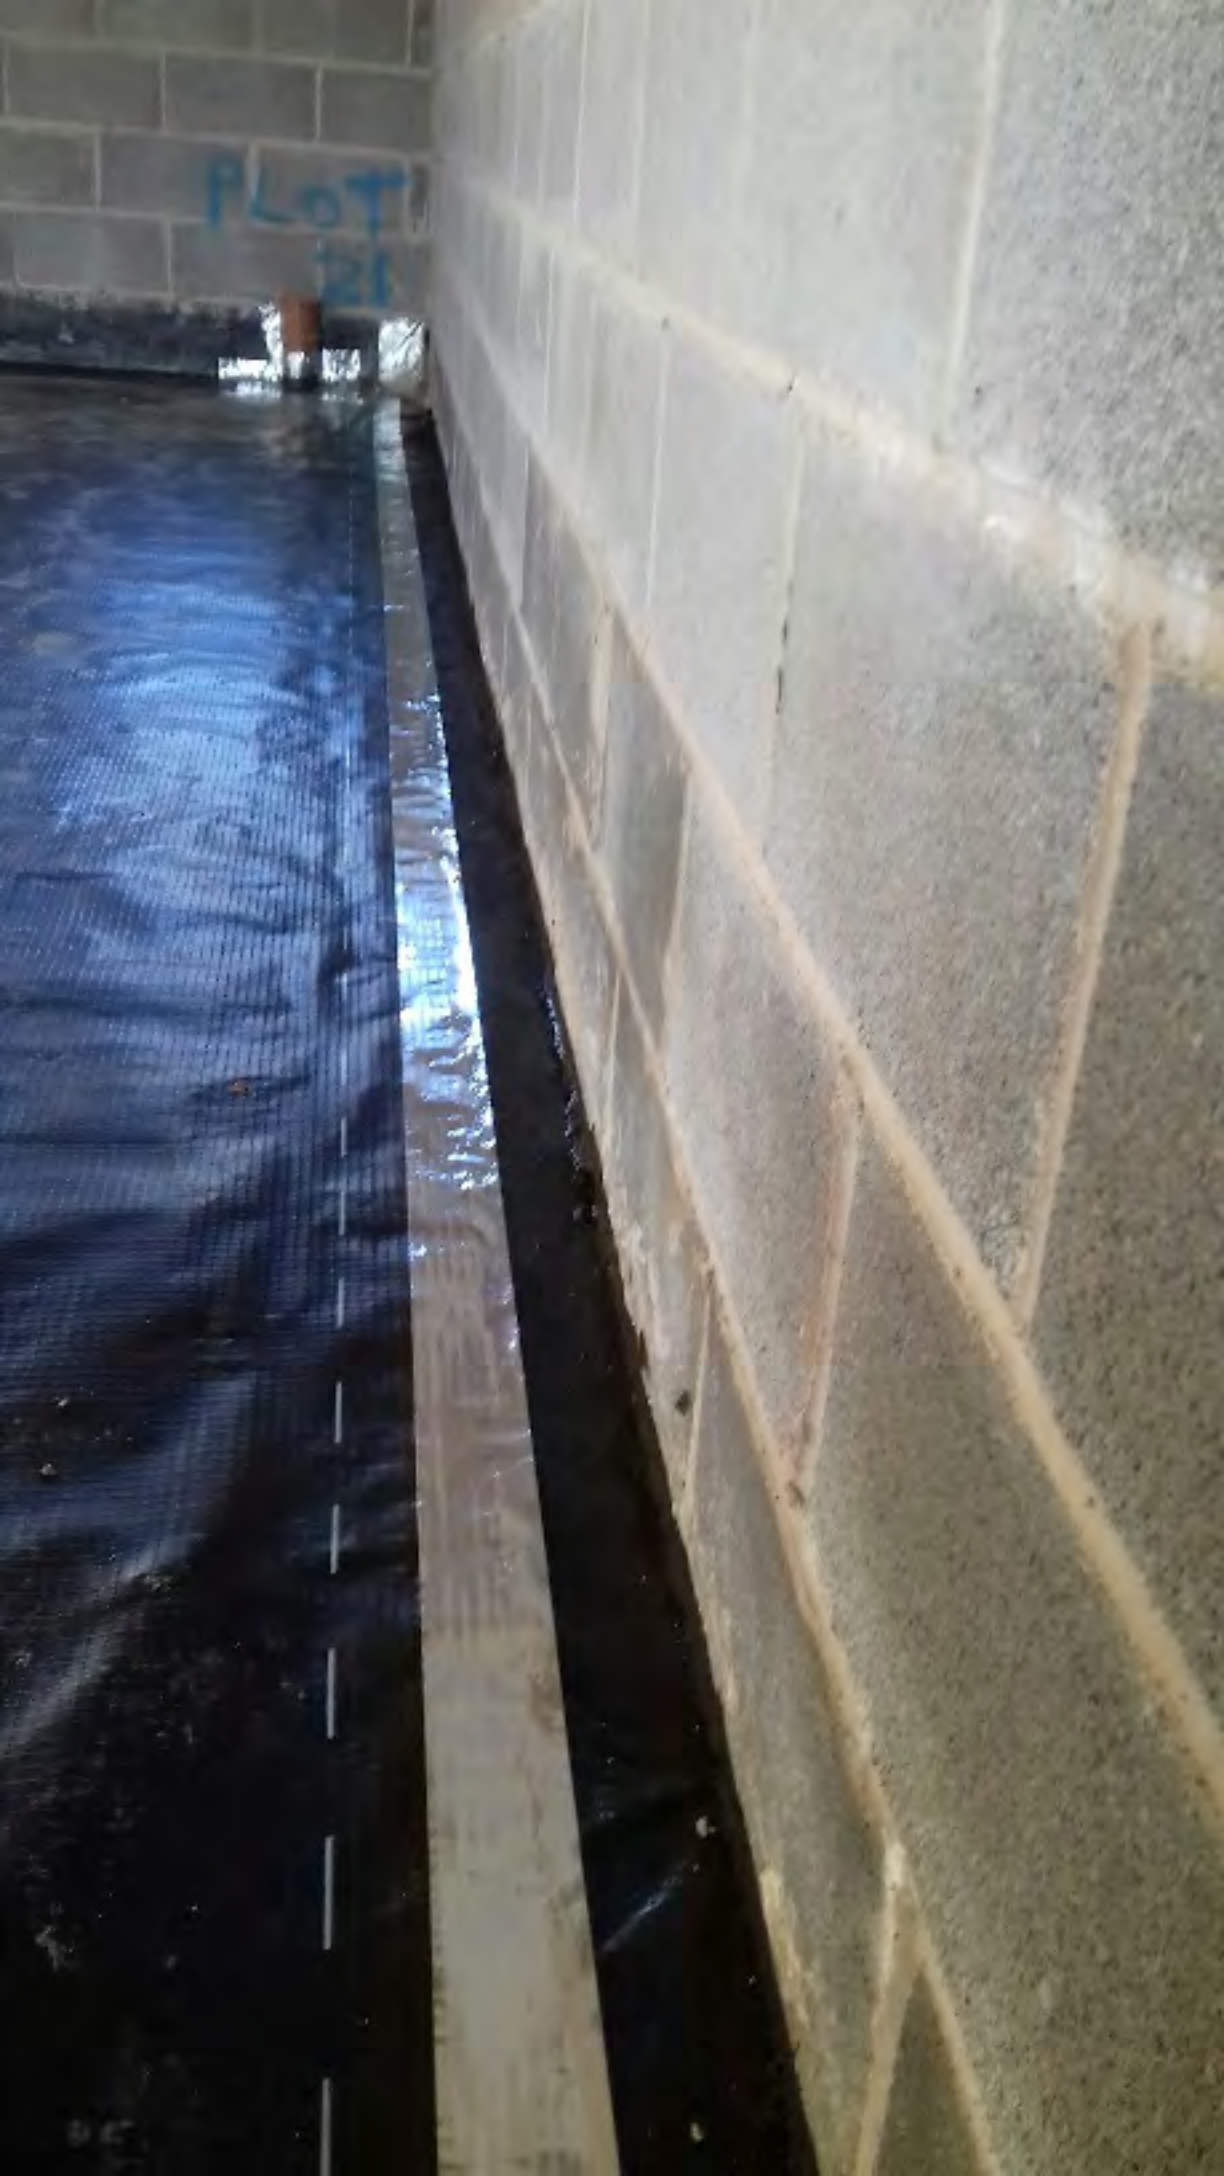
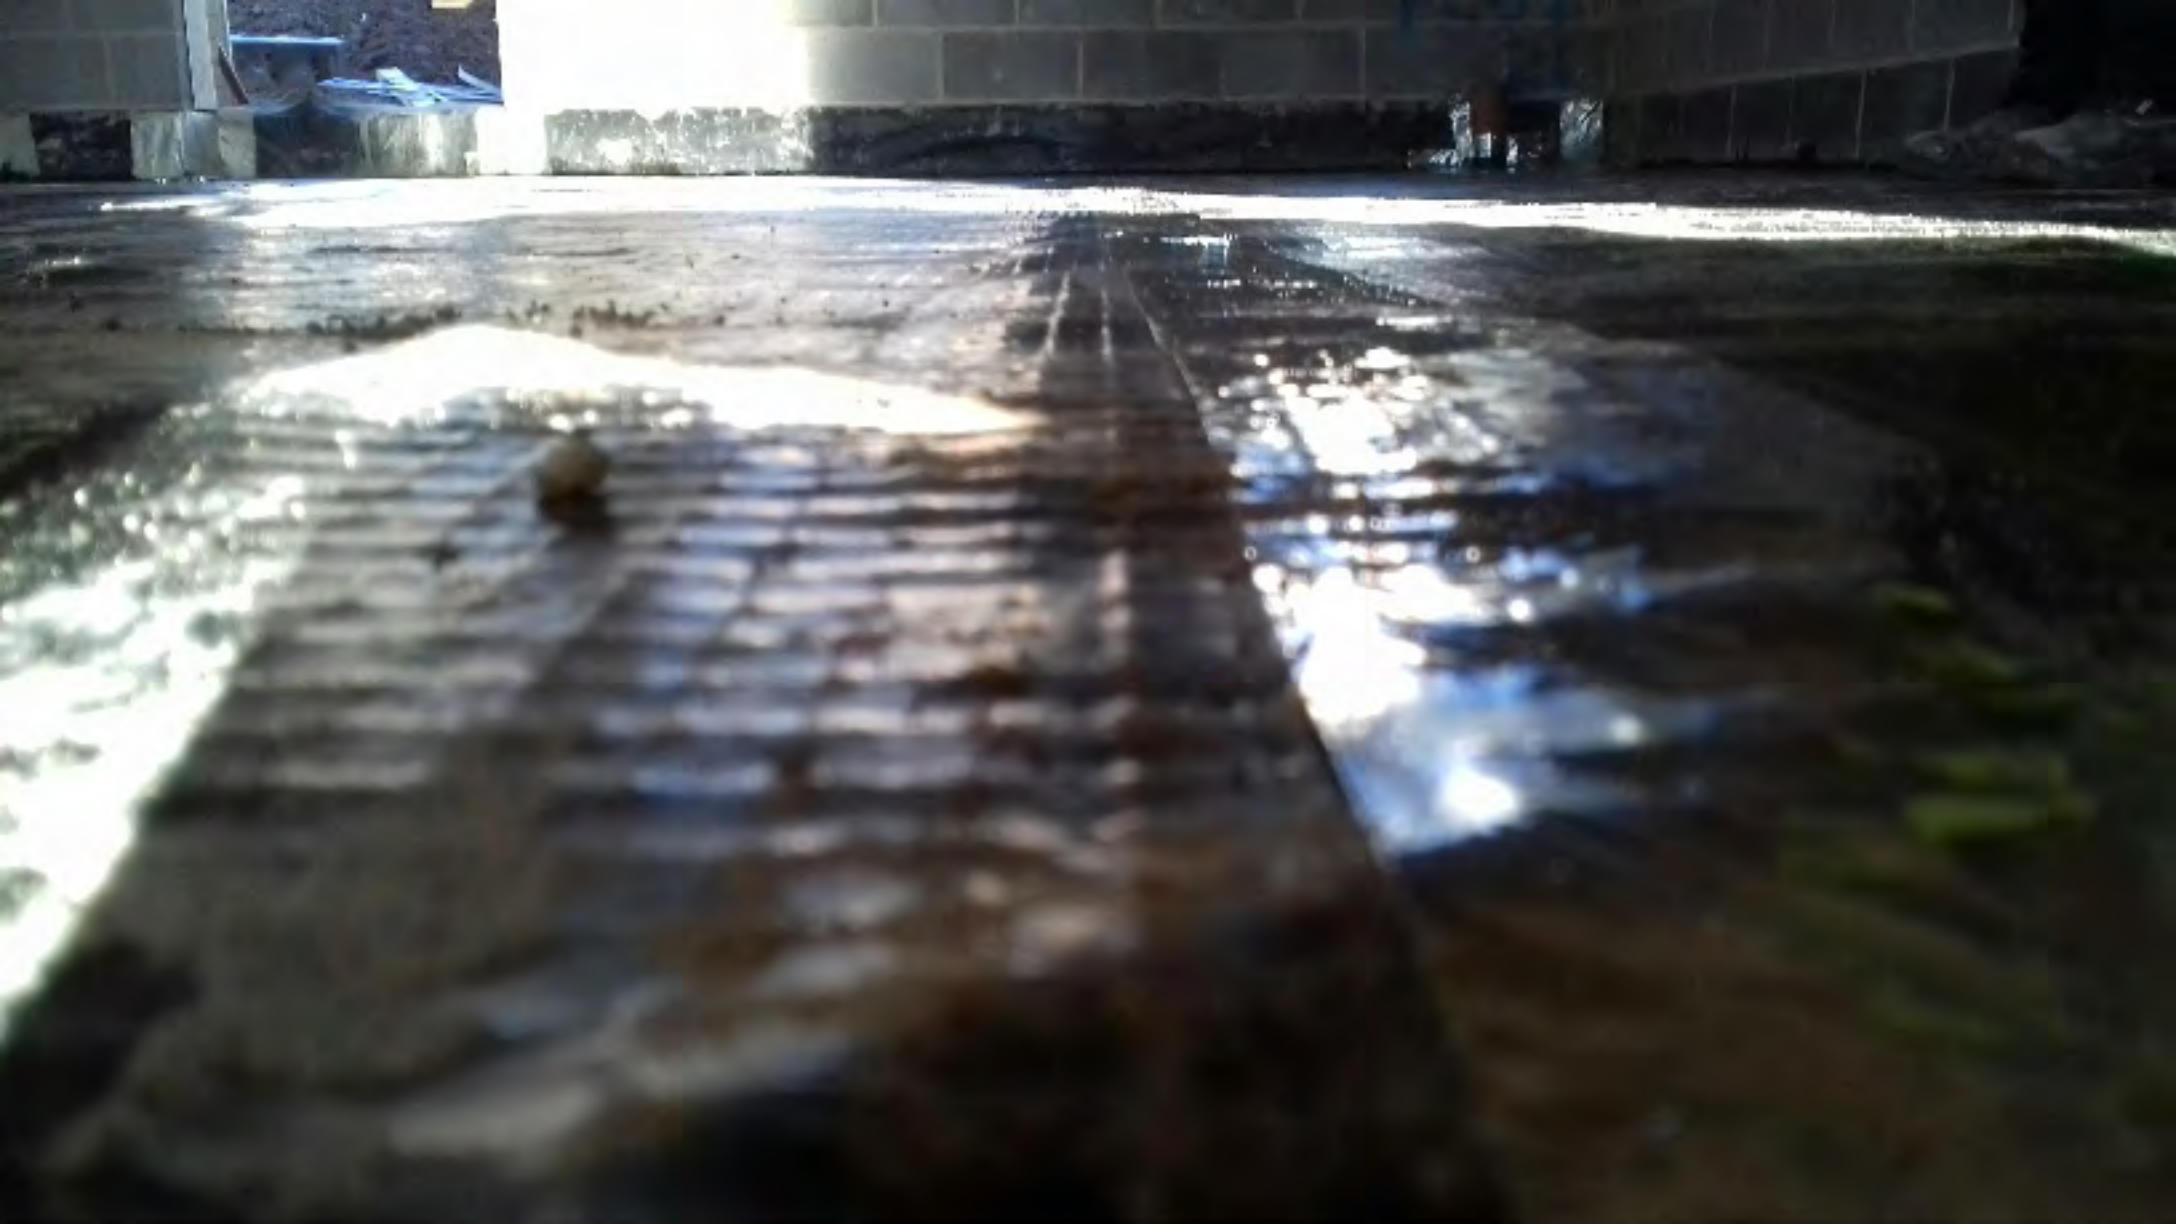
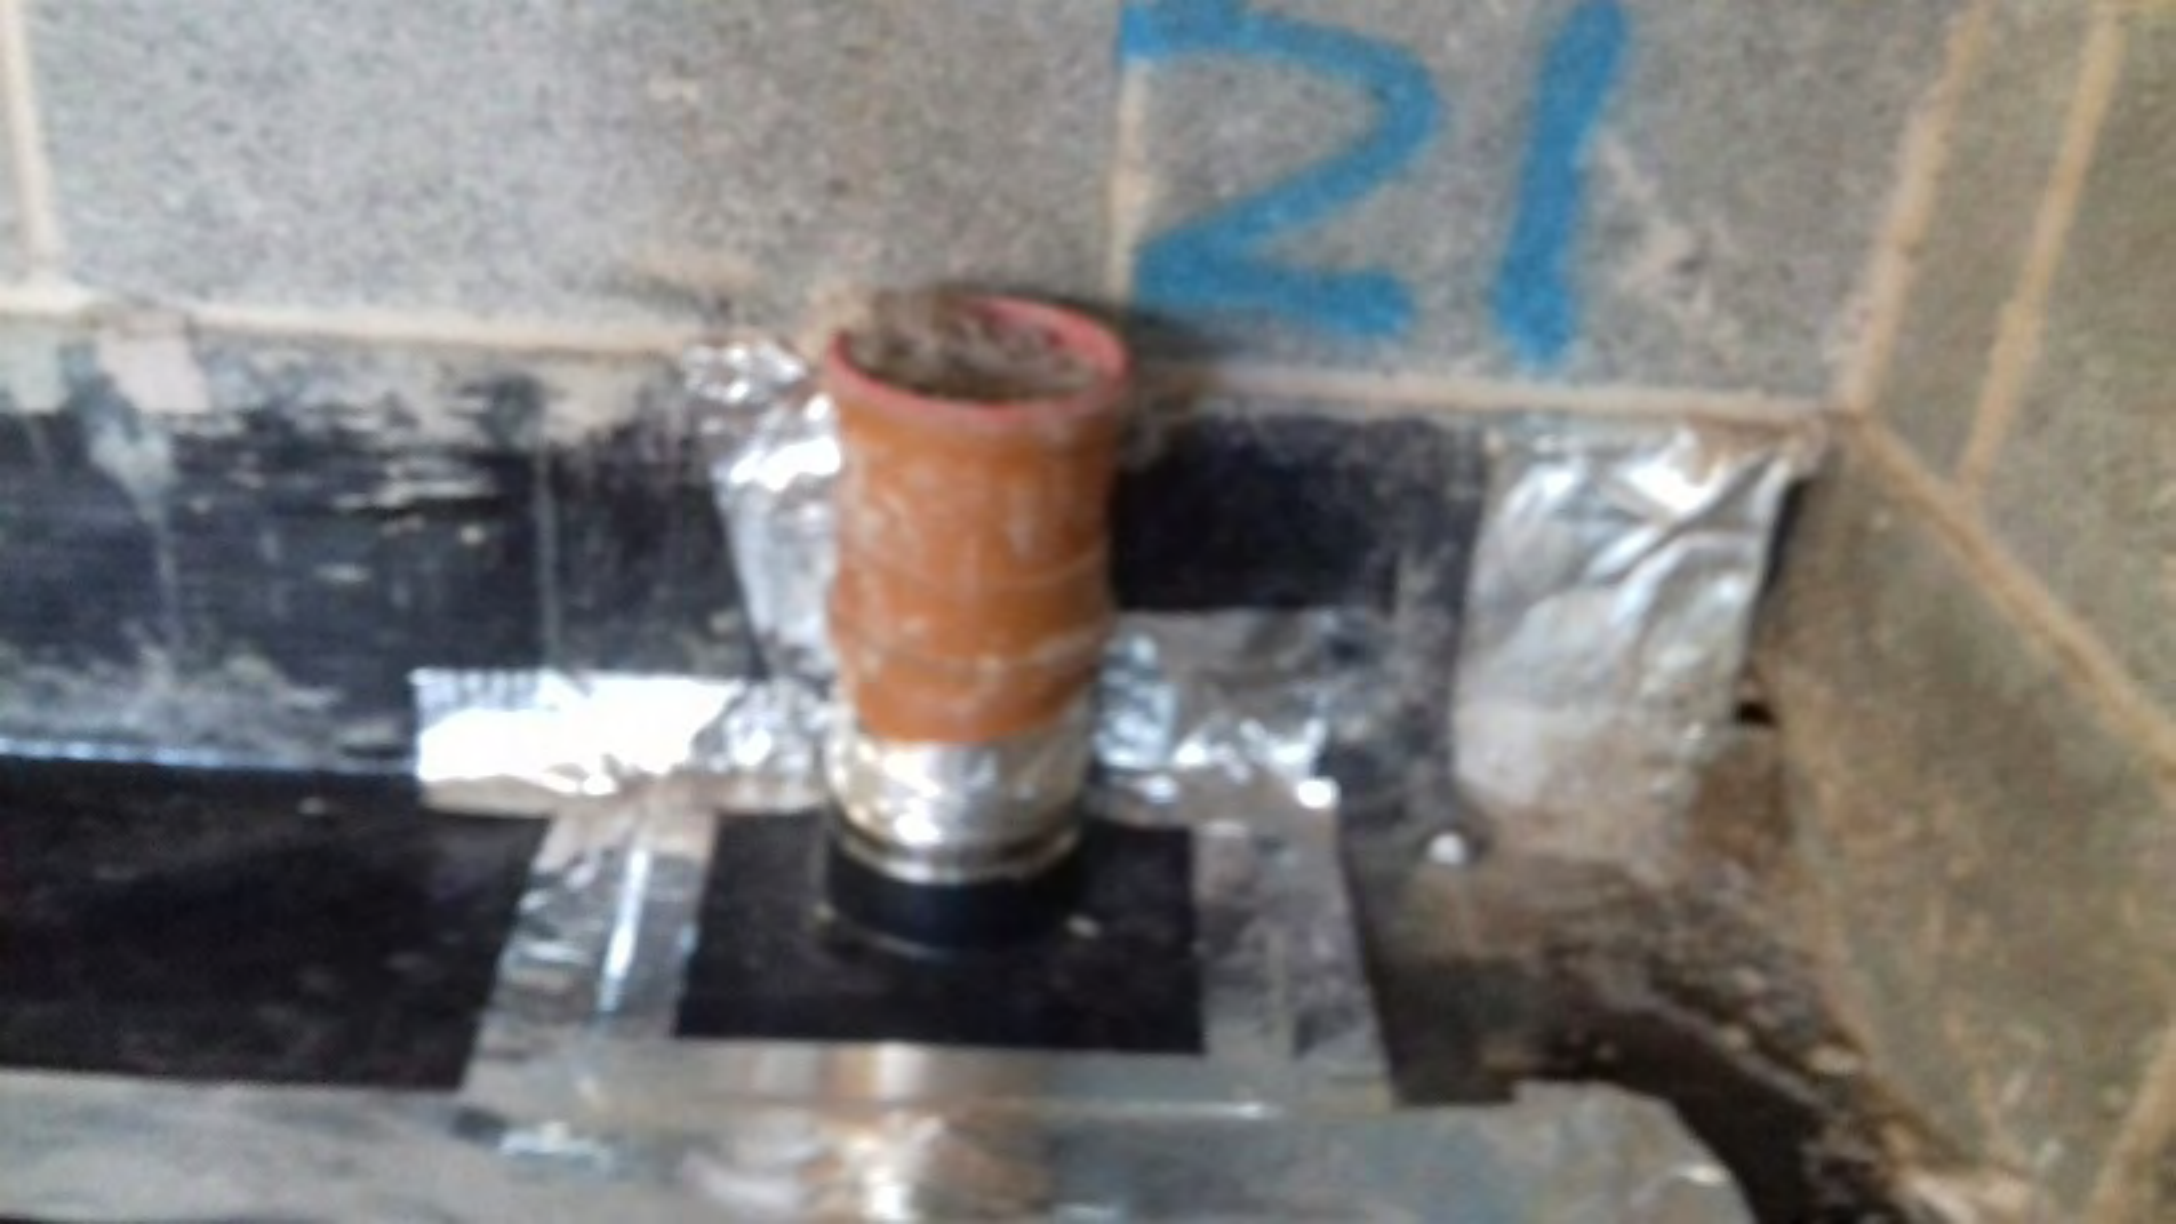
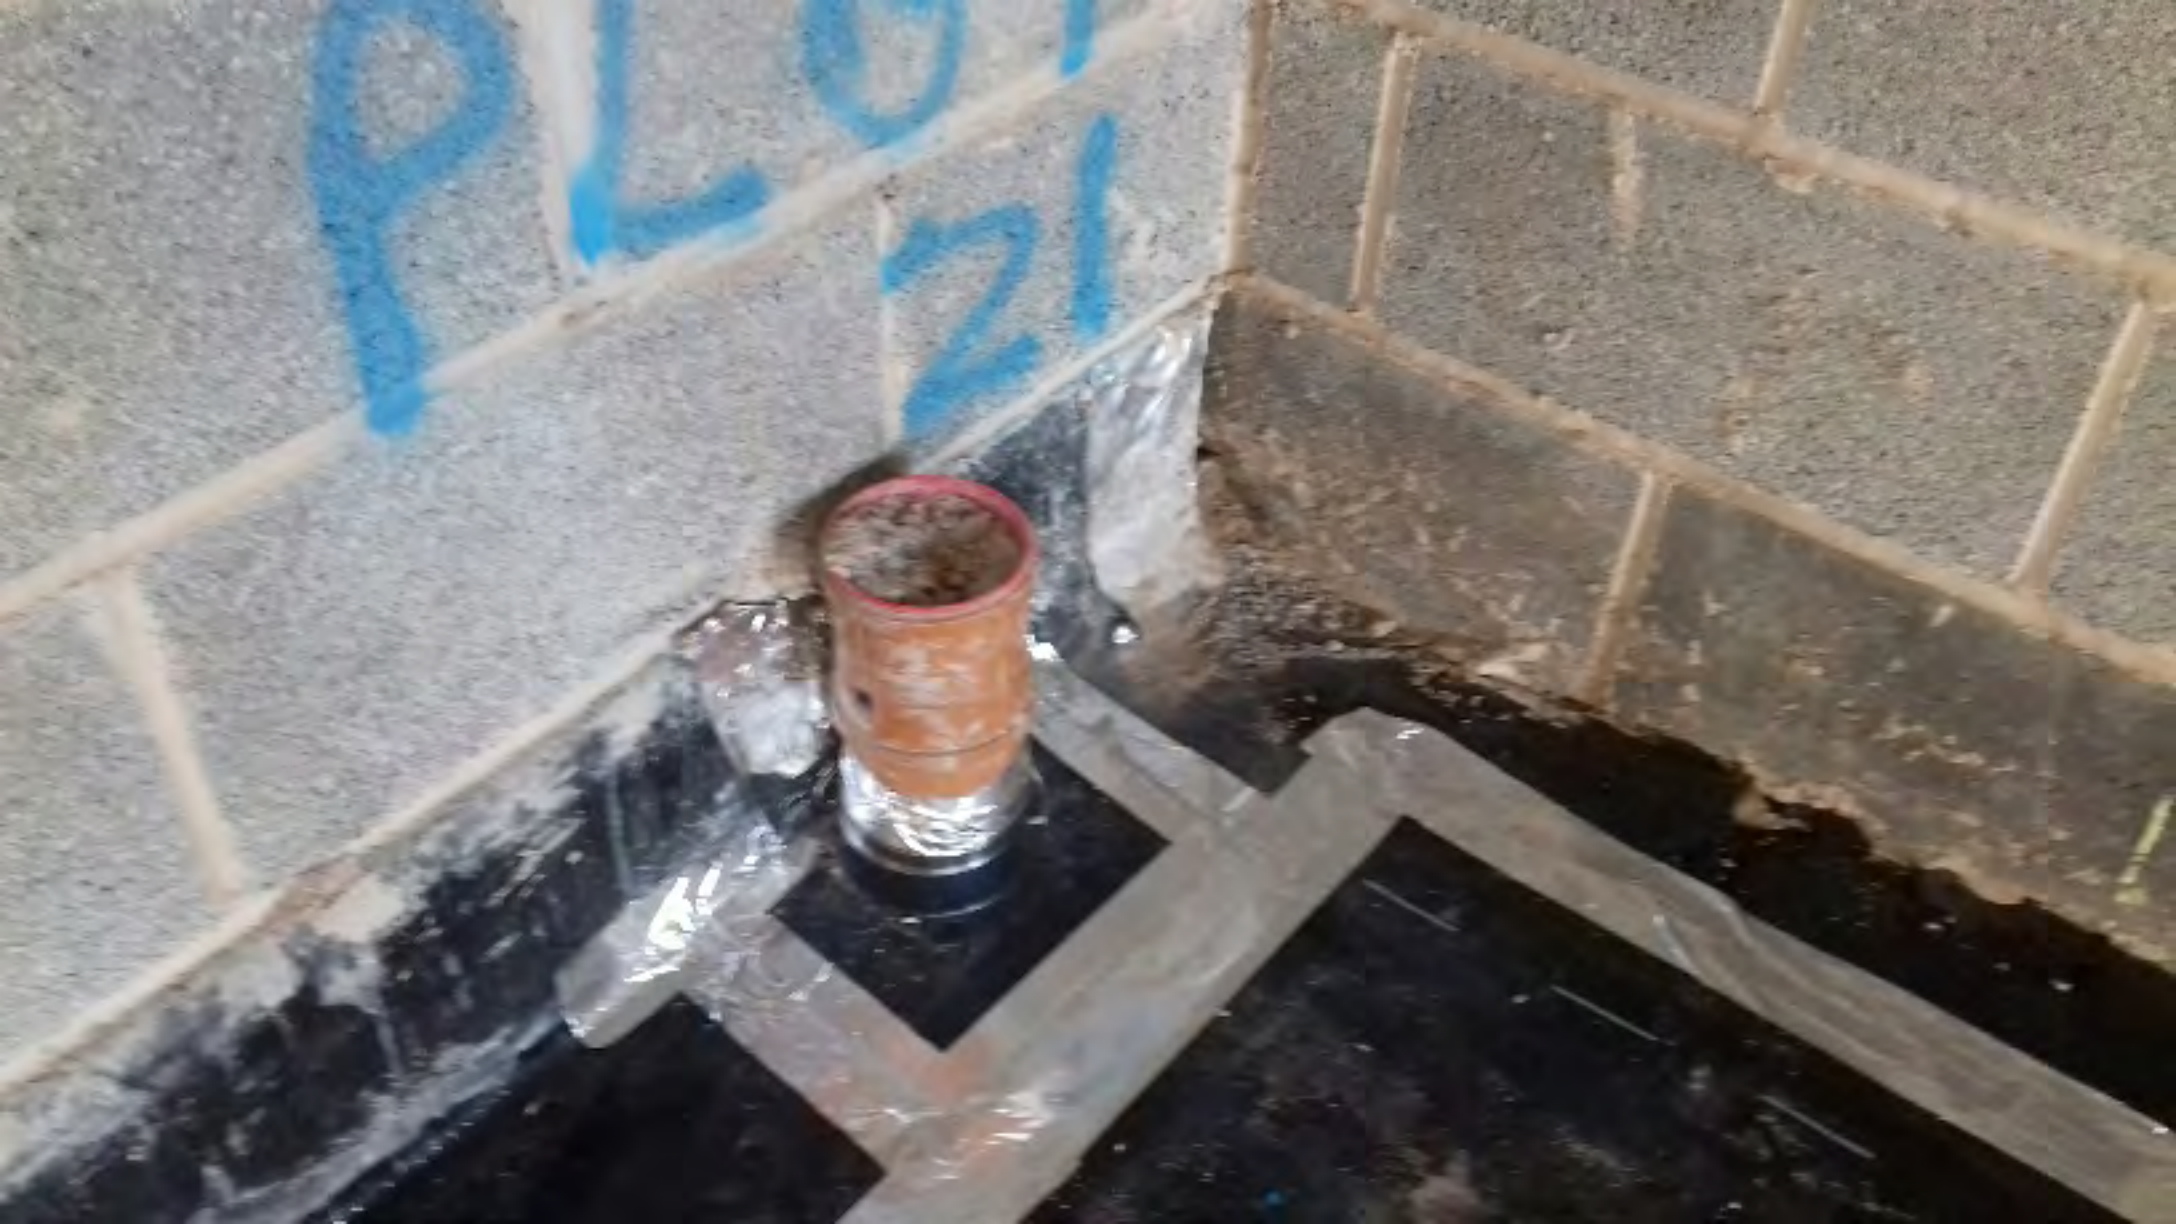
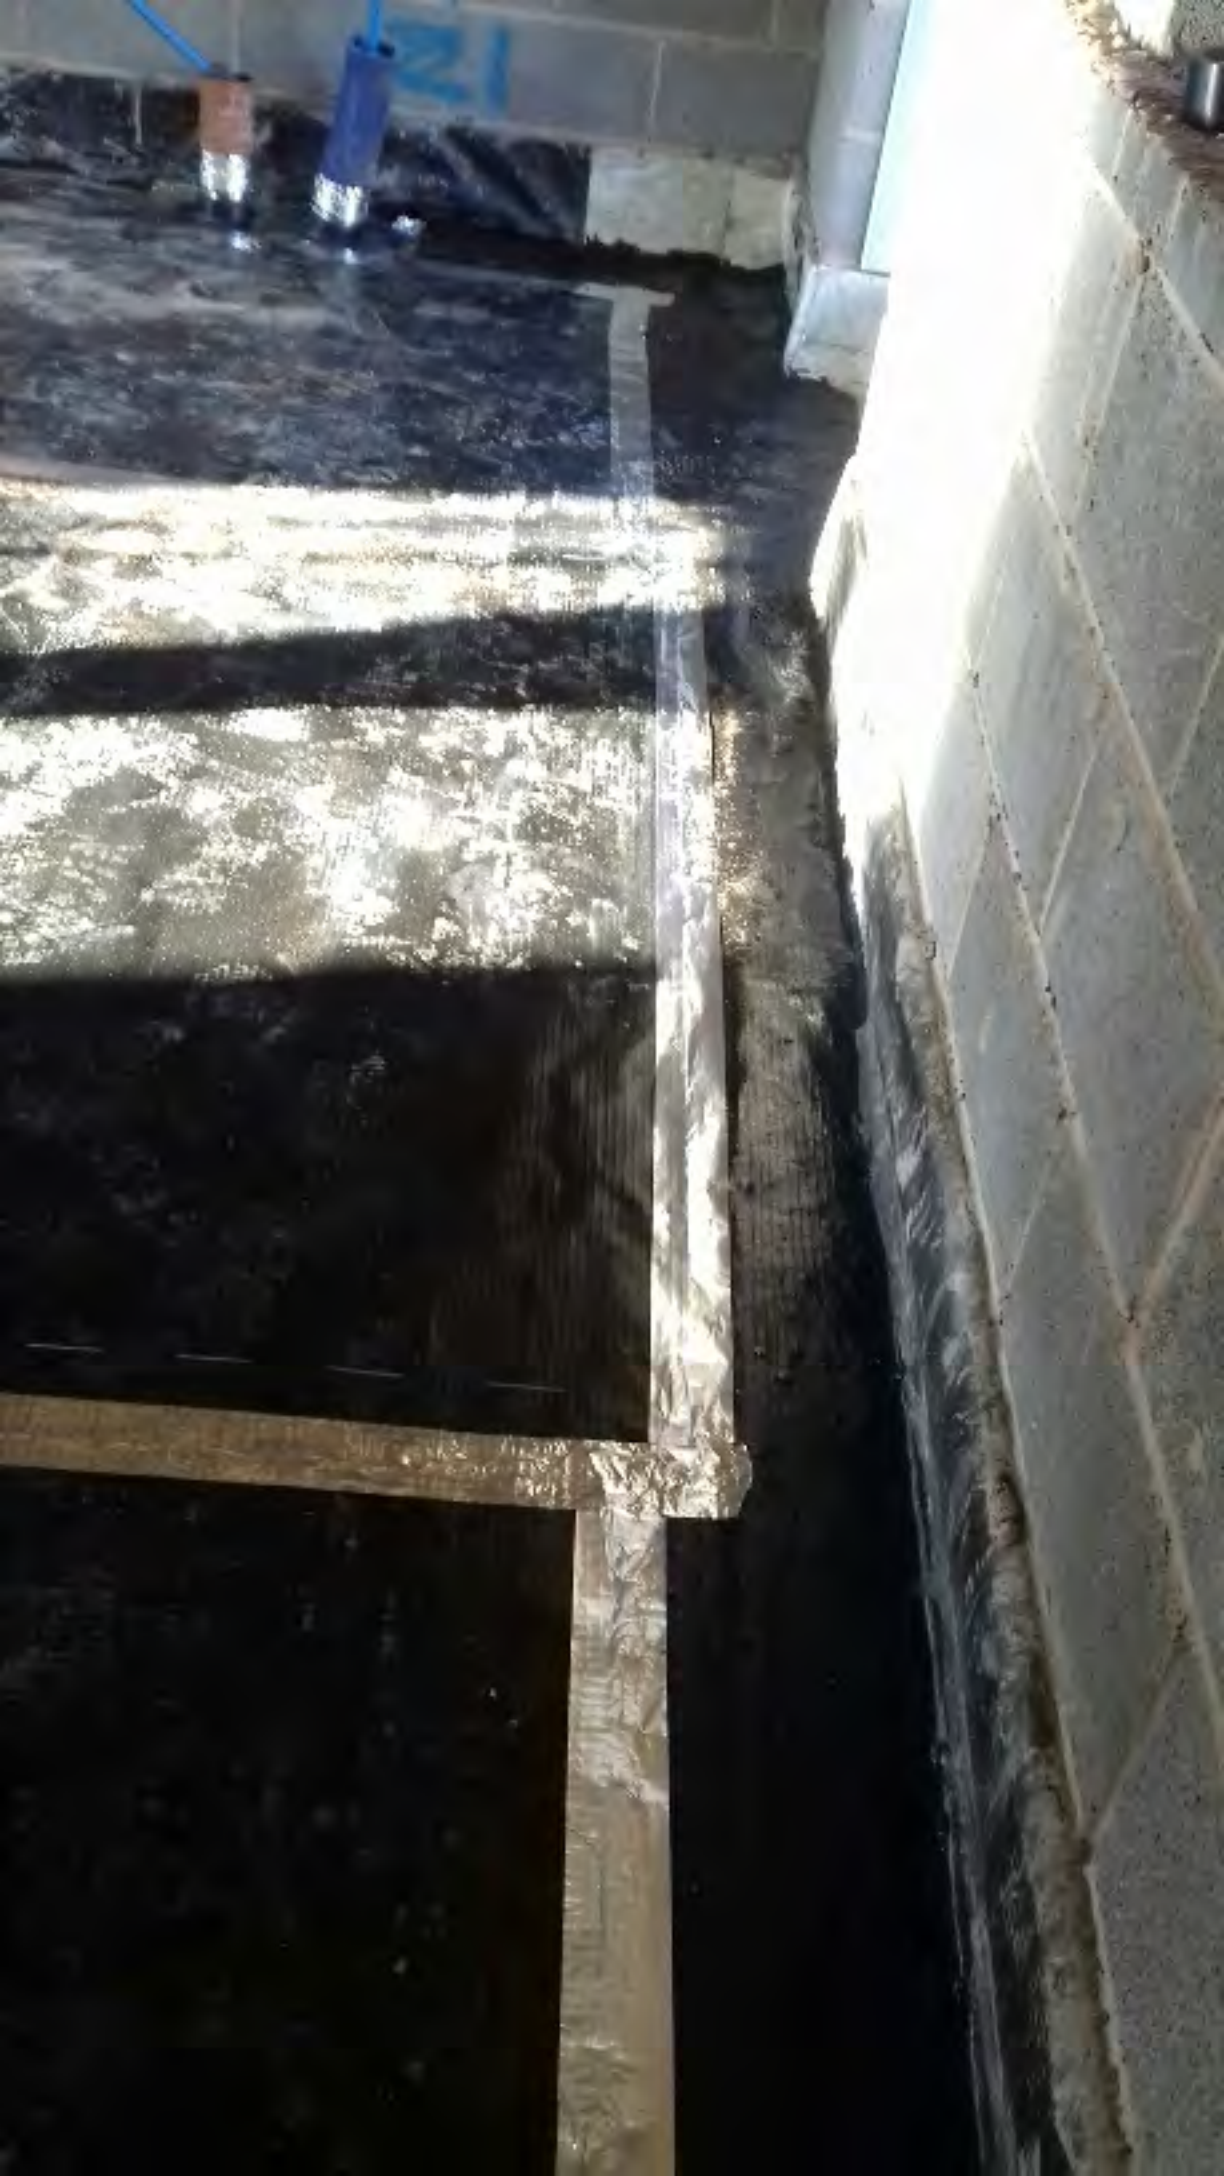
| 2.2 | Condition of sub-grade & underside of gas membrane | FLOOR SCRAPED & BRUSHED, PERIMETER MEMBRANE CLEANED, ALL TAPES APPLIED WELL, SEALED TO A GOOD QUALITY | | | | | |
| 2.4 | Gas membrane condition and coverage | SEALED ON ALL FOUR SIDES - ALL GOOD | | | | | |
| 2.7 | Condition of joints/seals | VISIBLE OVERLAPS - ALL GOOD | | | | | |
| 2.8 | Number and condition of service entry seals | 3 <sup>RD</sup> TOP HATS FITTED AROUND DRAINAGE/WATER, JUBILEE CLIPS STAPED - ALL GOOD | | | | | |
