**This Record sheet is only applicable to block and beam floor slabs for Characteristic Situation 2 gas protection systems**

Plot No.: 14 ..... Inspection Stage - Stage 2 - Floor Stage

**For Residential Development at New Church Street, Radcliffe.**

## Gas Protection - Validation Record Sheet

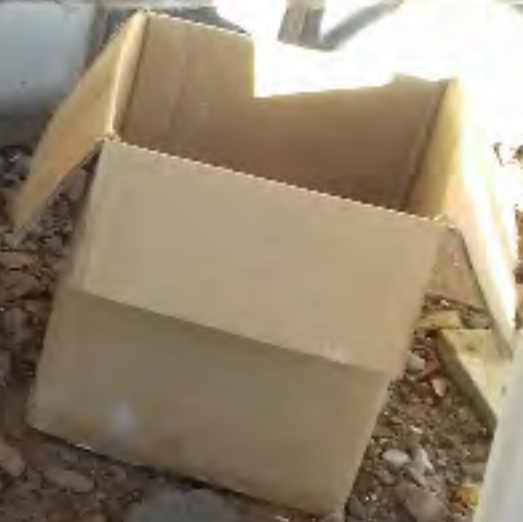
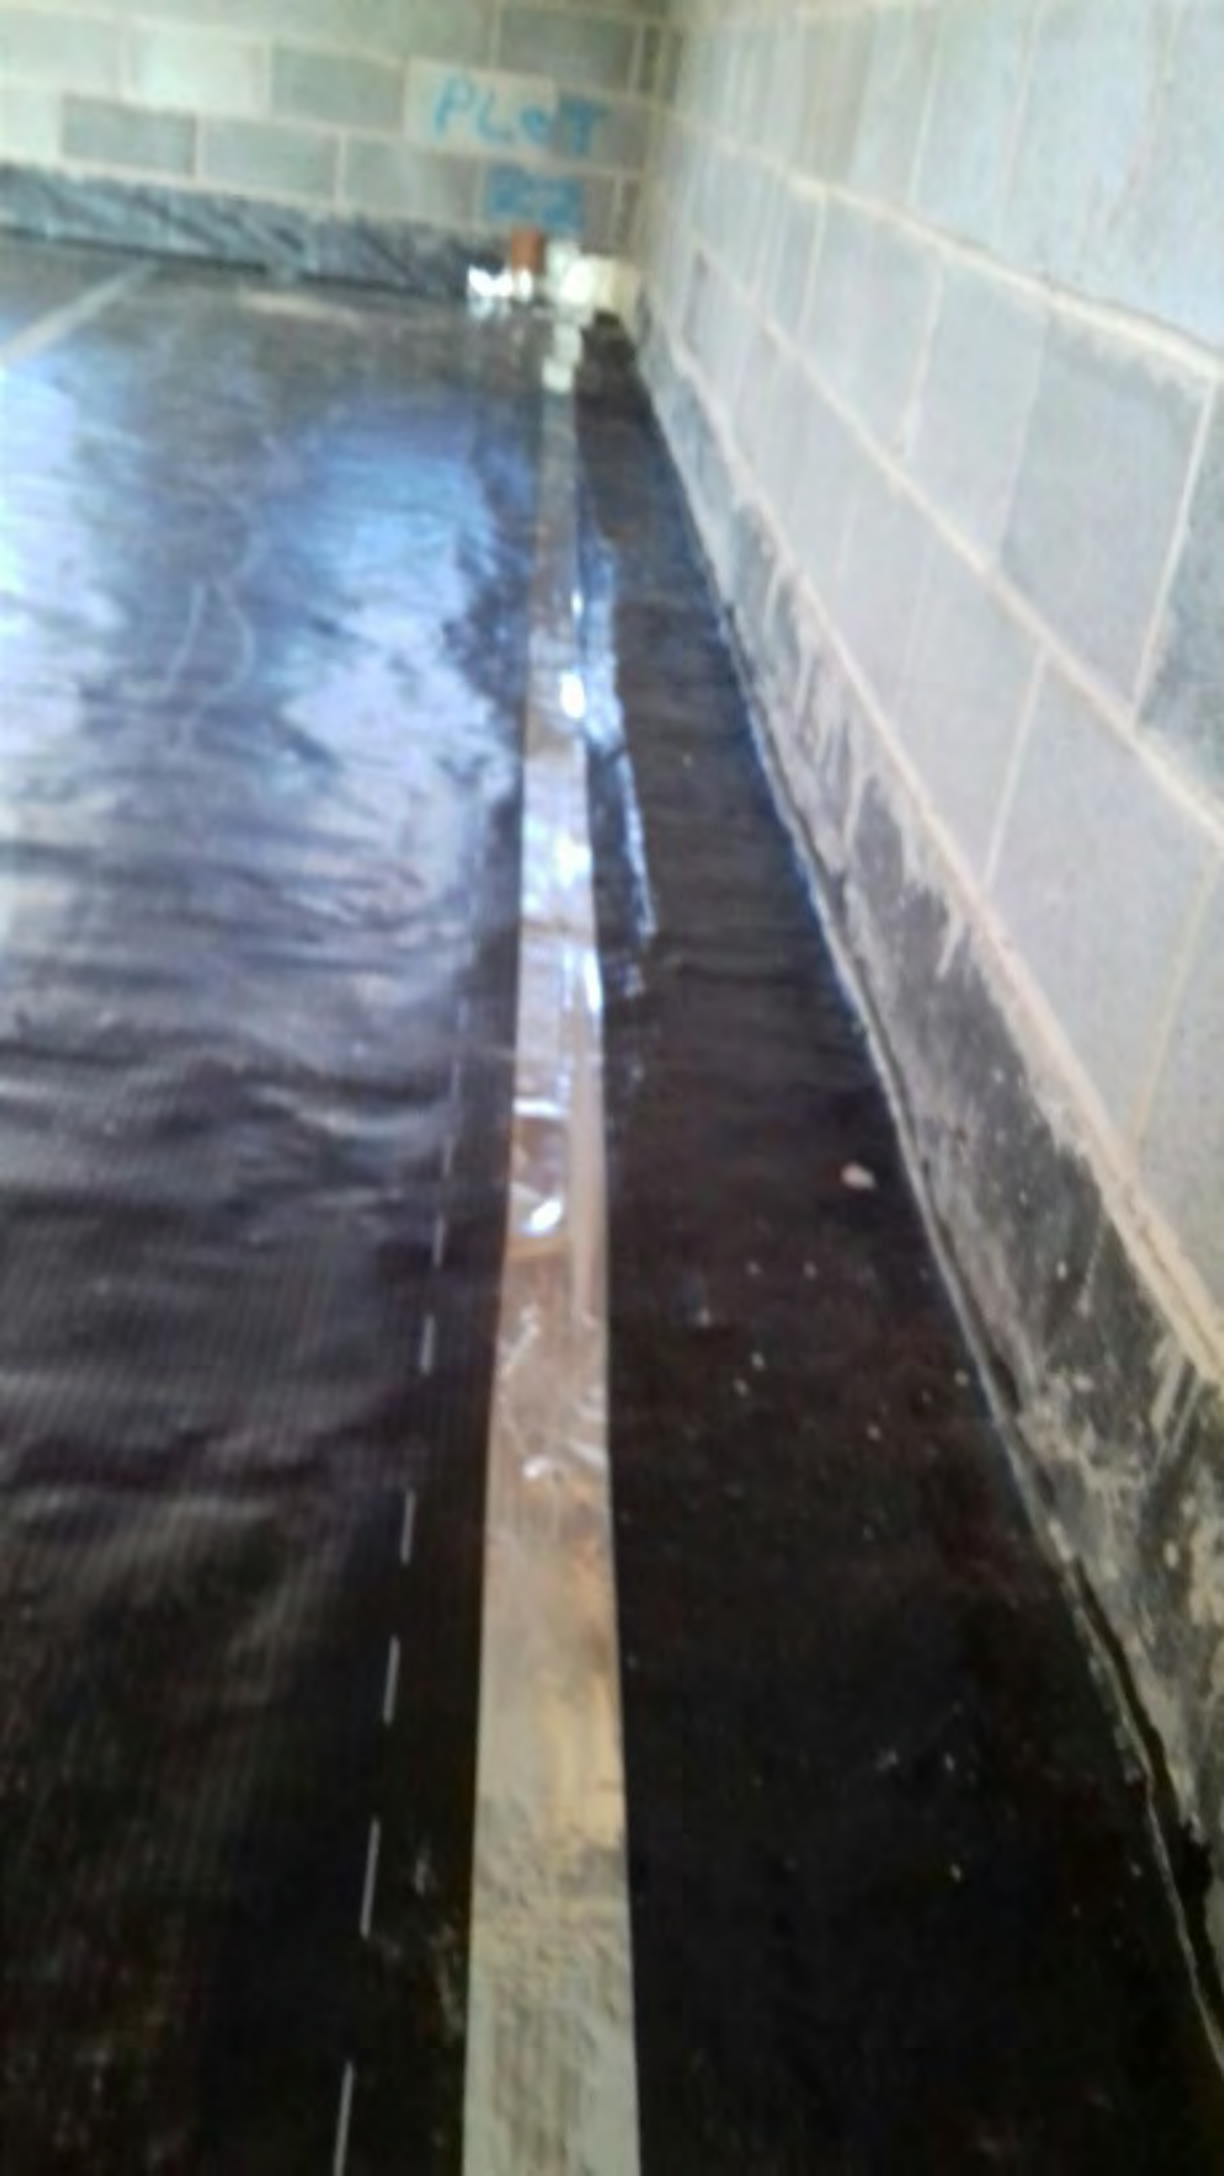
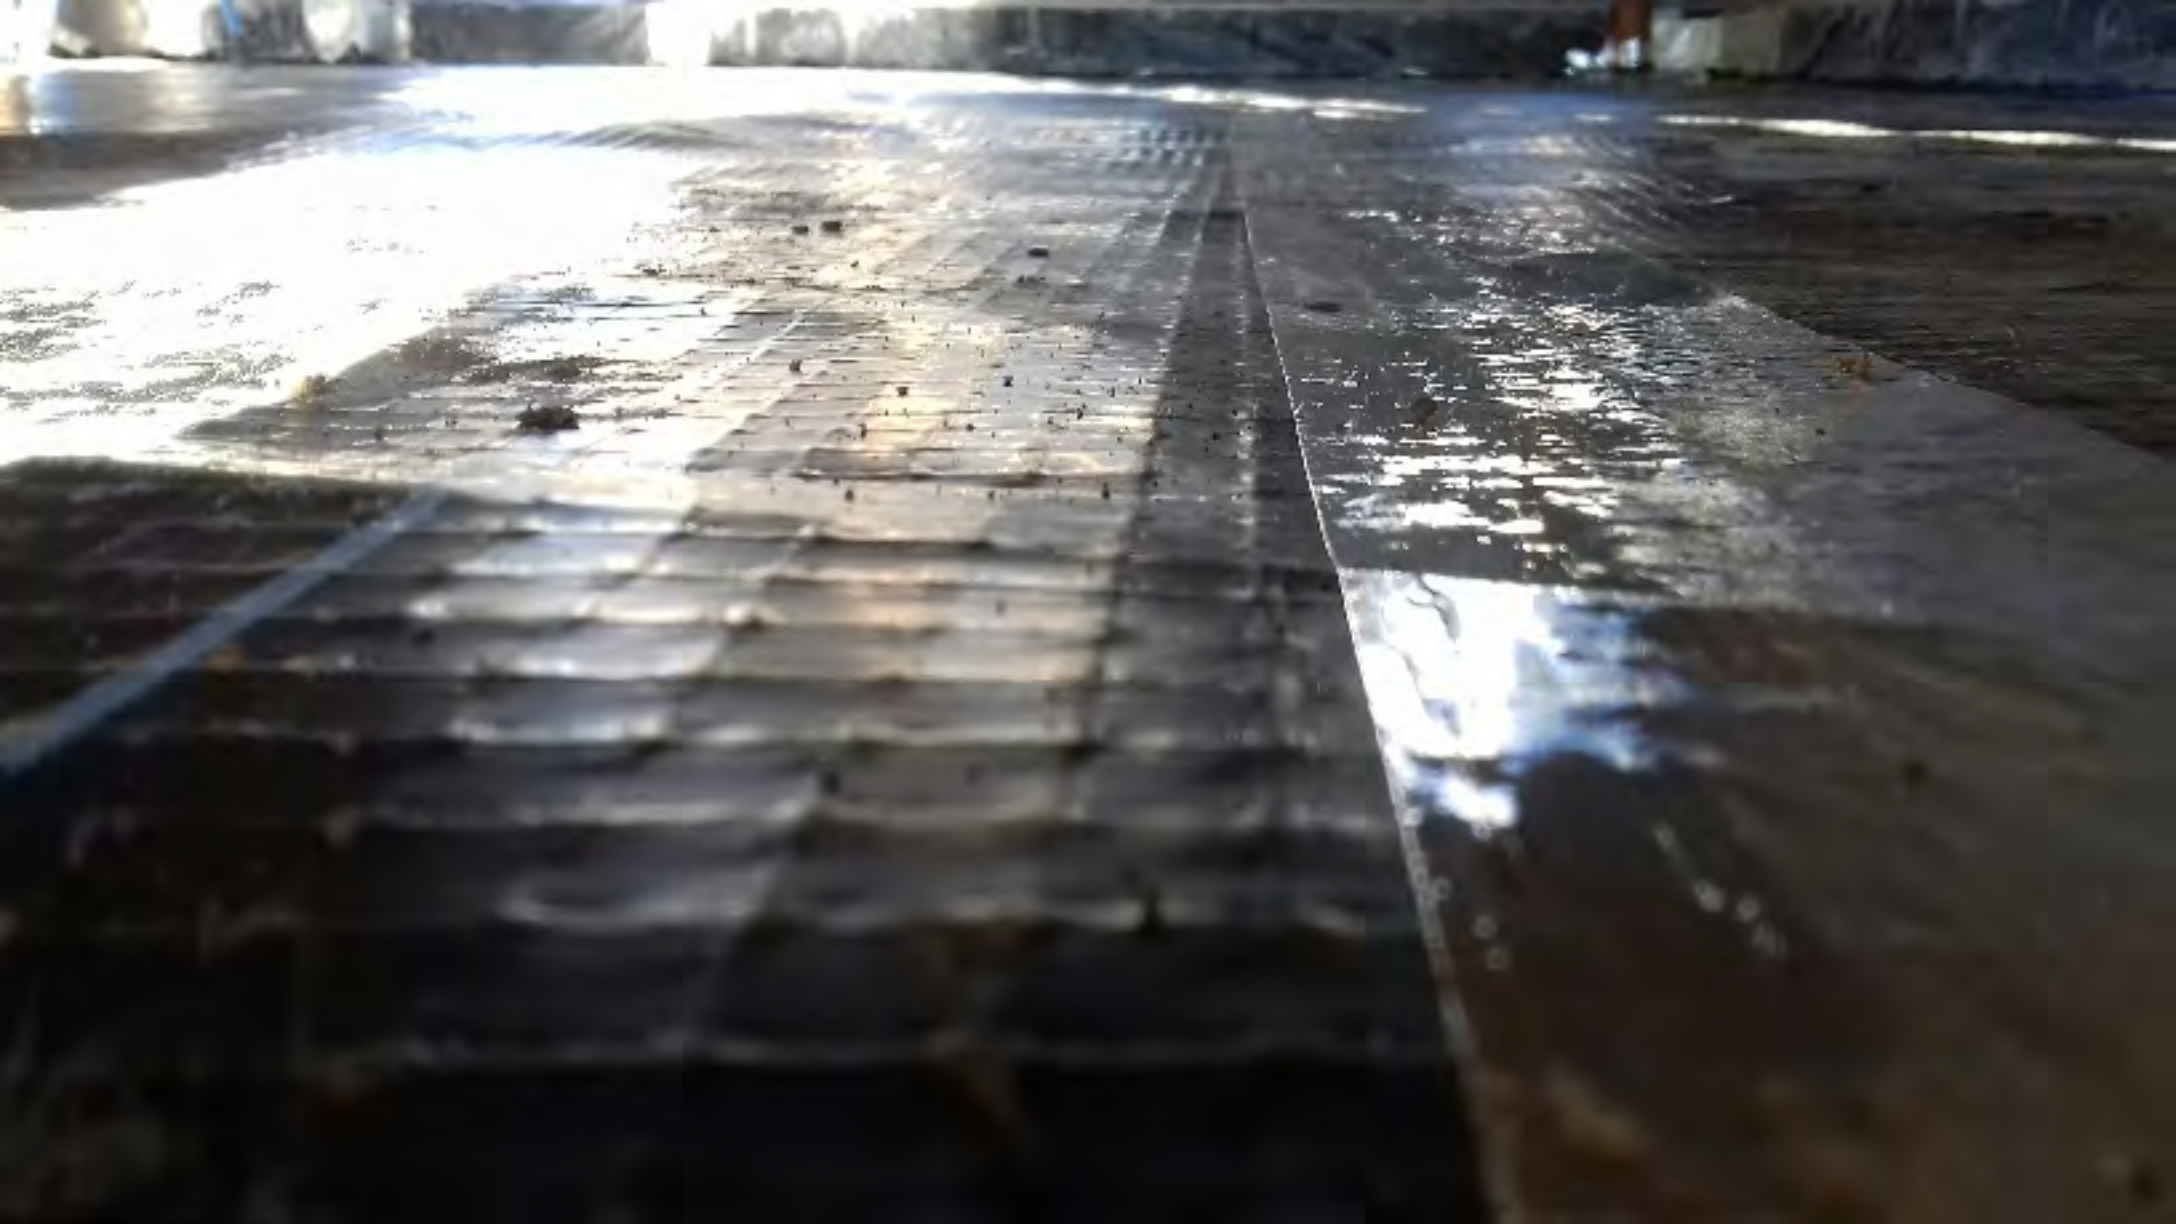
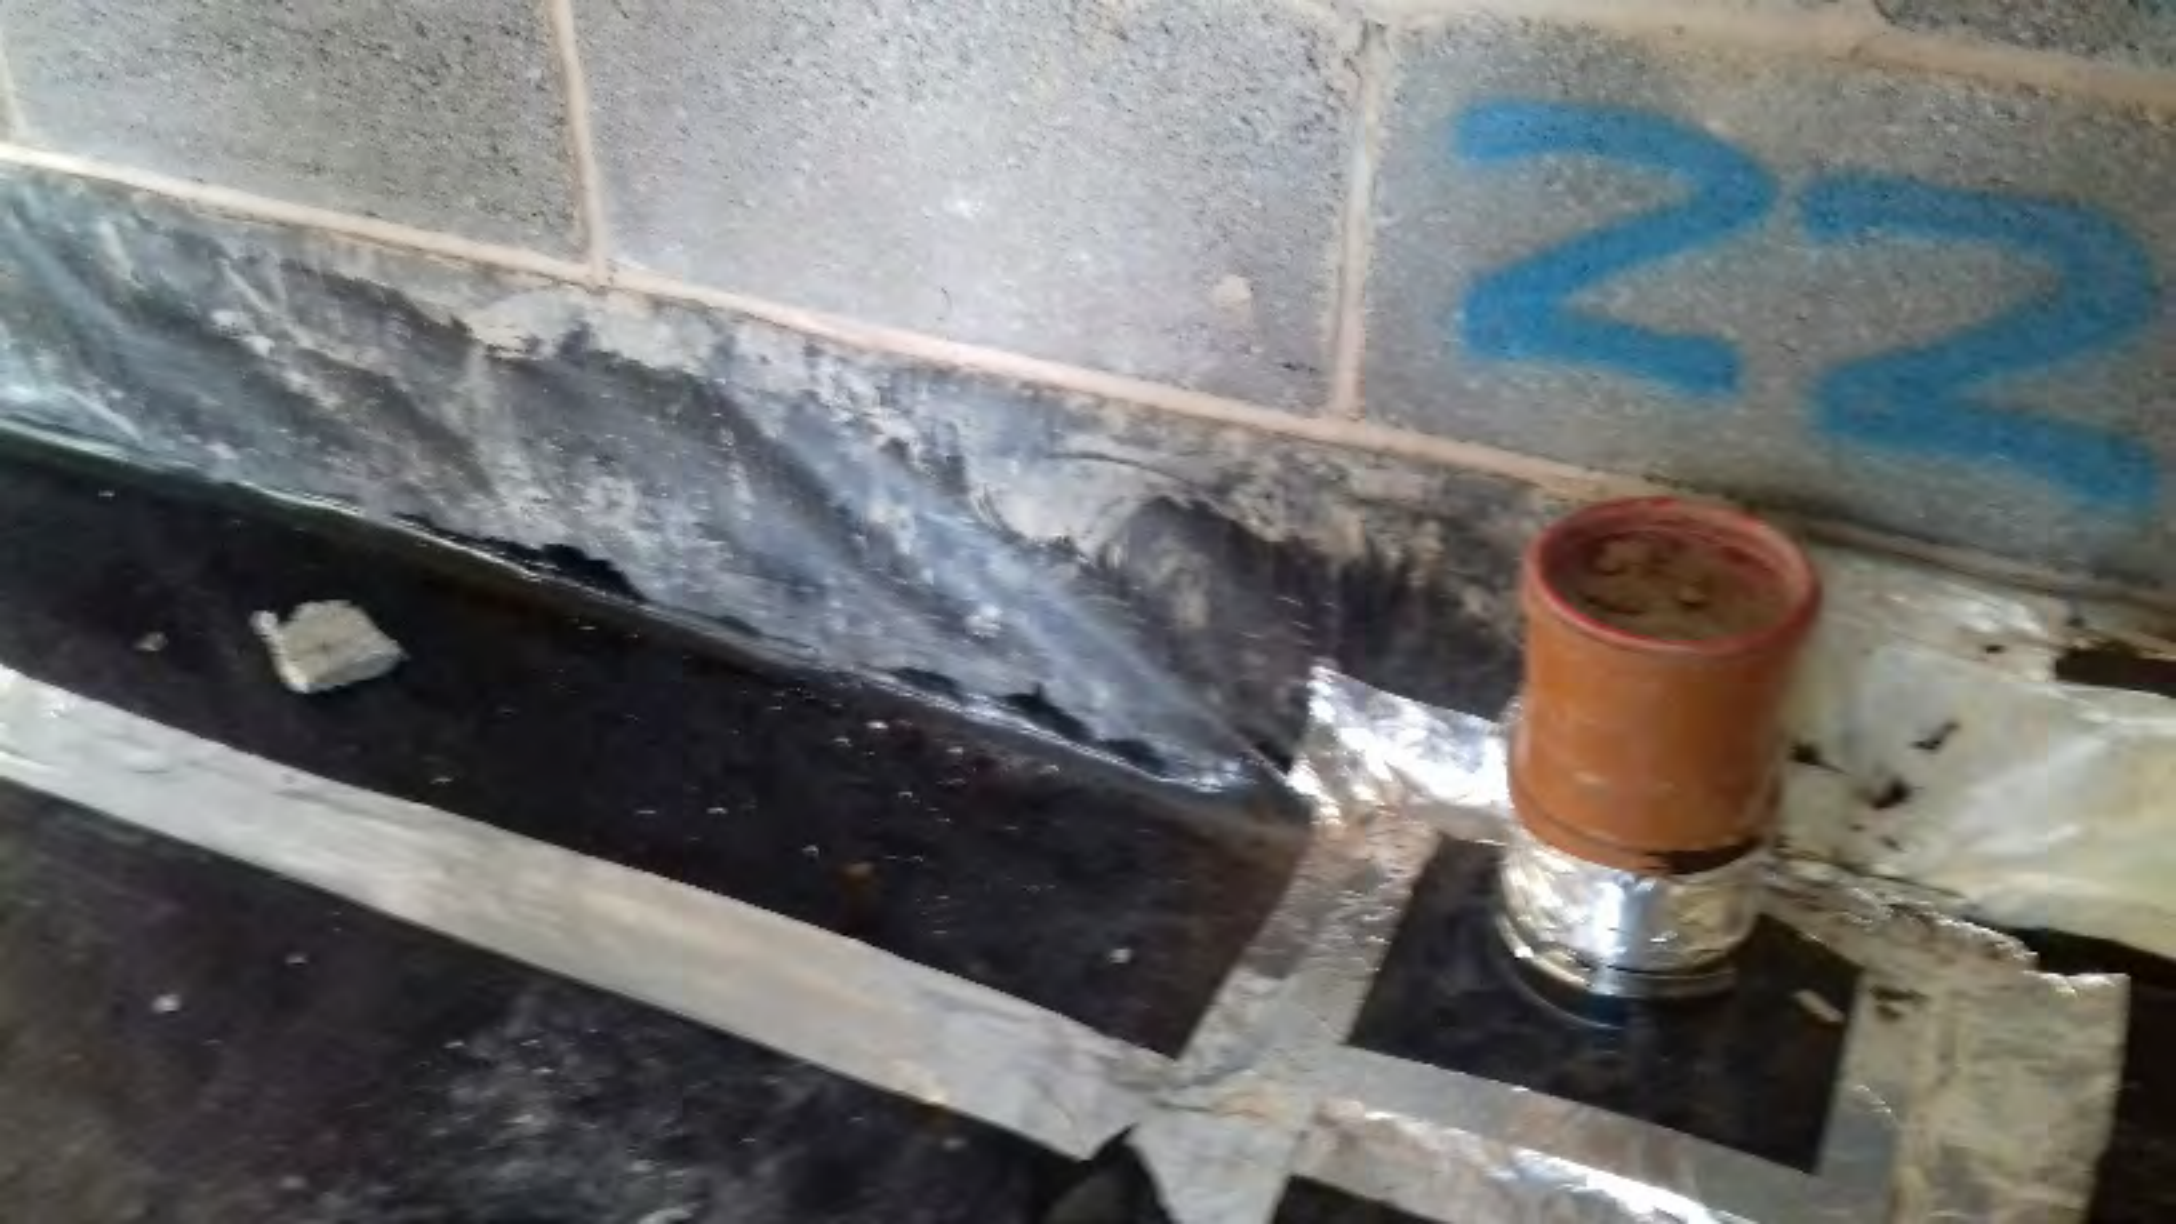
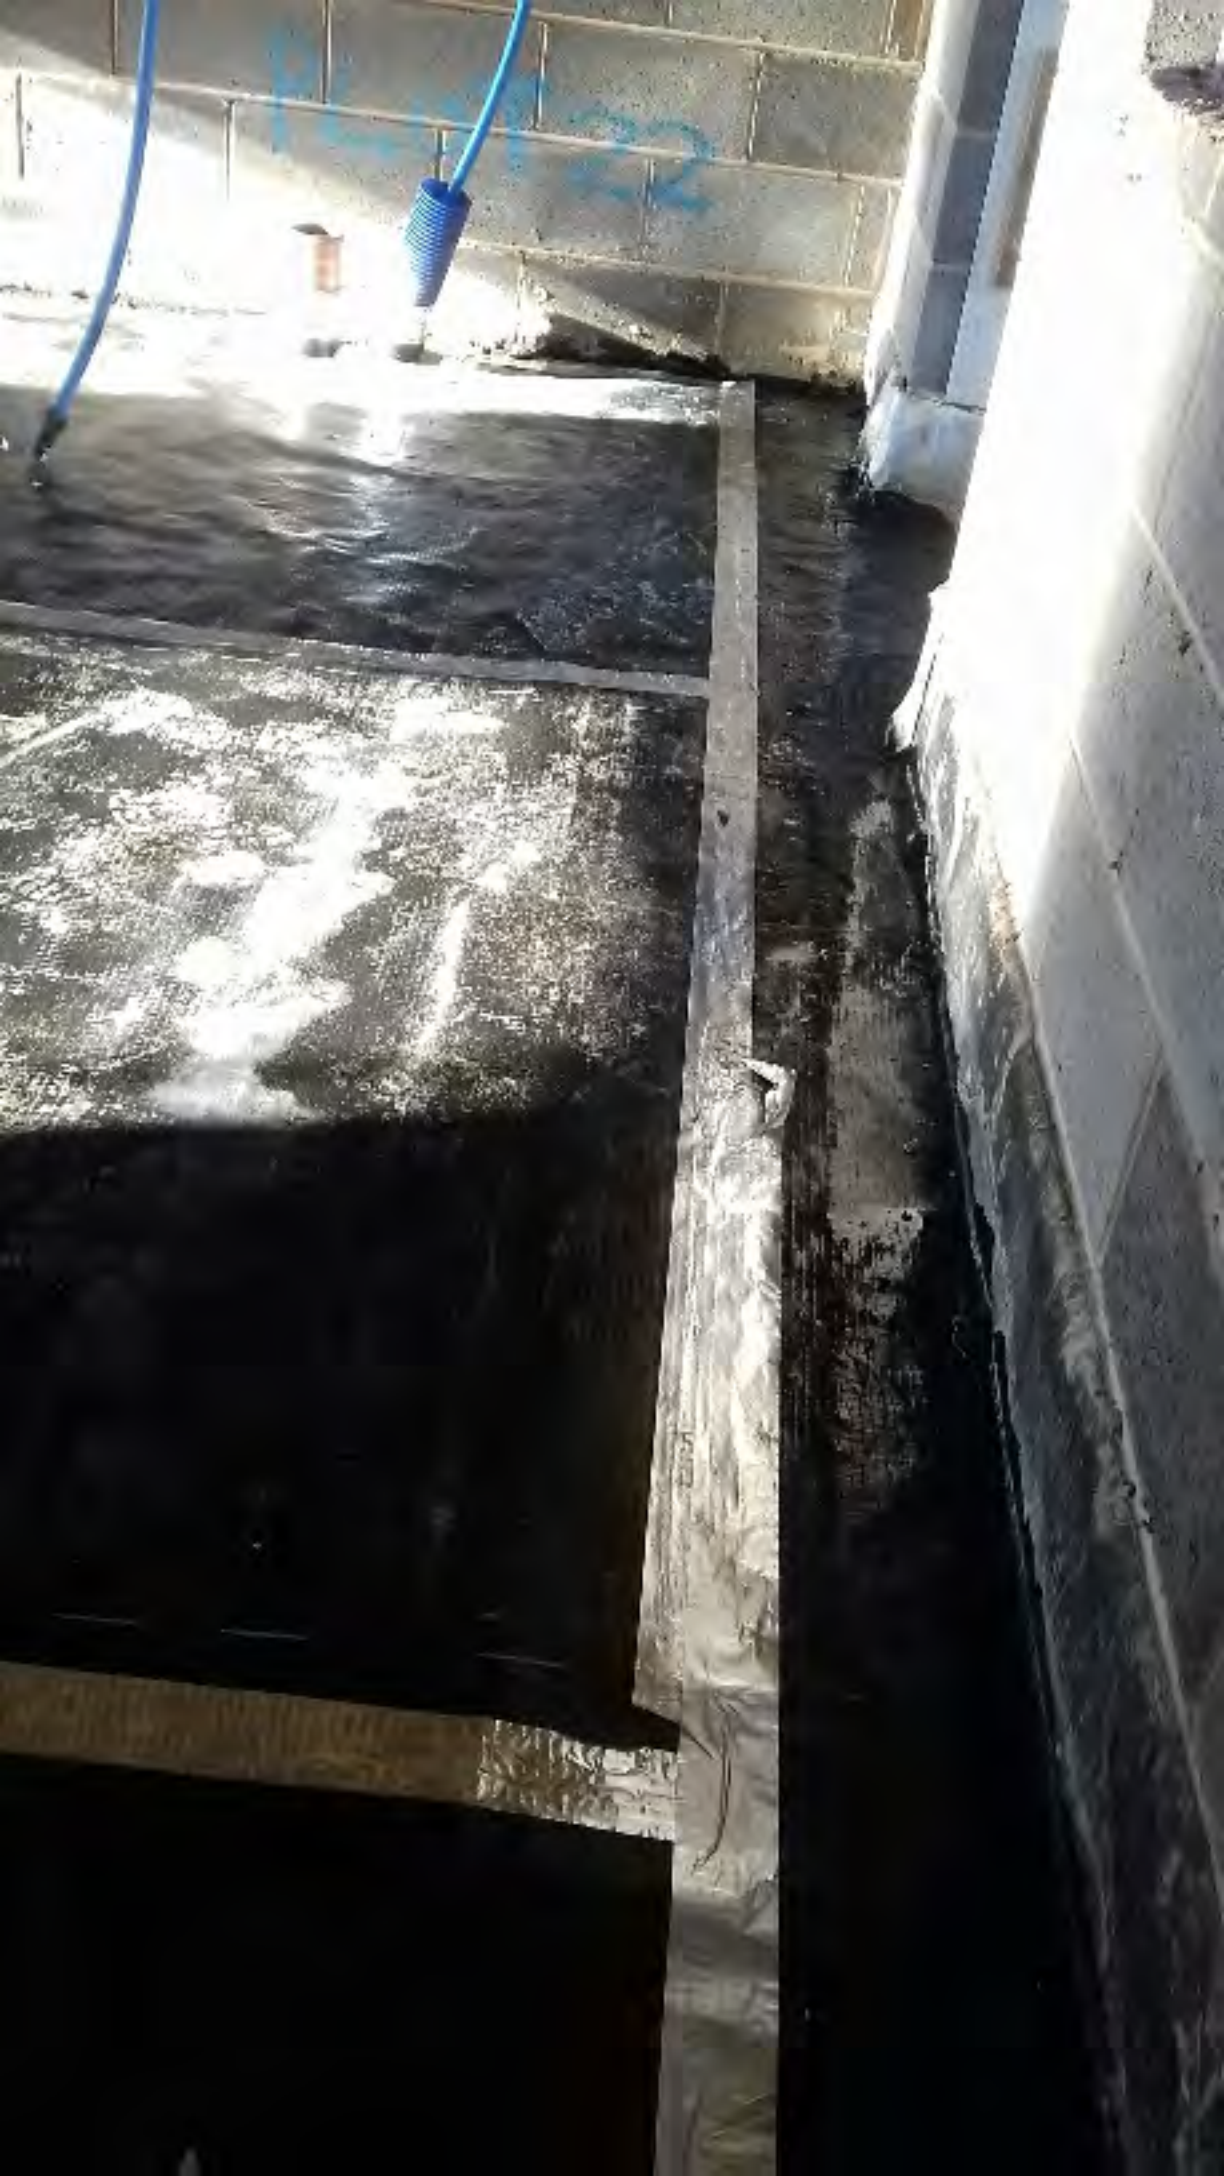
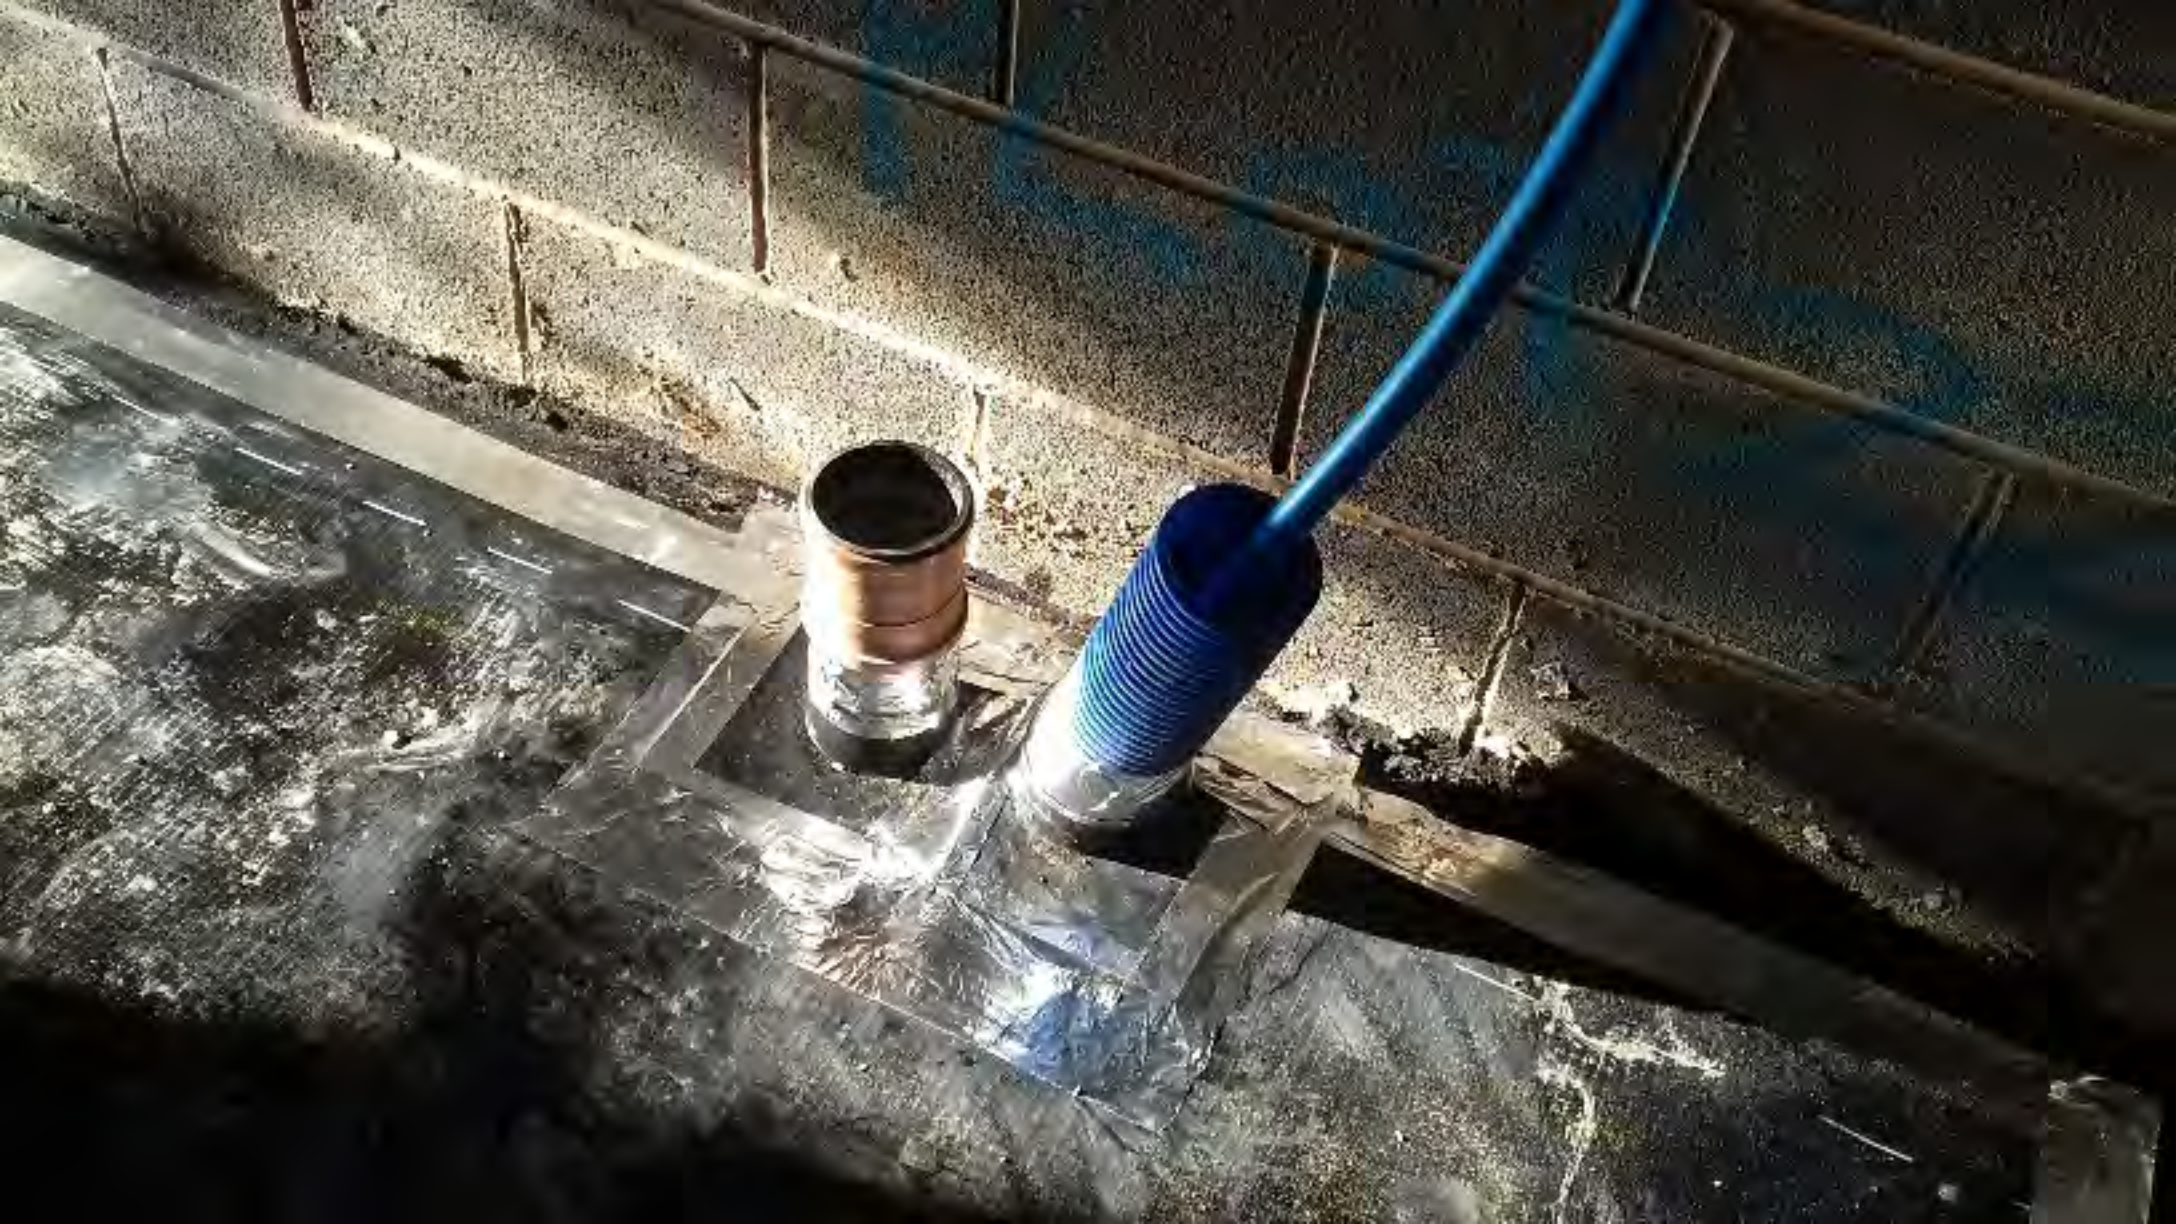
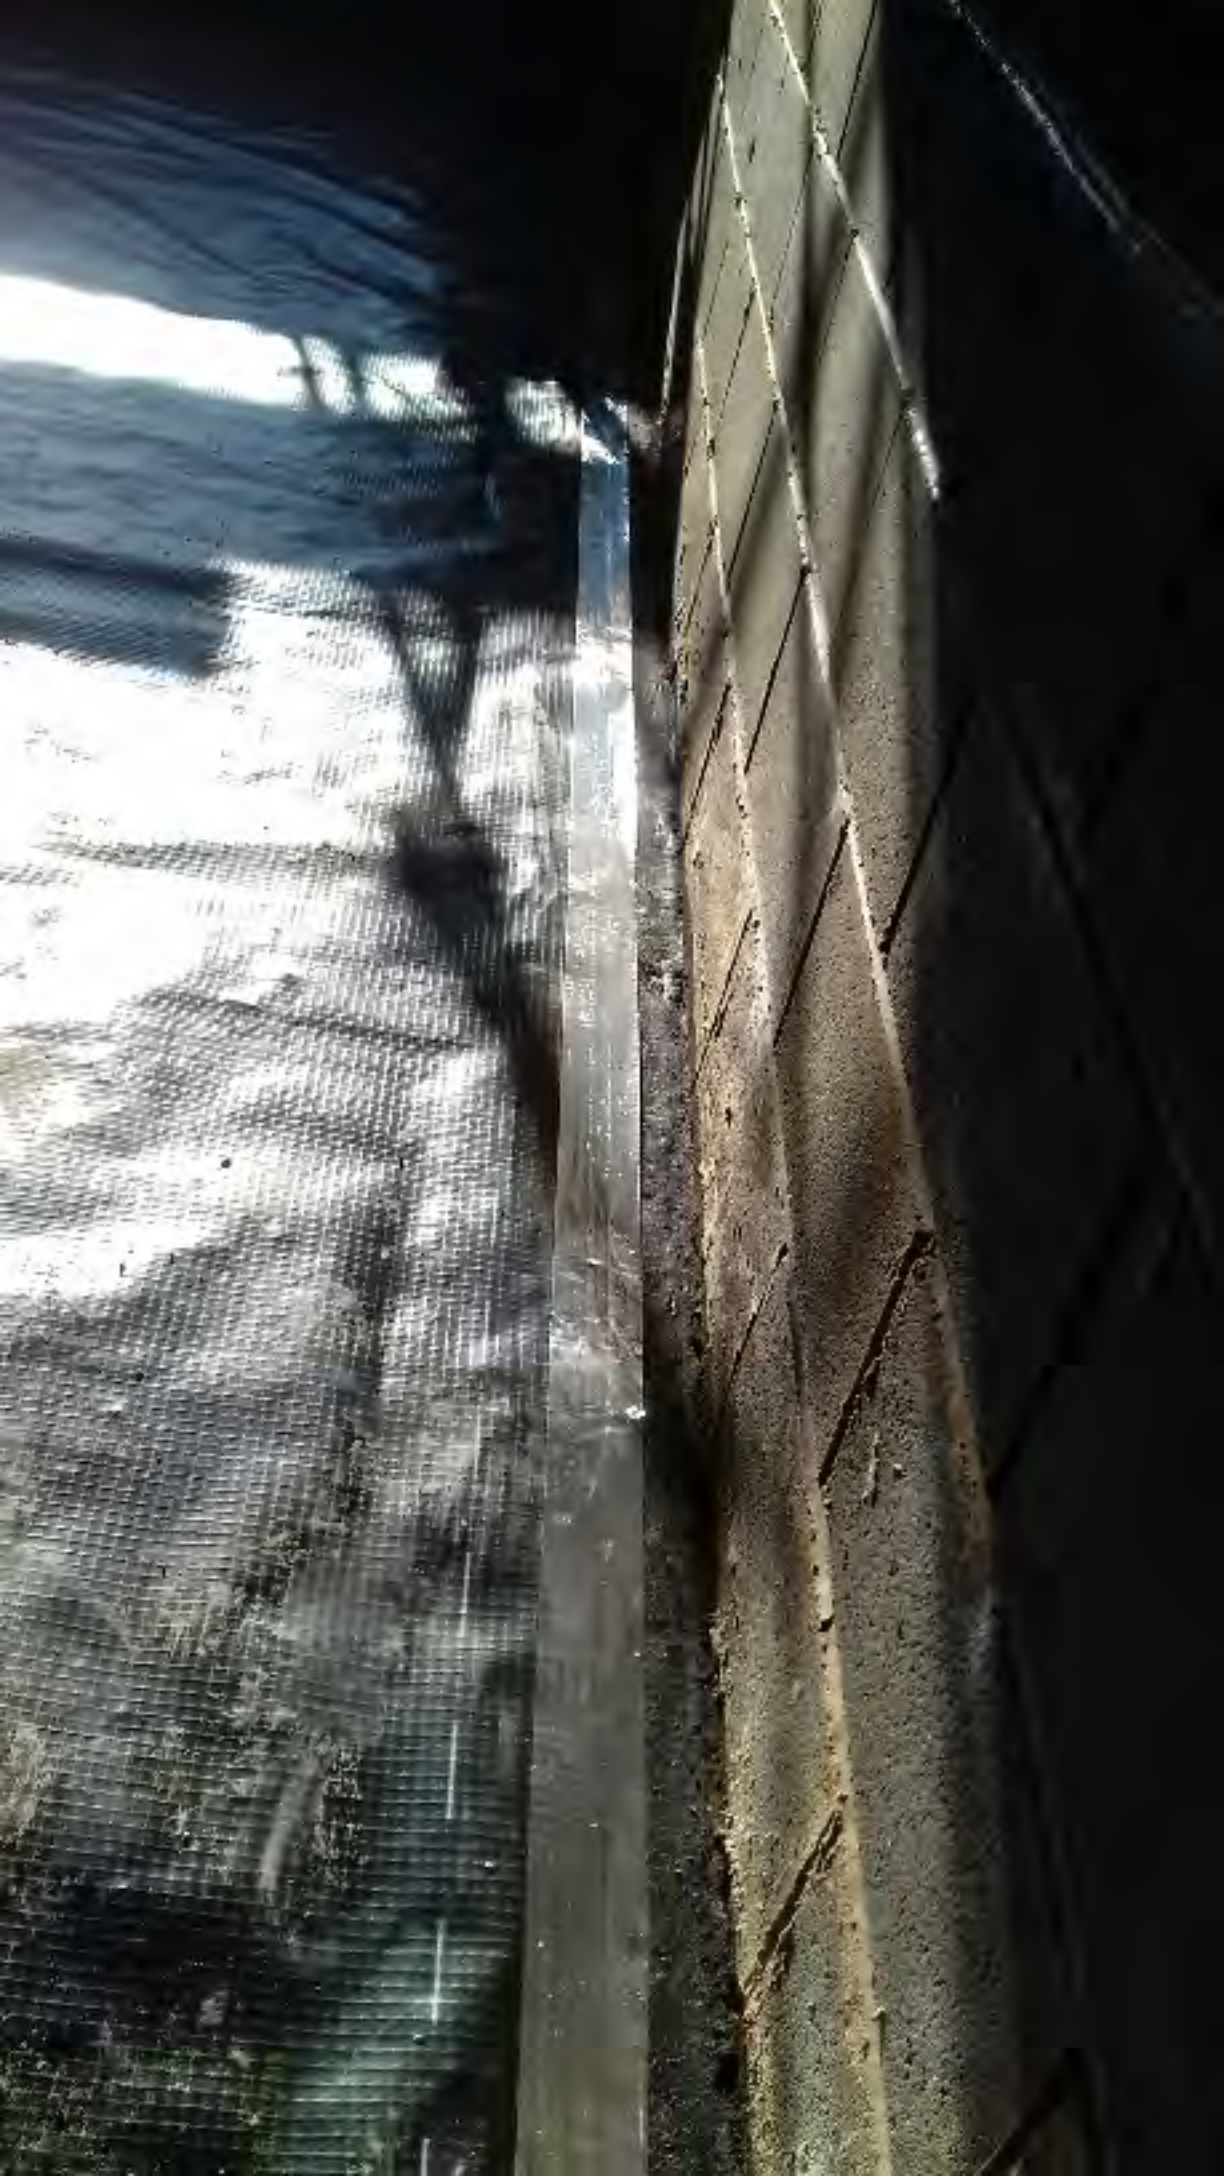
22

| 2.2 | Condition of sub-grade & underside of gas membrane | FLOOR BRUSHED AND ALL TAPES APPLIED WELL. SEALED TO A GOOD QUALITY | | | | | |
| 2.4 | Gas membrane condition and coverage | GOOD, SEALED ON ALL FOUR SIDES | | | | | |
| 2.7 | Condition of joints/seals | ALL GOOD, VISIBLE OVERLAPS | | | | | |
| 2.8 | Number and condition of service entry seals | 3 NO. TOPHATS WITH JUBILEE CLIPS – TAPES CHECKED, ALL OK | | | | | |
| 2.10 | Repairs or Corrections: | NONE VISIBLE | | | | | |

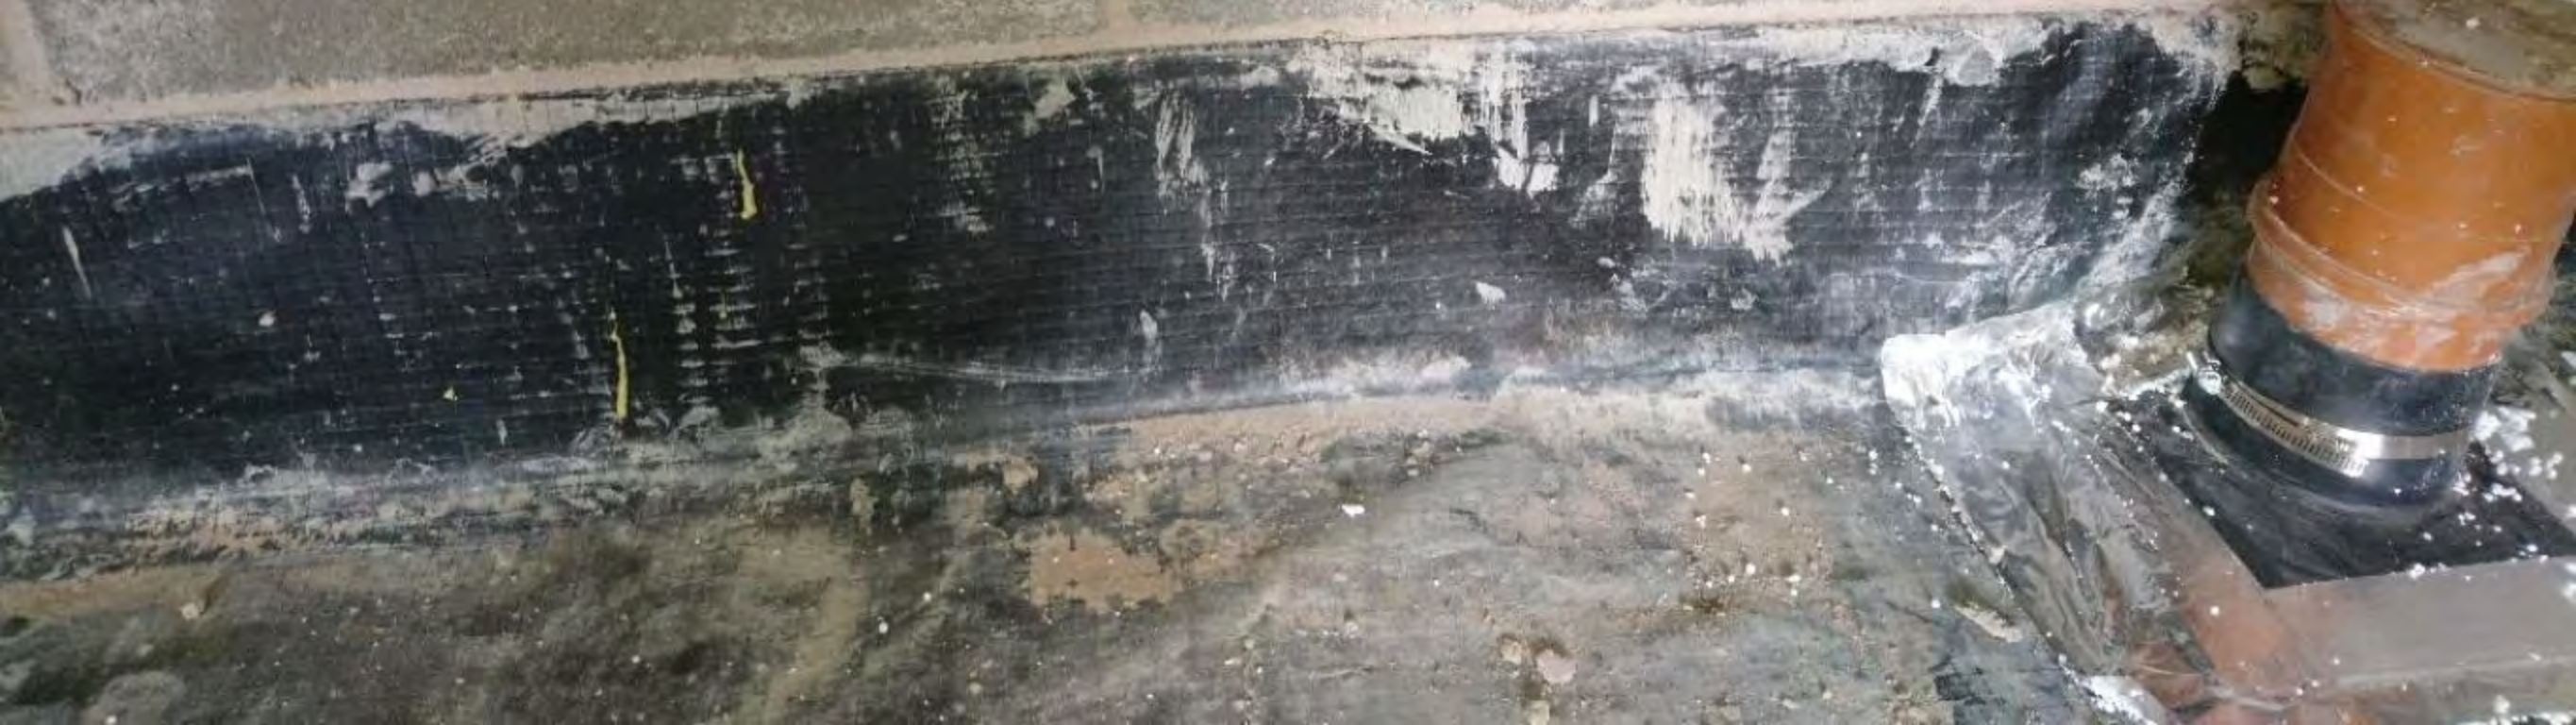
Plot 24

| 2.2 | Condition of sub-grade & underside of gas membrane | ALL TAPES APPLIED WELL + SEALED TO A GOOD QUALITY. FLOOR BRUSHED | | | | | |
| 2.4 | Gas membrane condition and coverage | GOOD AND SEALED ON ALL FOUR SIDES | | | | | |
| 2.7 | Condition of joints/seals | VISIBLE OVERLAPS, ALL APPEAR GOOD | | | | | |
| 2.8 | Number and condition of service entry seals | 3 NO TOPHATS WITH SUBILEE CLIPS (PICTURED). TAPES CHECKED, ALL OK | | | | | |
| 2.10 | Repairs or Corrections: | NONE VISIBLE | | | | | |

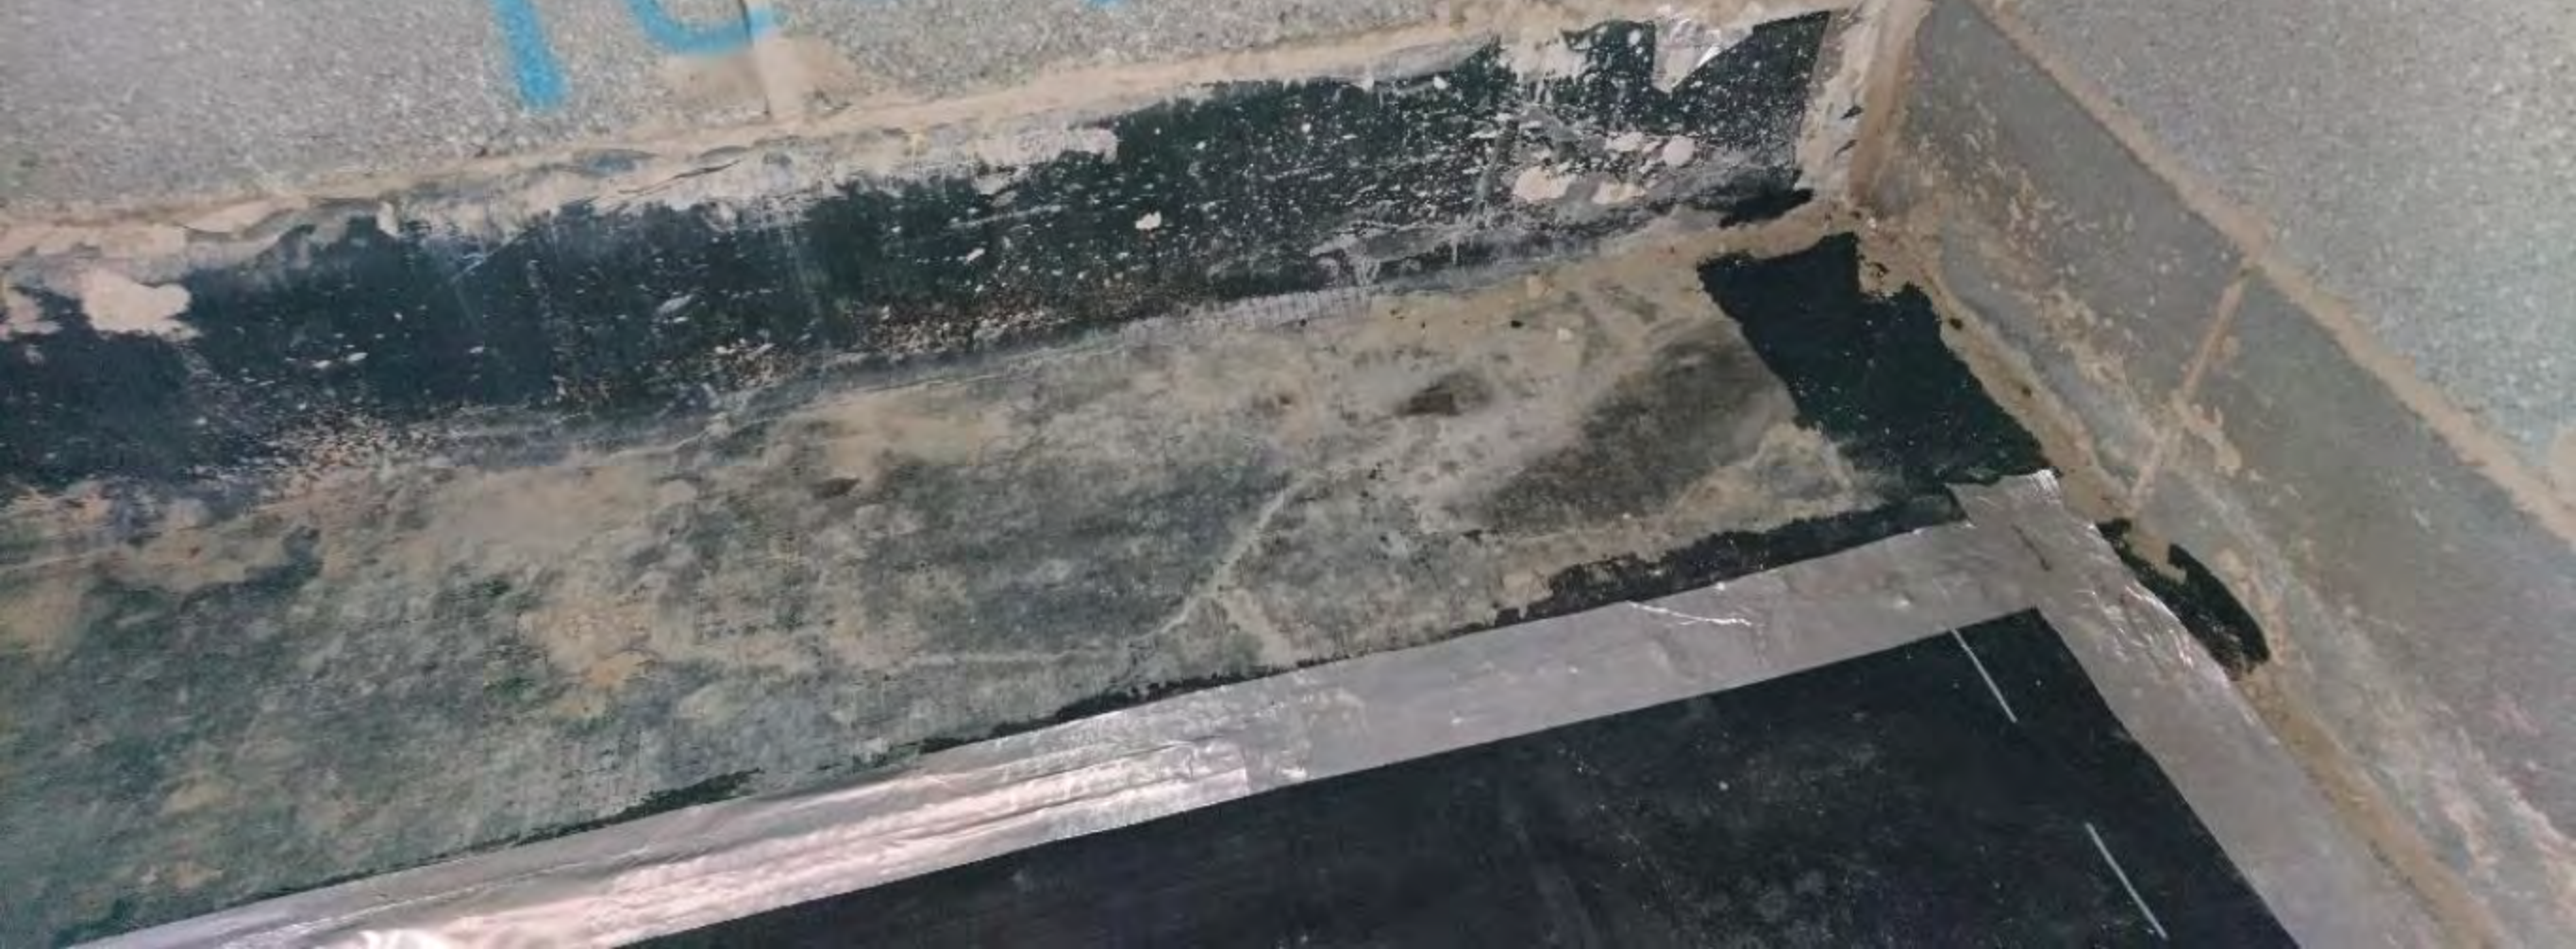
PLOT 26

| 2.2 | Condition of sub-grade & underside of gas membrane | ALL TAPES APPLIED WELL AND SEALED TO A GOOD QUALITY, WITH THE FLOOR BRUSHED | | | | | |
| 2.4 | Gas membrane condition and coverage | SEALED ON ALL SIDES AND IN GOOD CONDITION | | | | | |
| 2.7 | Condition of joints/seals | ALL GOOD, WITH VISIBLE OVERLAPS | | | | | |
| 2.8 | Number and condition of service entry seals | 3 NO. TO PLUMBS WITH SUBILKE CLIPS – ALL TAPES CHECKED AND OK | | | | | |
