This Record sheet is only applicable to block and beam floor slabs for Characteristic Situation 2 gas protection systems

Plot No.: 2

For Residential Development at New Church Street, Radcliffe.

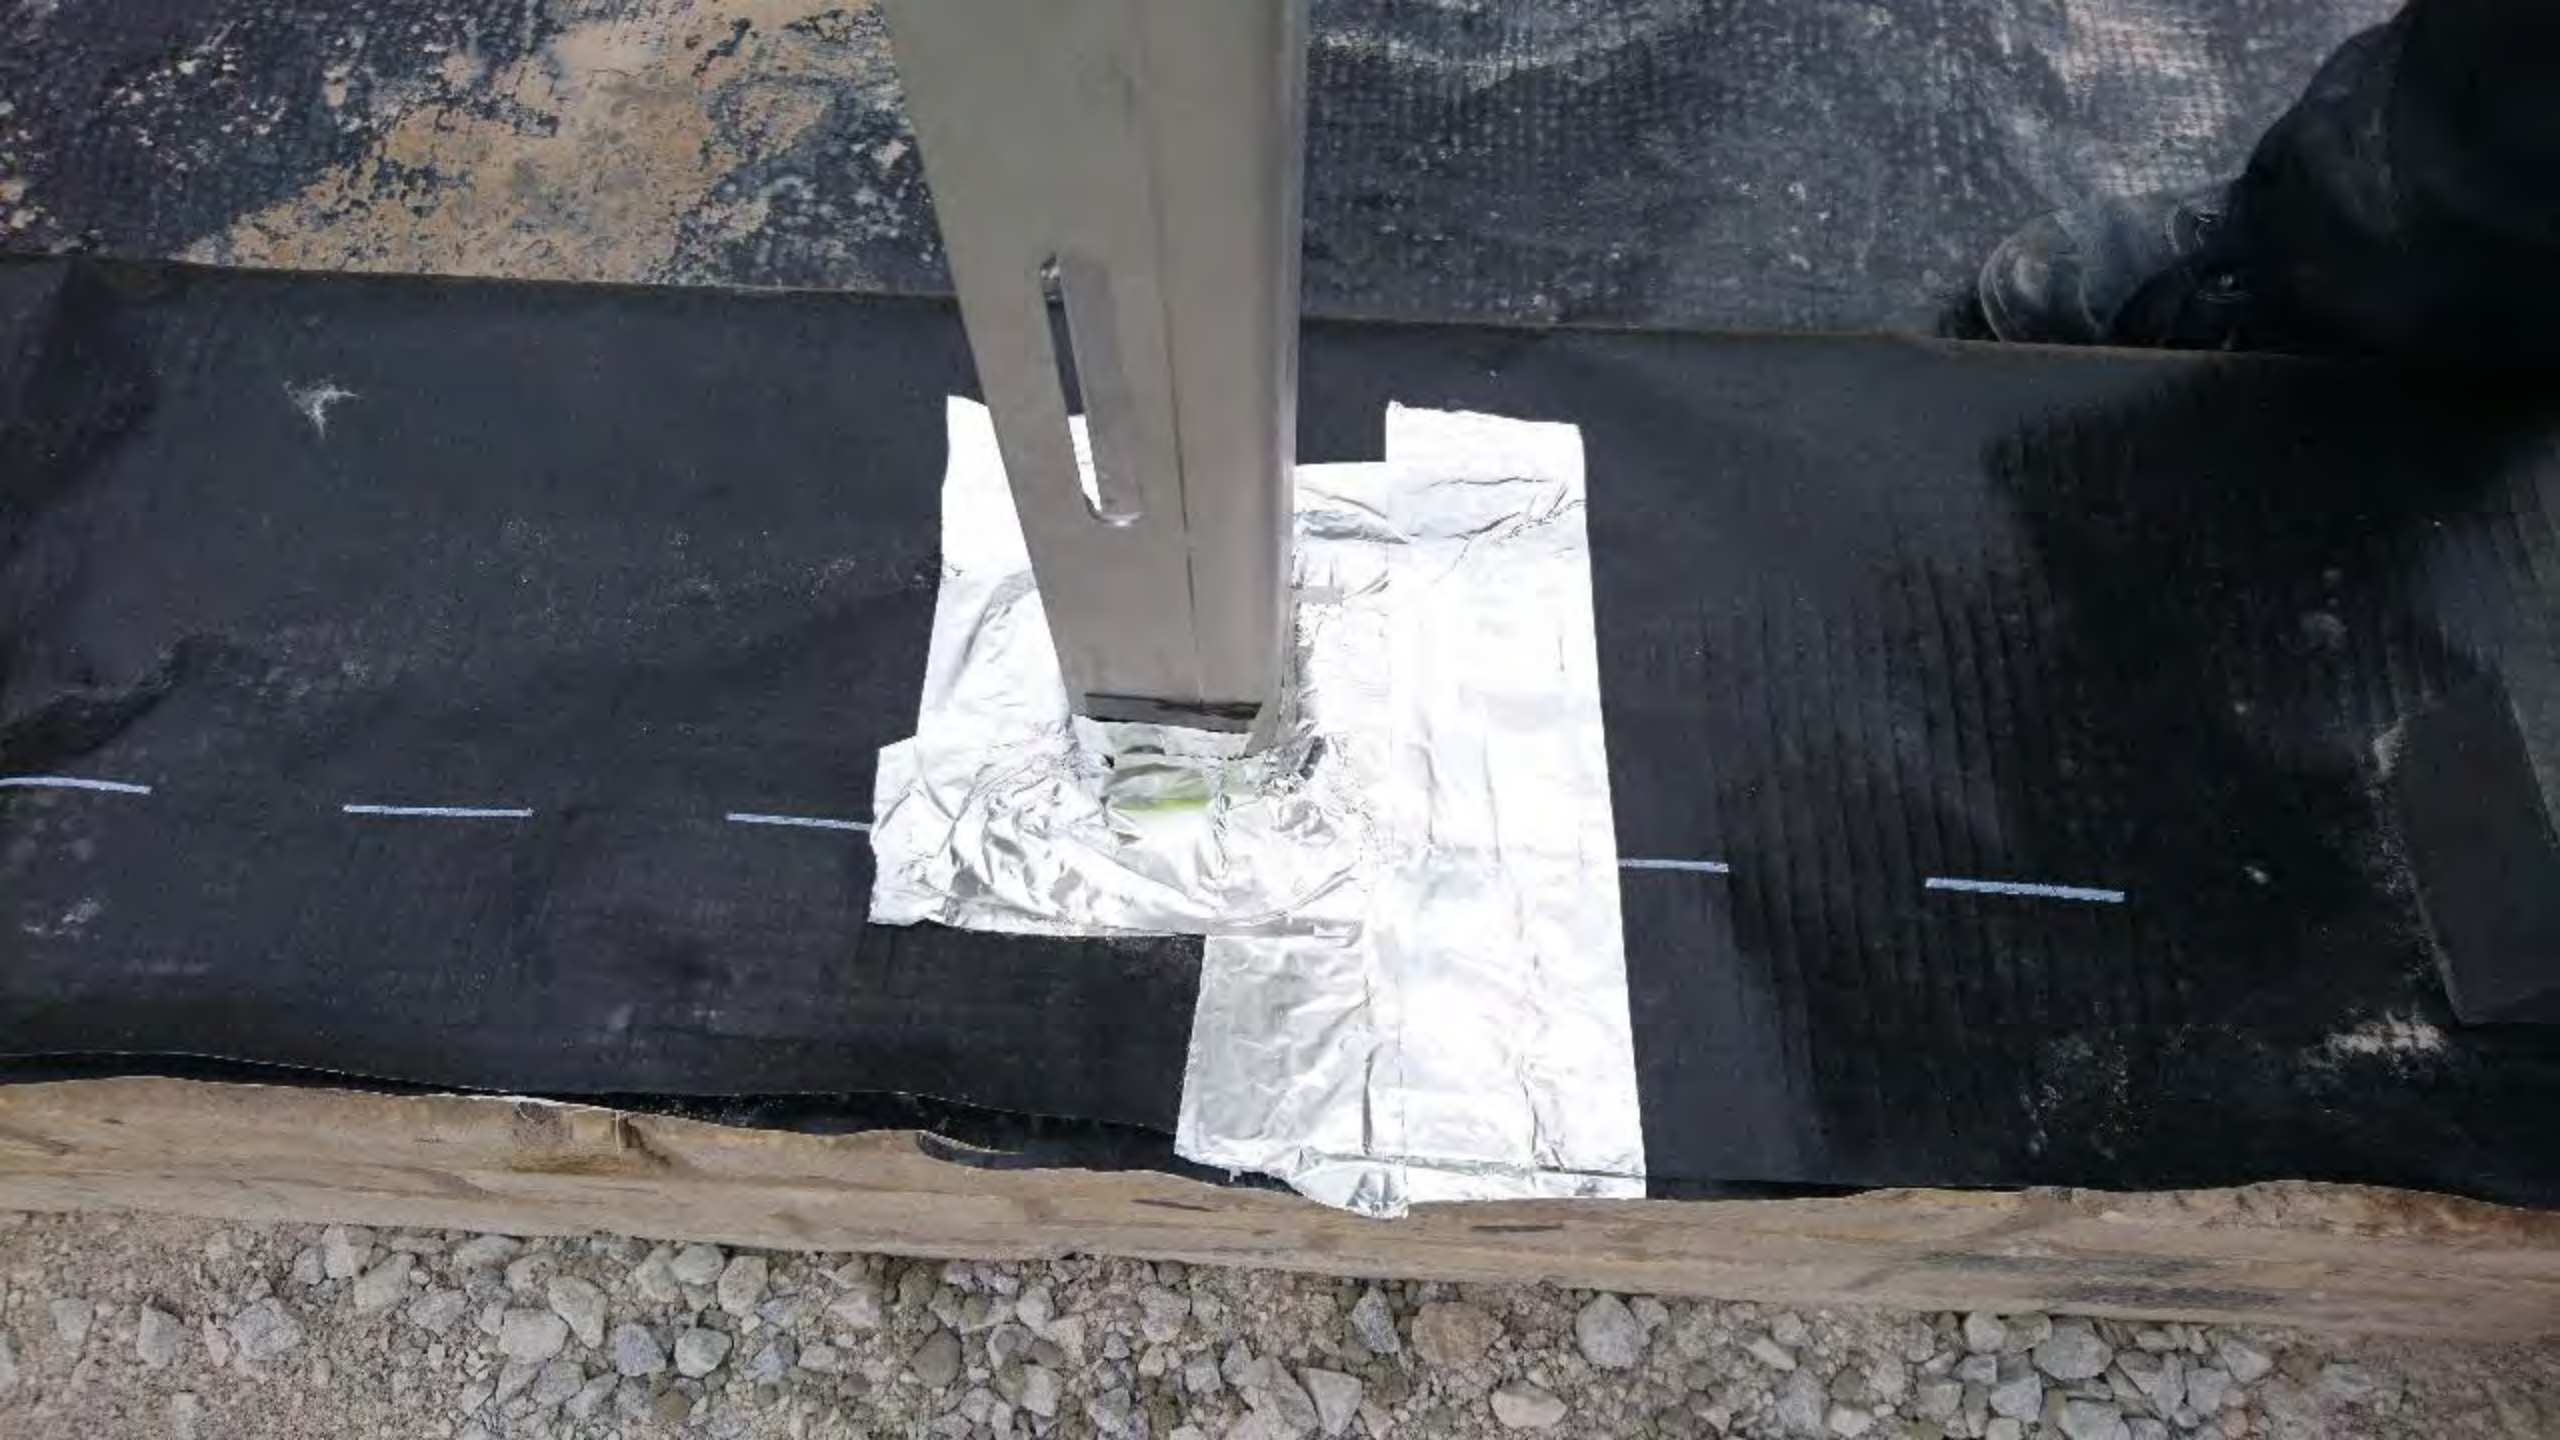
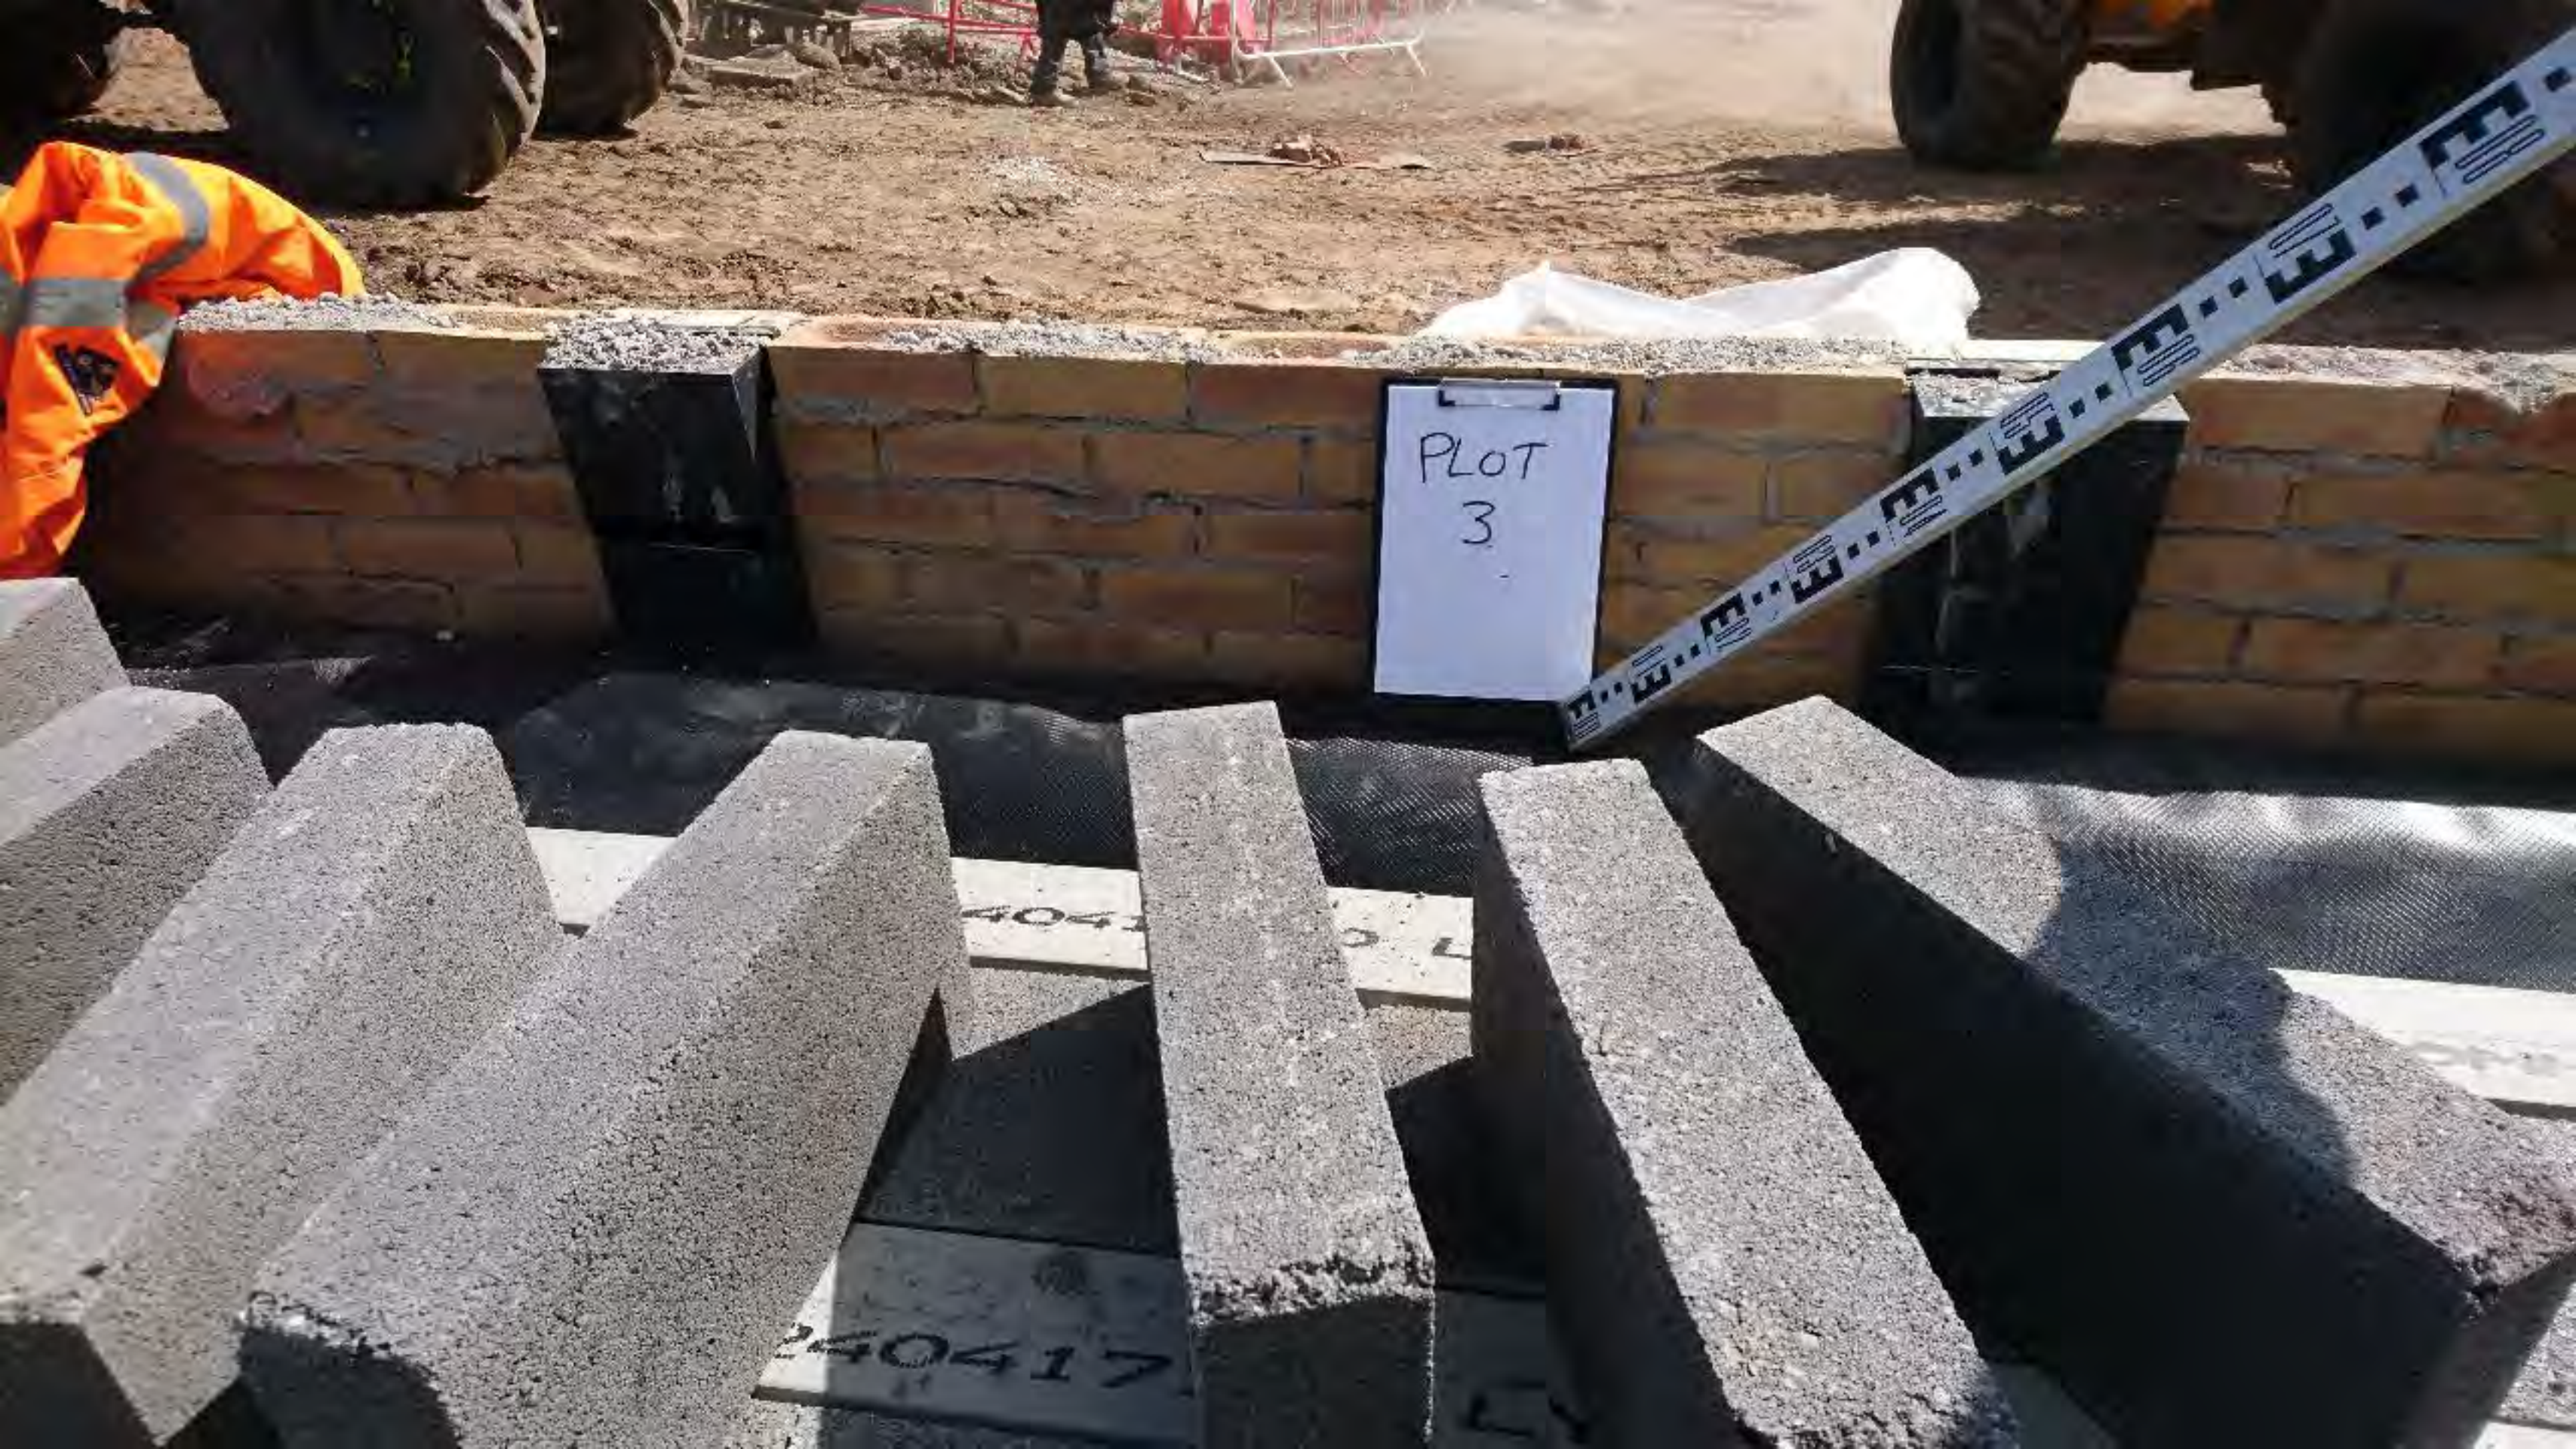
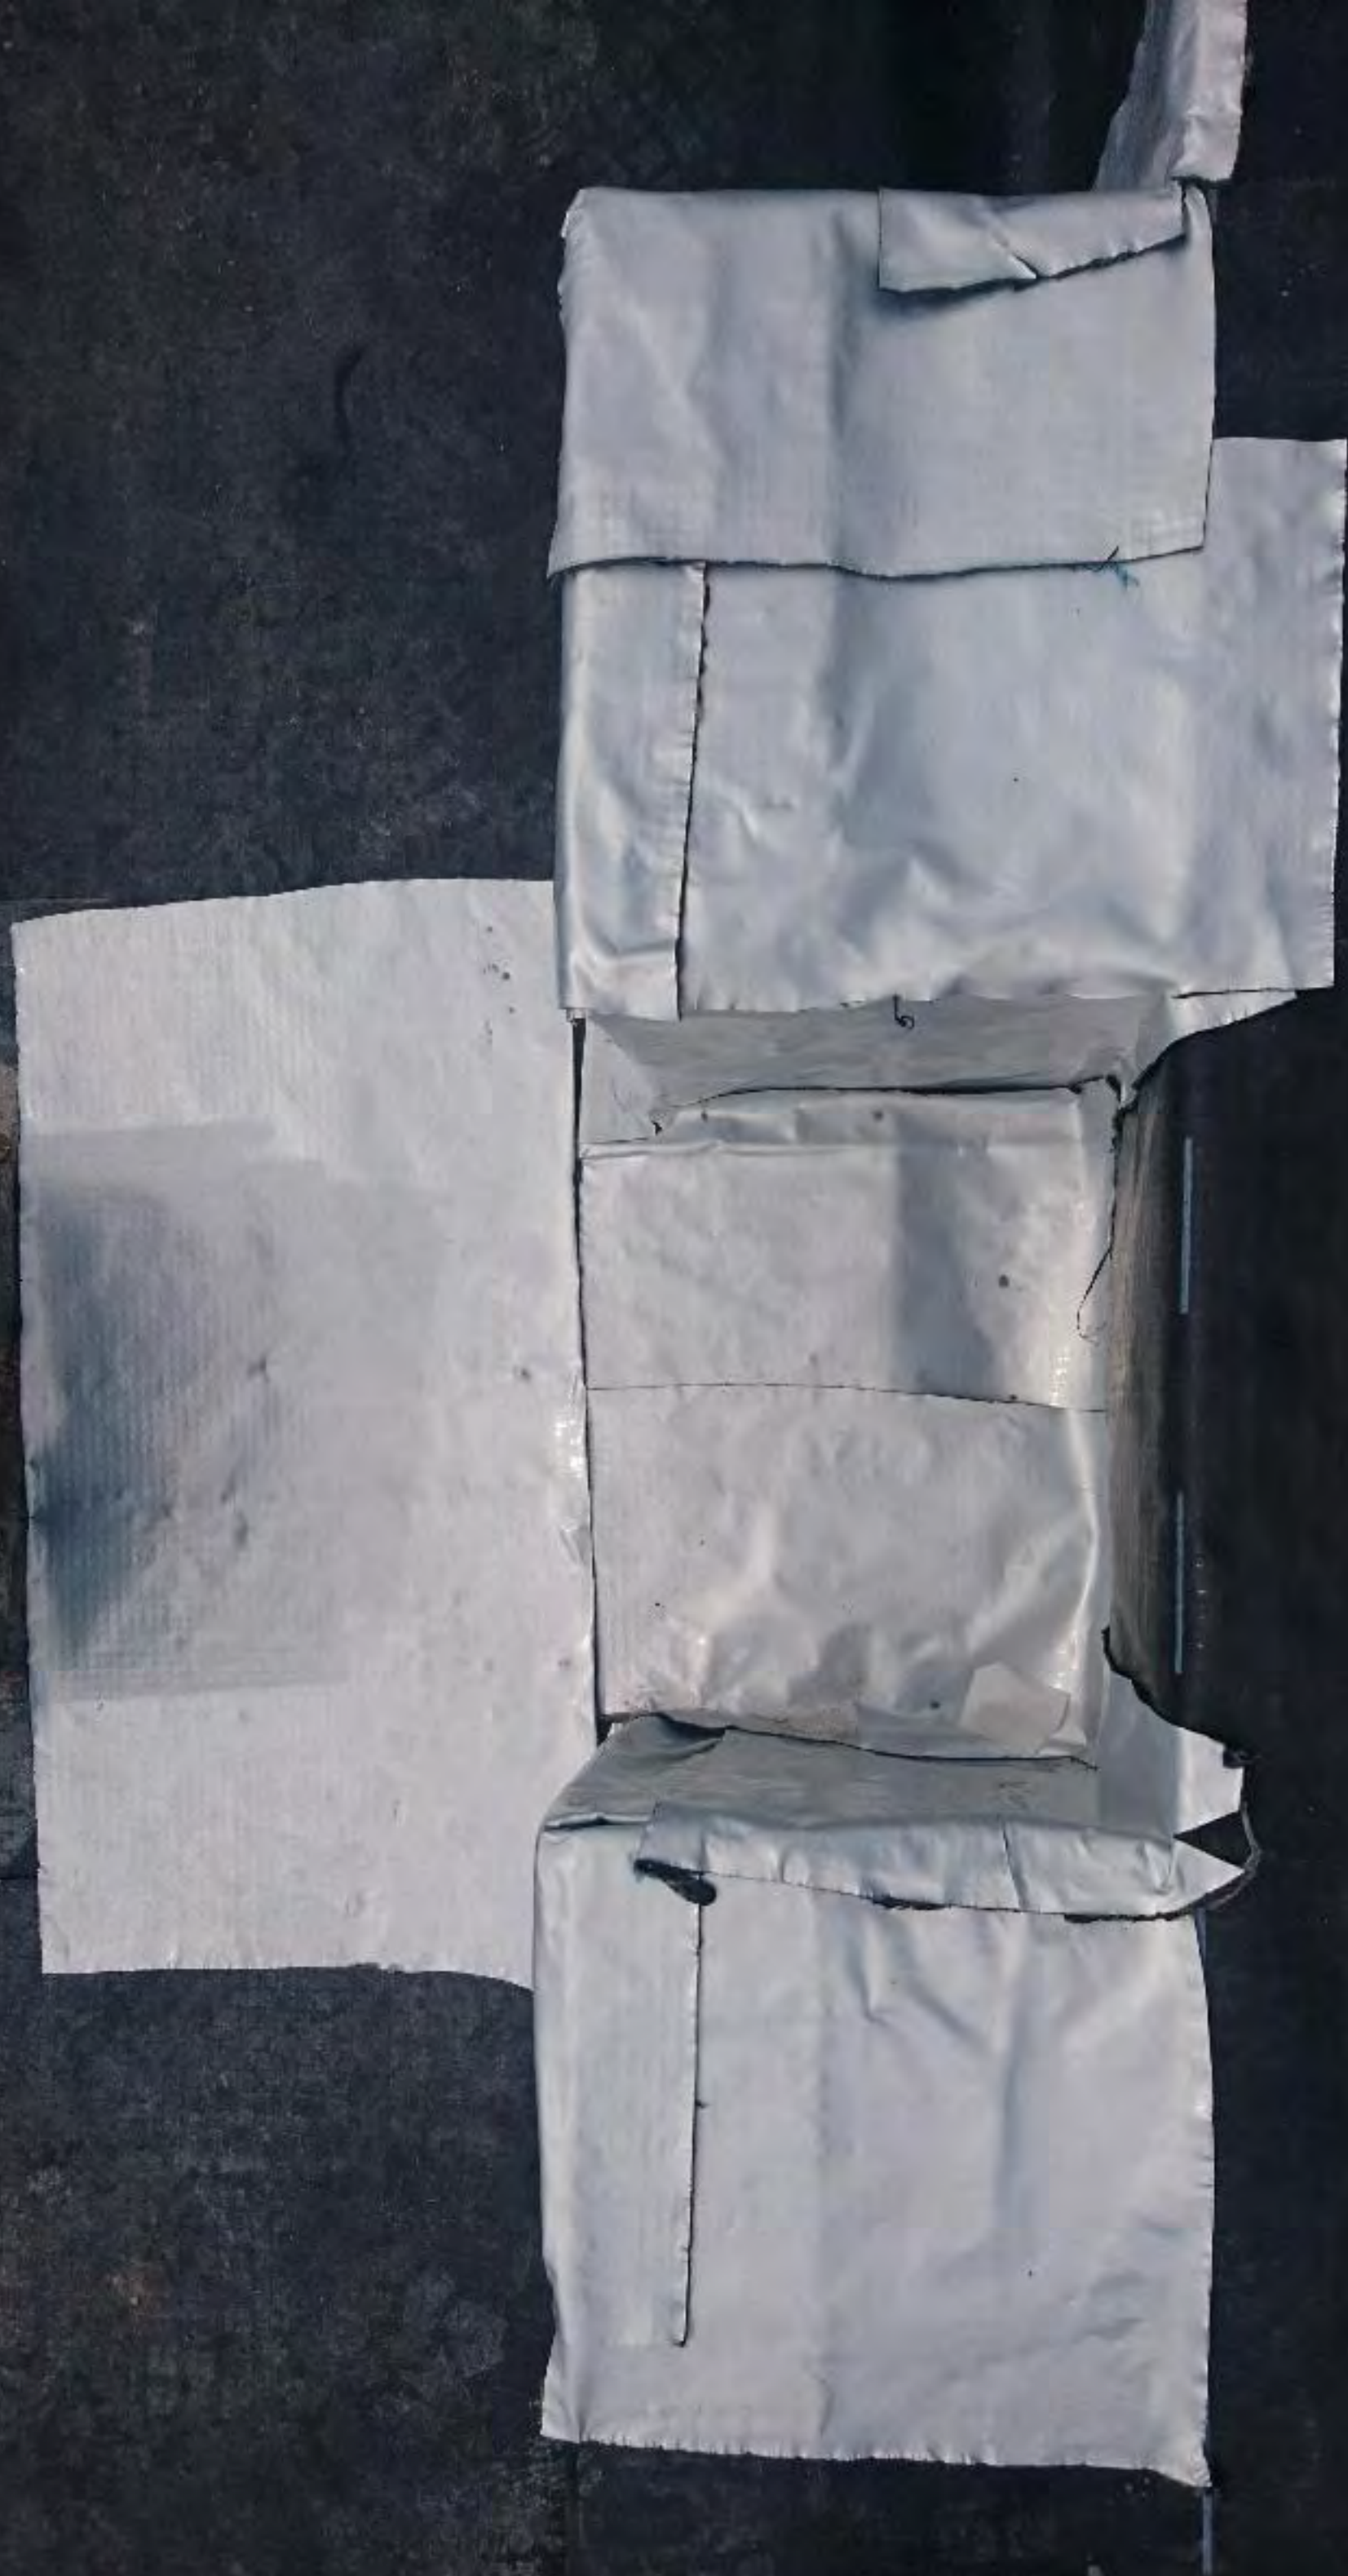
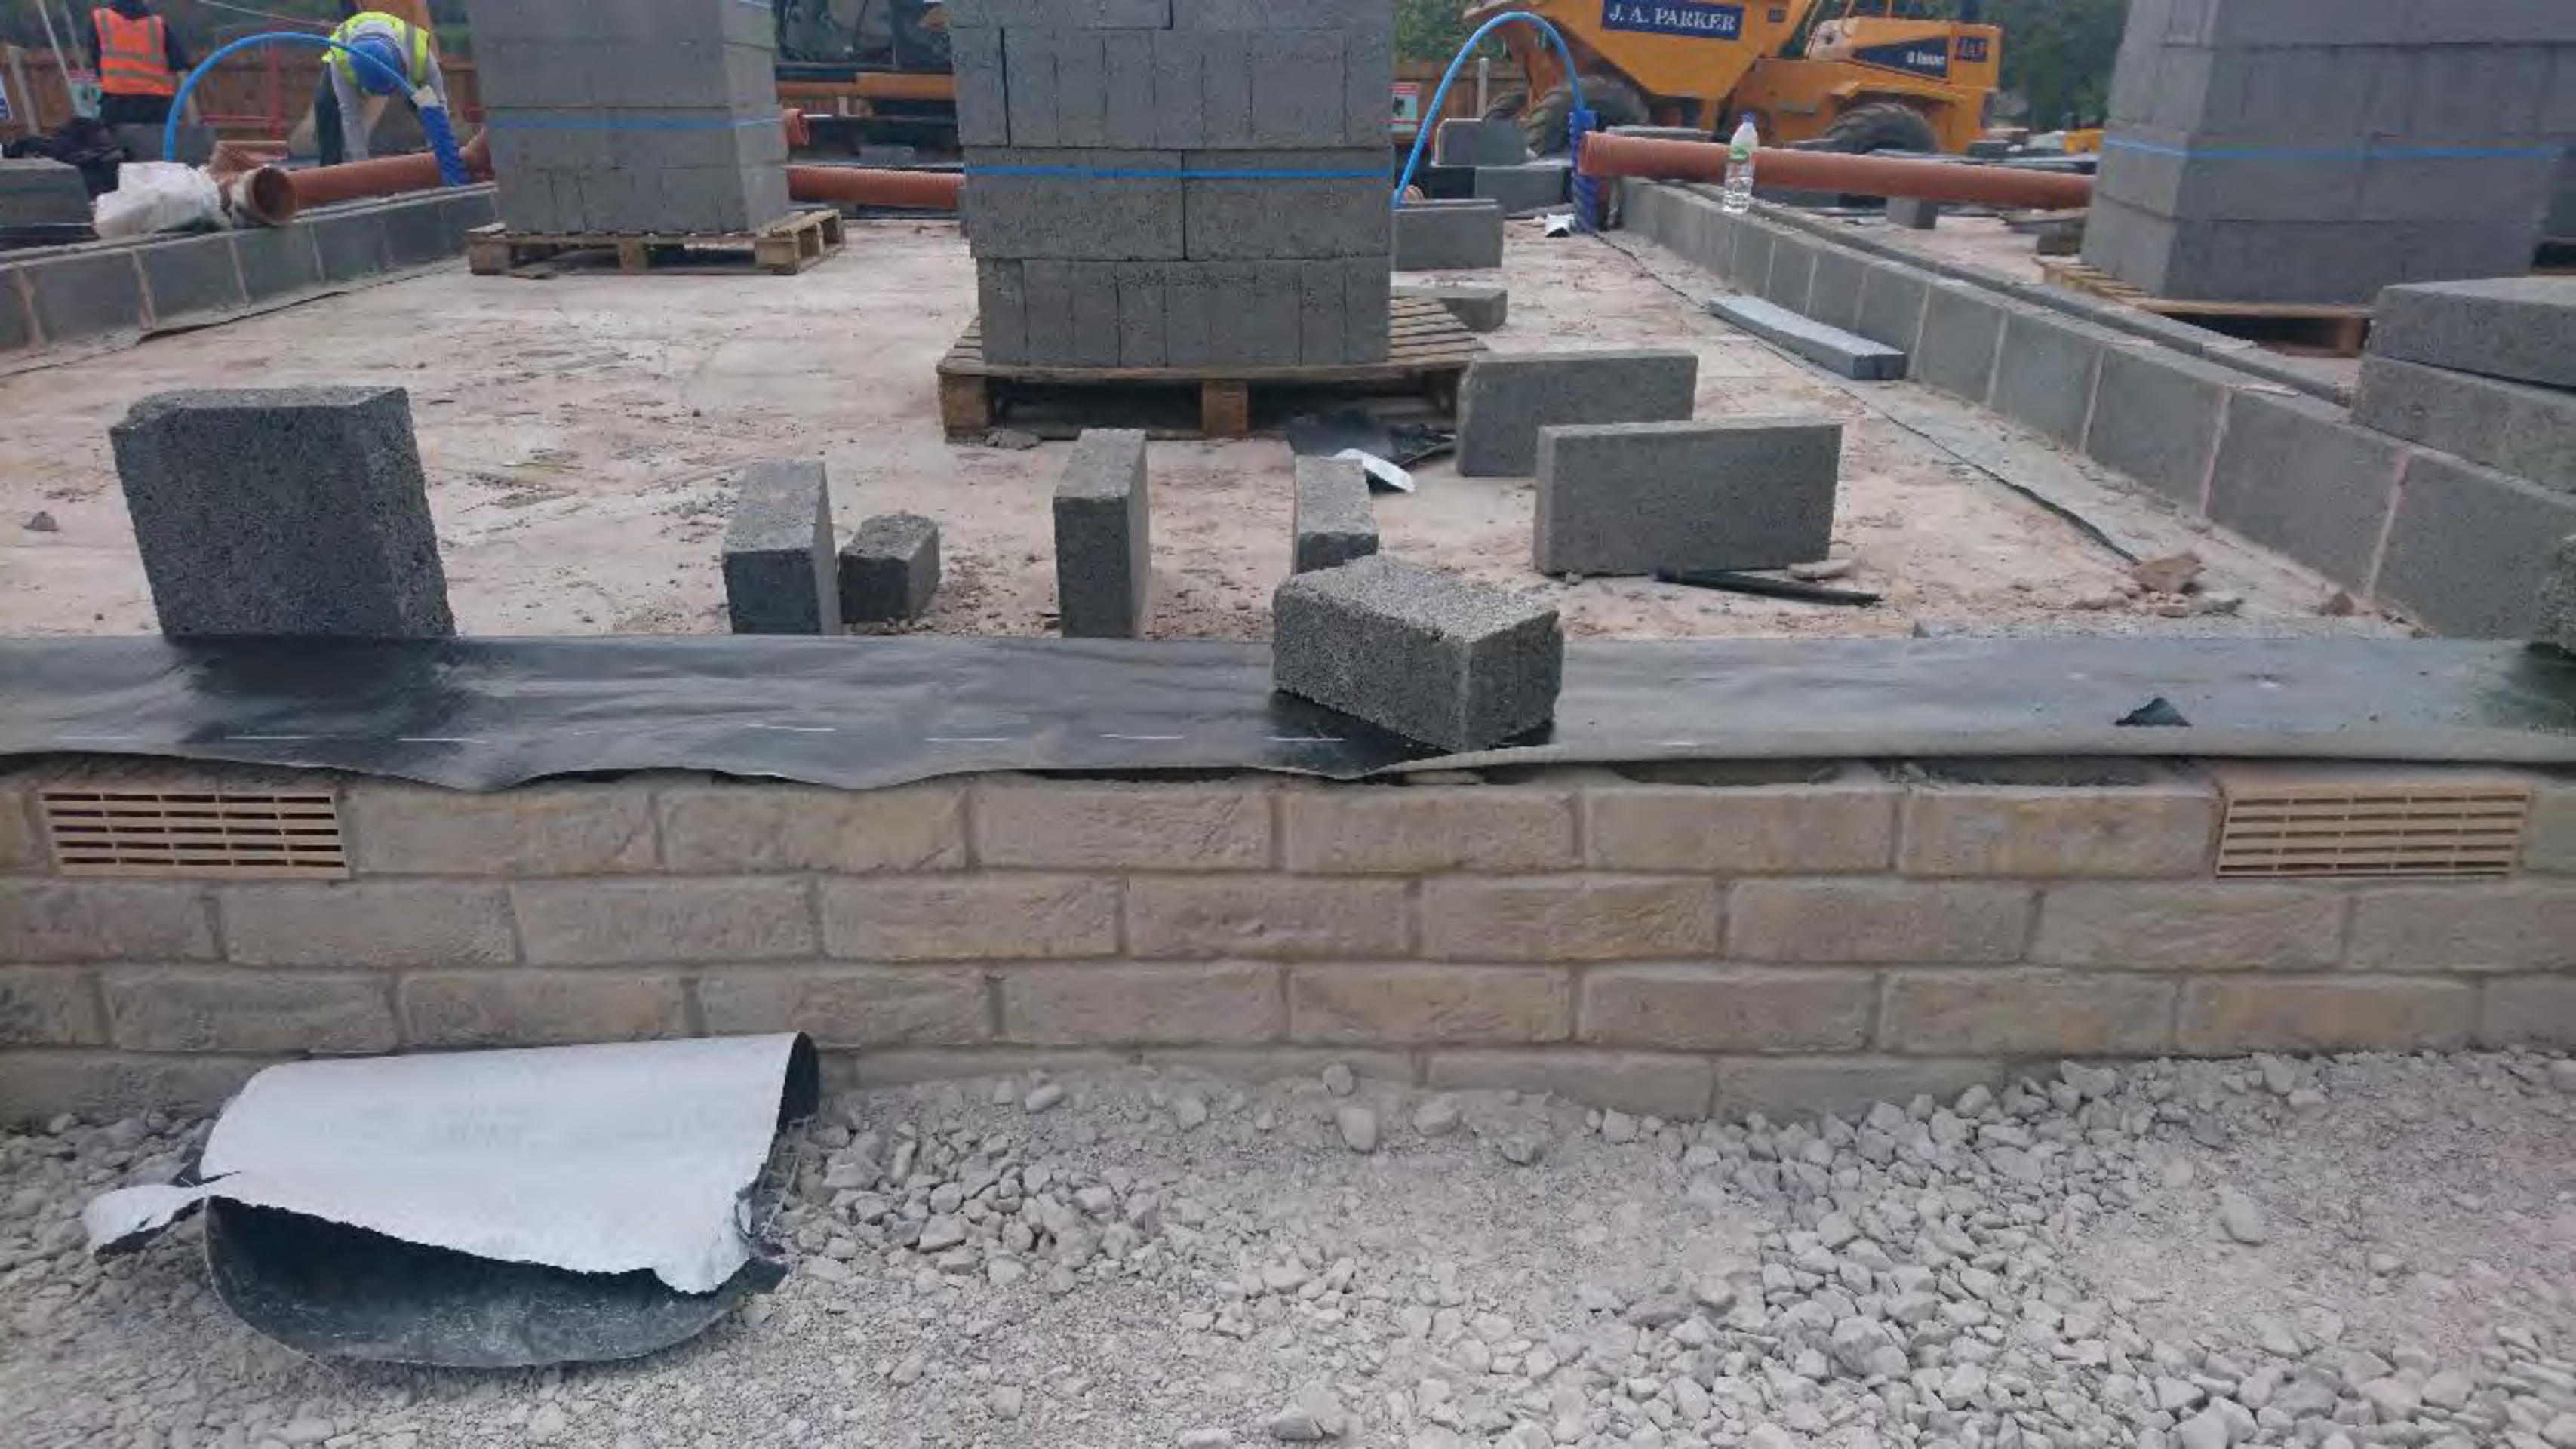
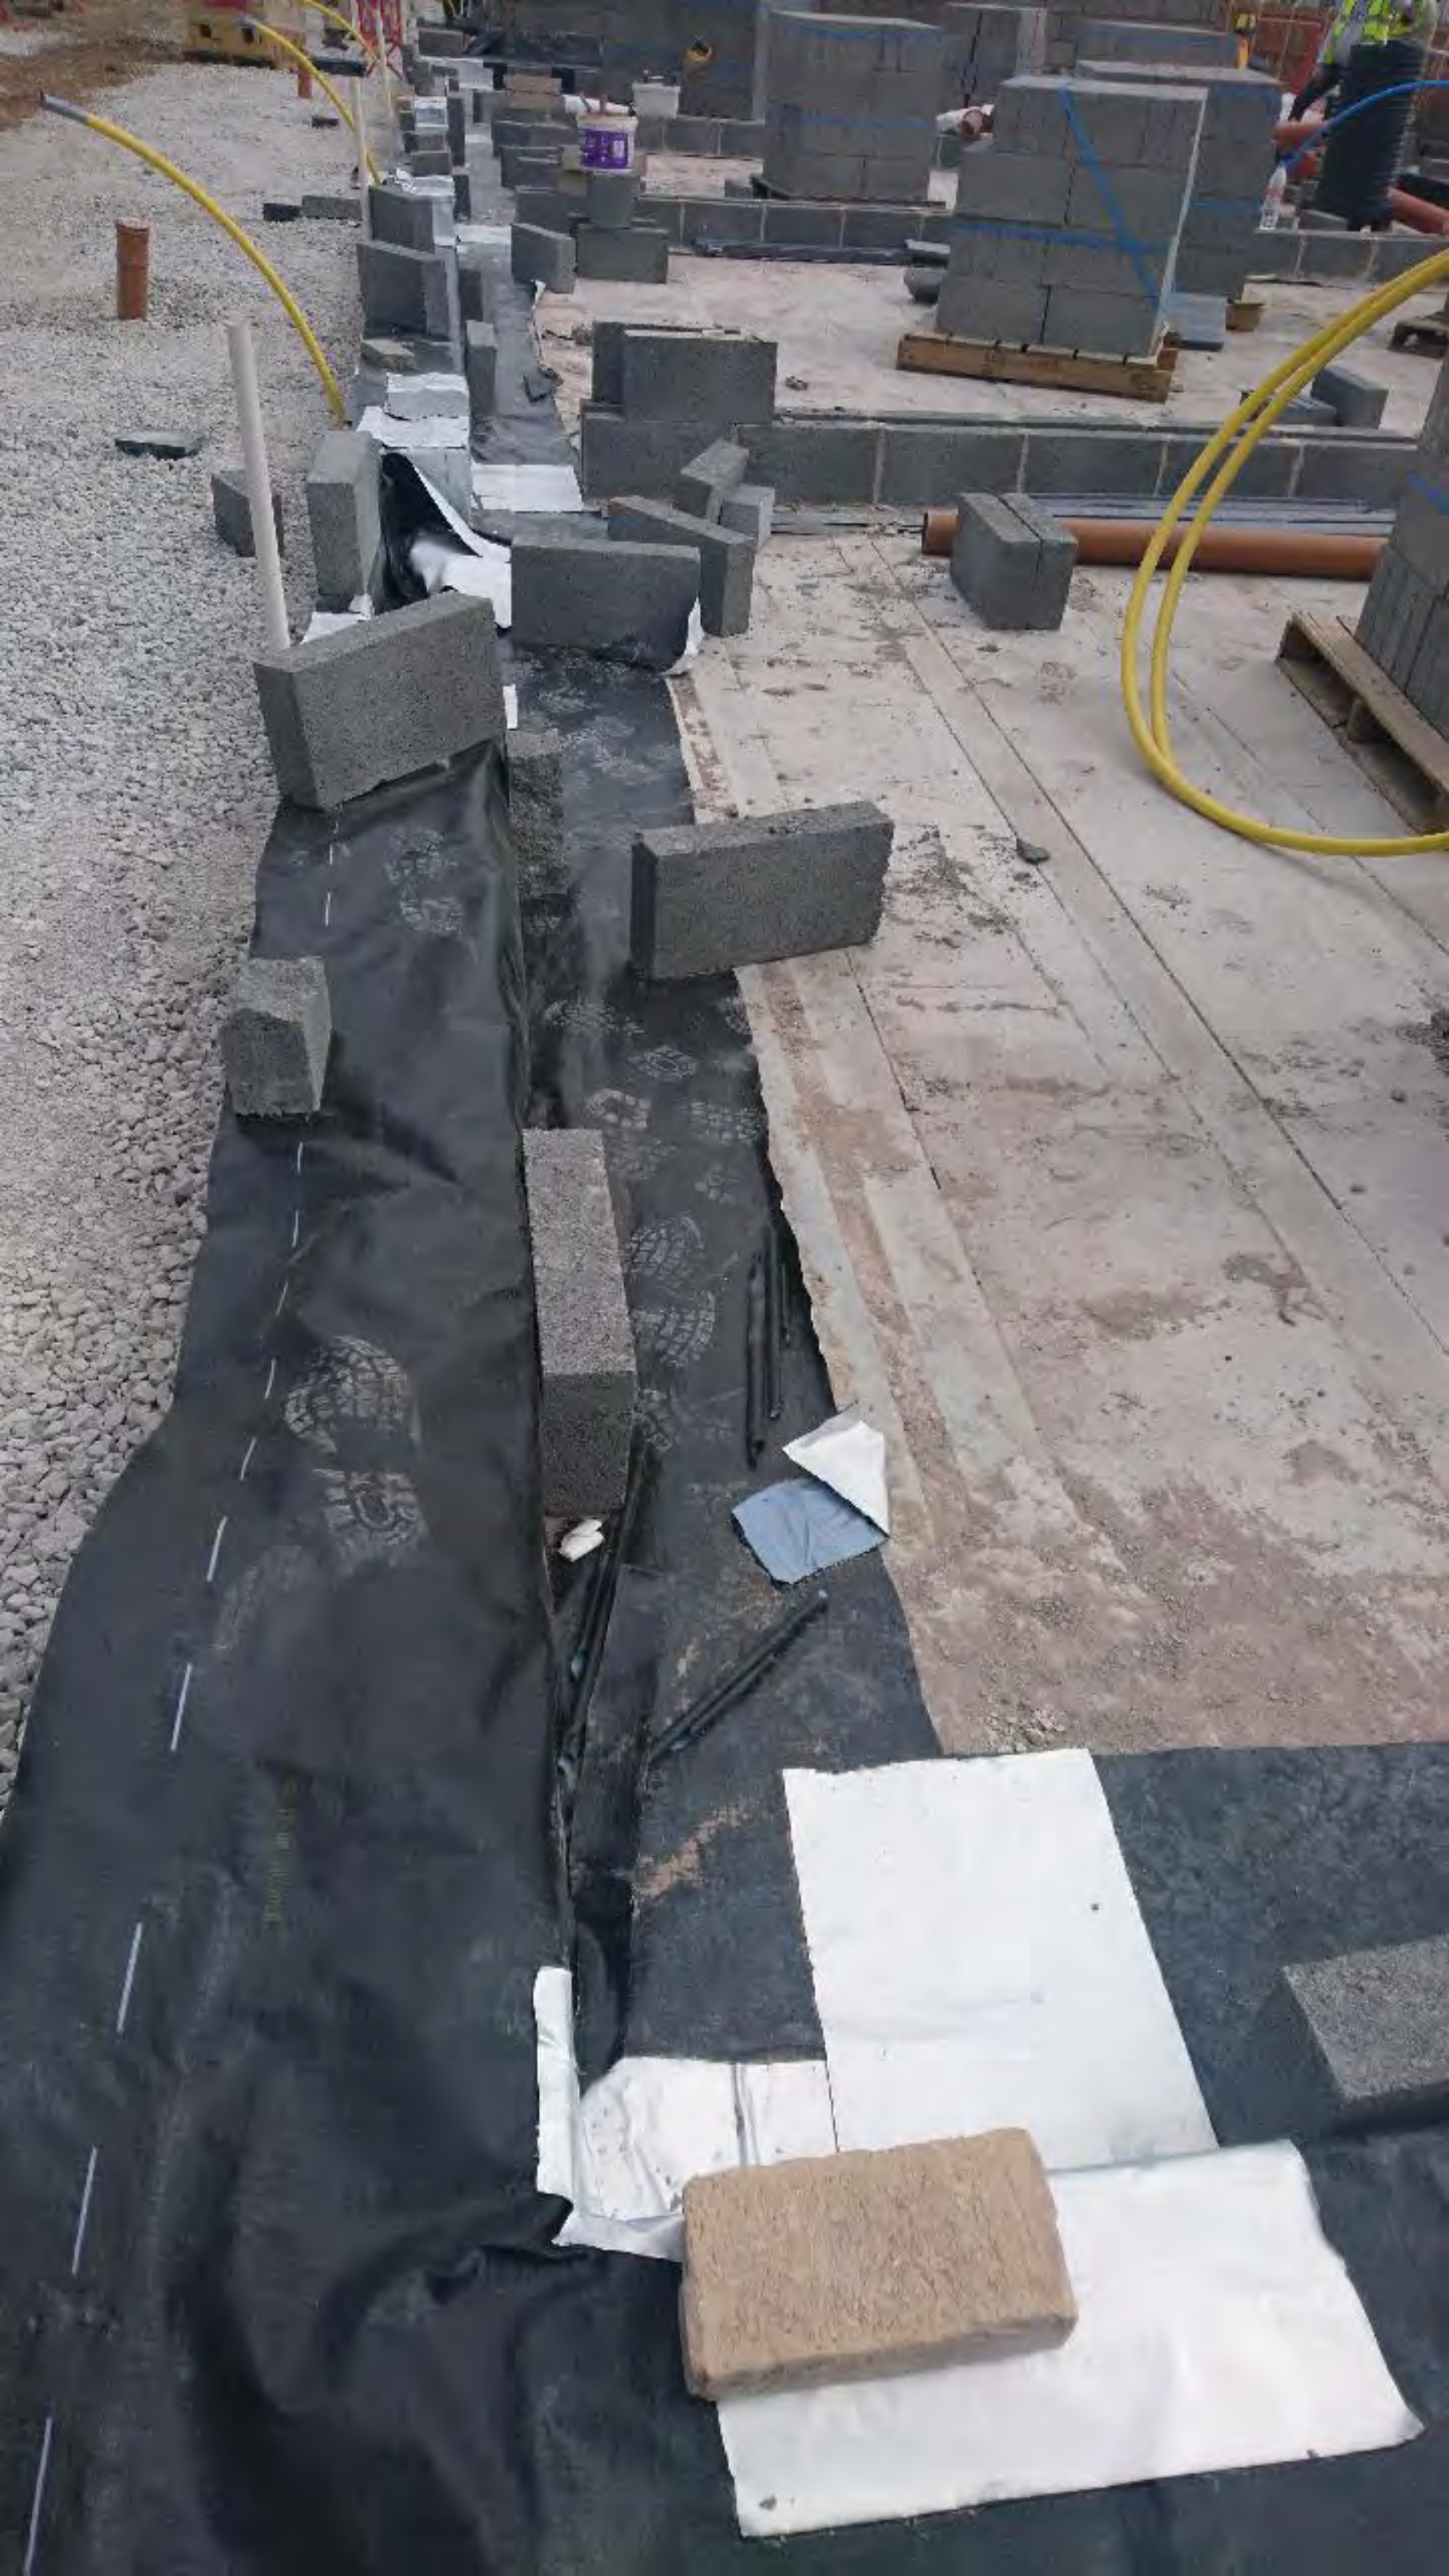
| 1.2 | External Wall Venting – cranked vent spacing | <u>LESS THAN 2M – 1.8M</u> | | | | | |
| 2.2 | Condition of sub-grade & underside of gas membrane | <u>VERY GOOD, NO ISSUES</u> | | | | | |
| 2.4 | Gas membrane condition and coverage | <u>FULL CAVITY</u> | | | | | |
| 2.7 | Condition of joints/seals | <u>GOOD – 150mm OVERLAPS</u> | | | | | |
| 2.9 | Membrane steps/corner seals | <u>ALL OK, CORNER SEALS TIDY</u> | | | | | |
