This Record sheet is only applicable to block and beam floor slabs for Characteristic Situation 2 gas protection systems

Plot No.: 2

For Residential Development at New Church Street, Radcliffe.

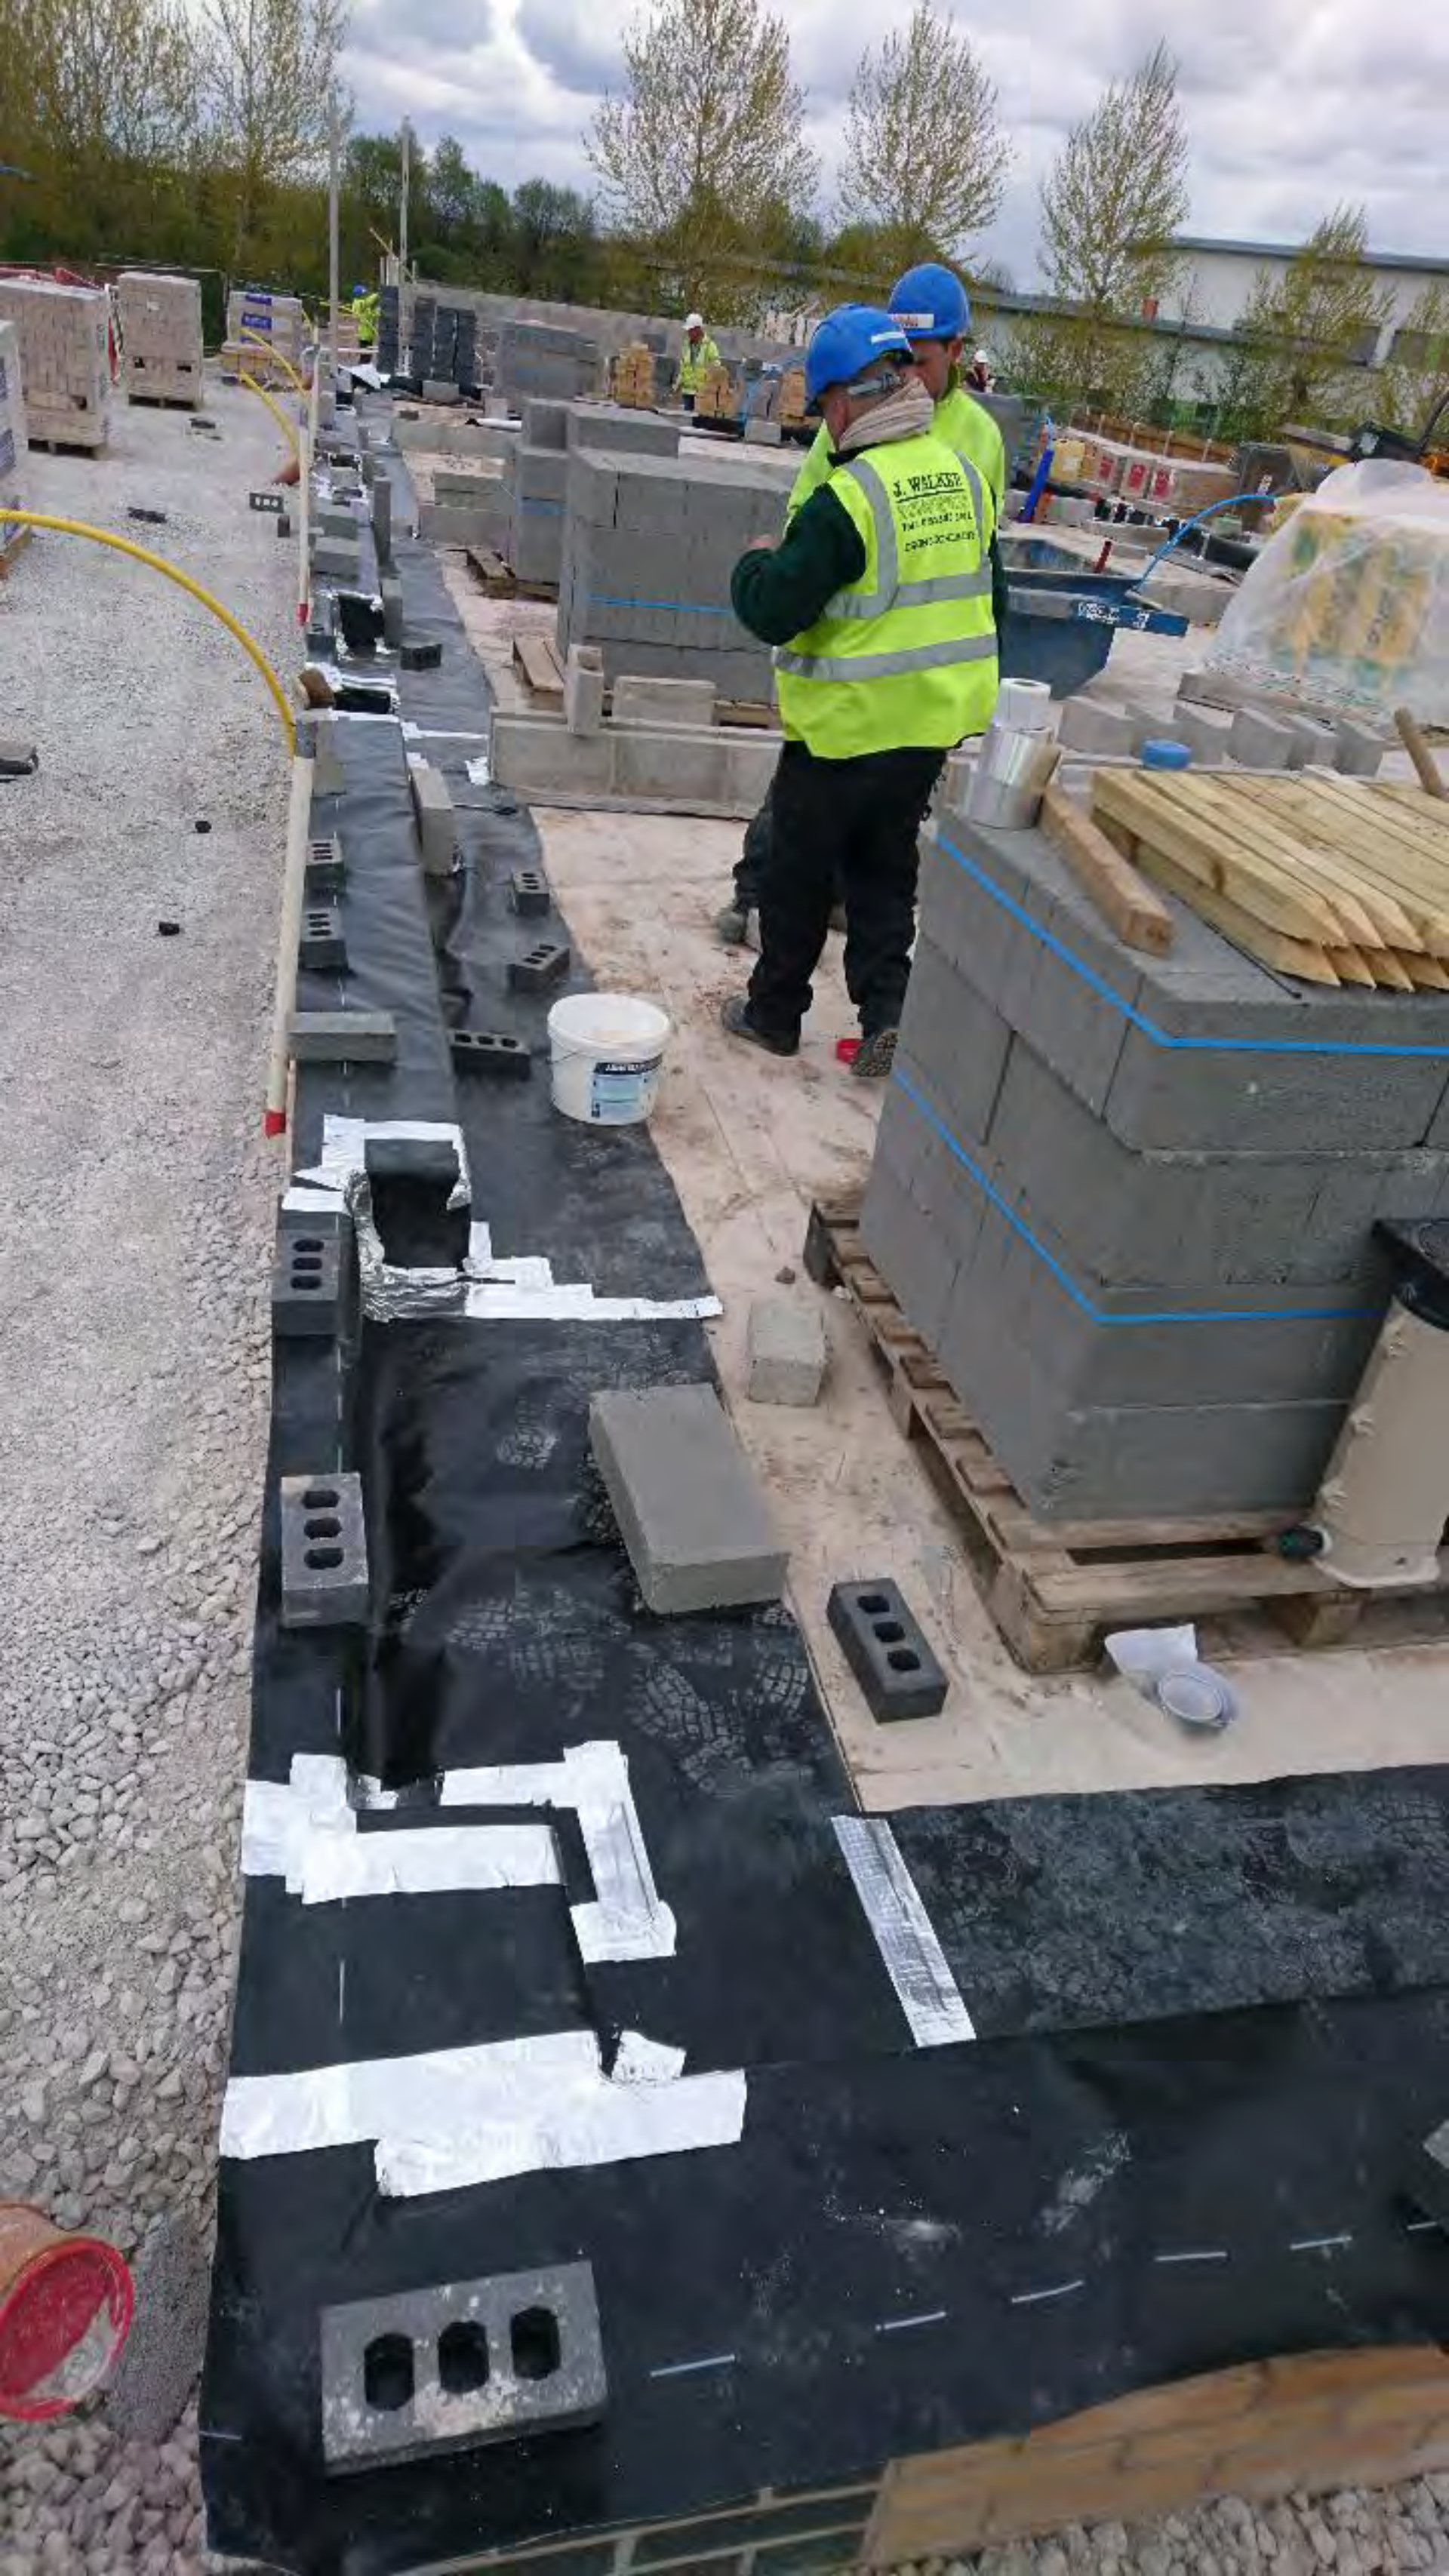
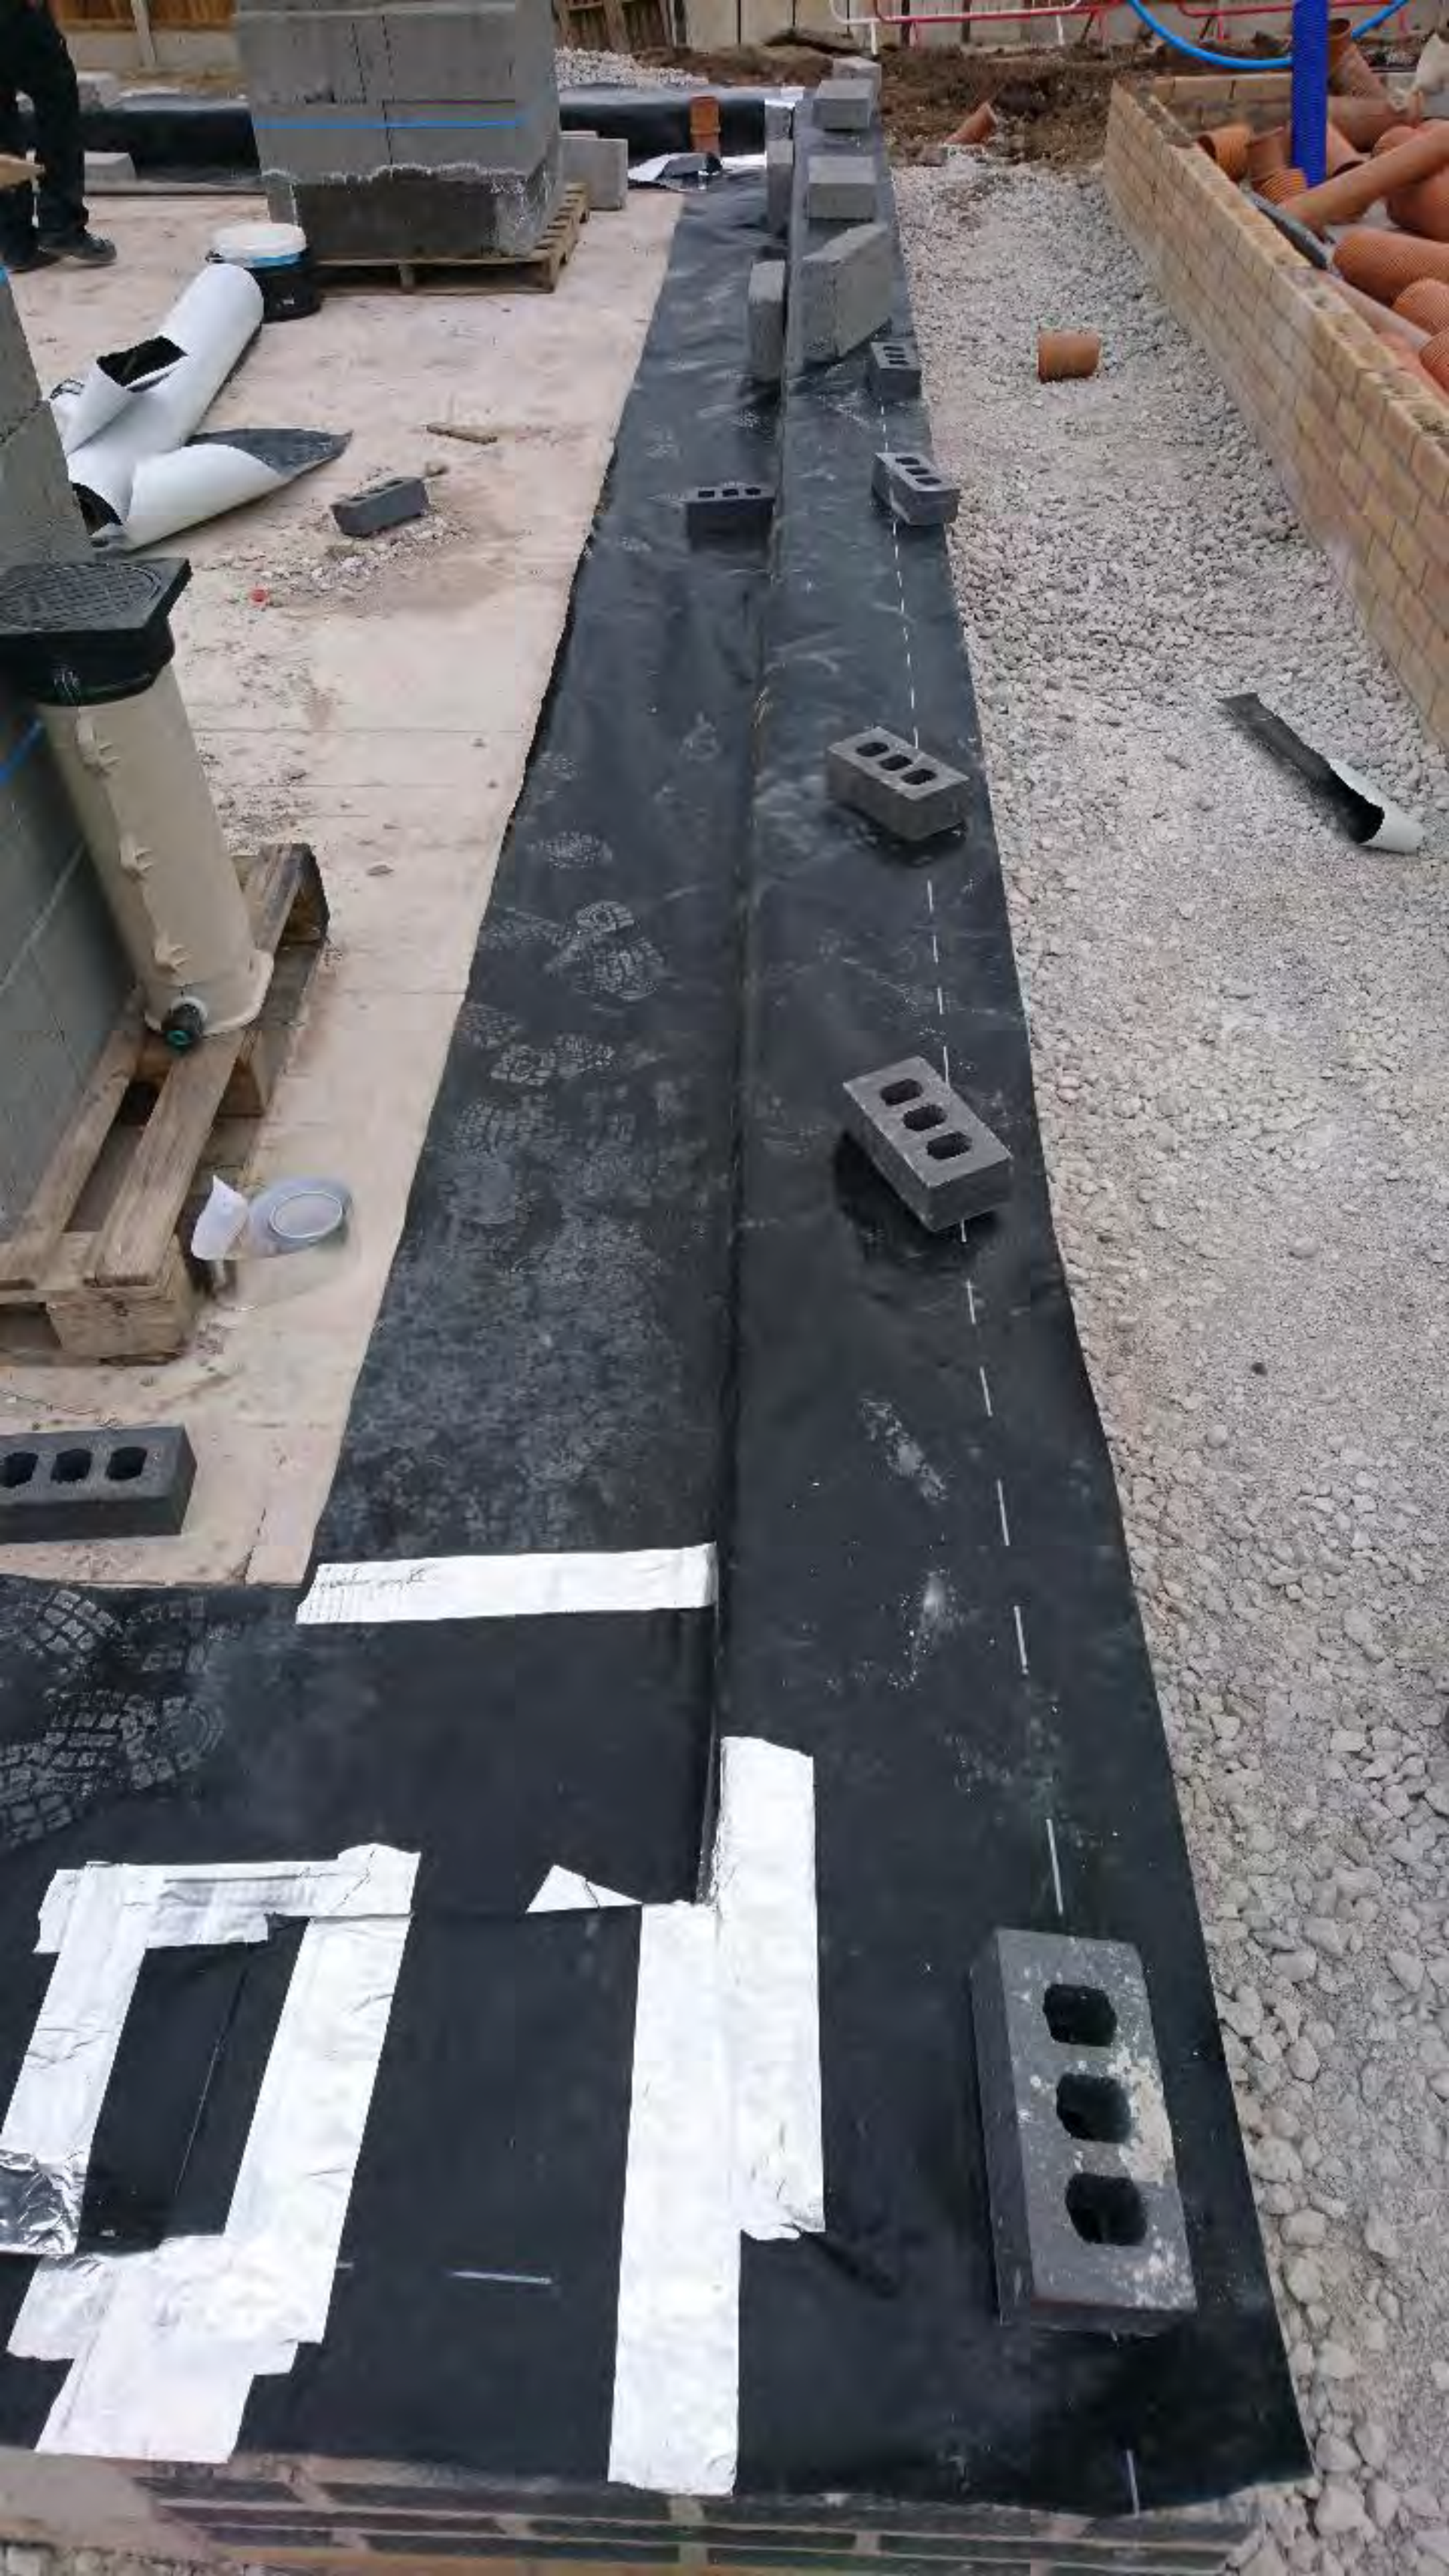
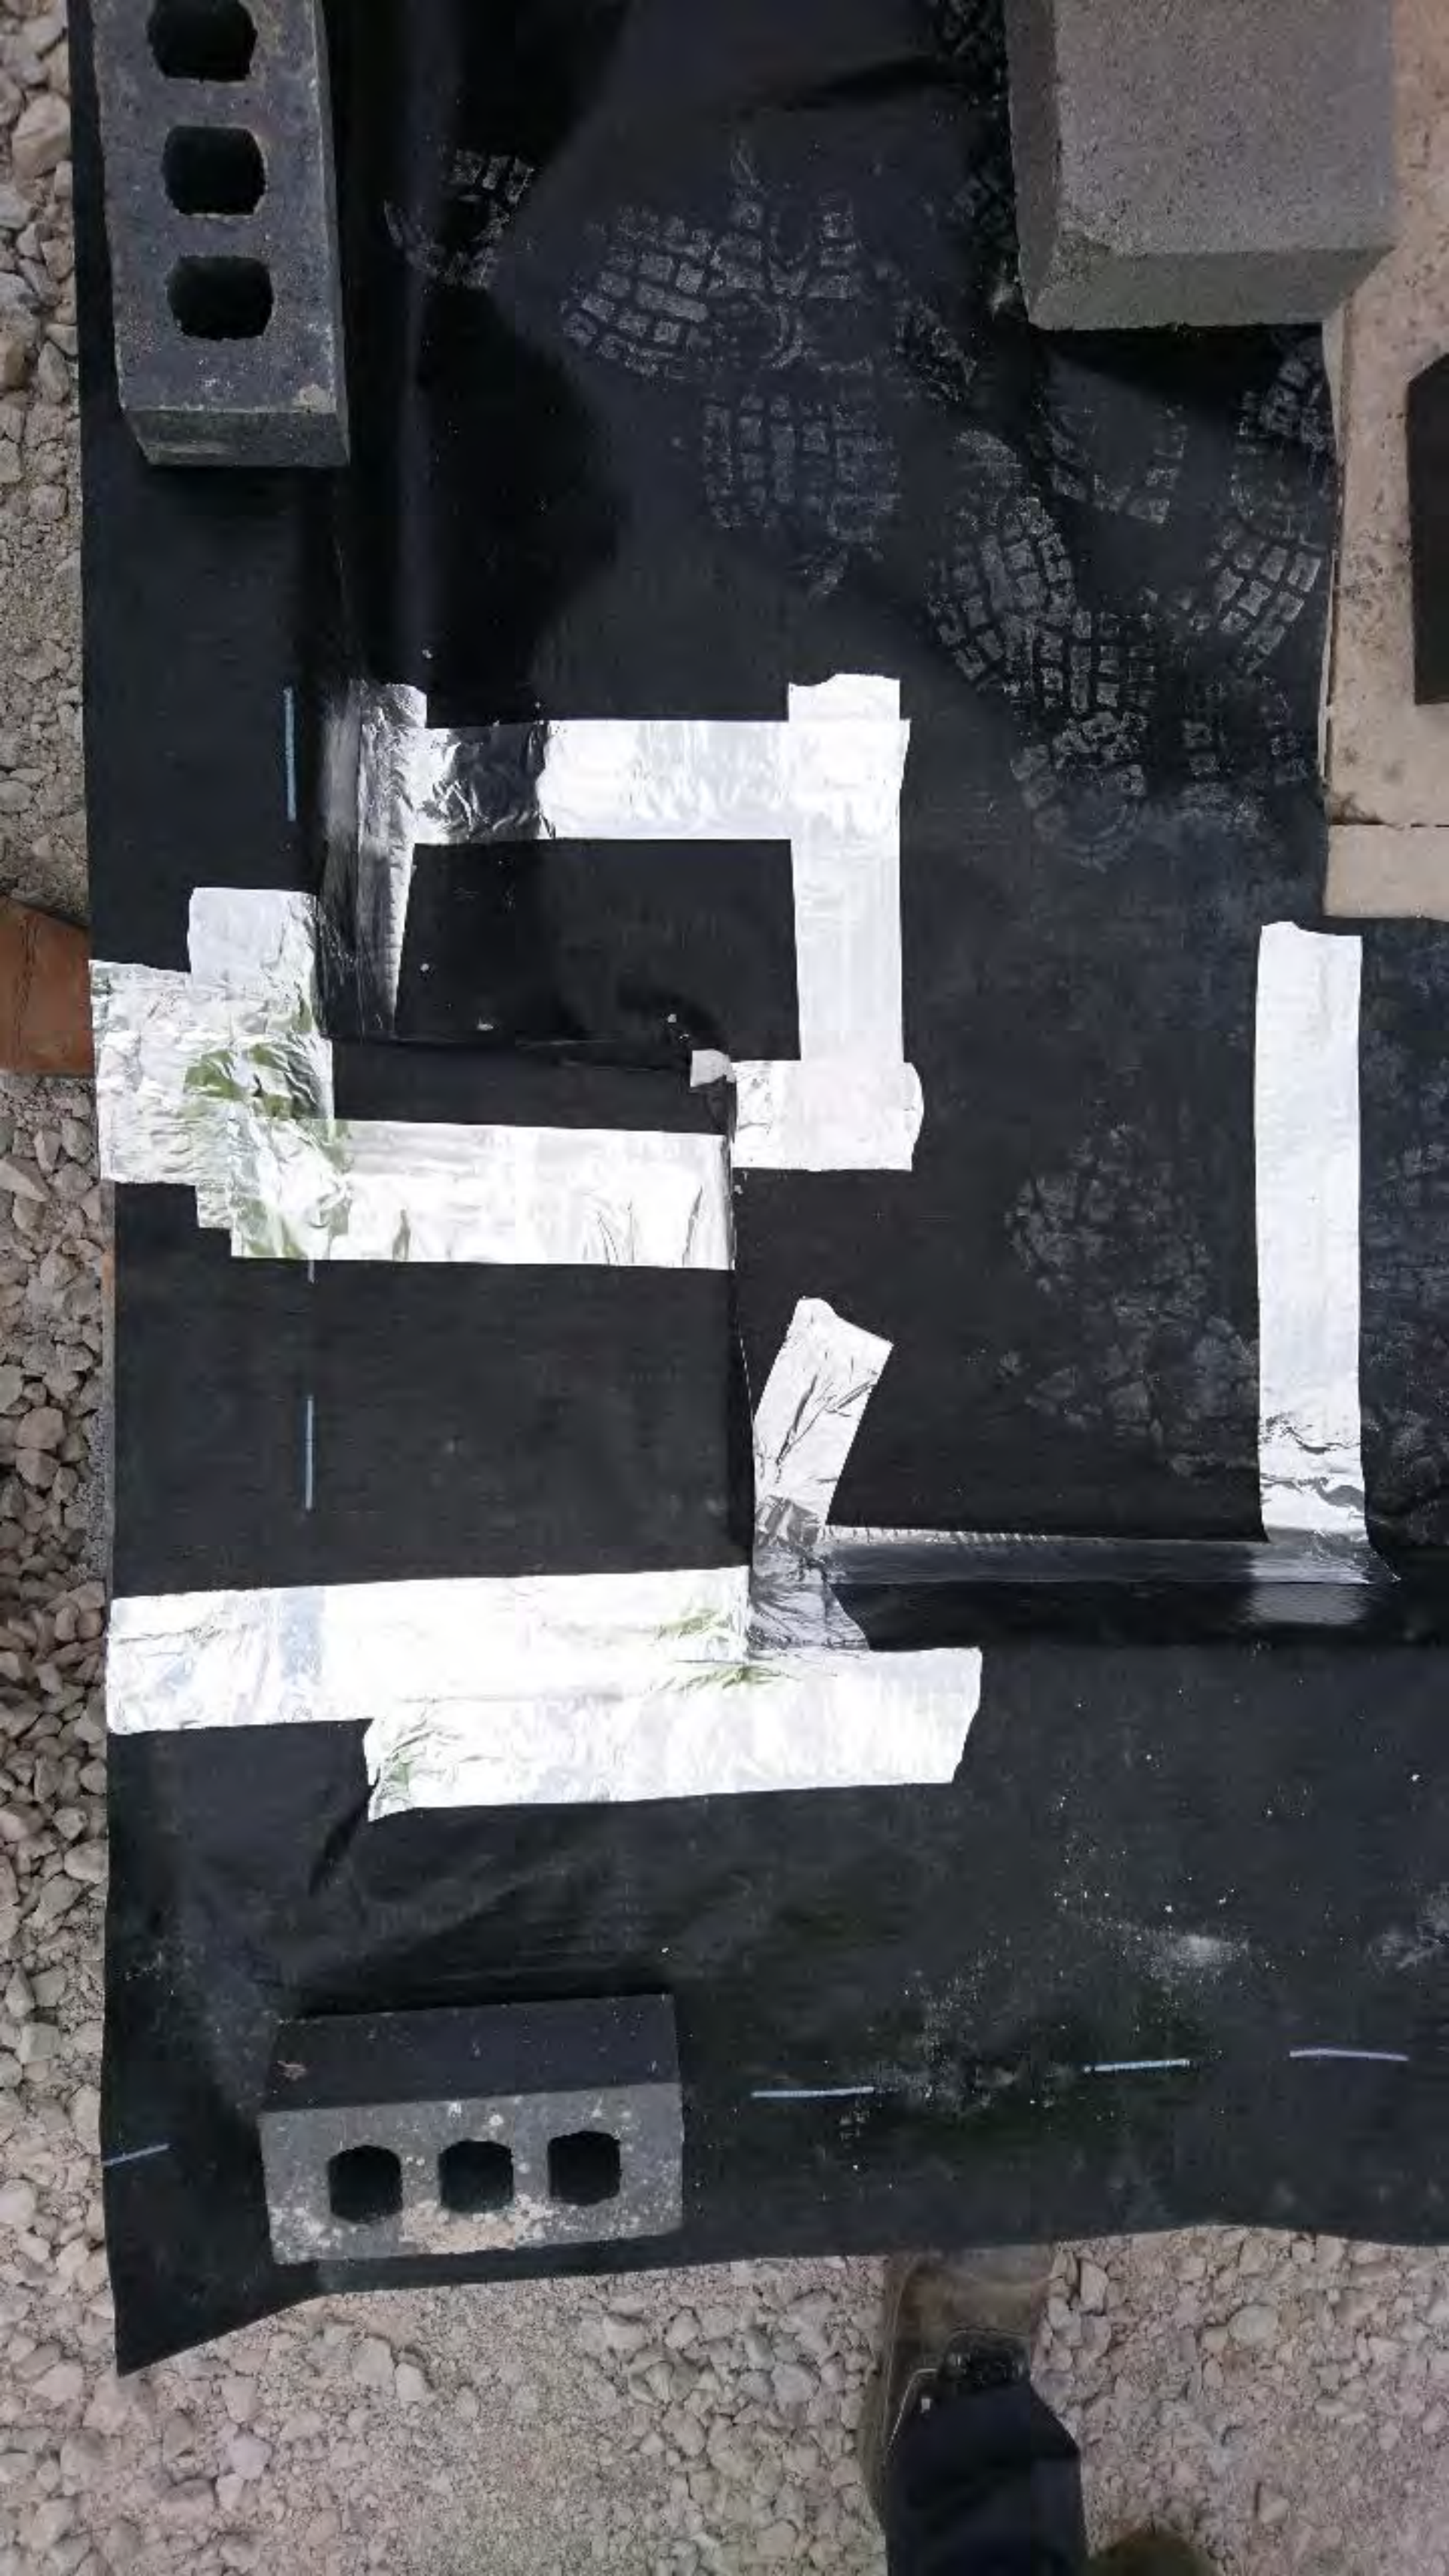
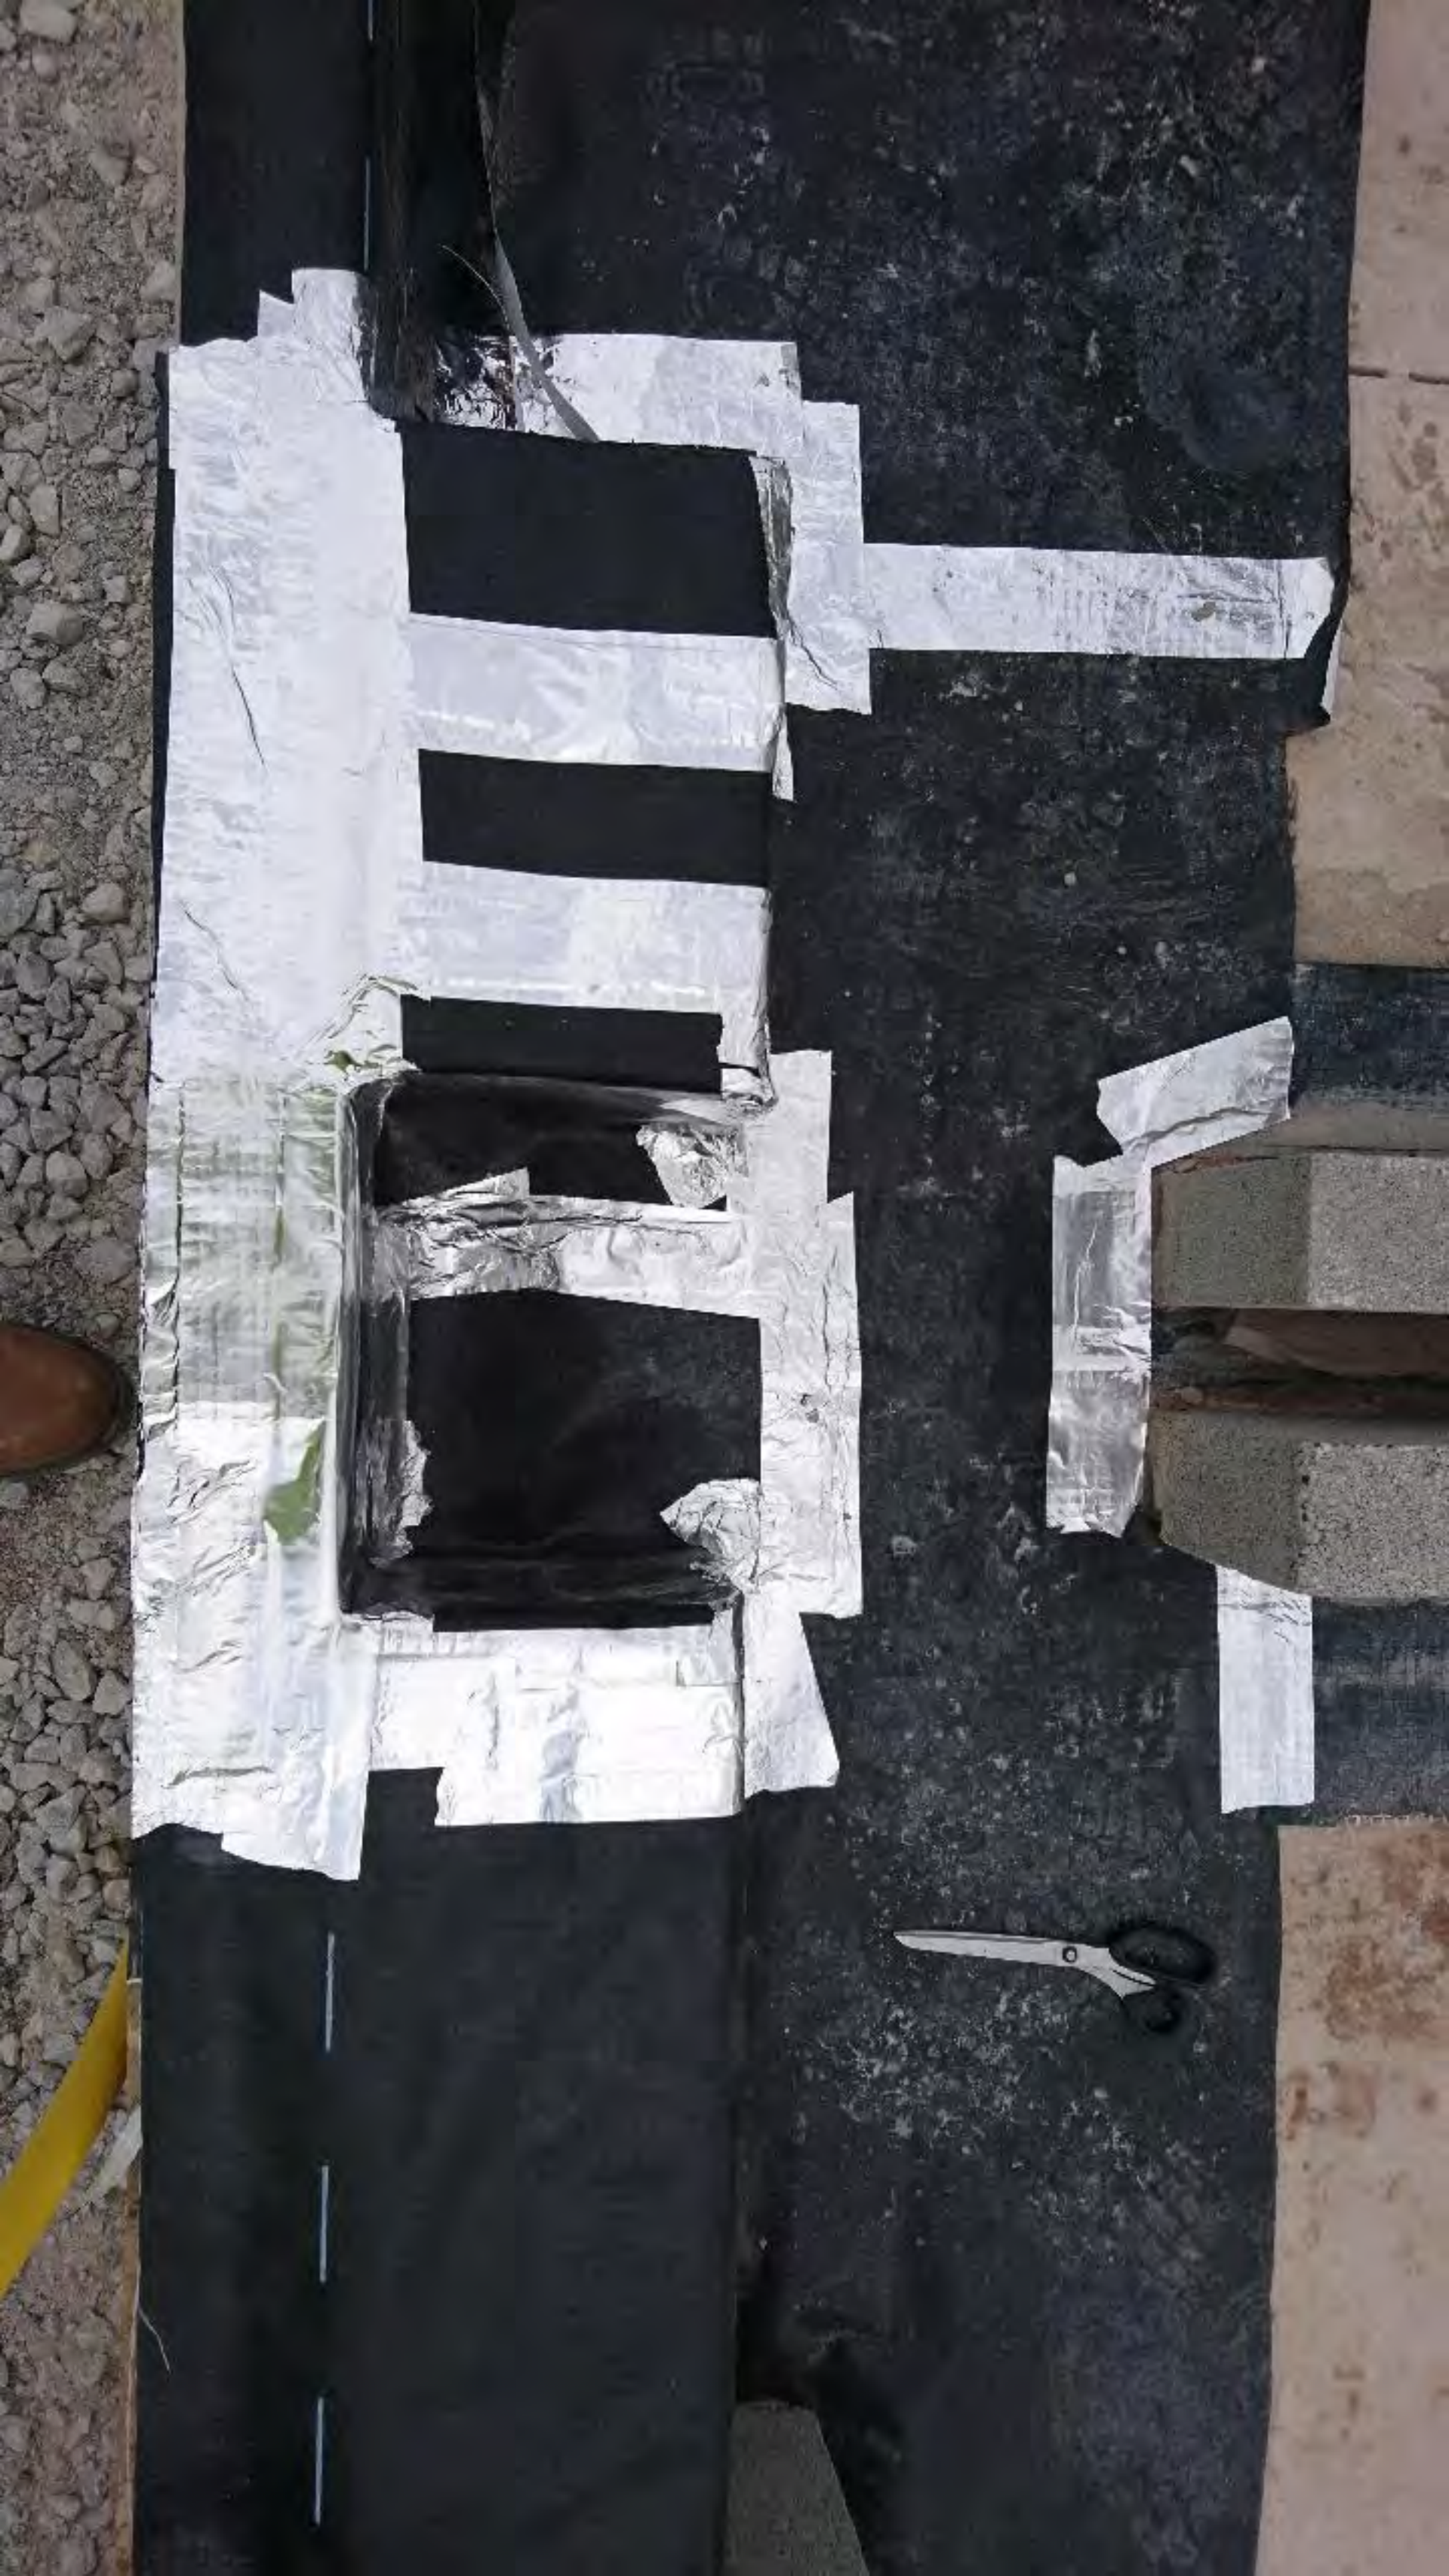
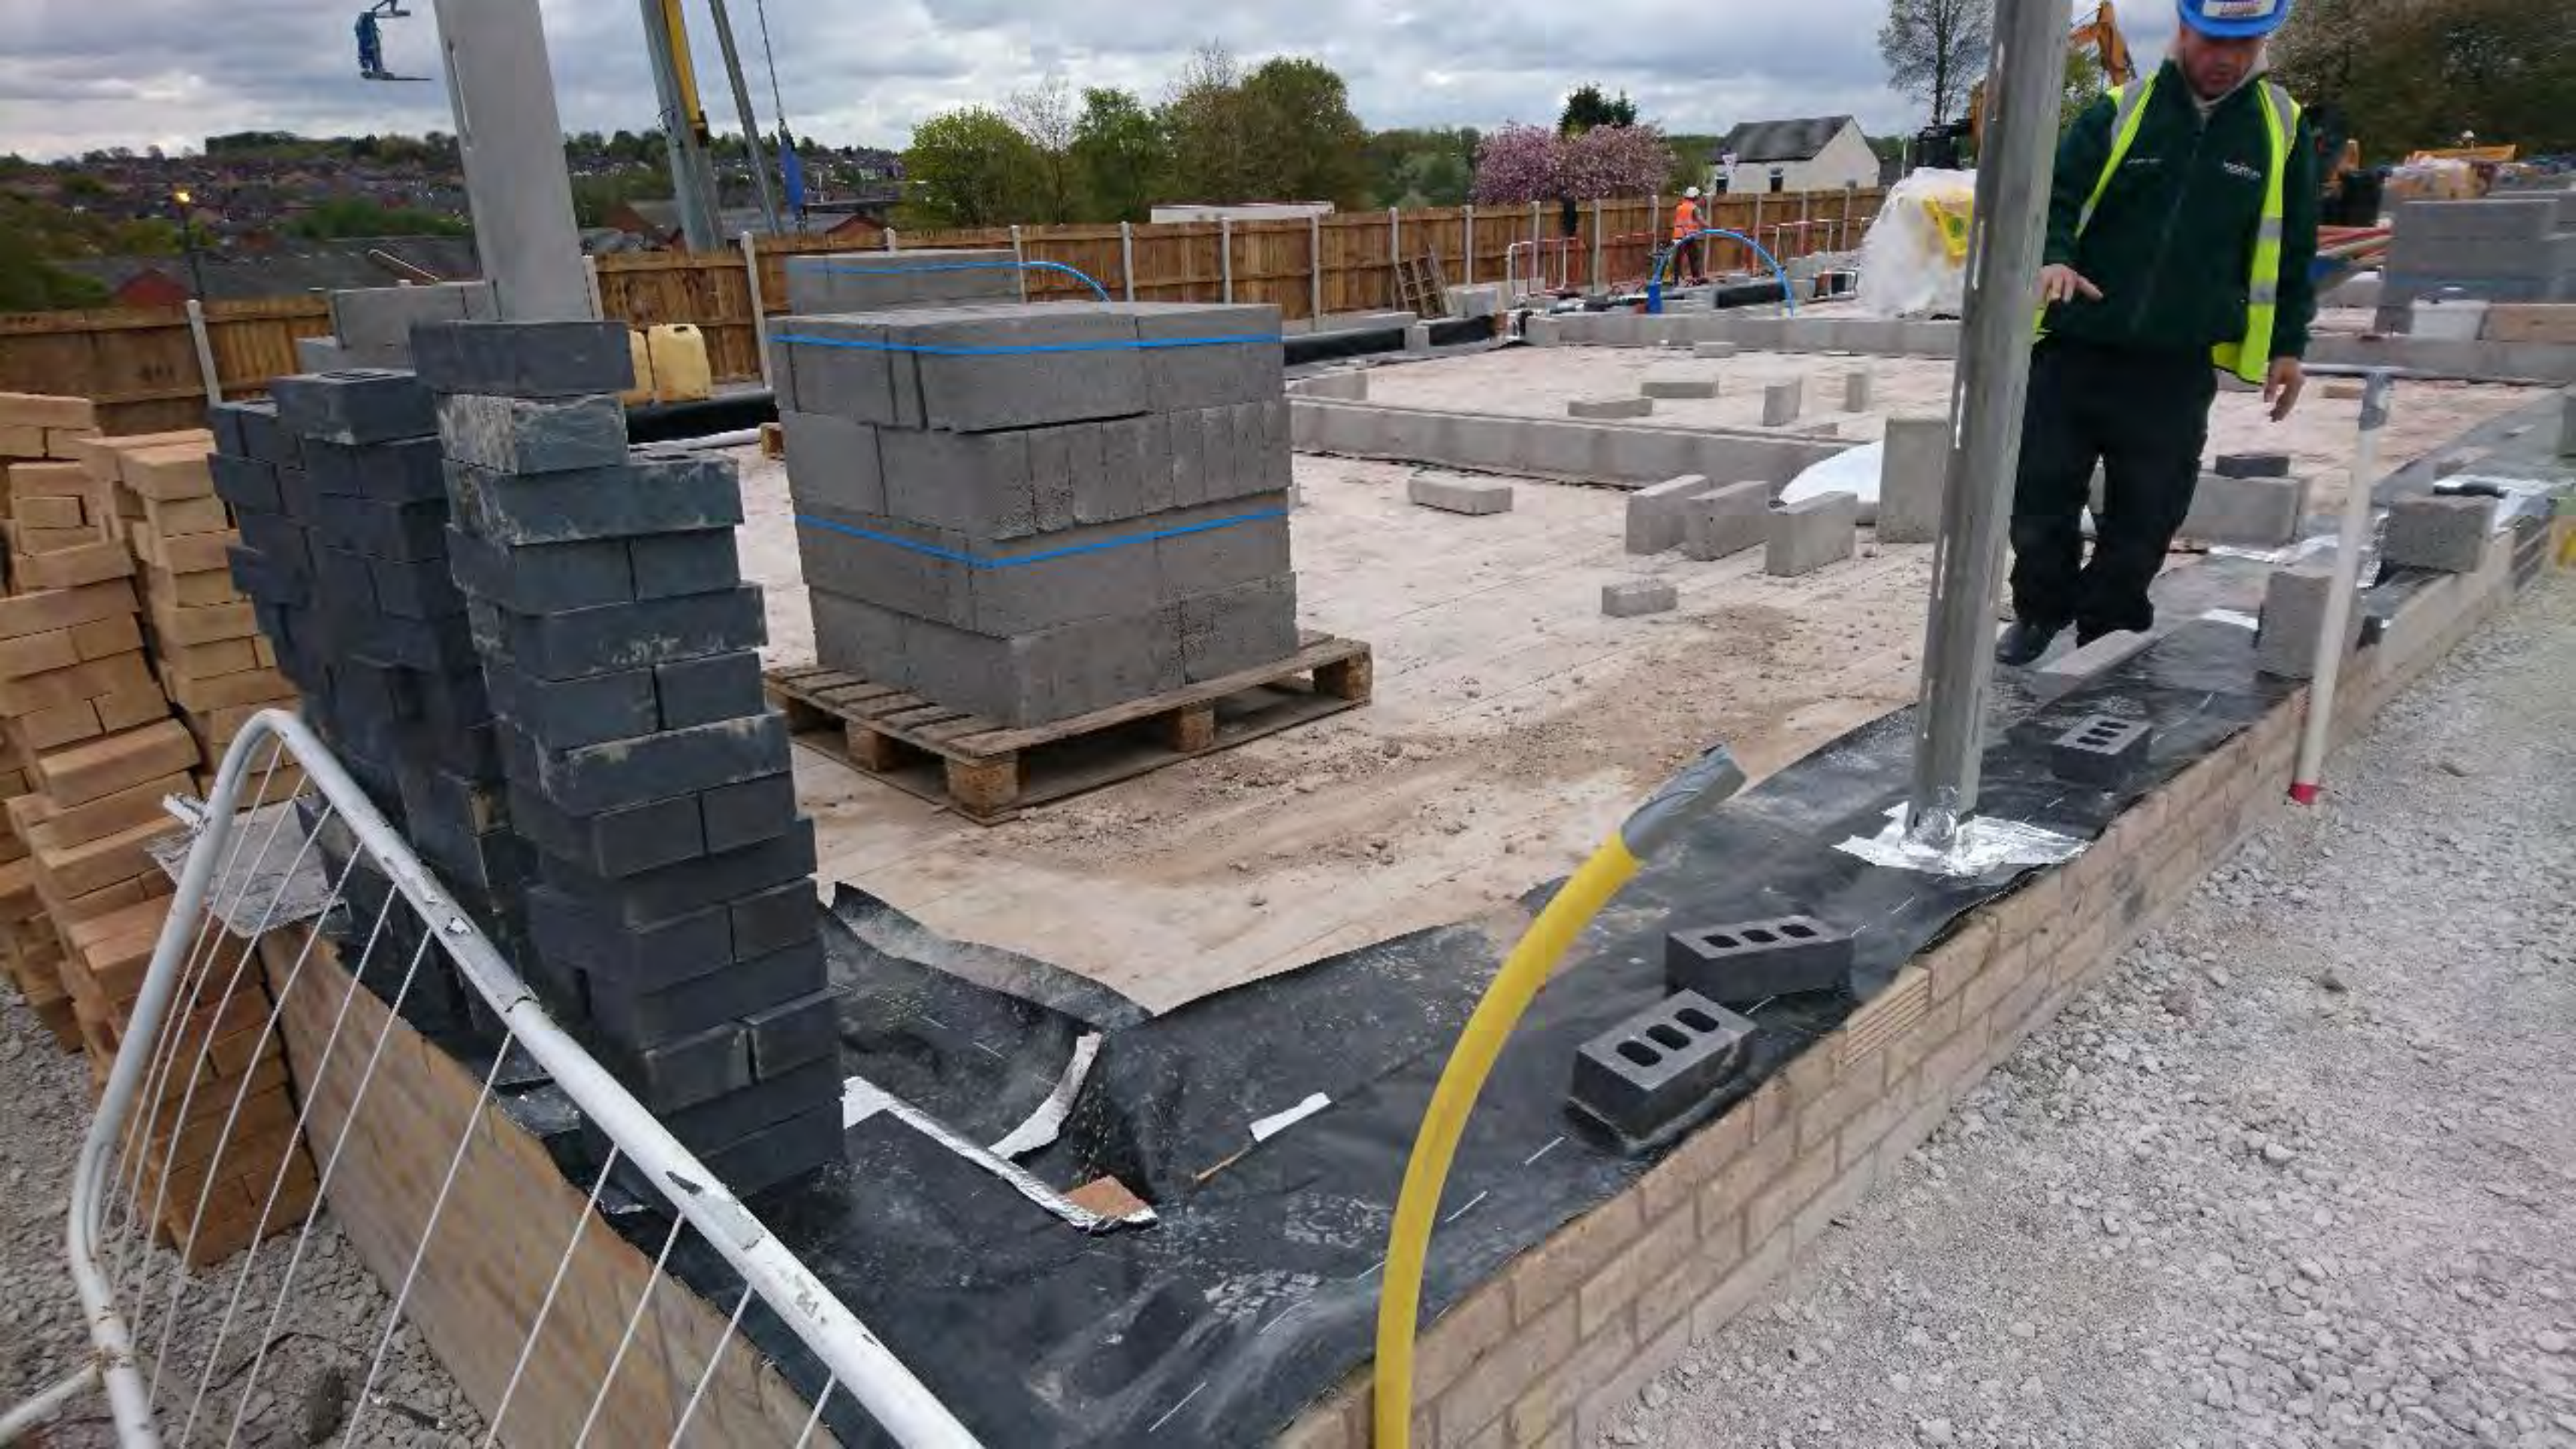
| 1.2 | External Wall Venting – cranked vent spacing | LESS THAN 2M (1.8m) | | | | | |
| 2.2 | Condition of sub-grade & underside of gas membrane | GENERALLY VERY GOOD, NO ISSUES FOR WALL CAVITY | | | | | |
| 2.7 | Condition of joints/seals | ALL GOOD - 150mm OVERLAPS | | | | | |
| 2.9 | Membrane steps/corner seals | GOOD - CORNER SEALS NEAT AND TIDY | | | | | |
