This Record sheet is only applicable to block and beam floor slabs for Characteristic Situation 2 gas protection systems

Plot No.: 2

For Residential Development at New Church Street, Radcliffe.

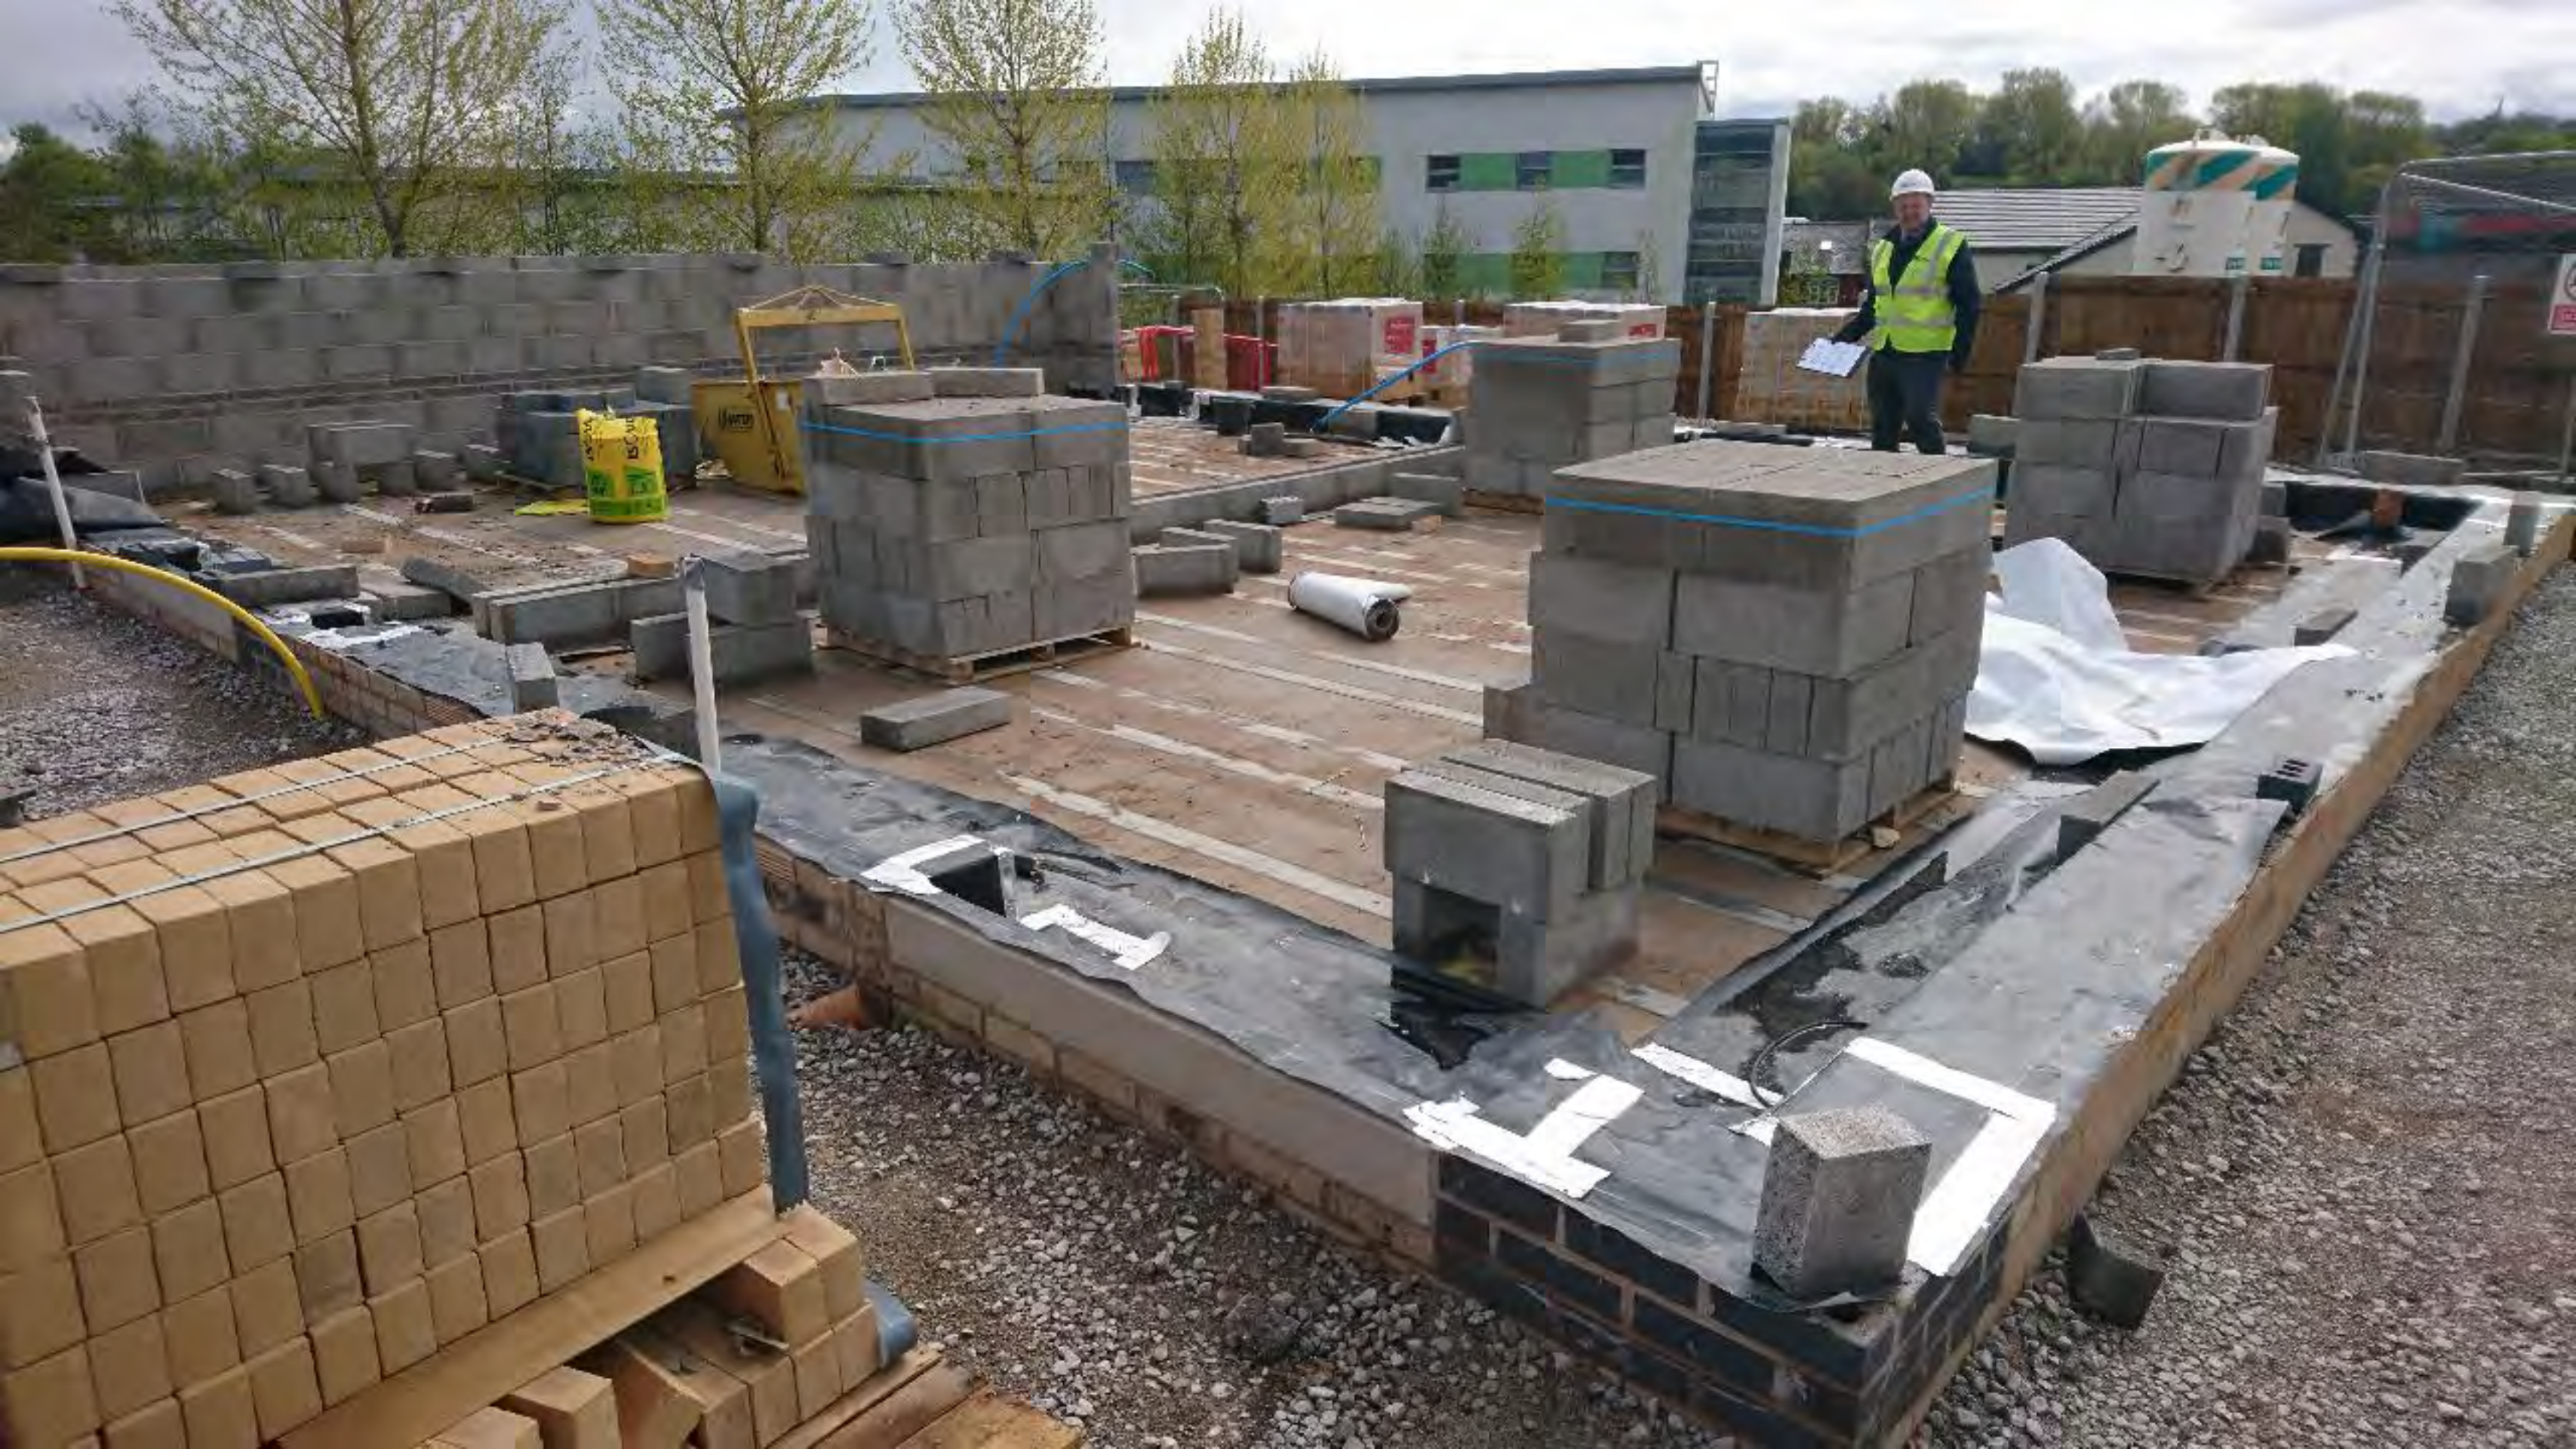
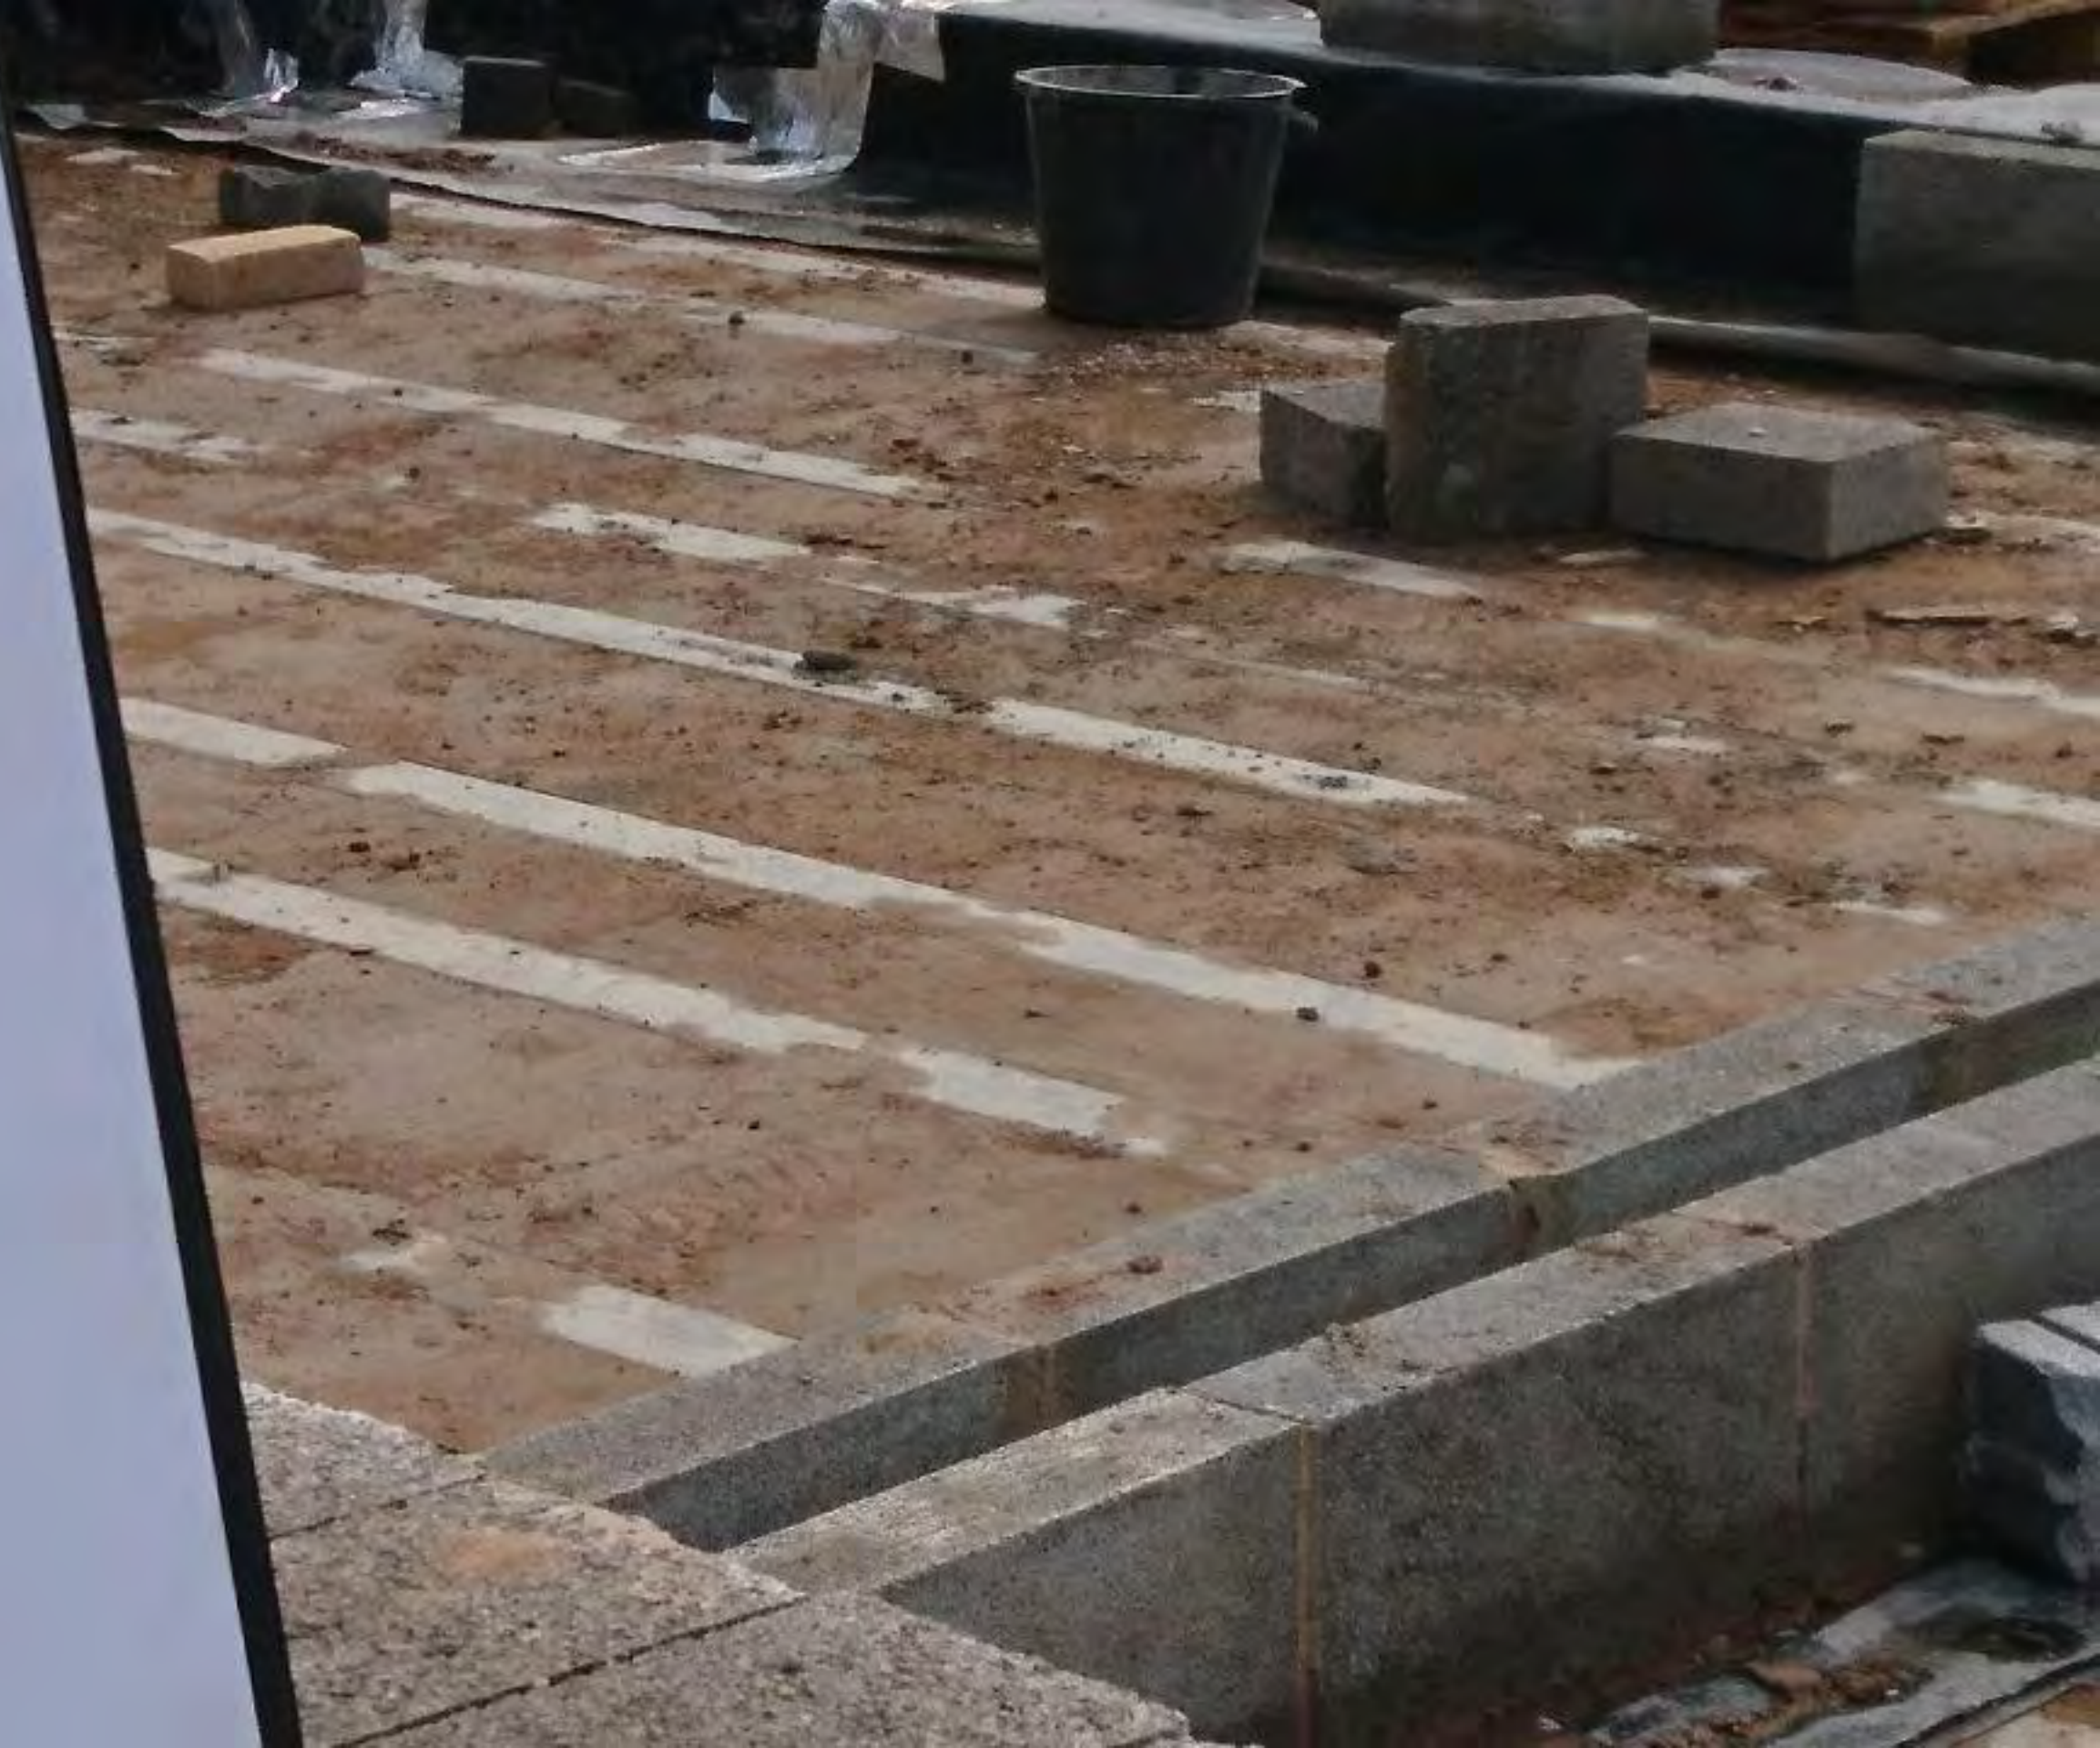
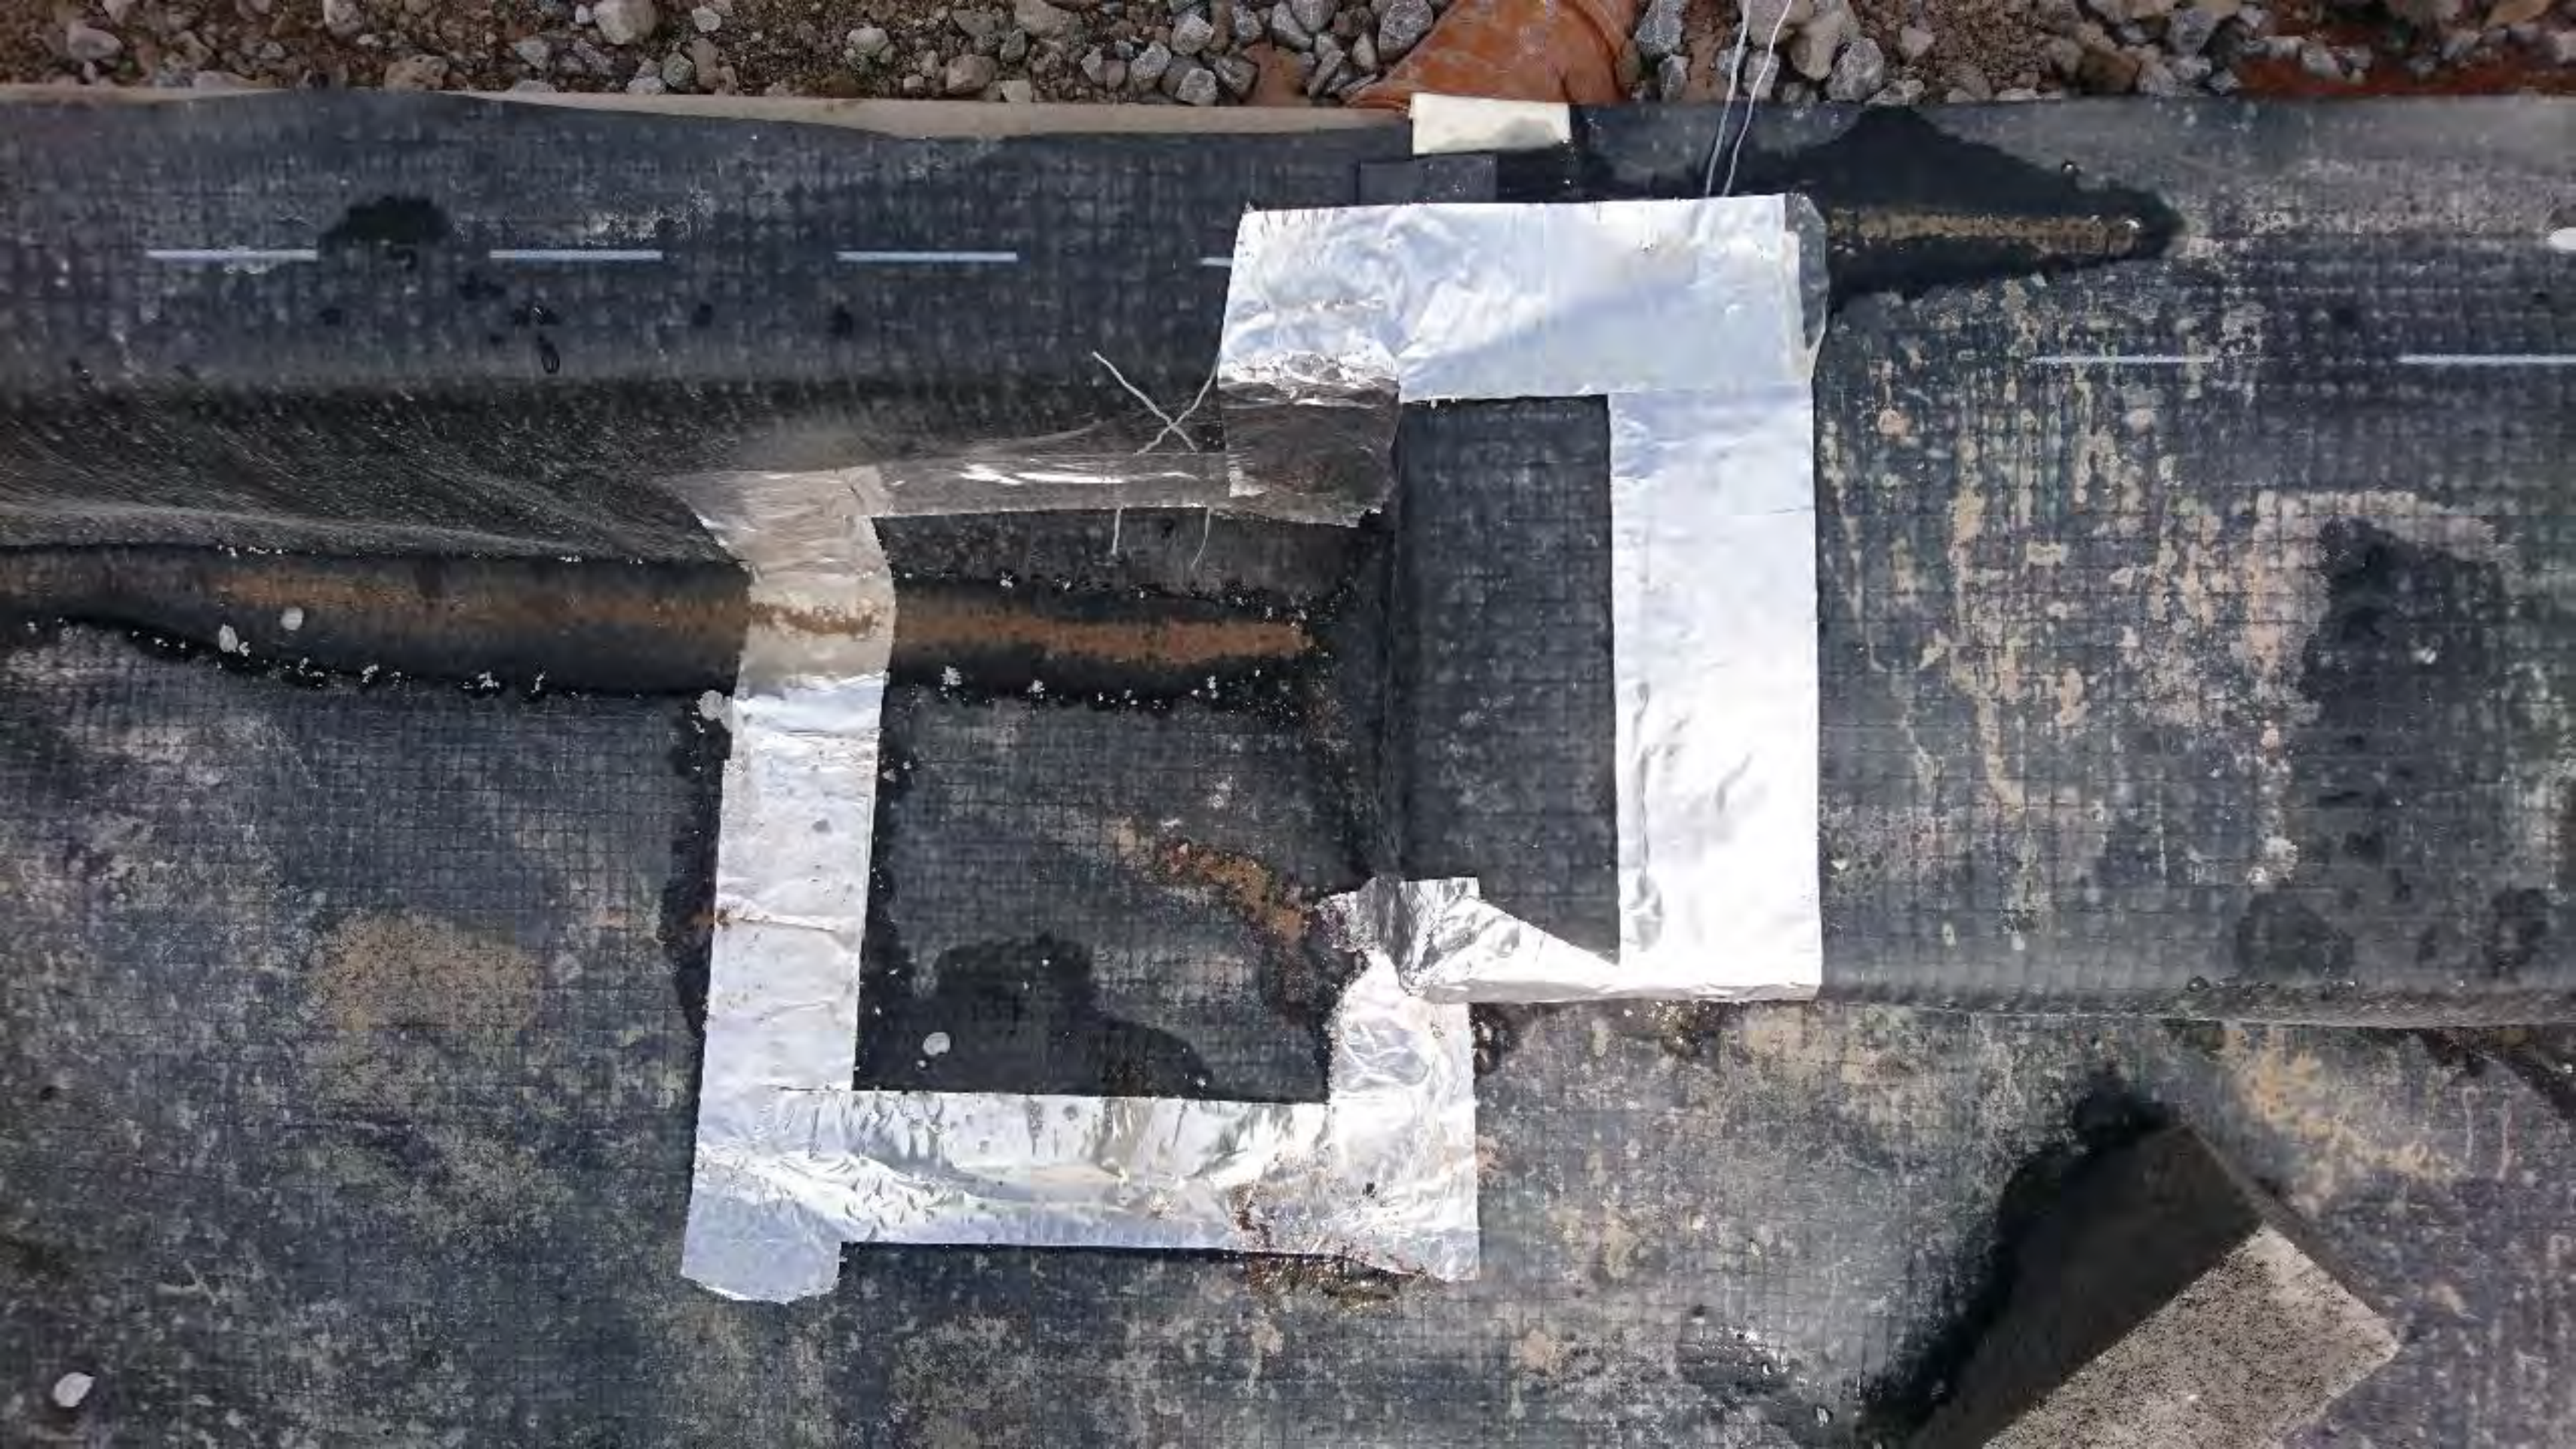
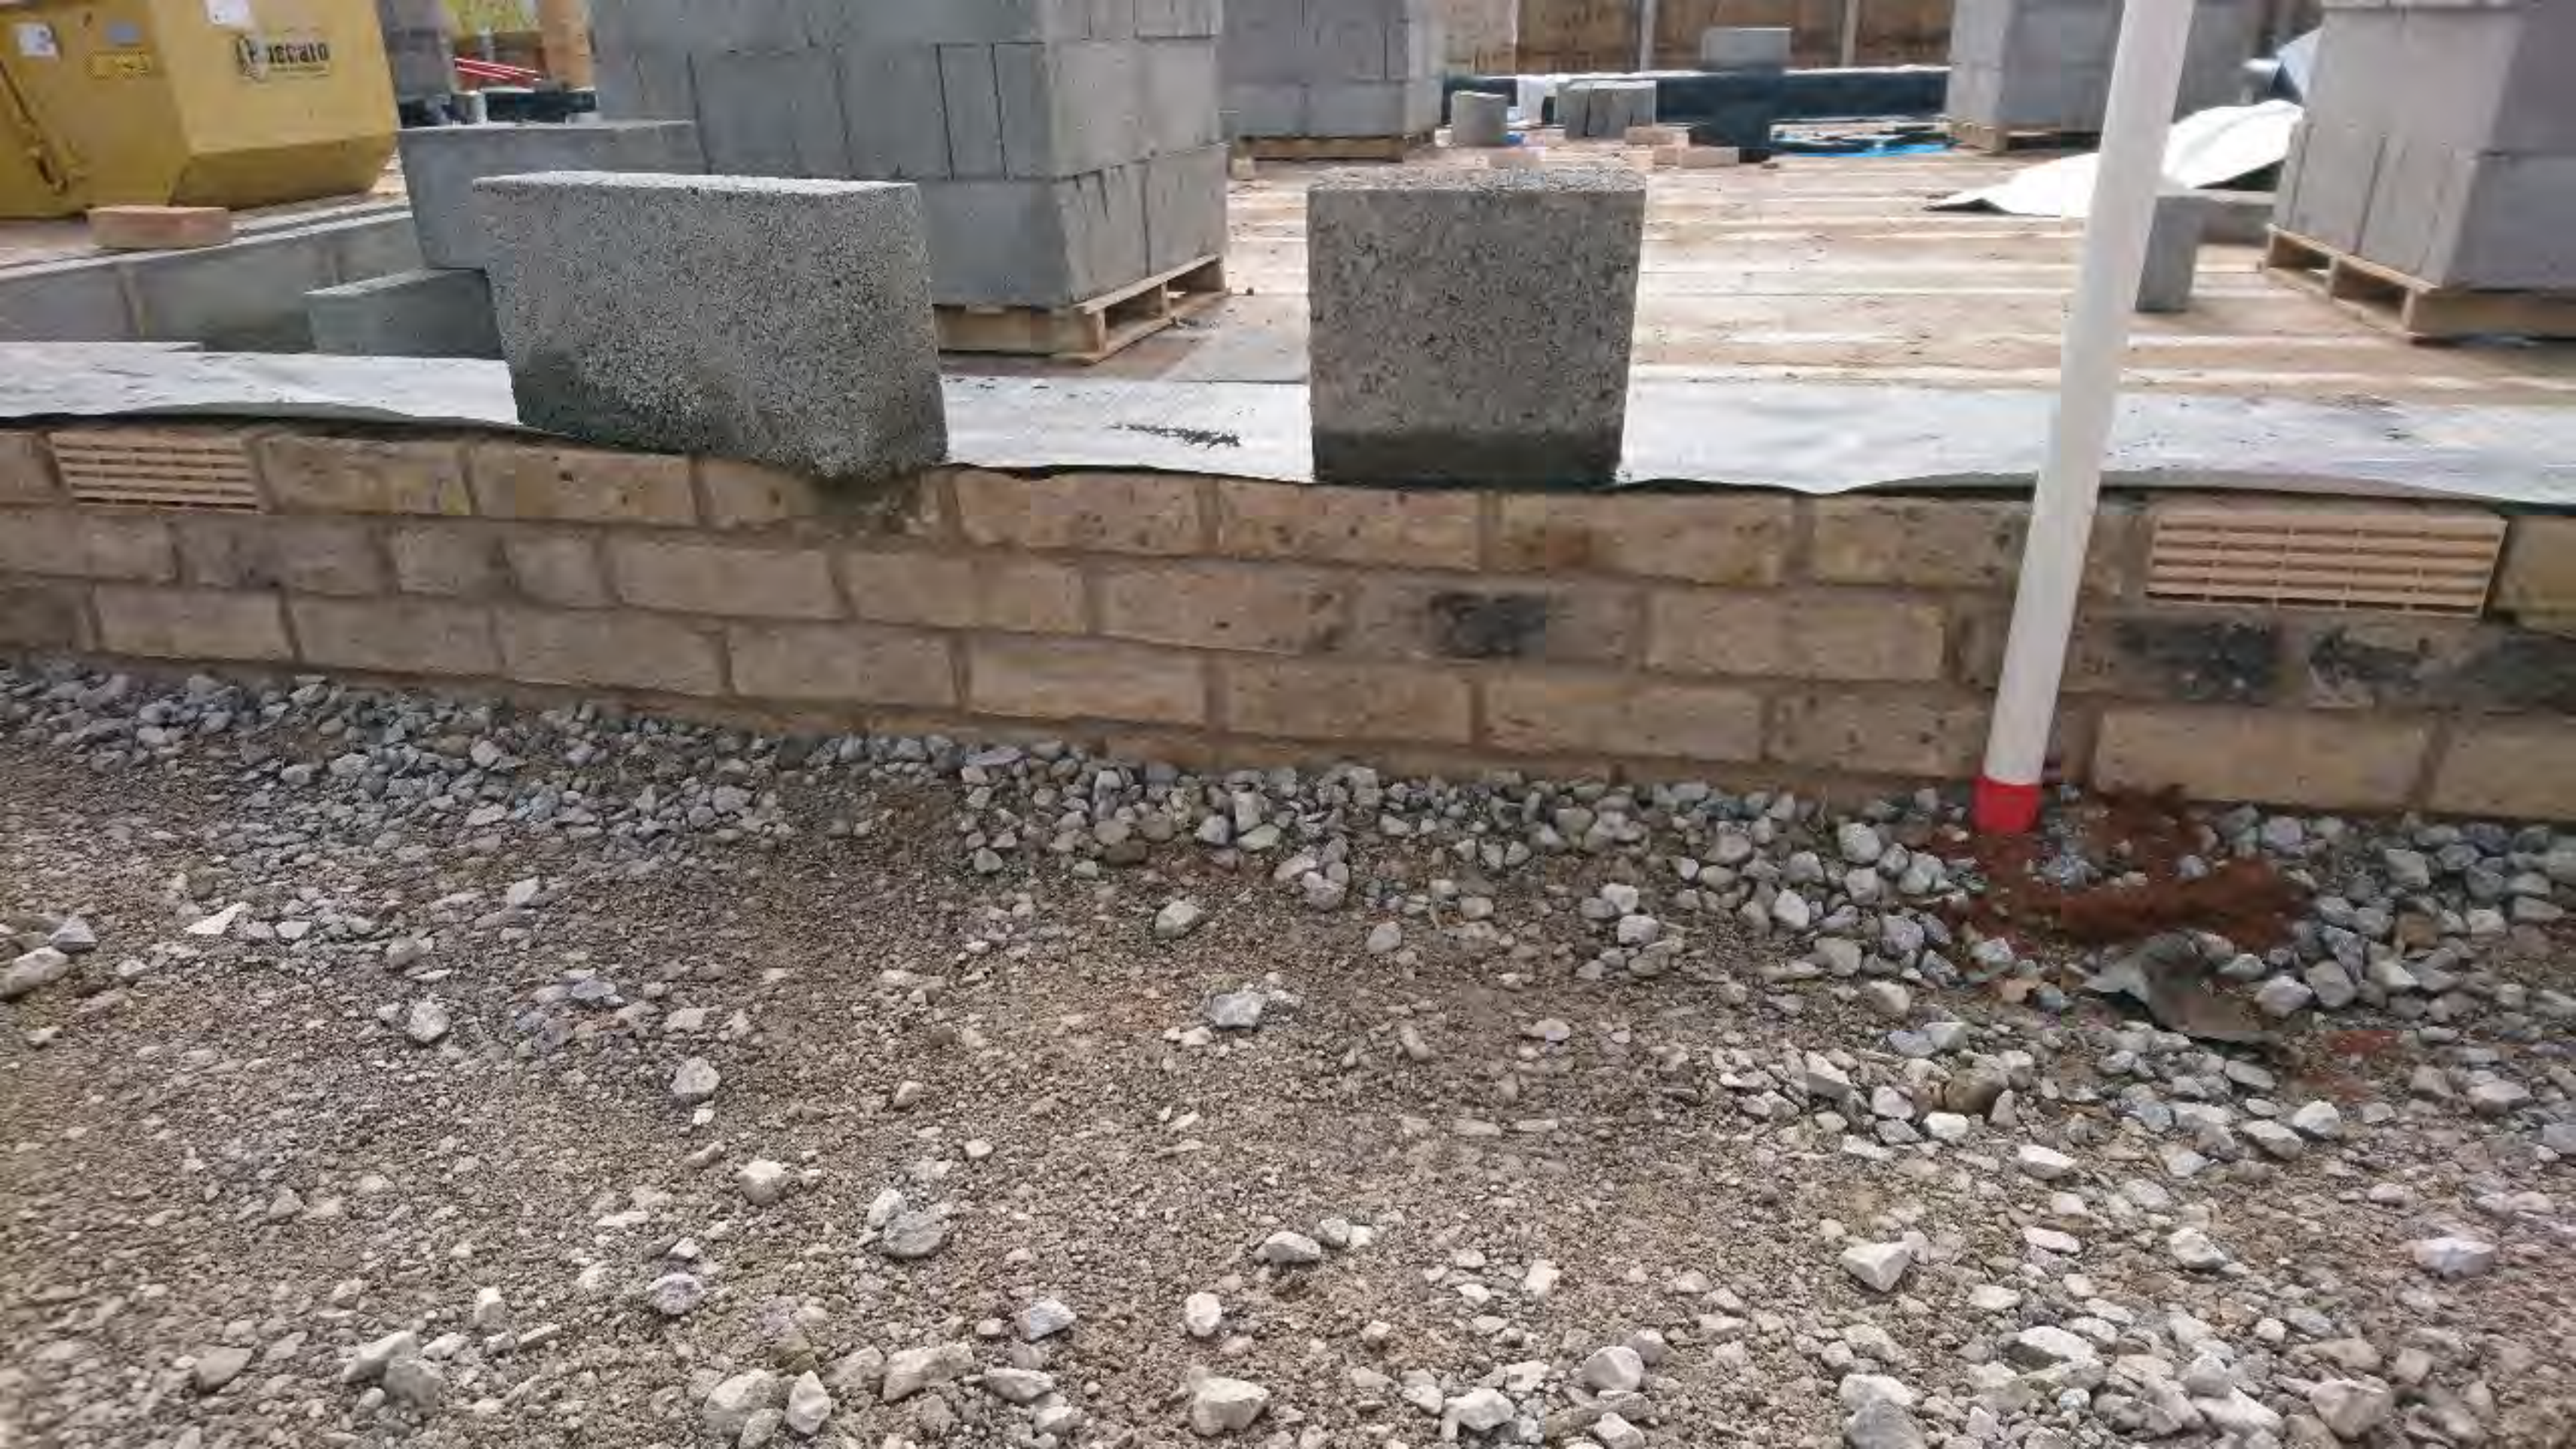
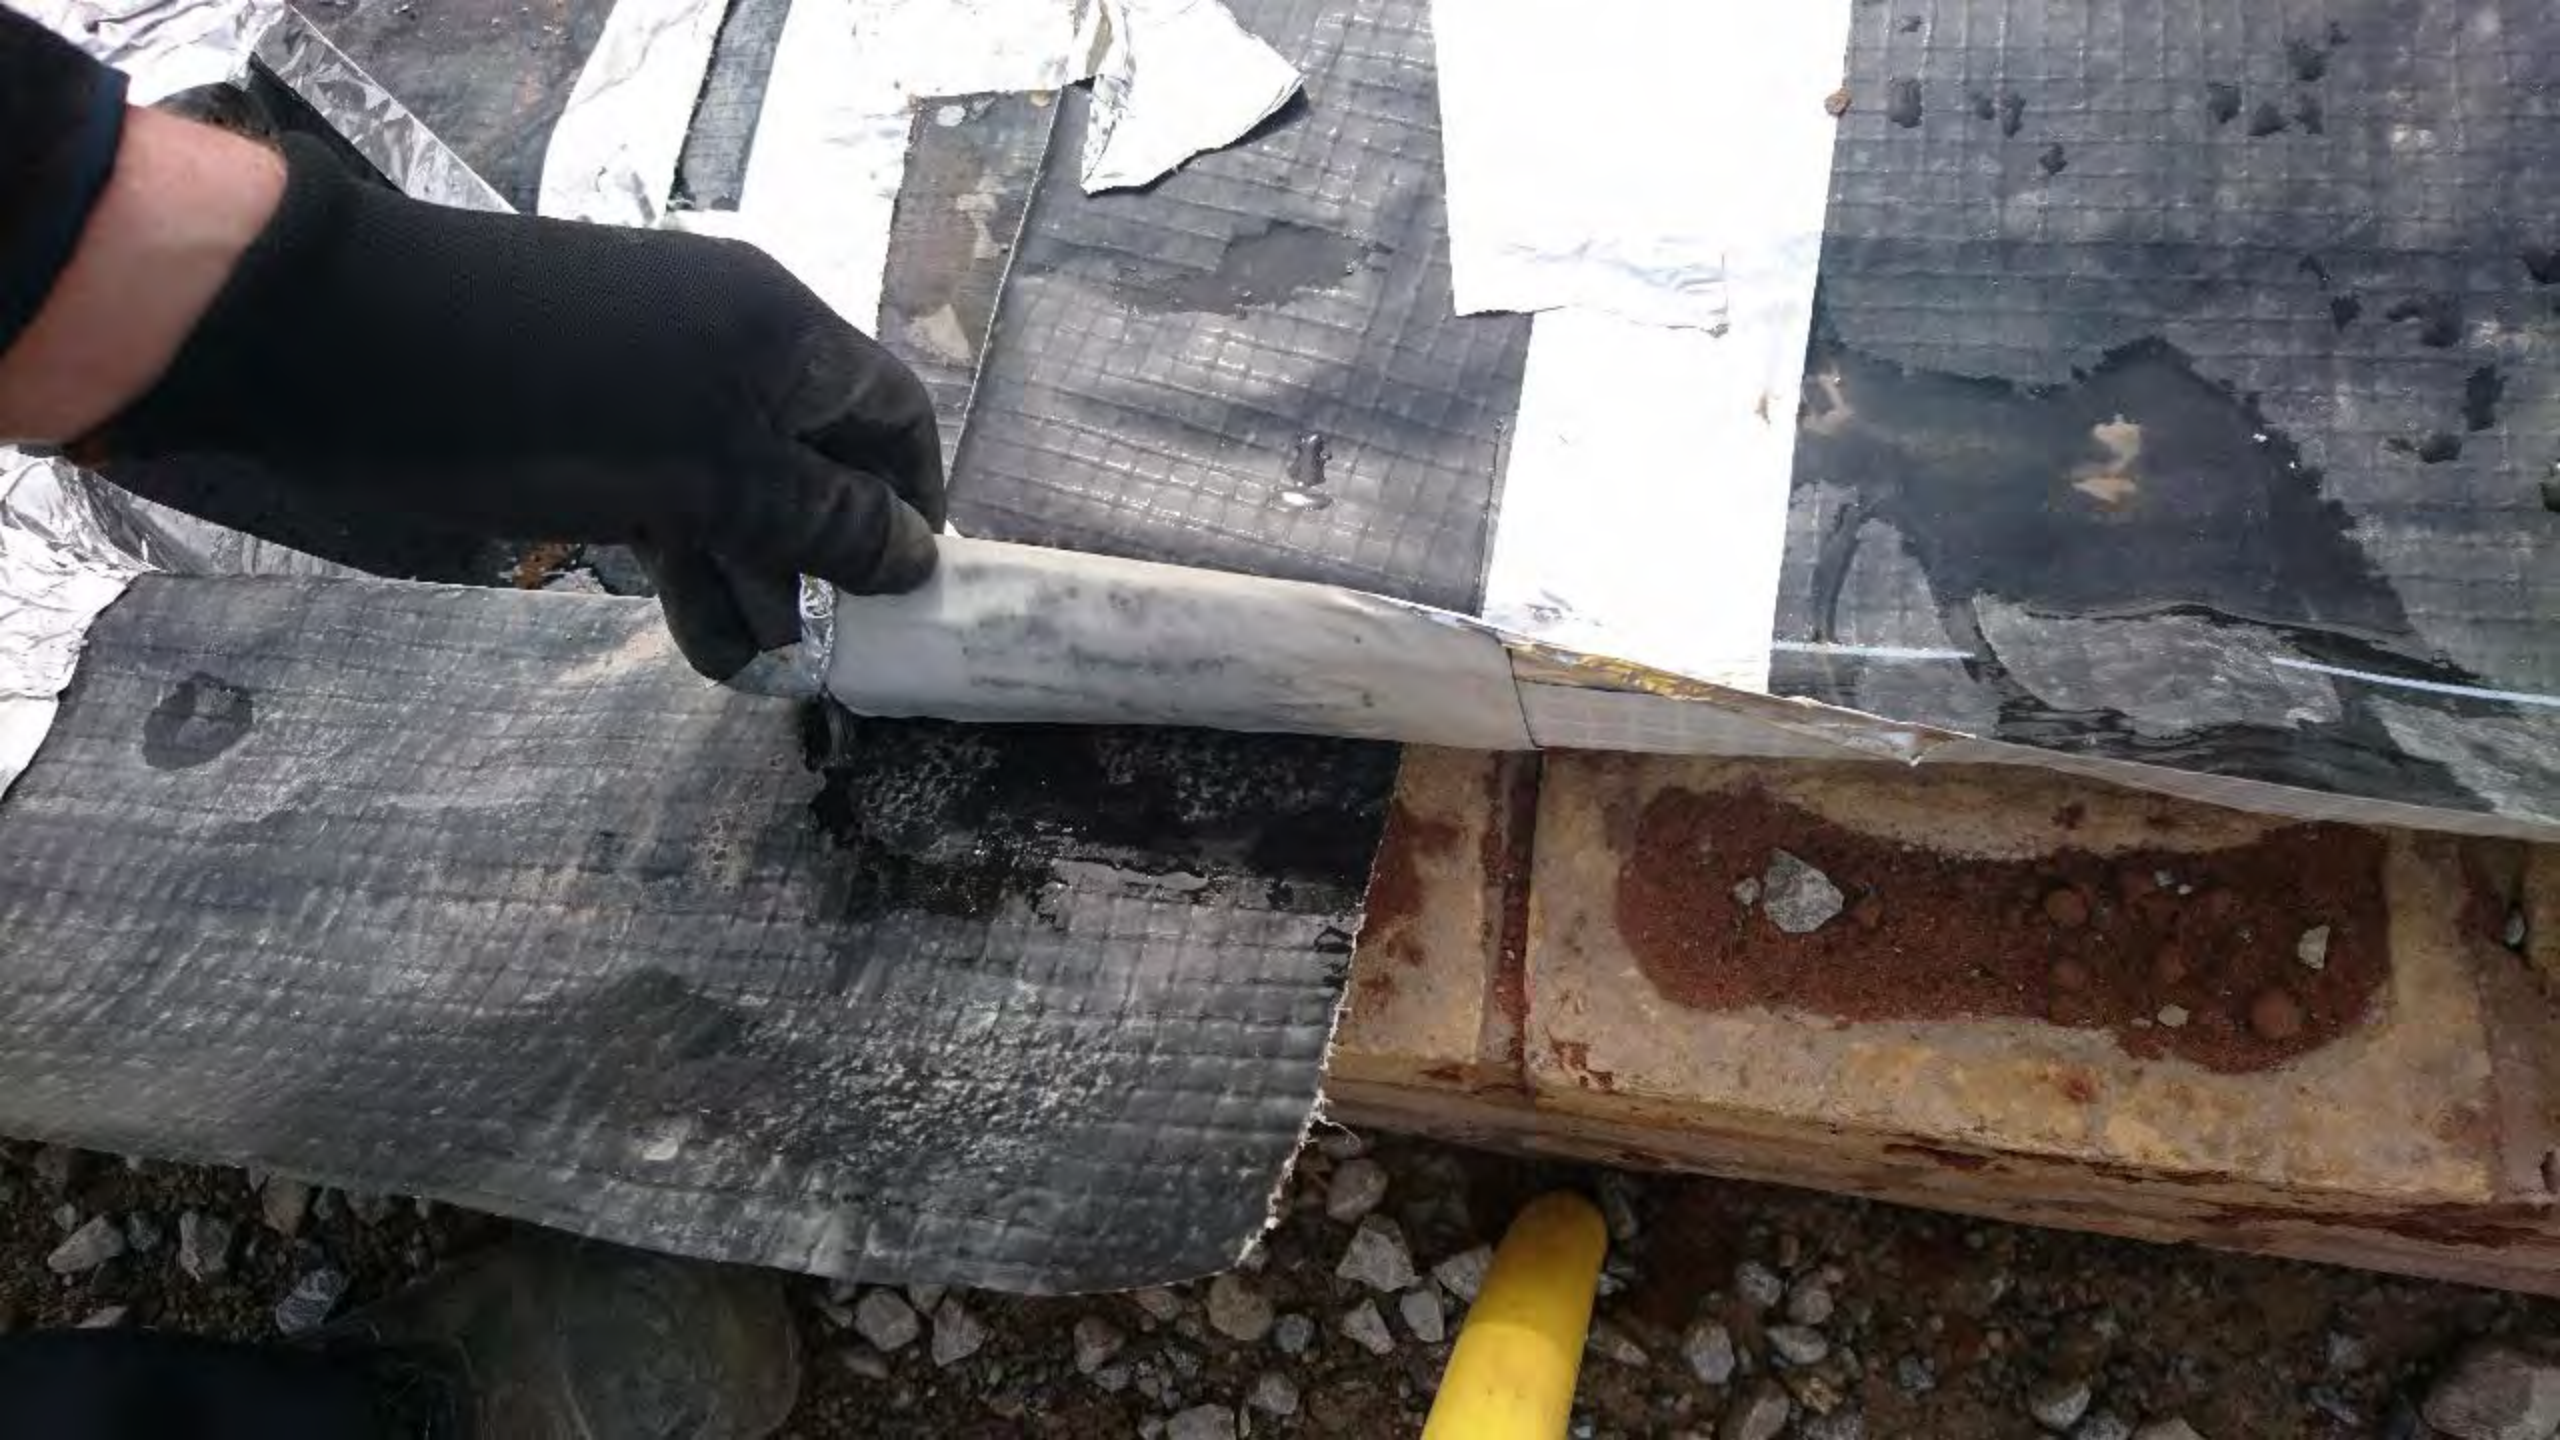
BLK 5

| 1.2 | External Wall Venting – cranked vent spacing | <u>LESS THAN 2.4 (1.8m)</u> | | | | | |
| 2.2 | Condition of sub-grade & underside of gas membrane | <u>ALL GOOD, NO ISSUES FOR WALL CAVITY</u> | | | | | |
| 2.7 | Condition of joints/seals | <u>VERY GOOD - 150mm LAPS</u> | | | | | |
| 2.9 | Membrane steps/corner seals | <u>VERY GOOD - CORNER SEALS NEAT + TIDY</u> | | | | | |
