This Record sheet is only applicable to block and beam floor slabs for Characteristic Situation 2 gas protection systems

Plot No.: 2

For Residential Development at New Church Street, Radcliffe.

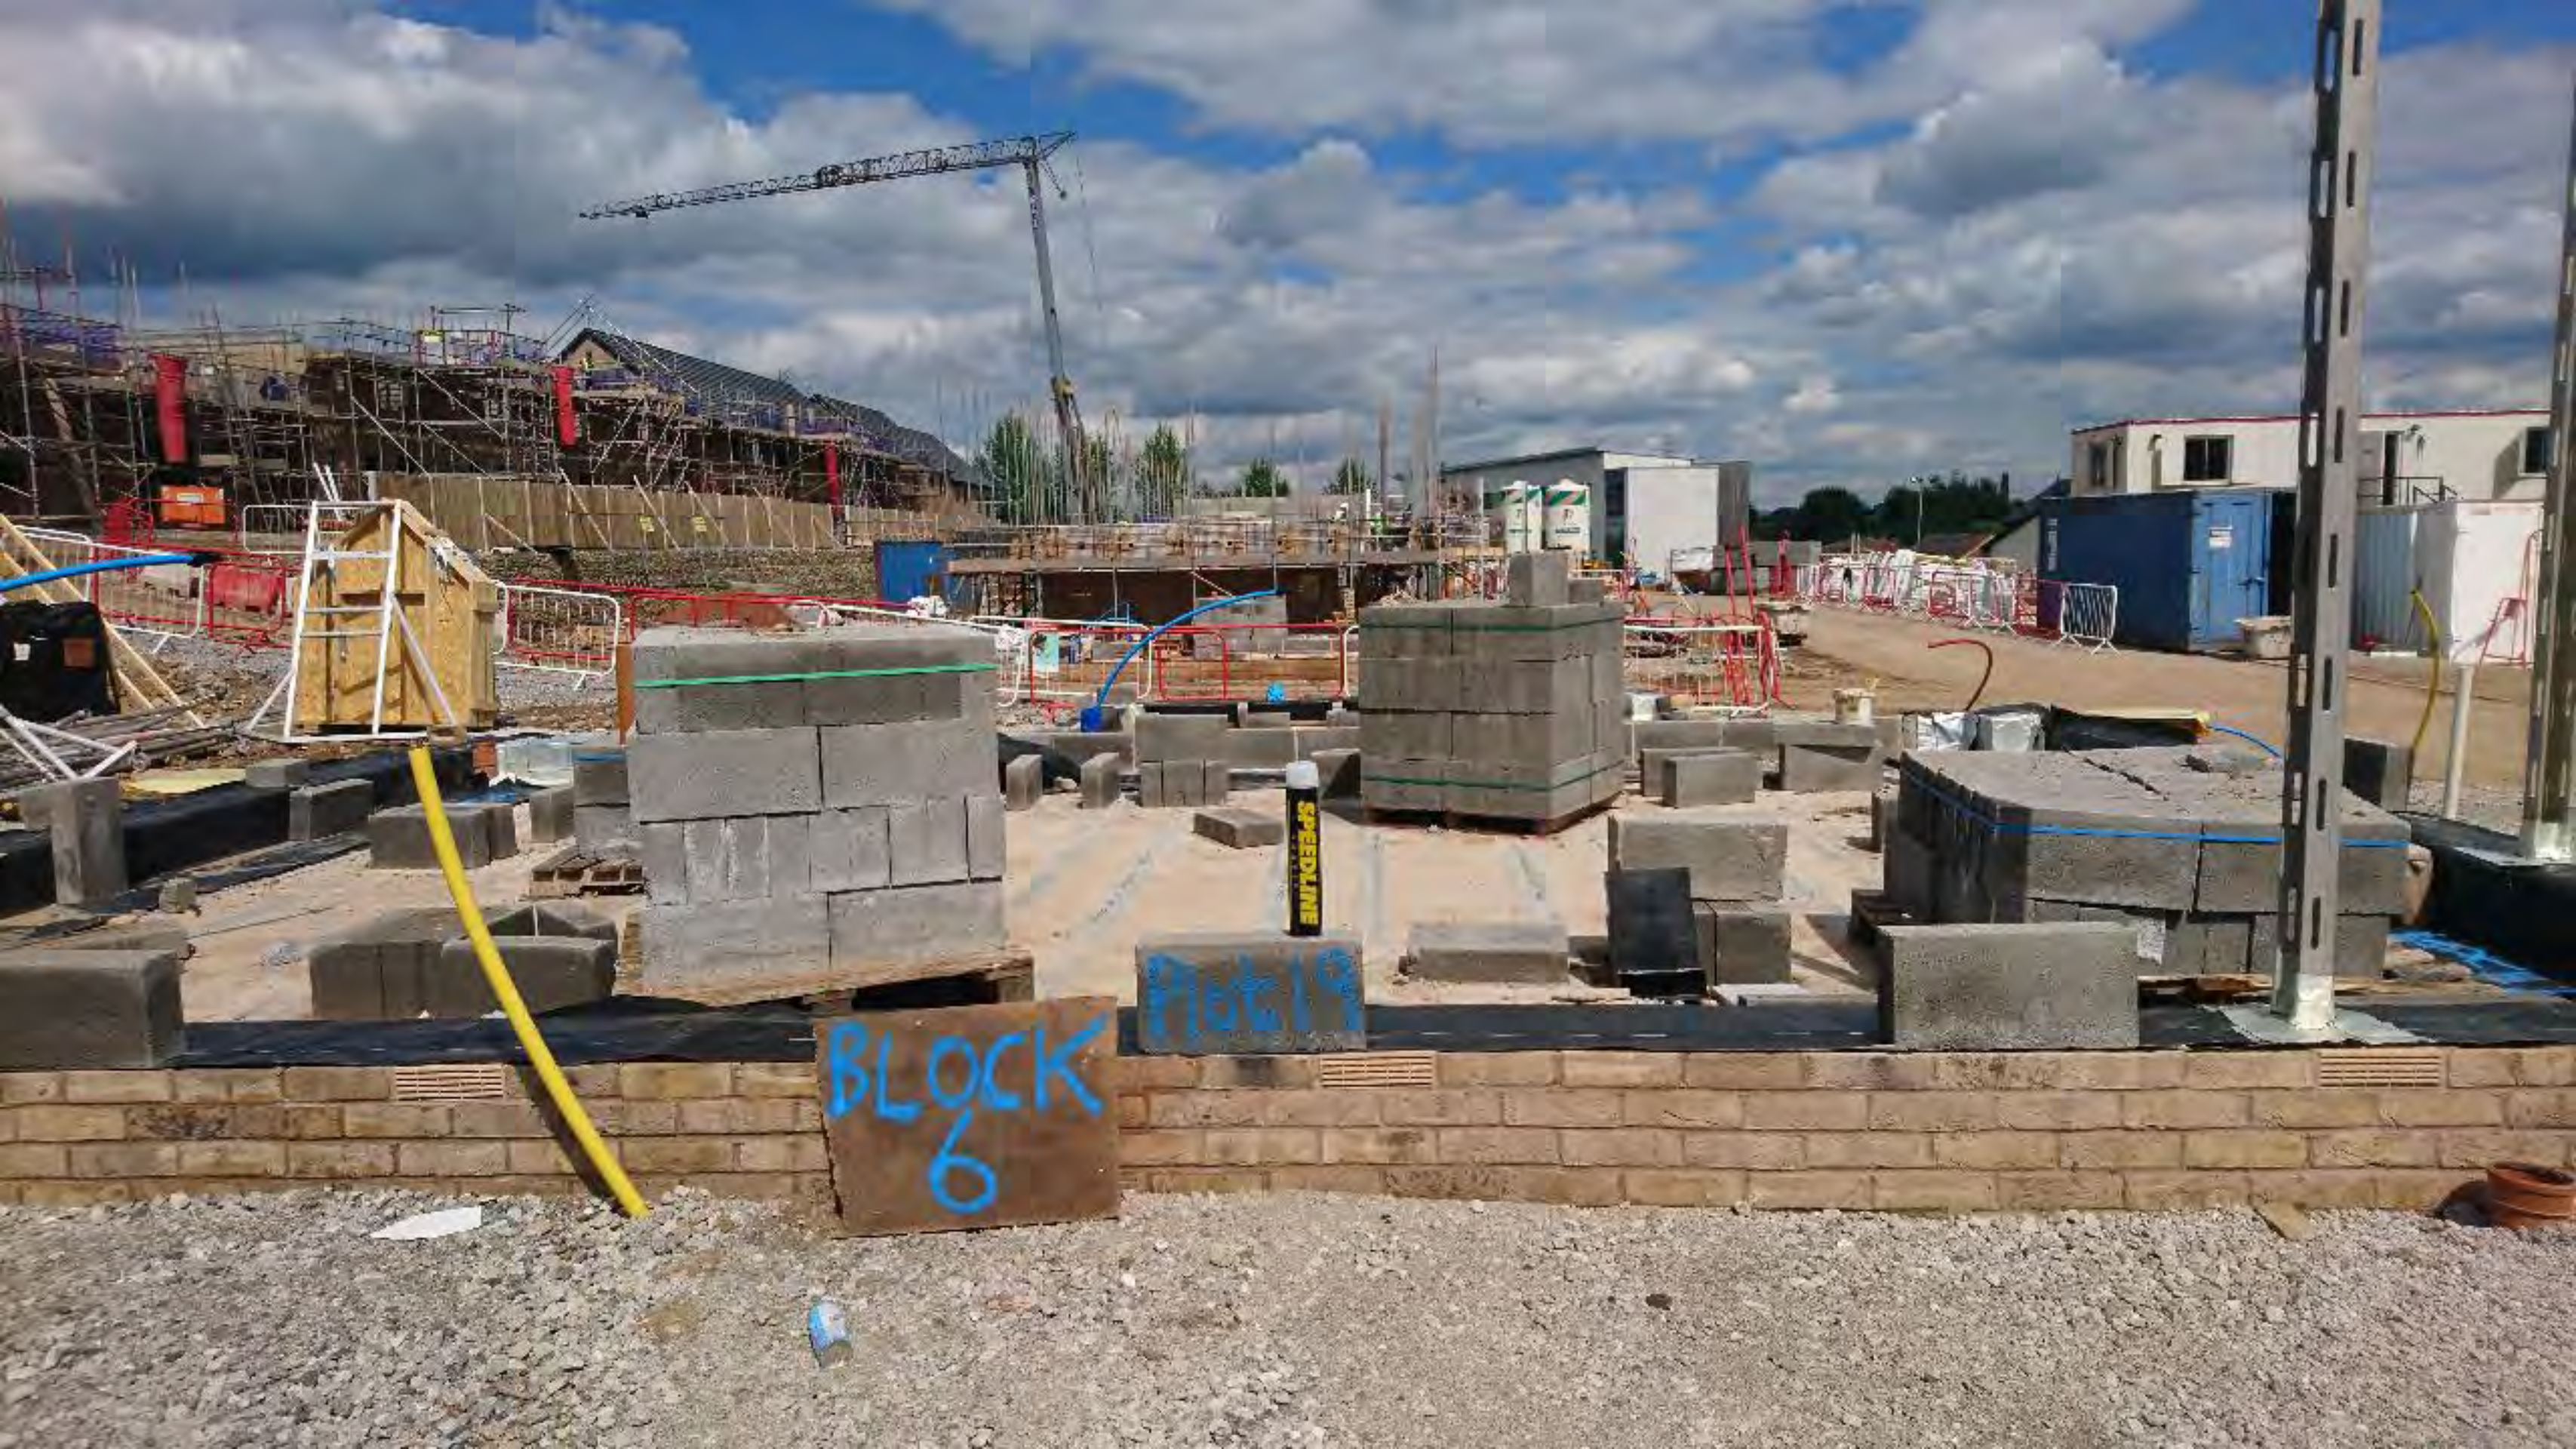
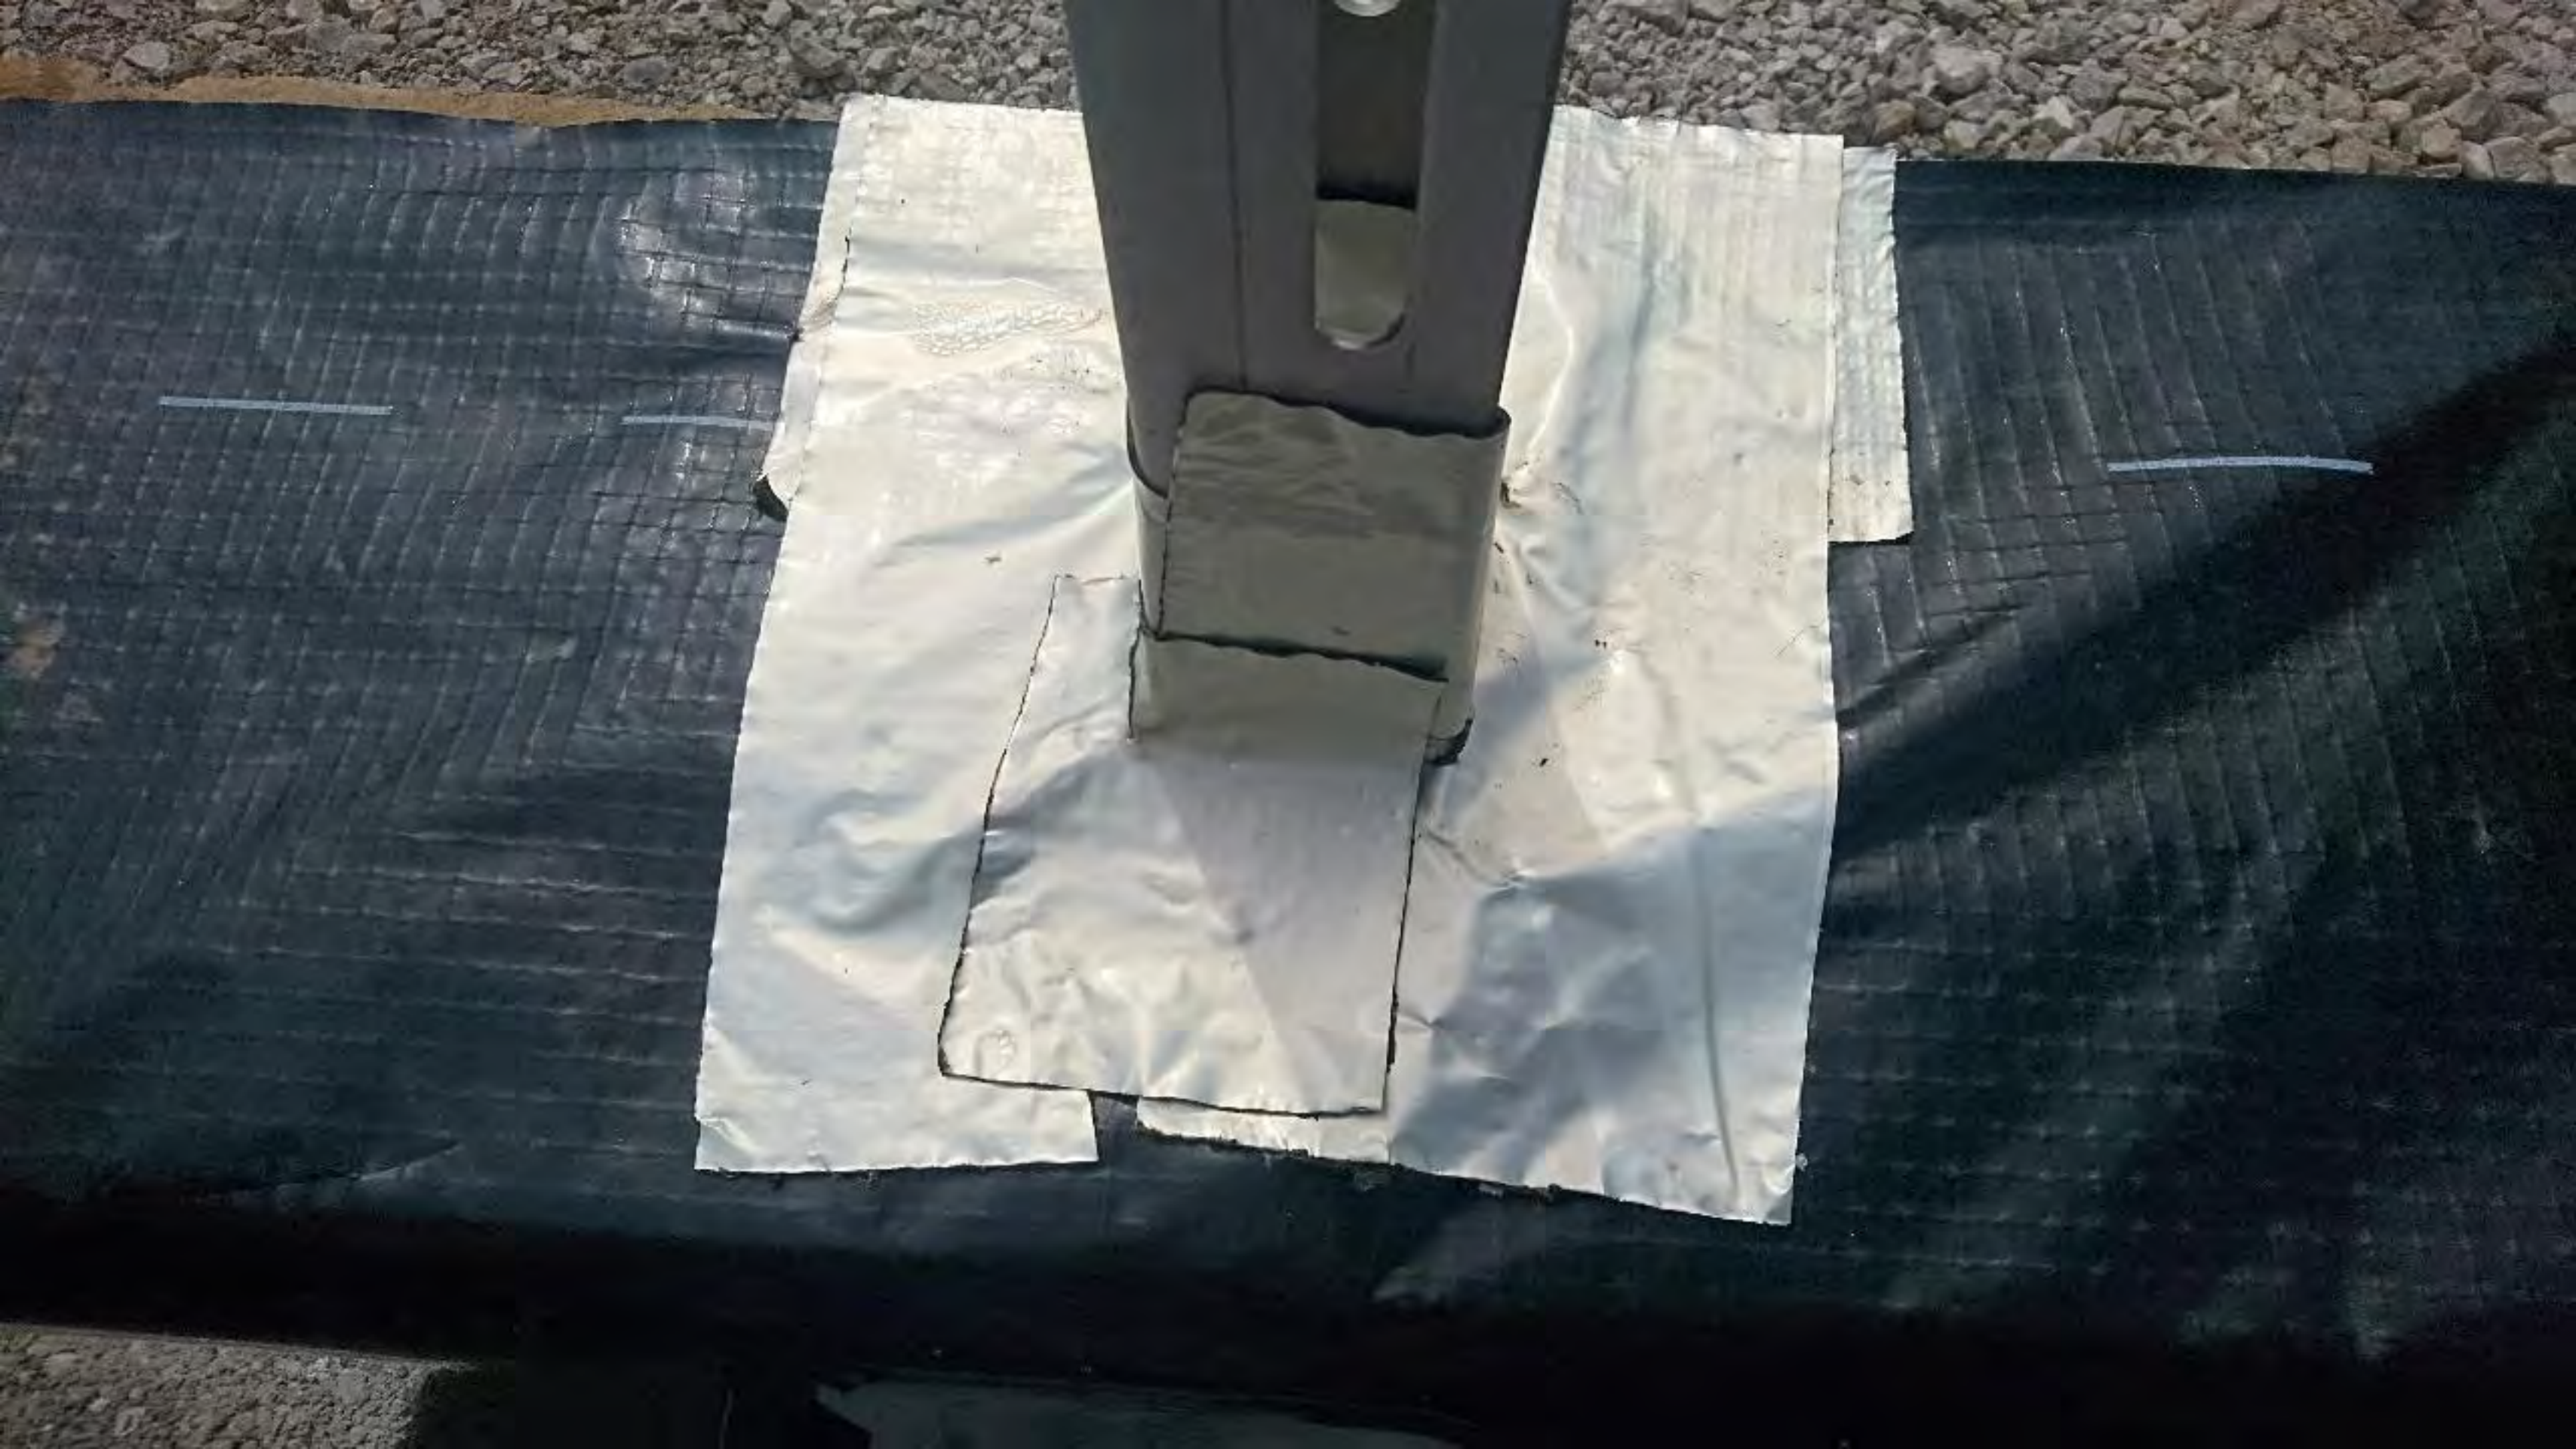
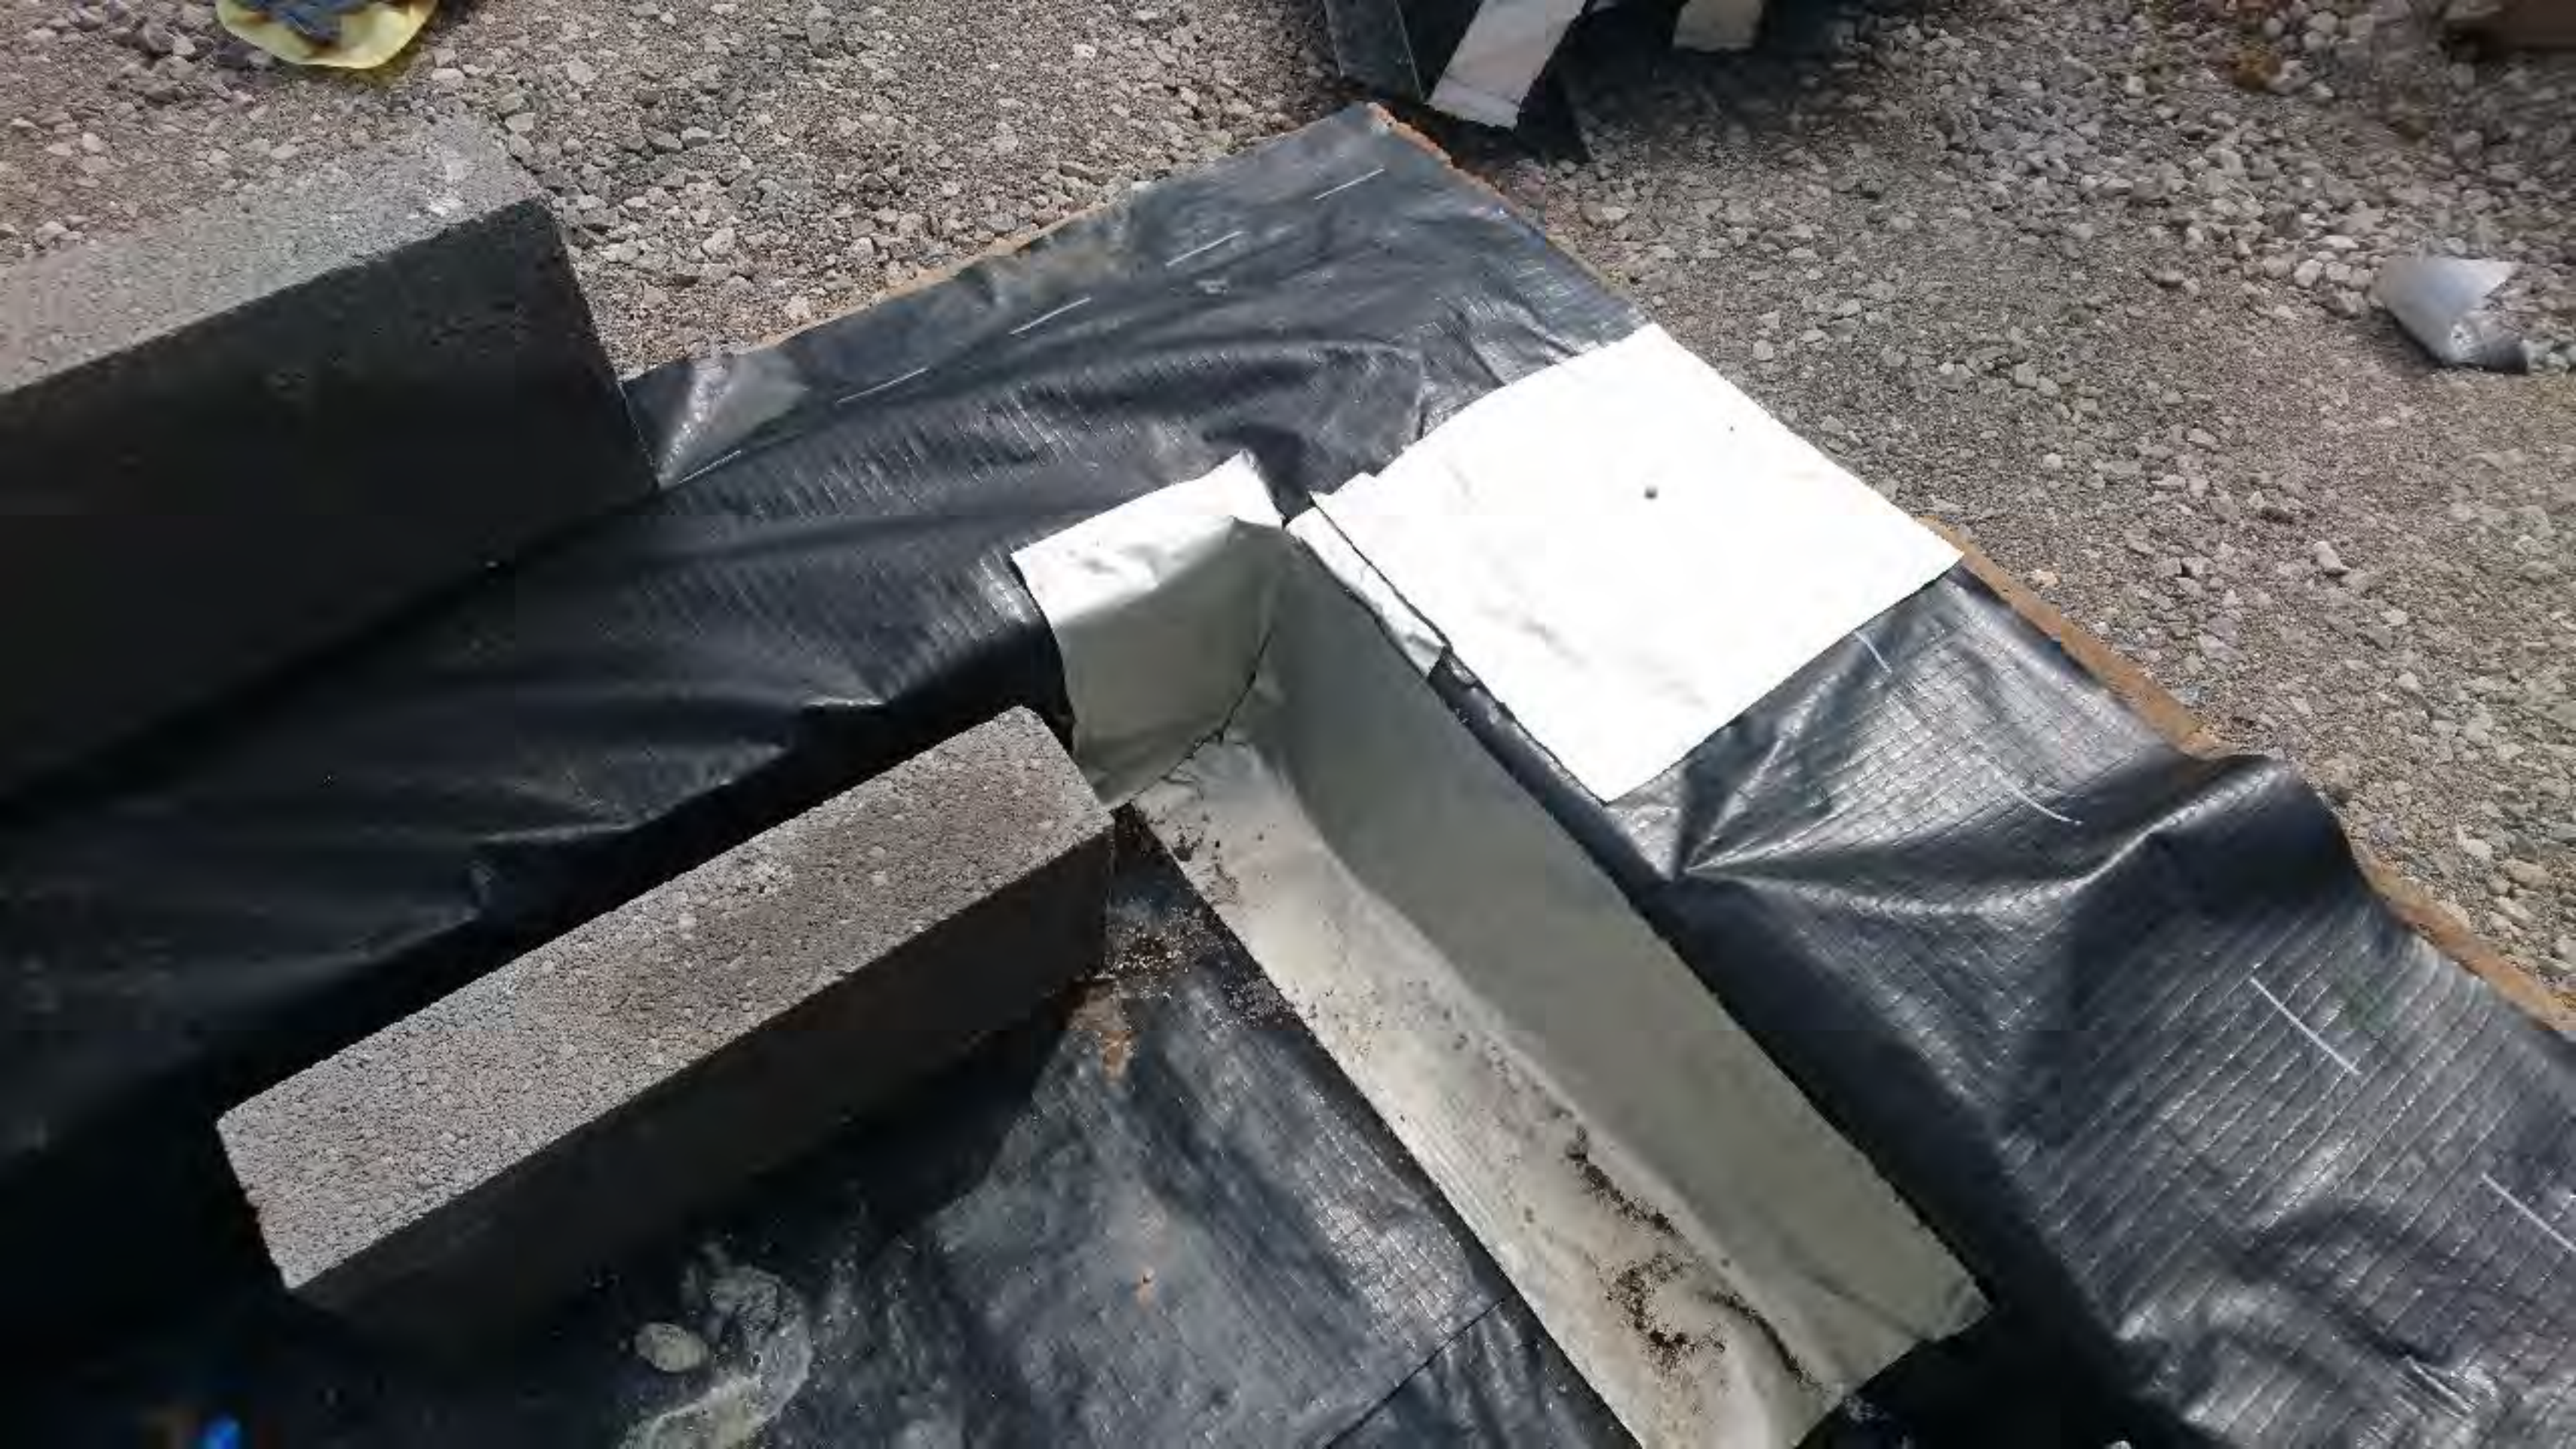
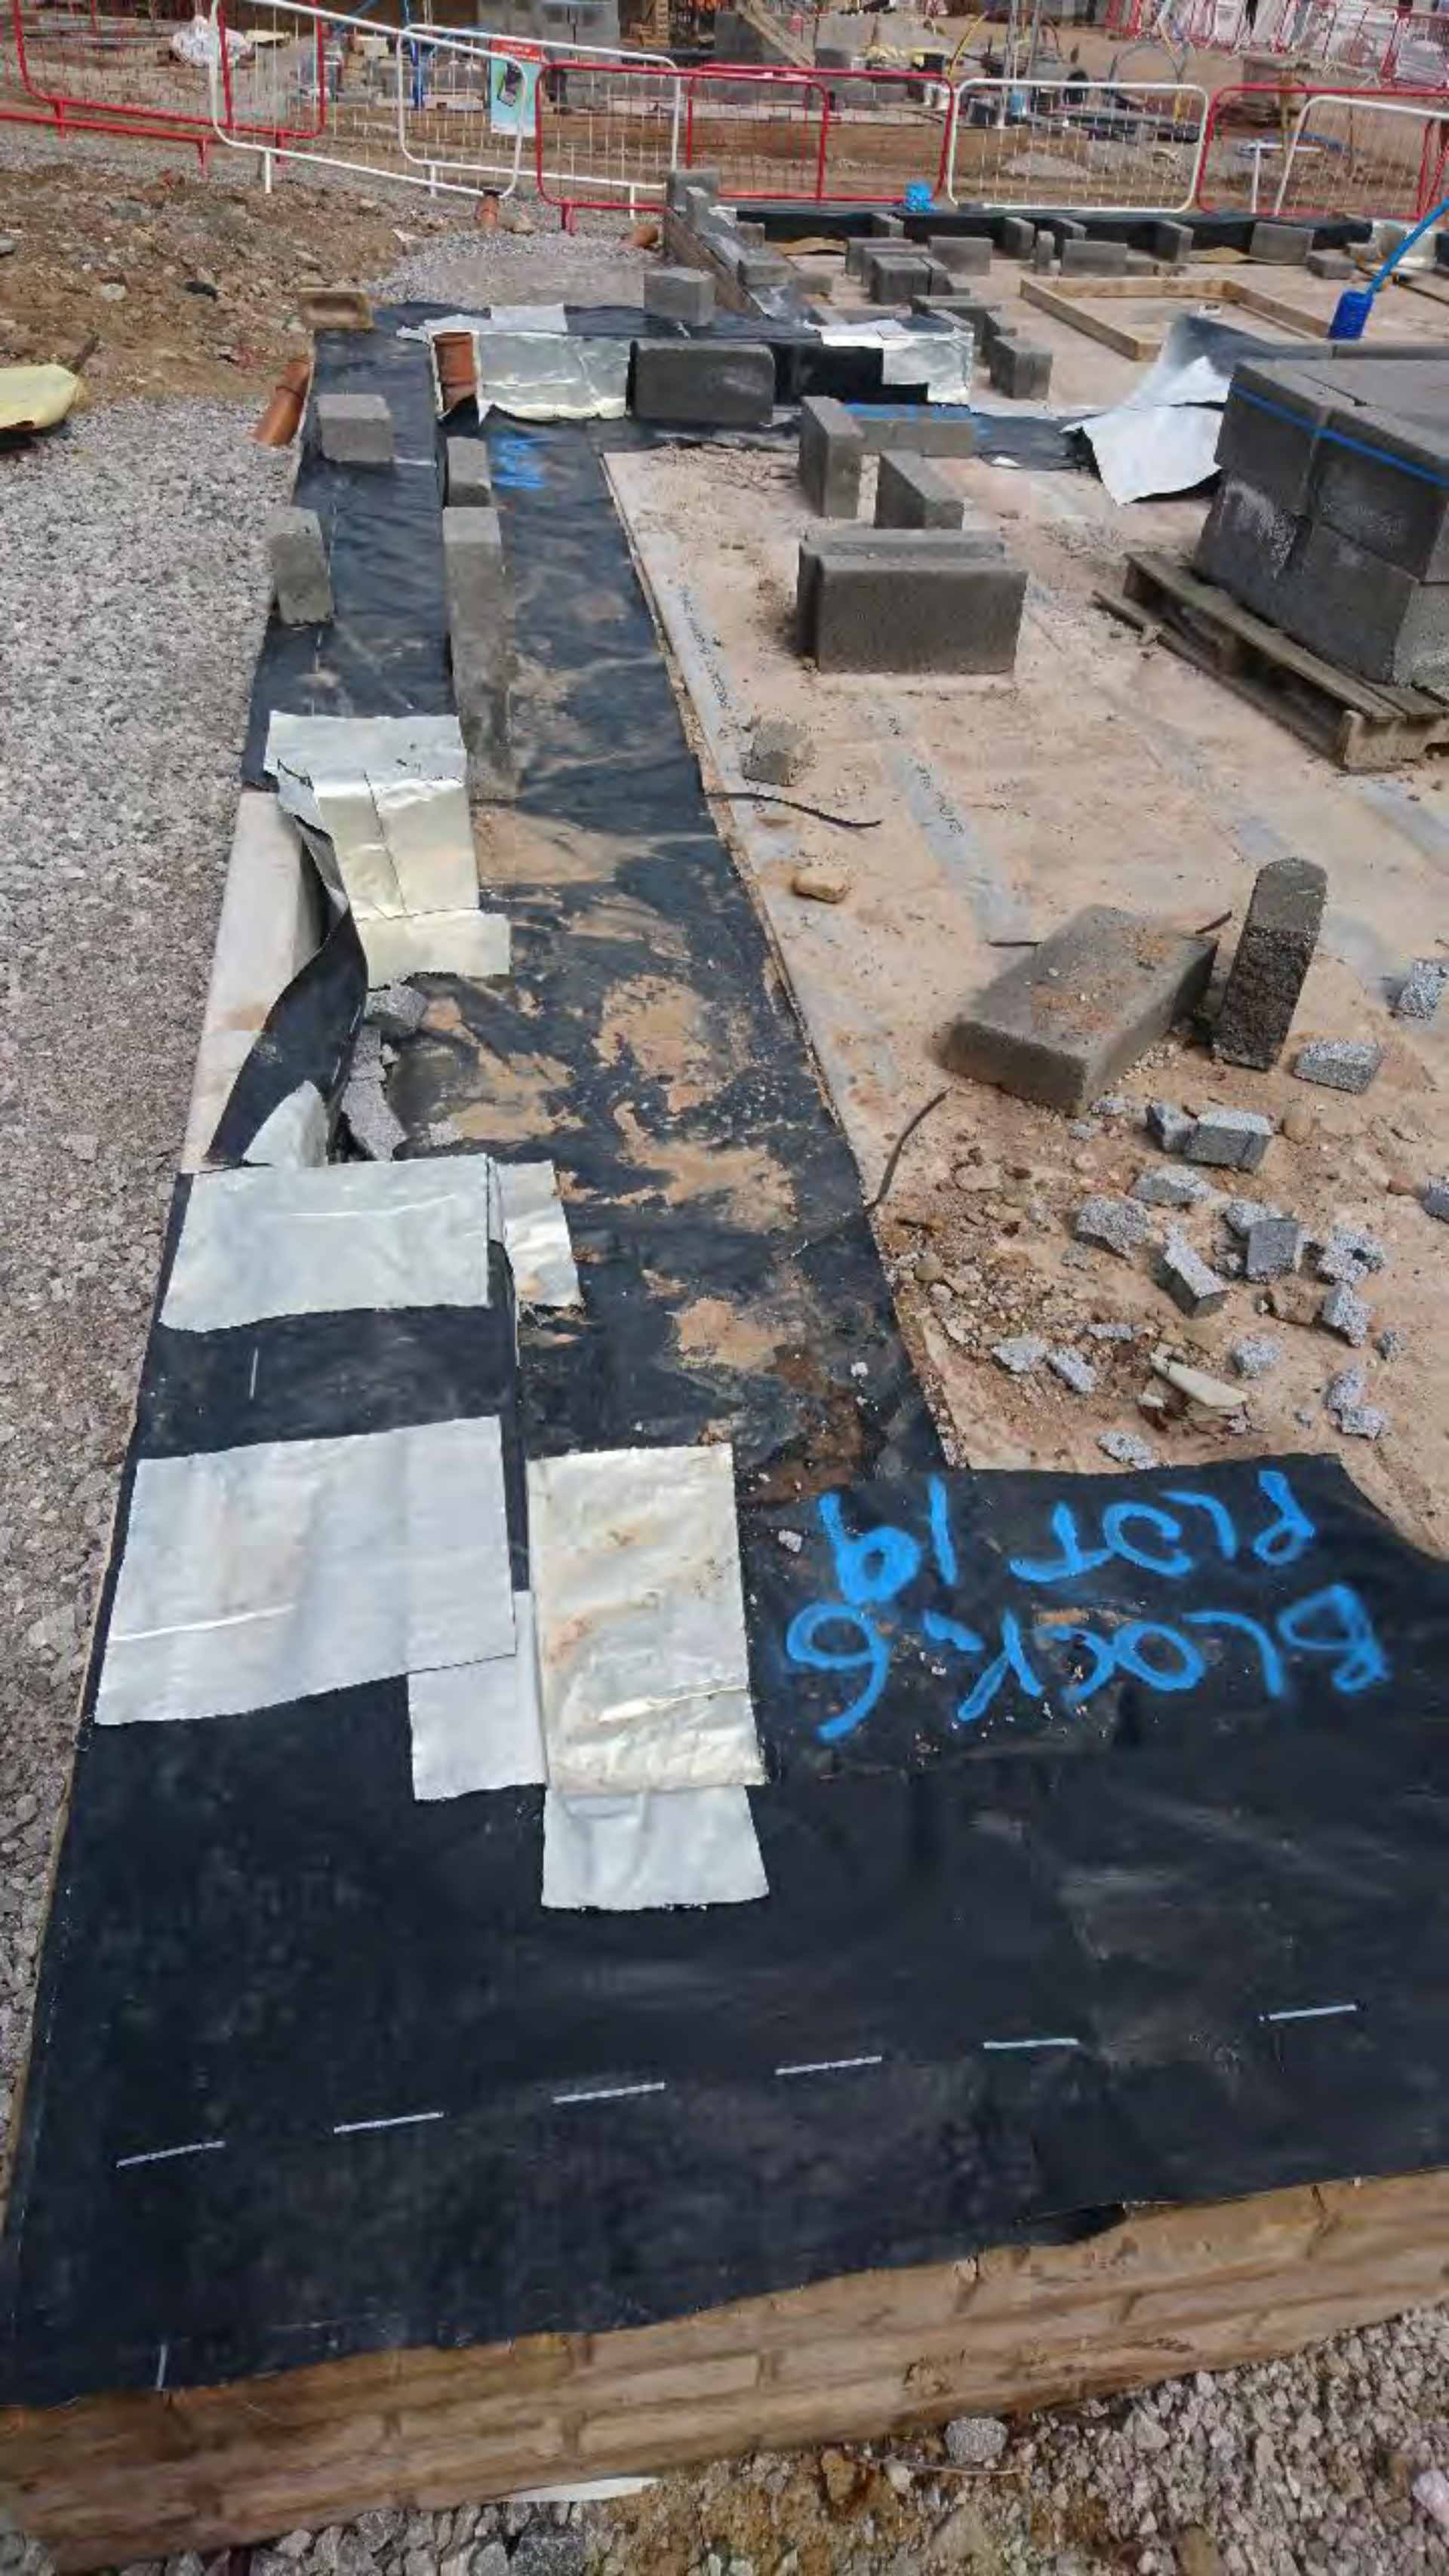
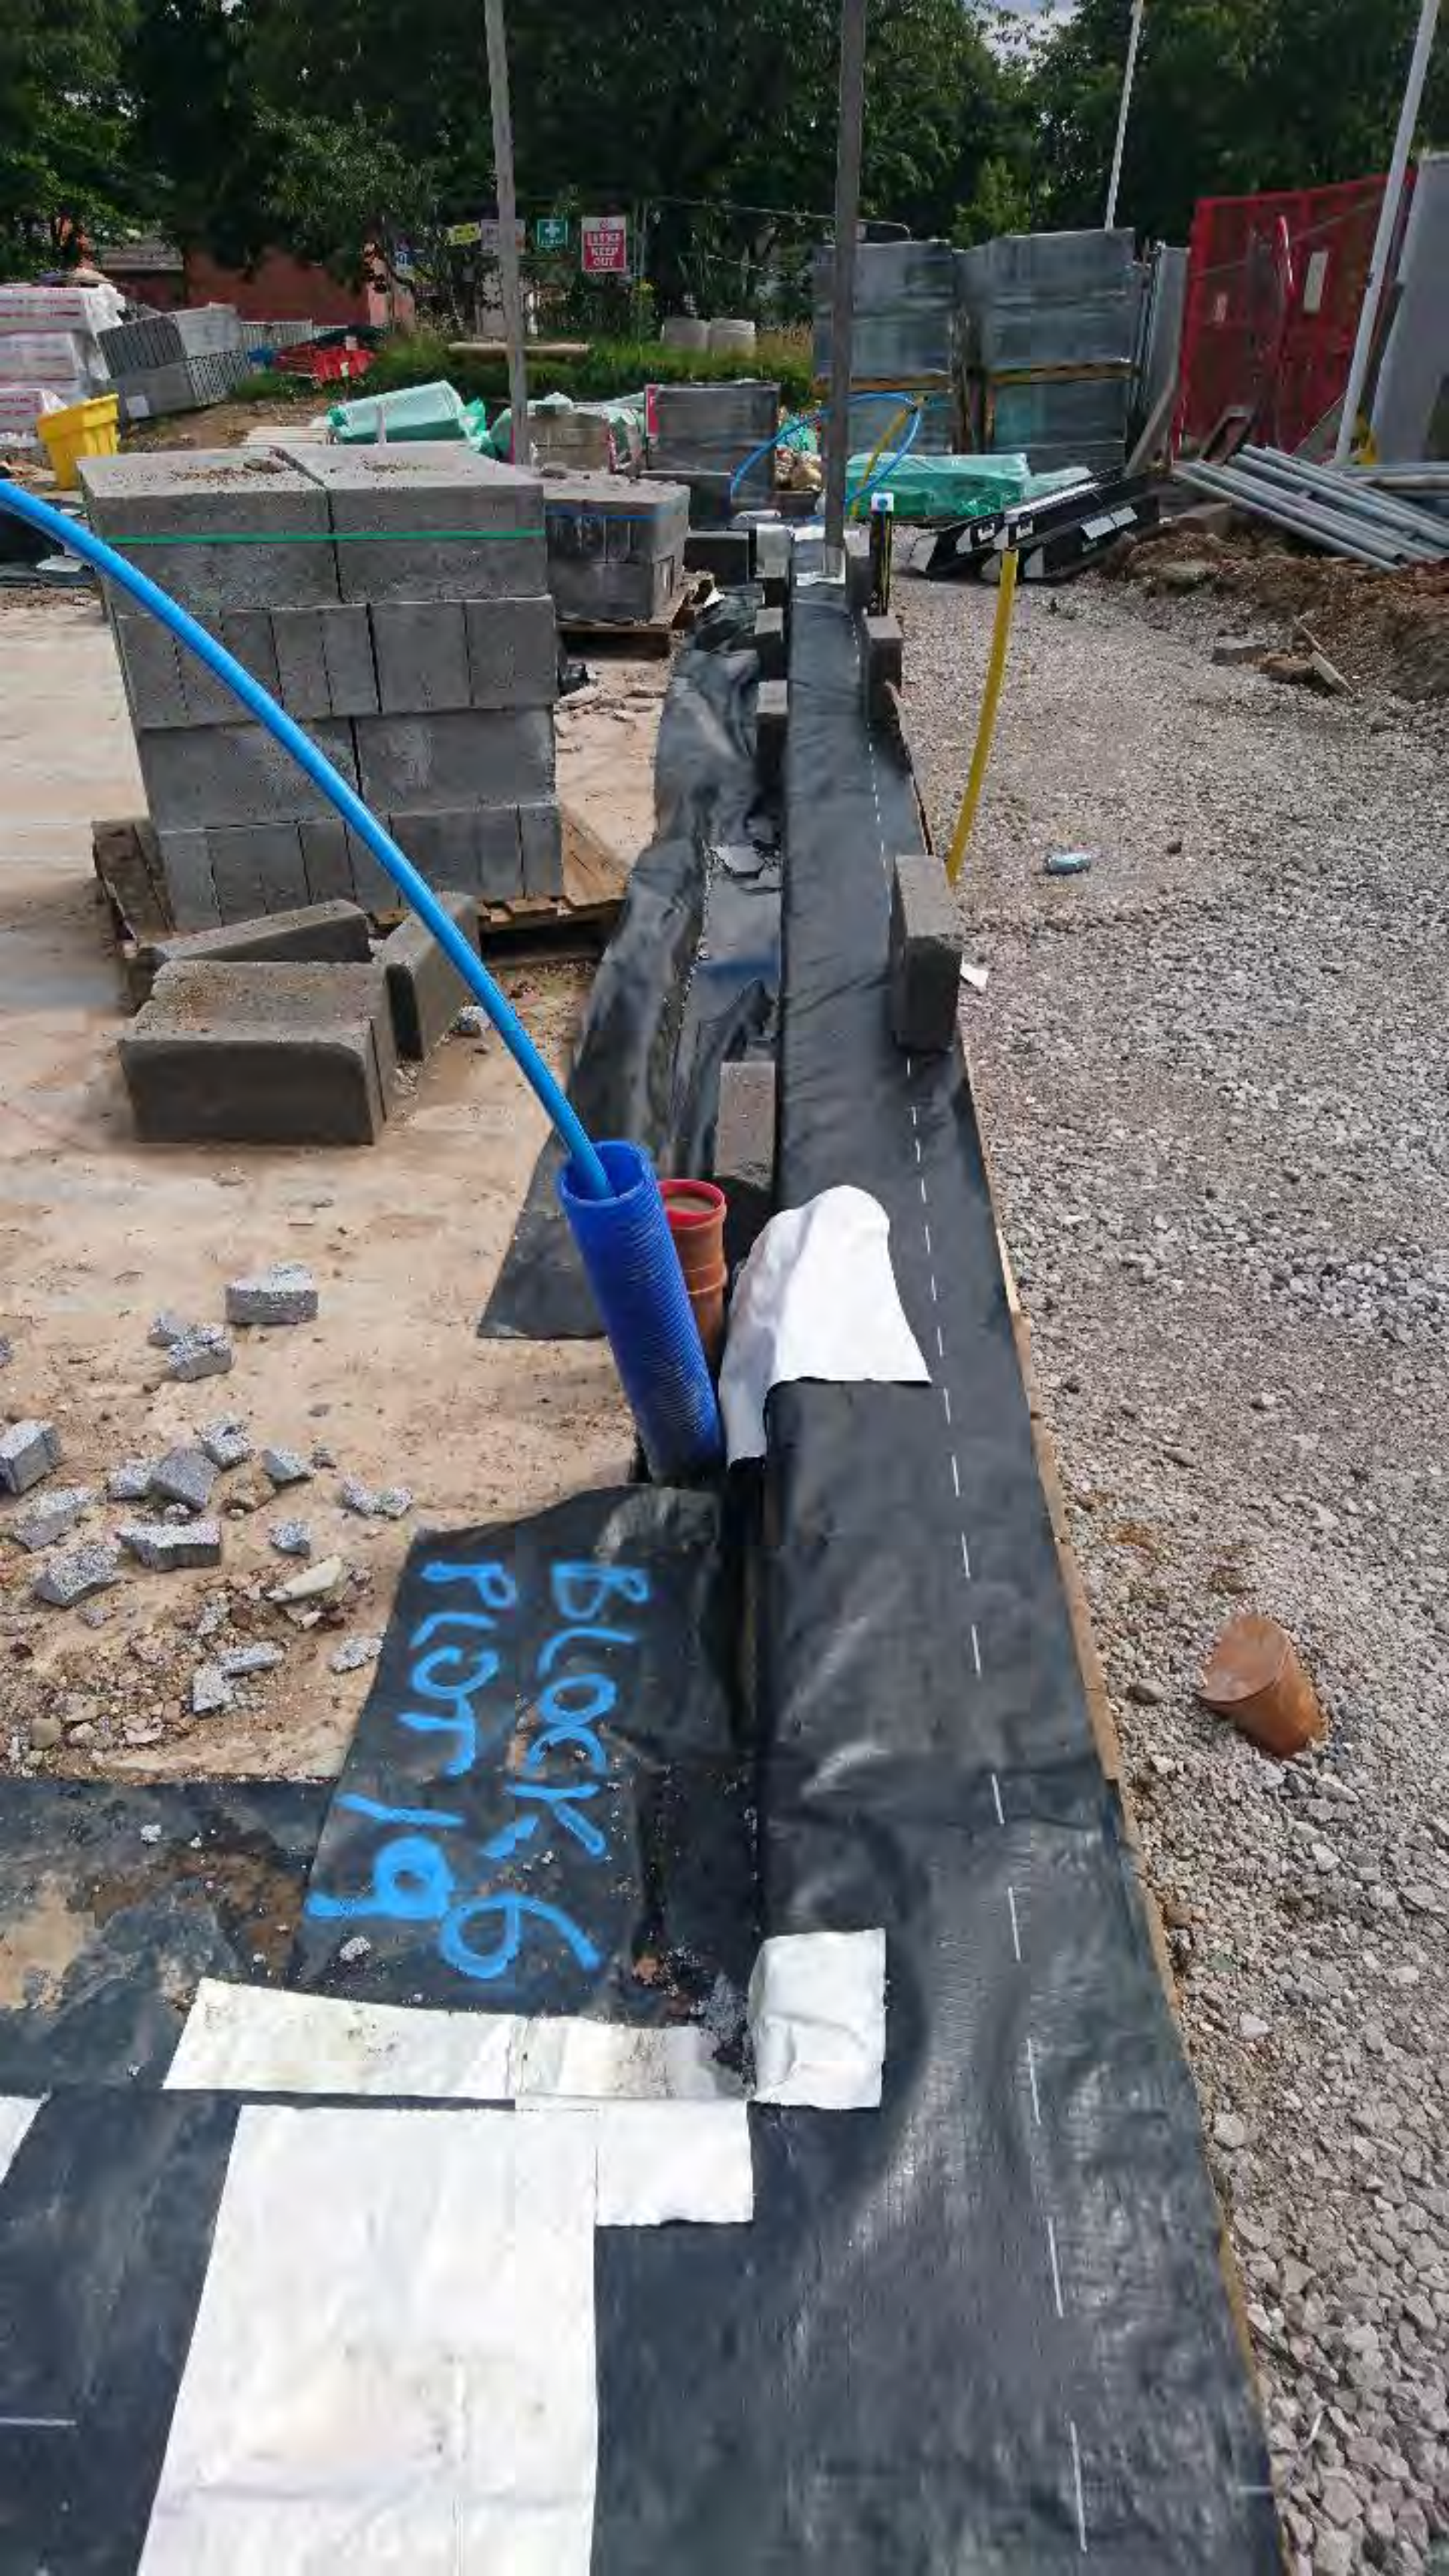
BLOCK  
6

| 1.2 | External Wall Venting – cranked vent spacing | LESS THAN 2M – 1.8M – SEE PHOTOS |
| 2.2 | Condition of sub-grade & underside of gas membrane | ALL GOOD |
| 2.7 | Condition of joints/seals | ALL GOOD – 150mm OVERLAPS |
| 2.9 | Membrane steps/corner seals | NEAT + TIDY |
