This Record sheet is only applicable to block and beam floor slabs for Characteristic Situation 2 gas protection systems

Plot No.: 2

For Residential Development at New Church Street, Radcliffe.

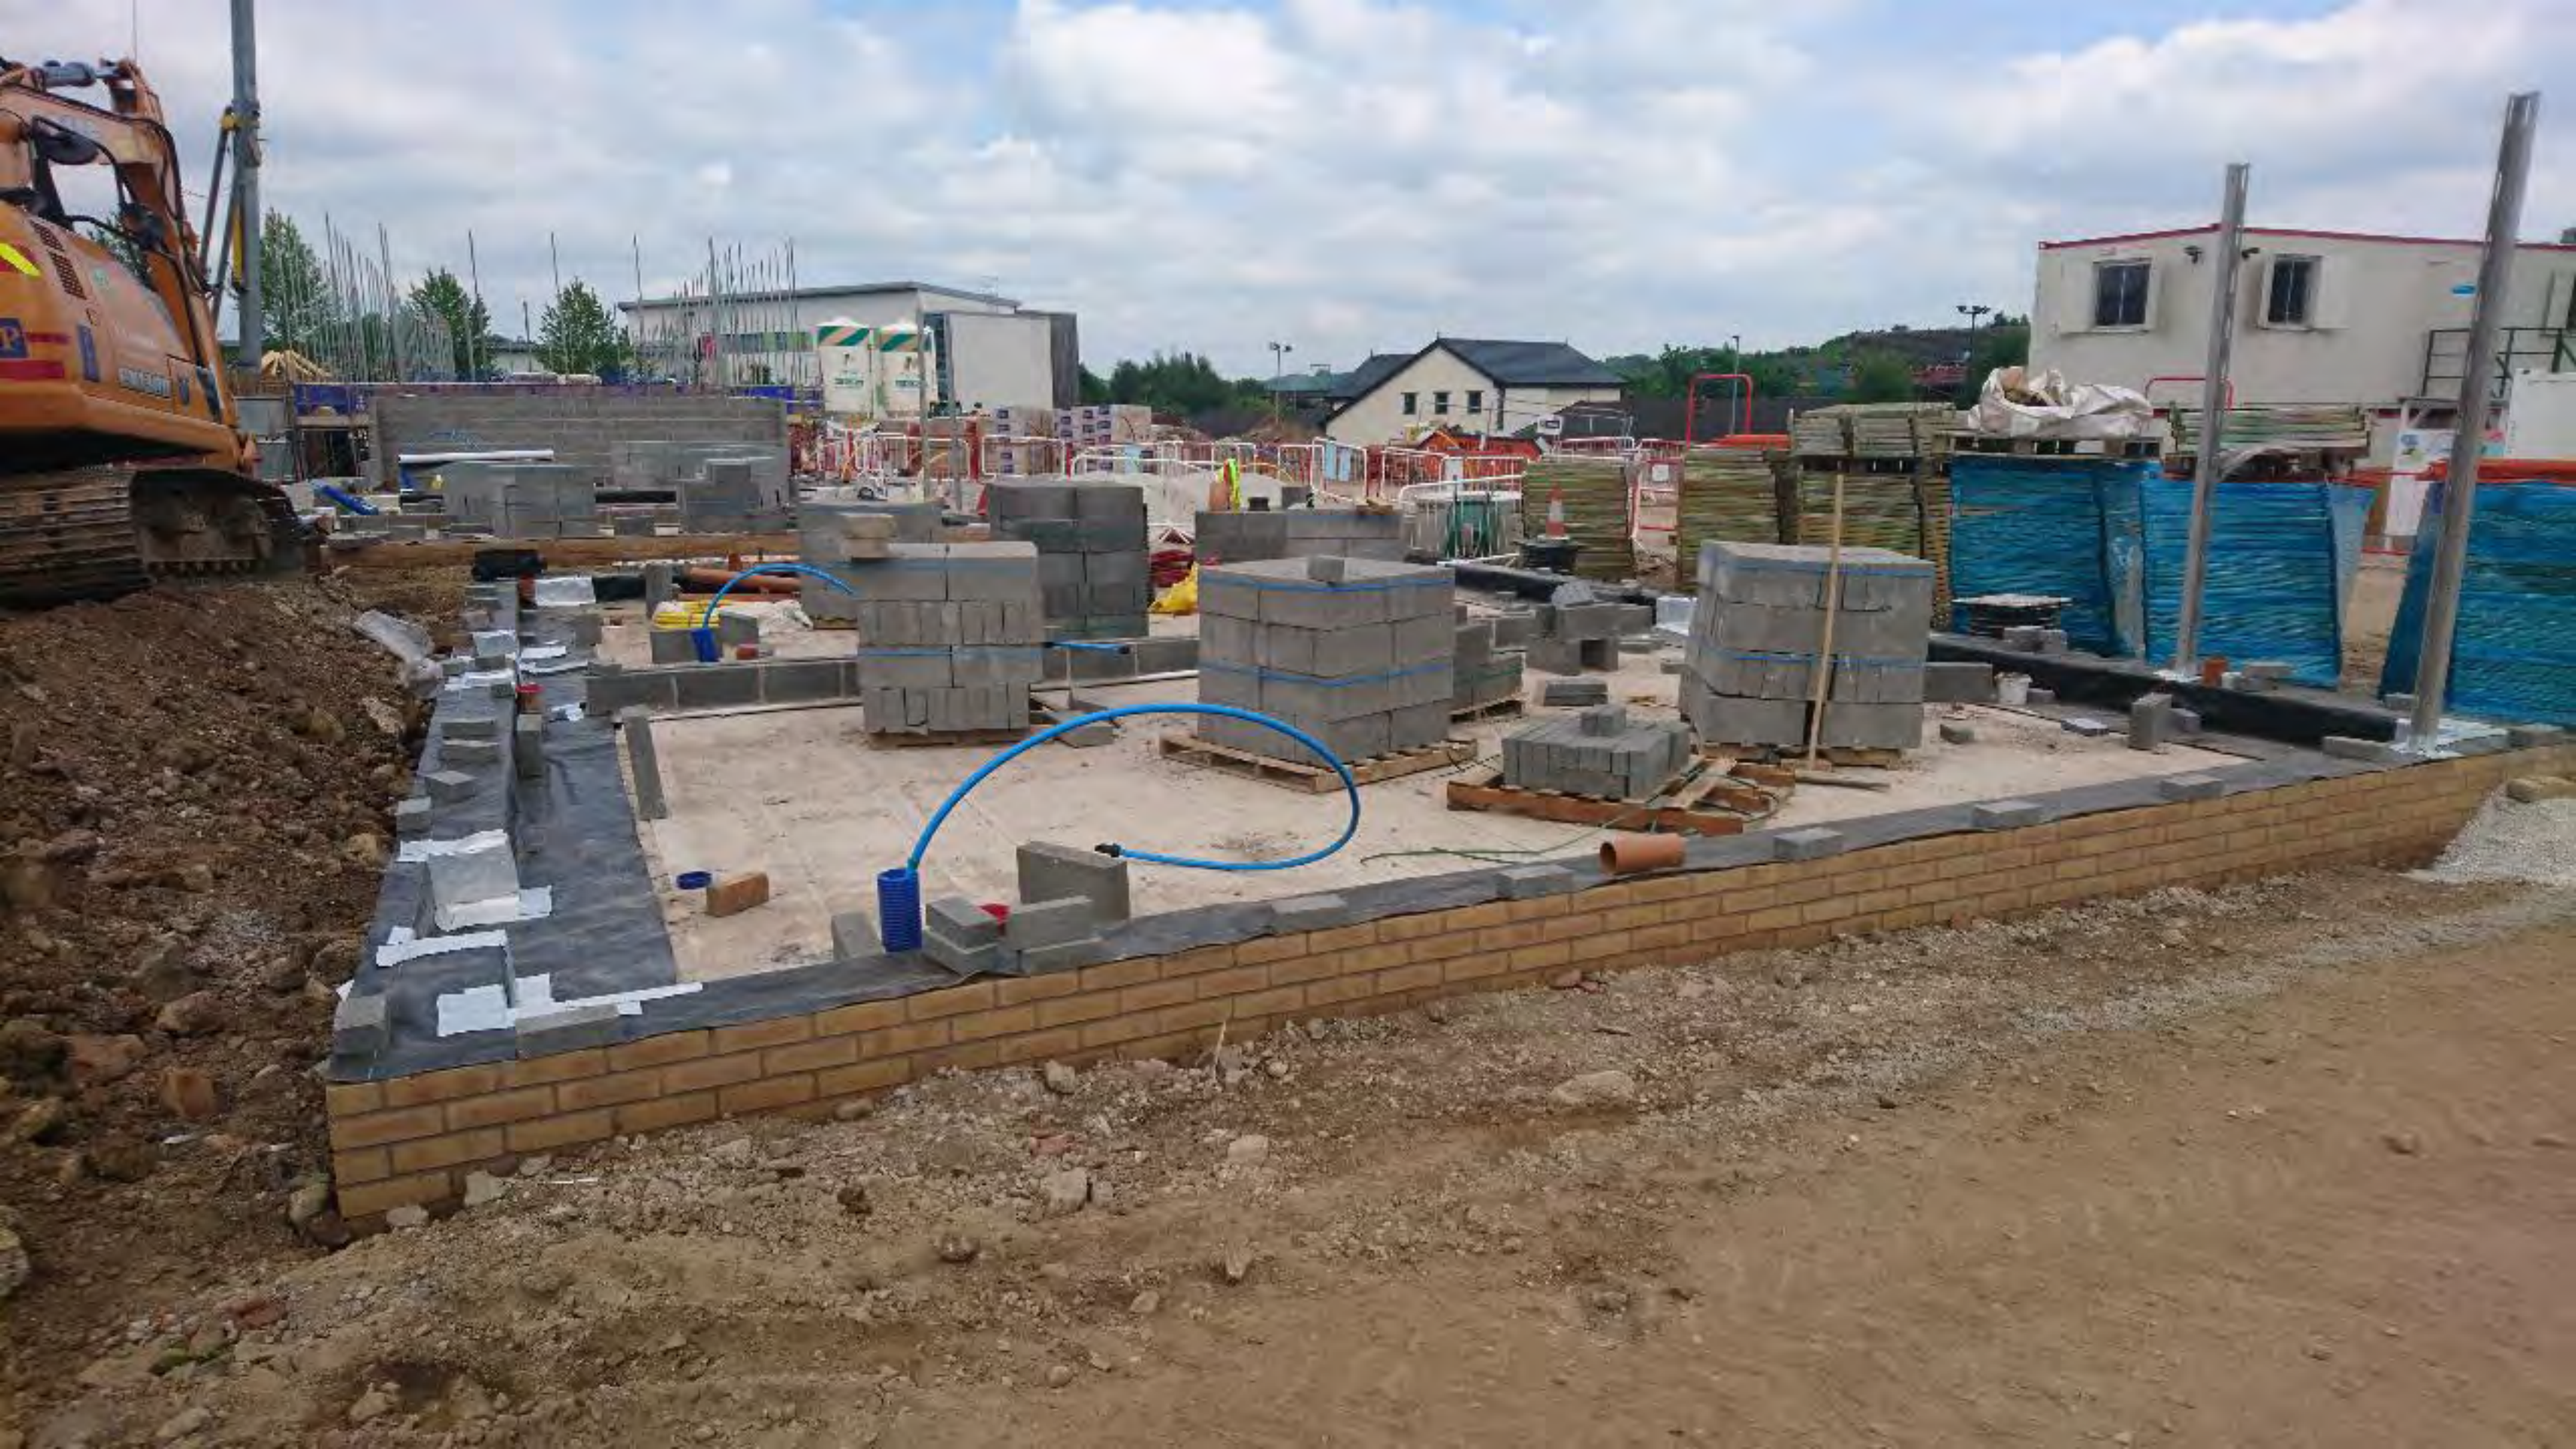
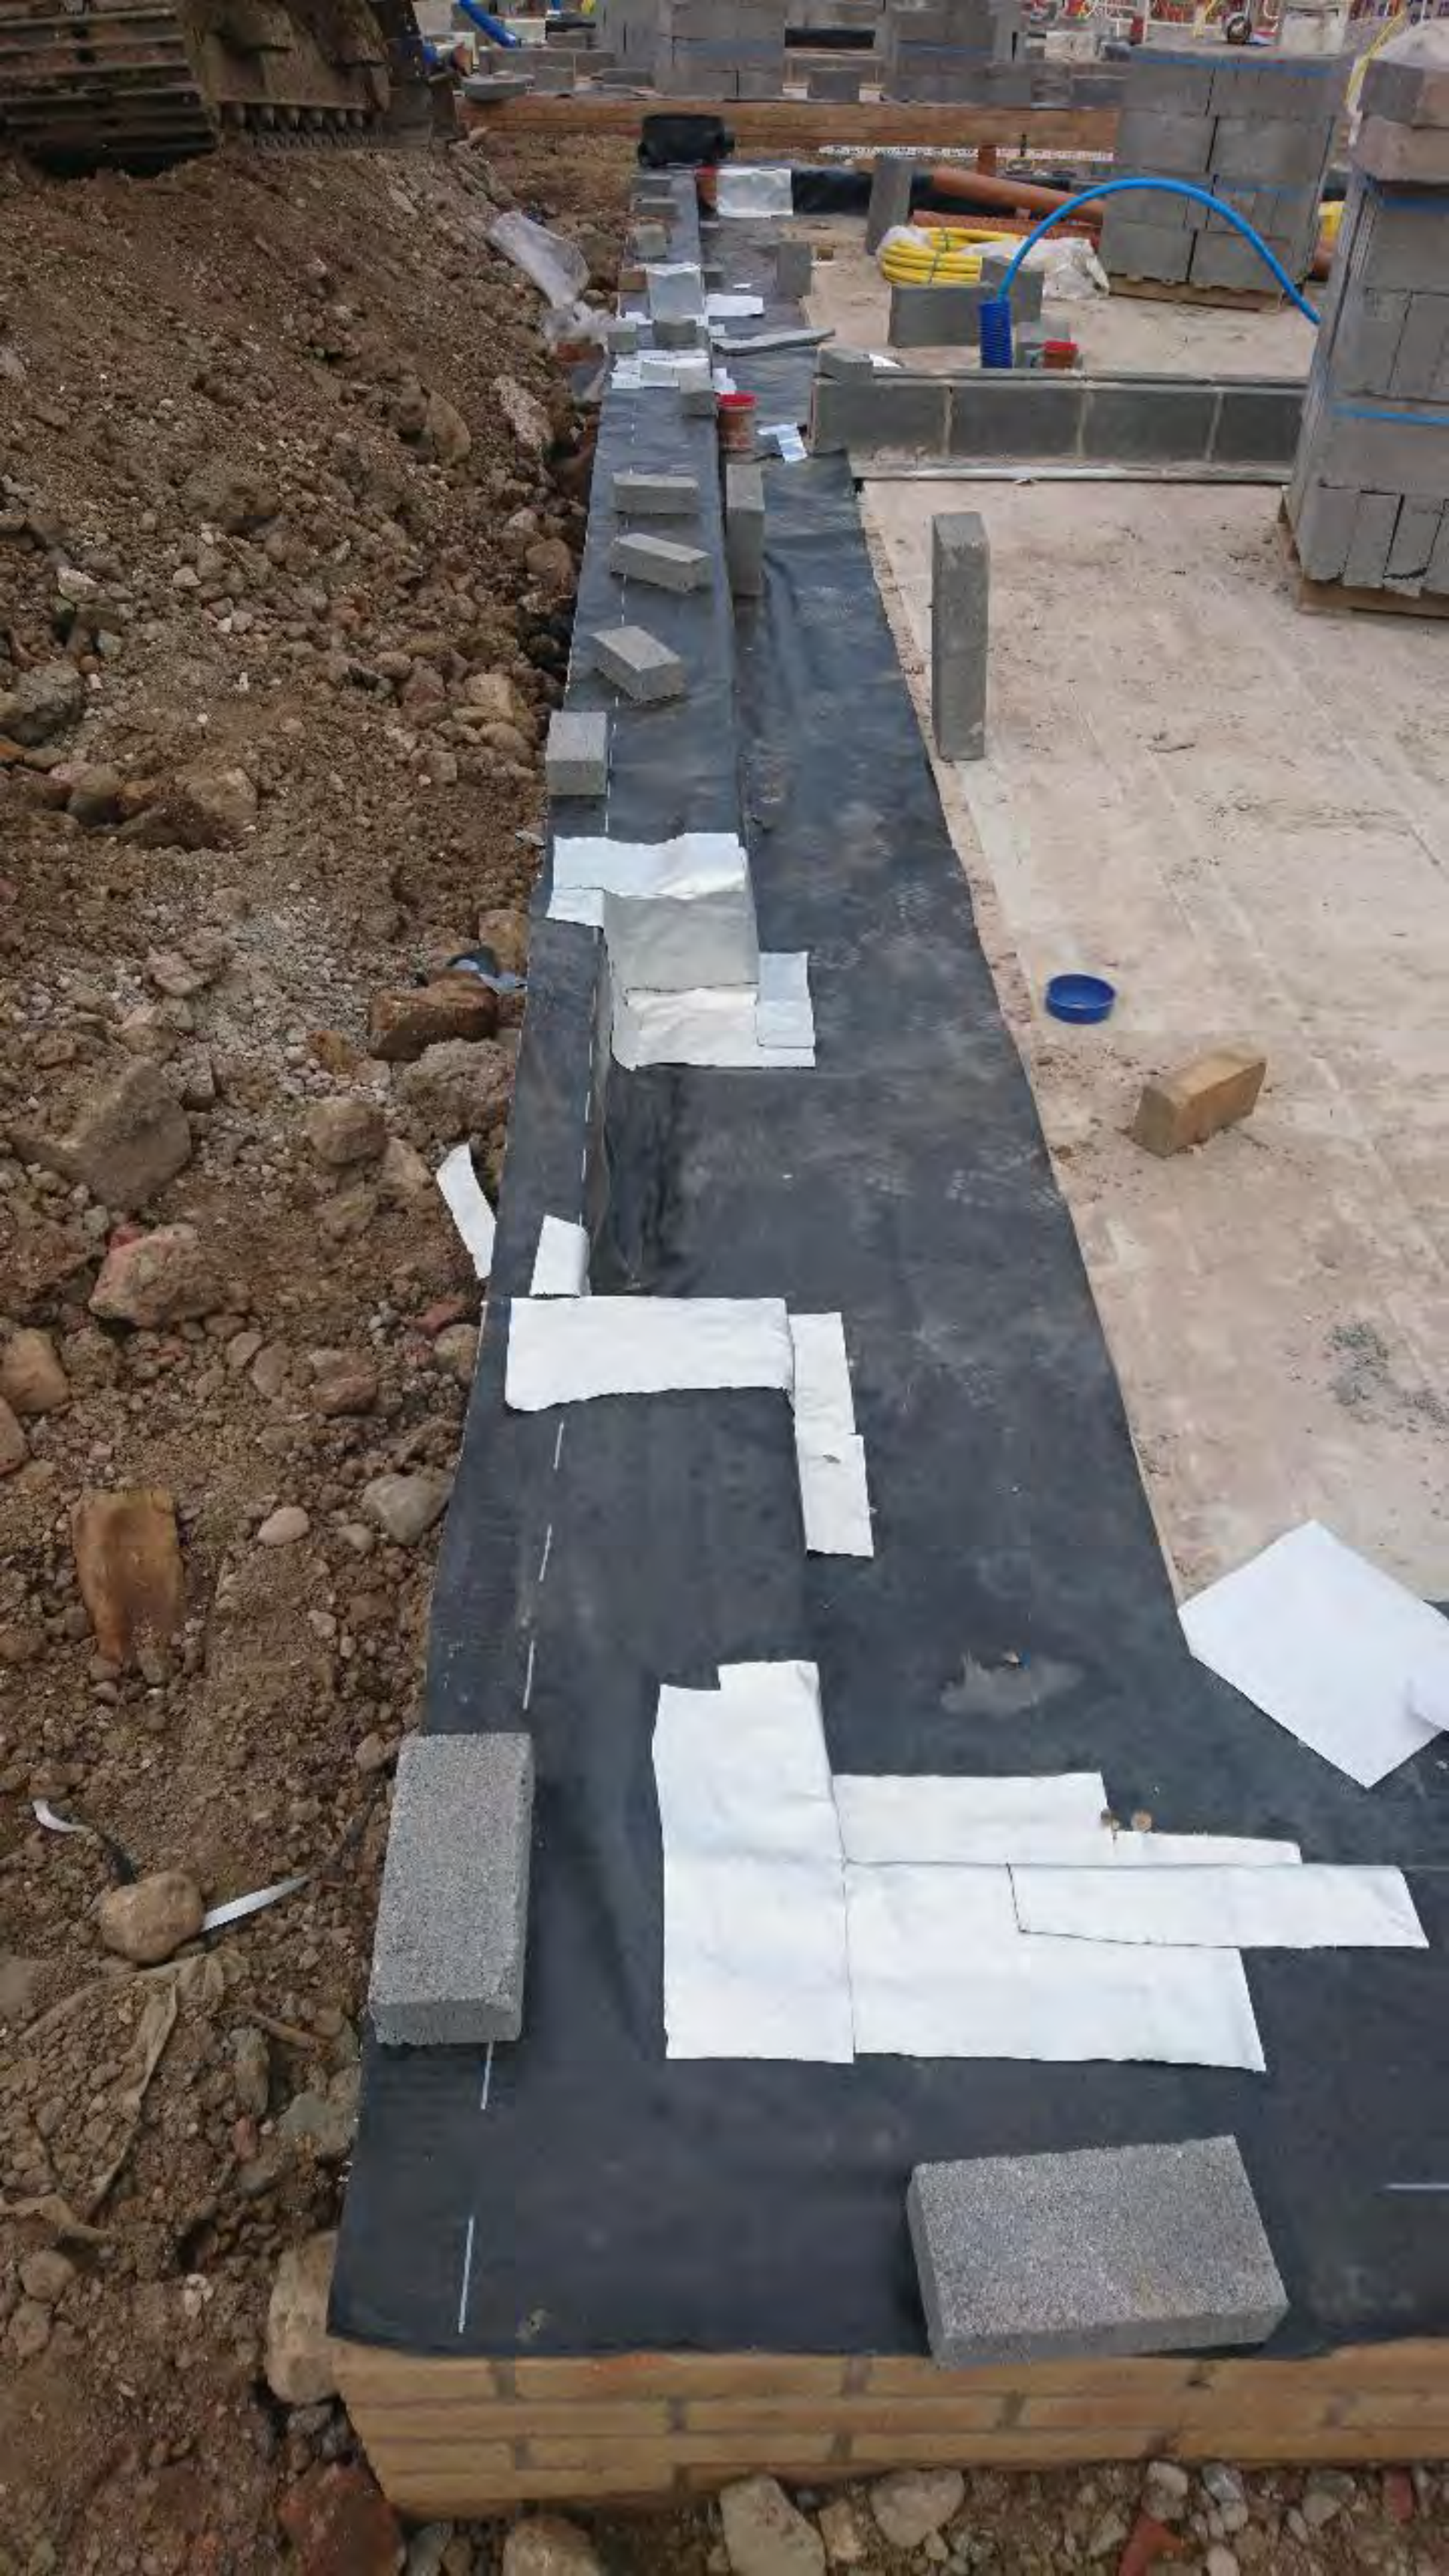
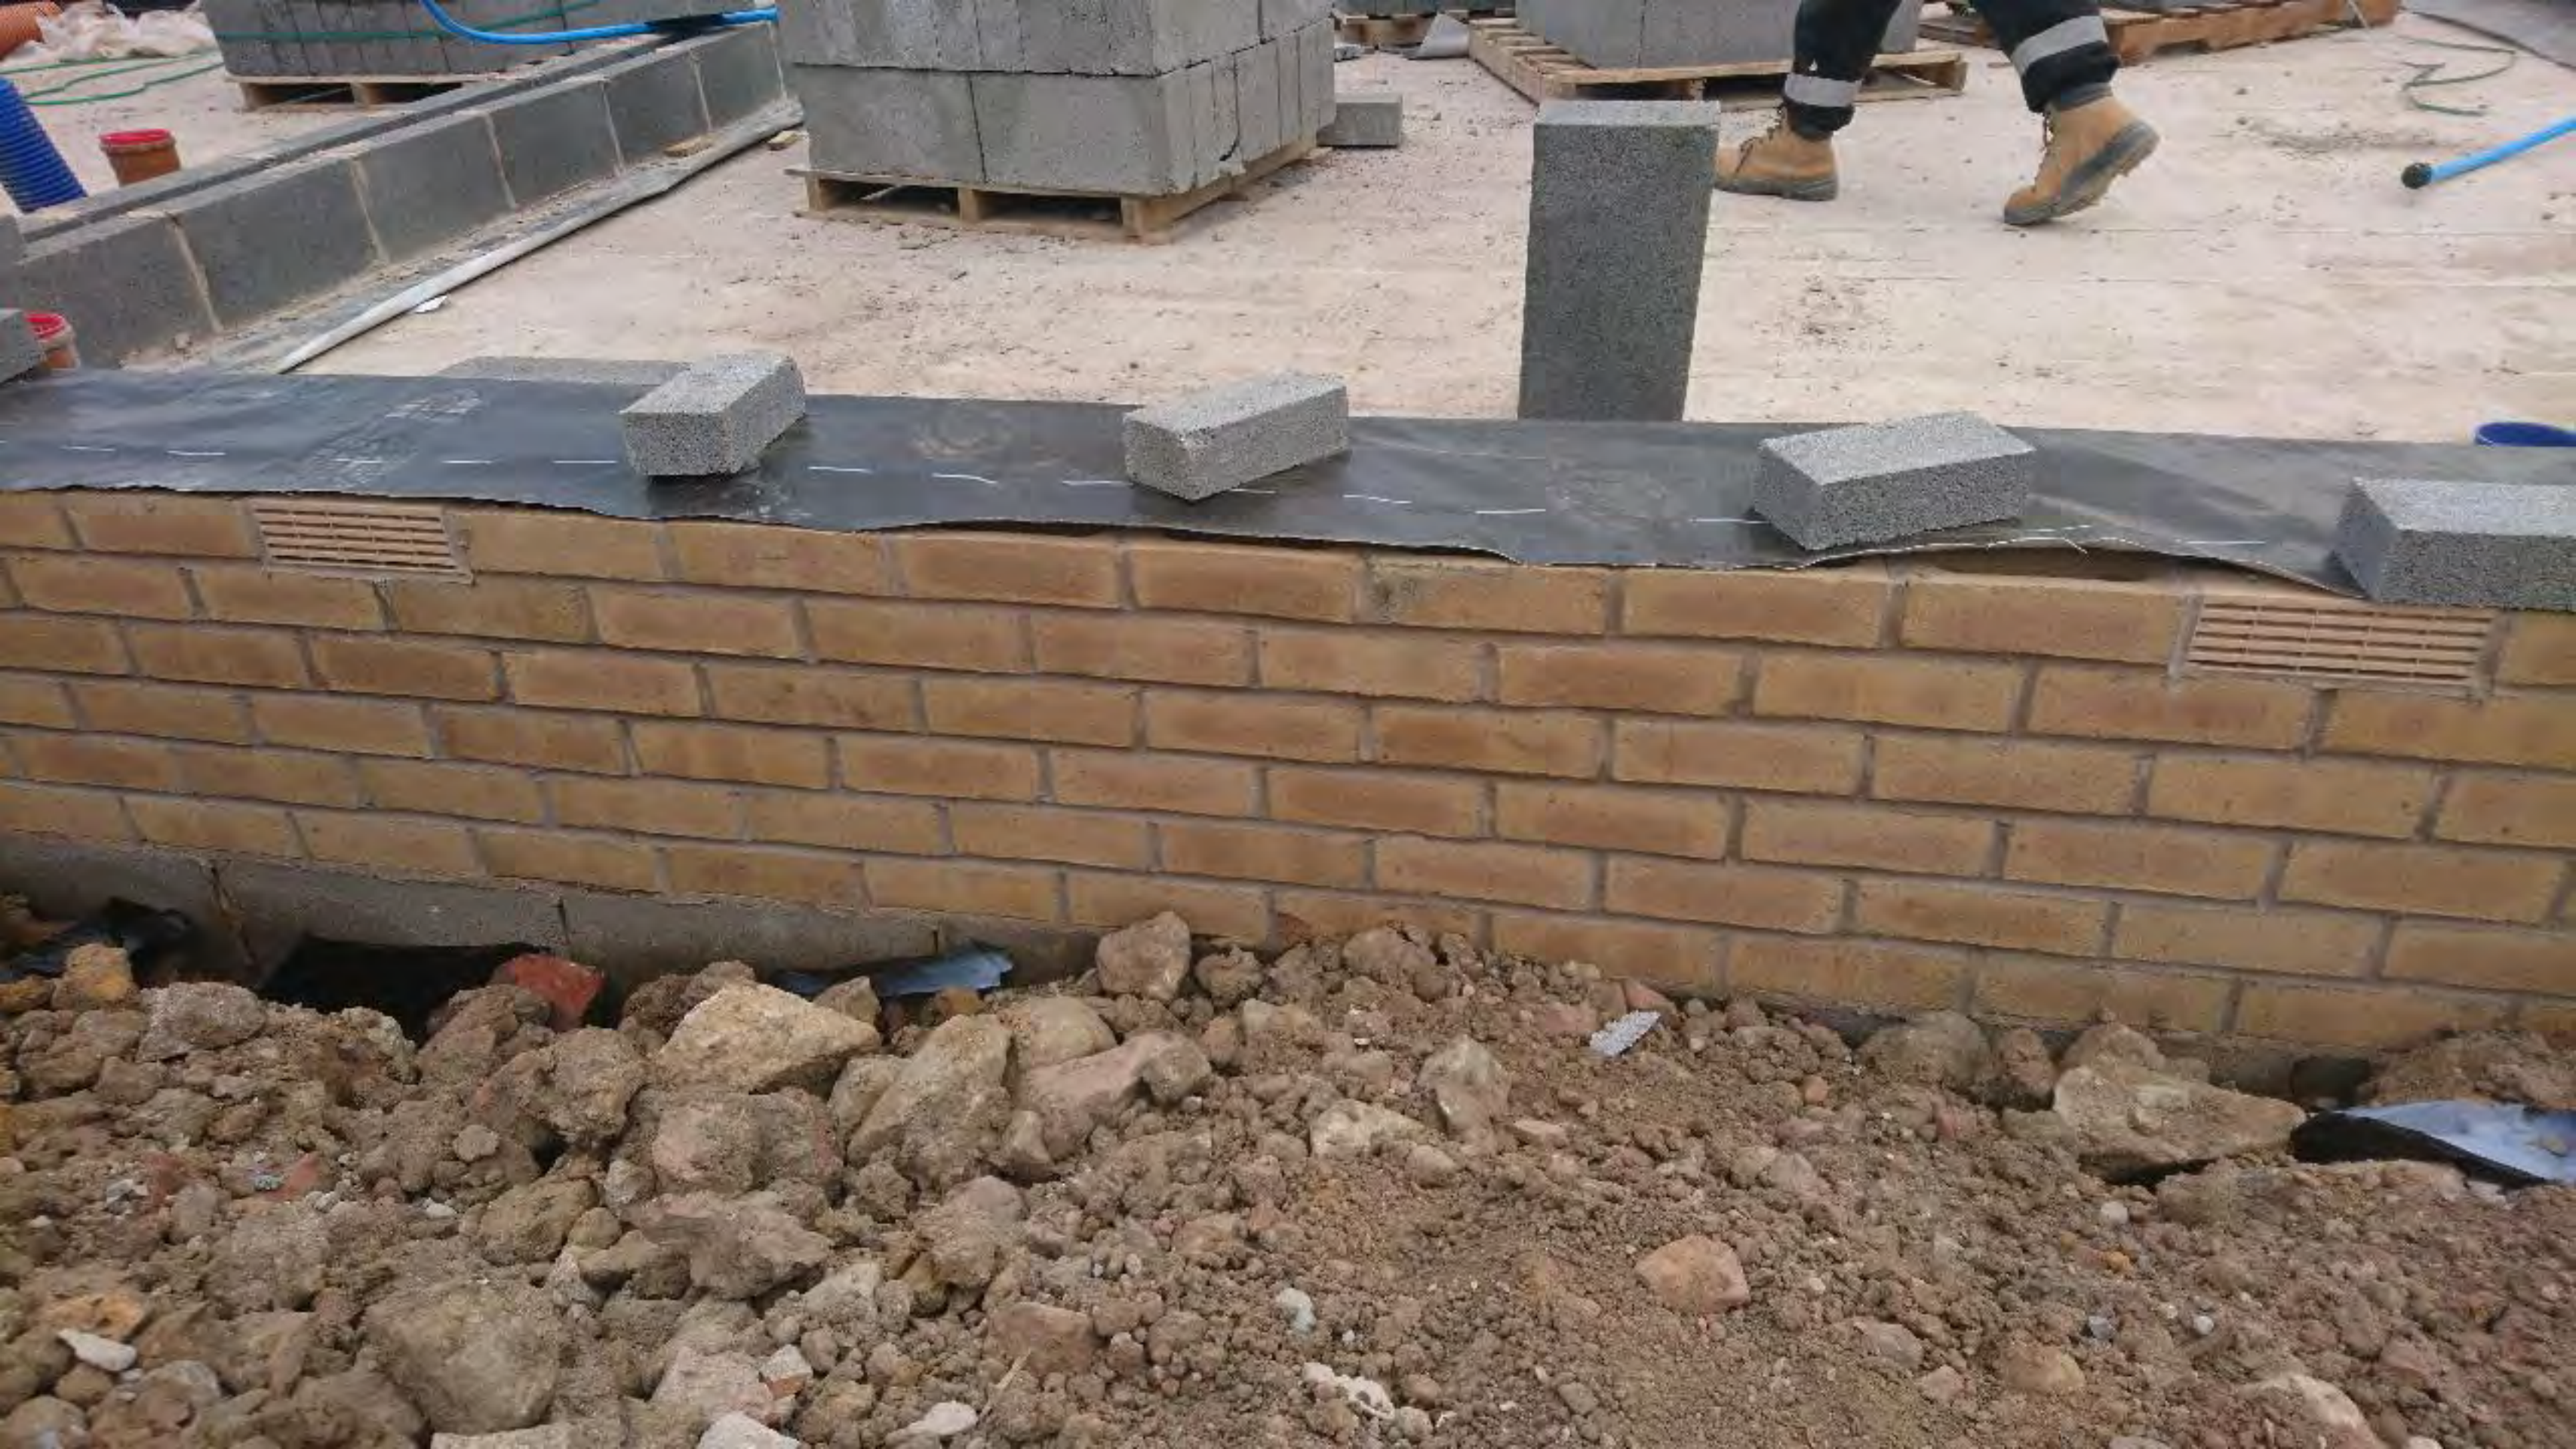
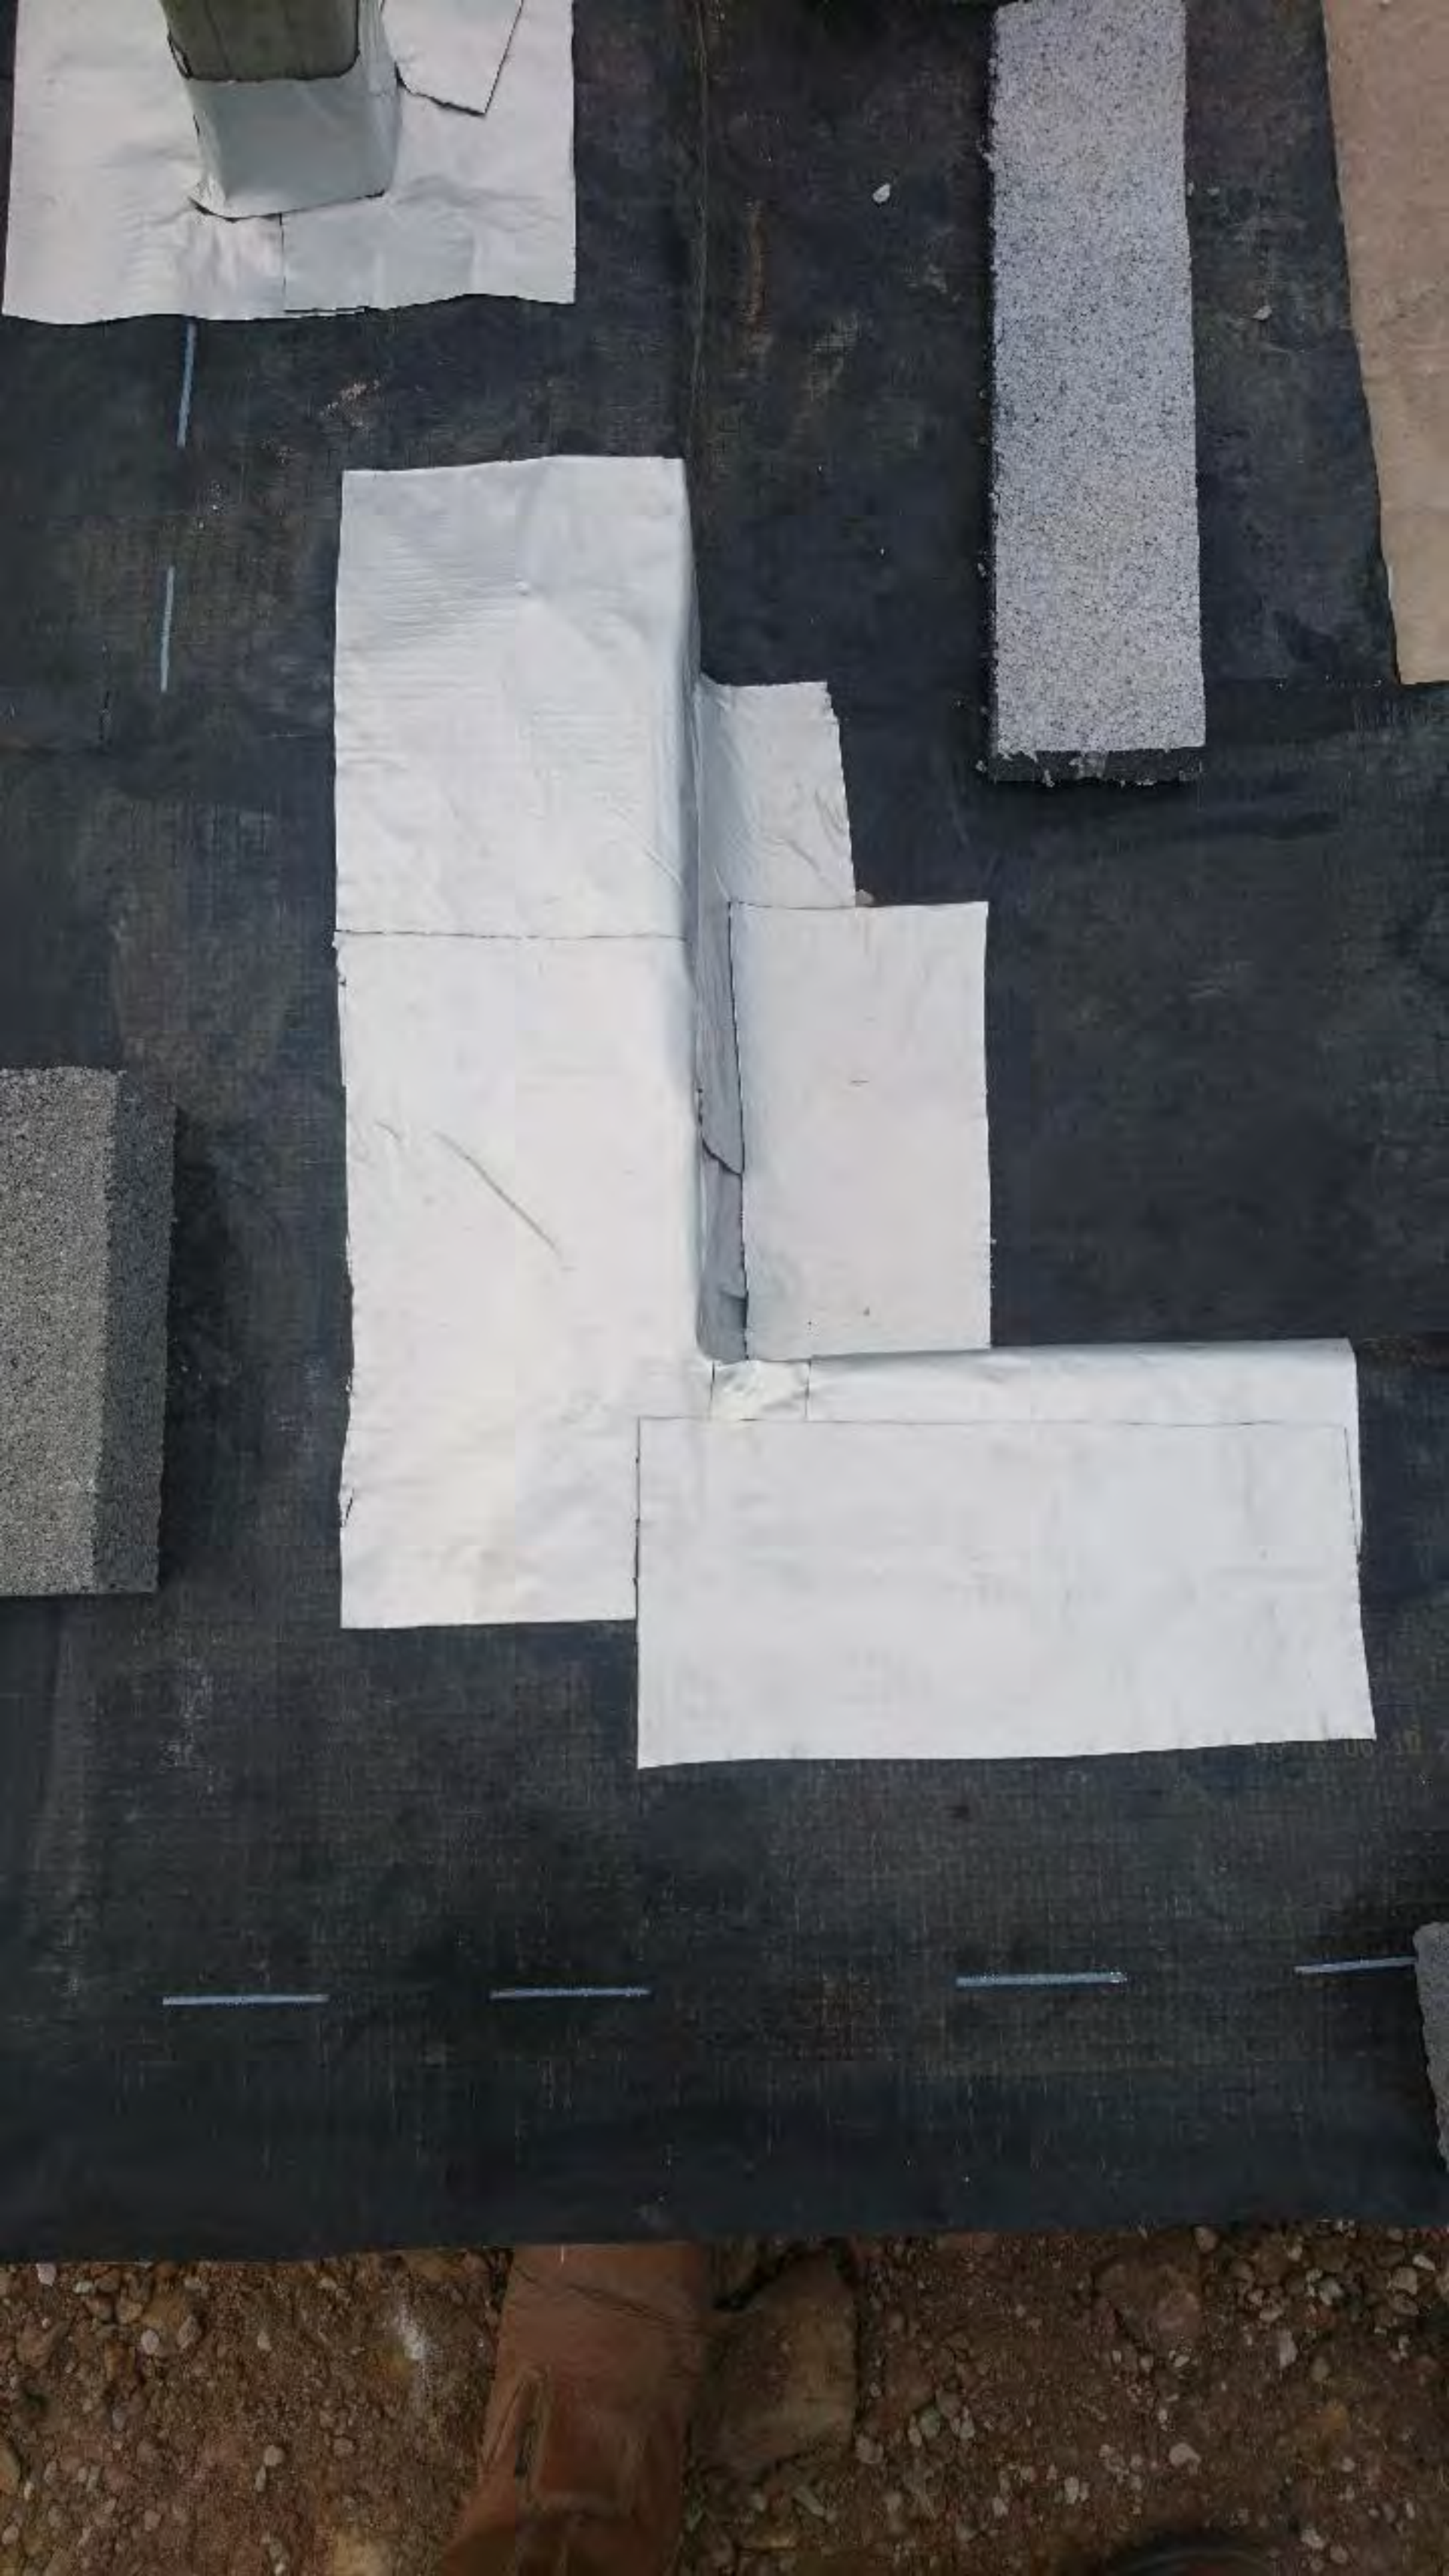
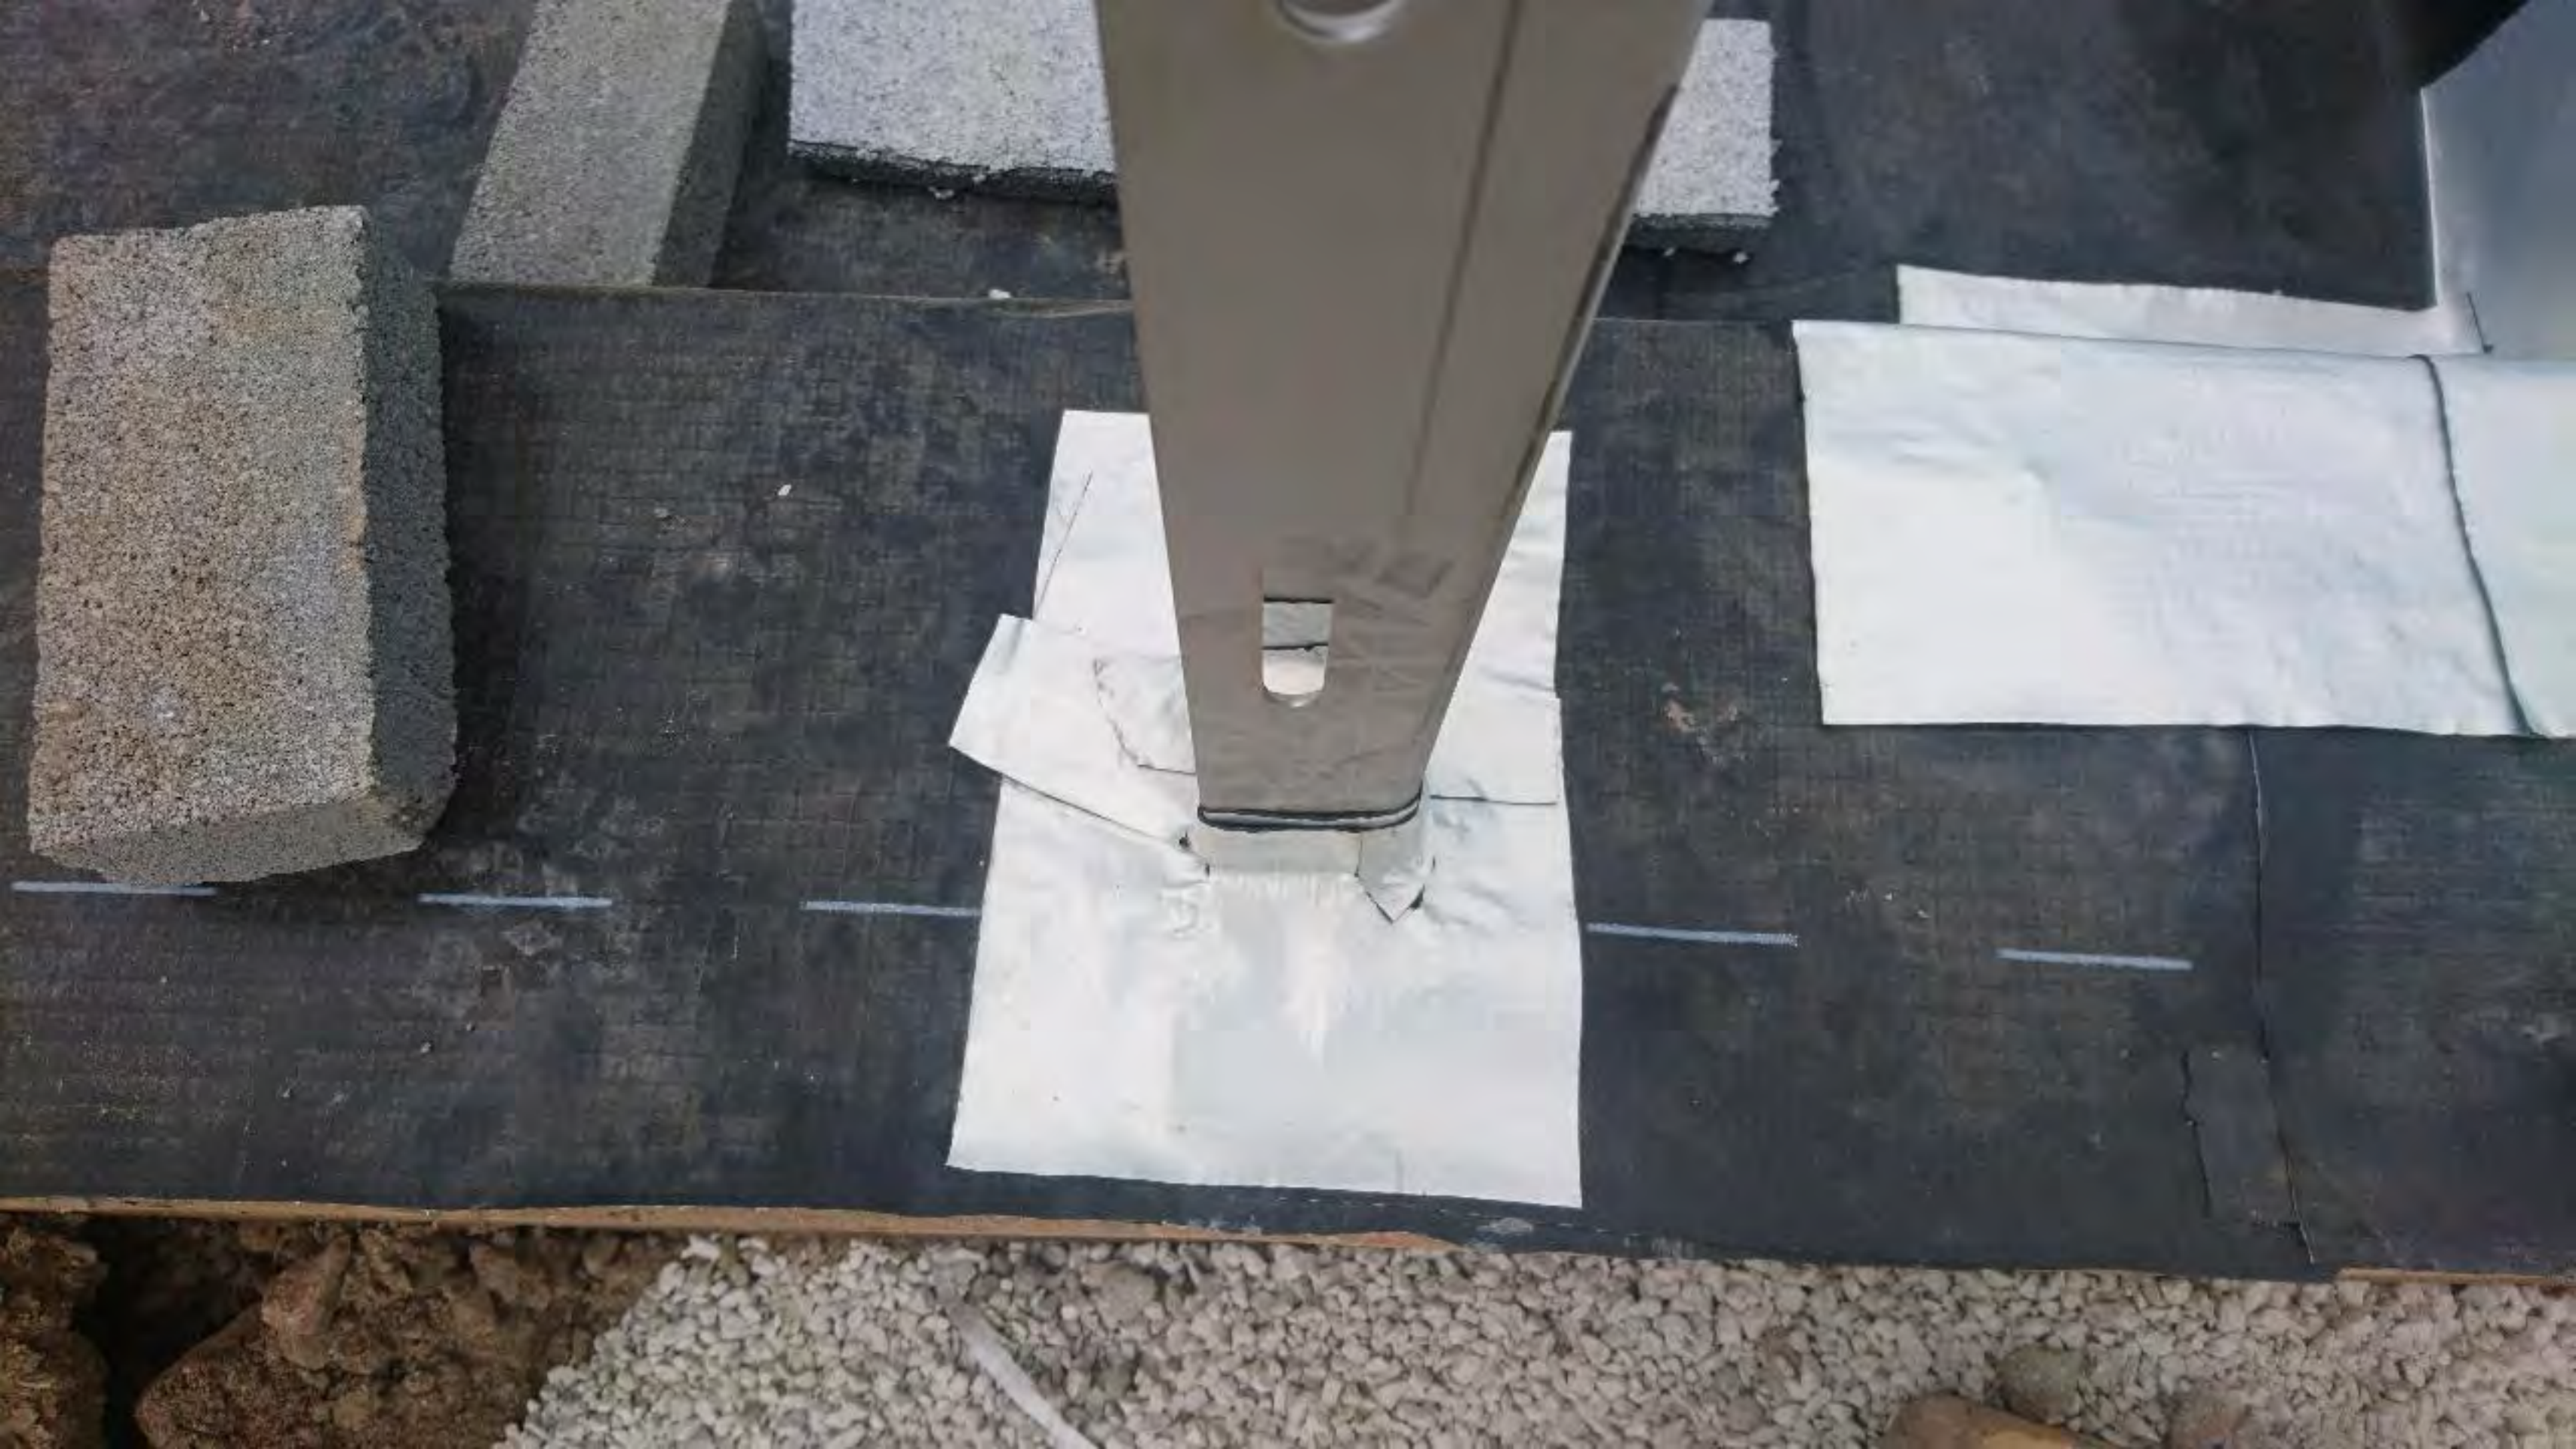
| 1.2 | External Wall Venting – cranked vent spacing | LESS THAN 2M – 1.8M | | | | | |
| 2.2 | Condition of sub-grade & underside of gas membrane | ALL GOOD | | | | | |
| 2.7 | Condition of joints/seals | GOOD - 150mm OVERLAPS | | | | | |
| 2.9 | Membrane steps/corner seals | ALL GOOD + TIDY | | | | | |
