This Record sheet is only applicable to block and beam floor slabs for Characteristic Situation 2 gas protection systems

Plot No.: 2

For Residential Development at New Church Street, Radcliffe.

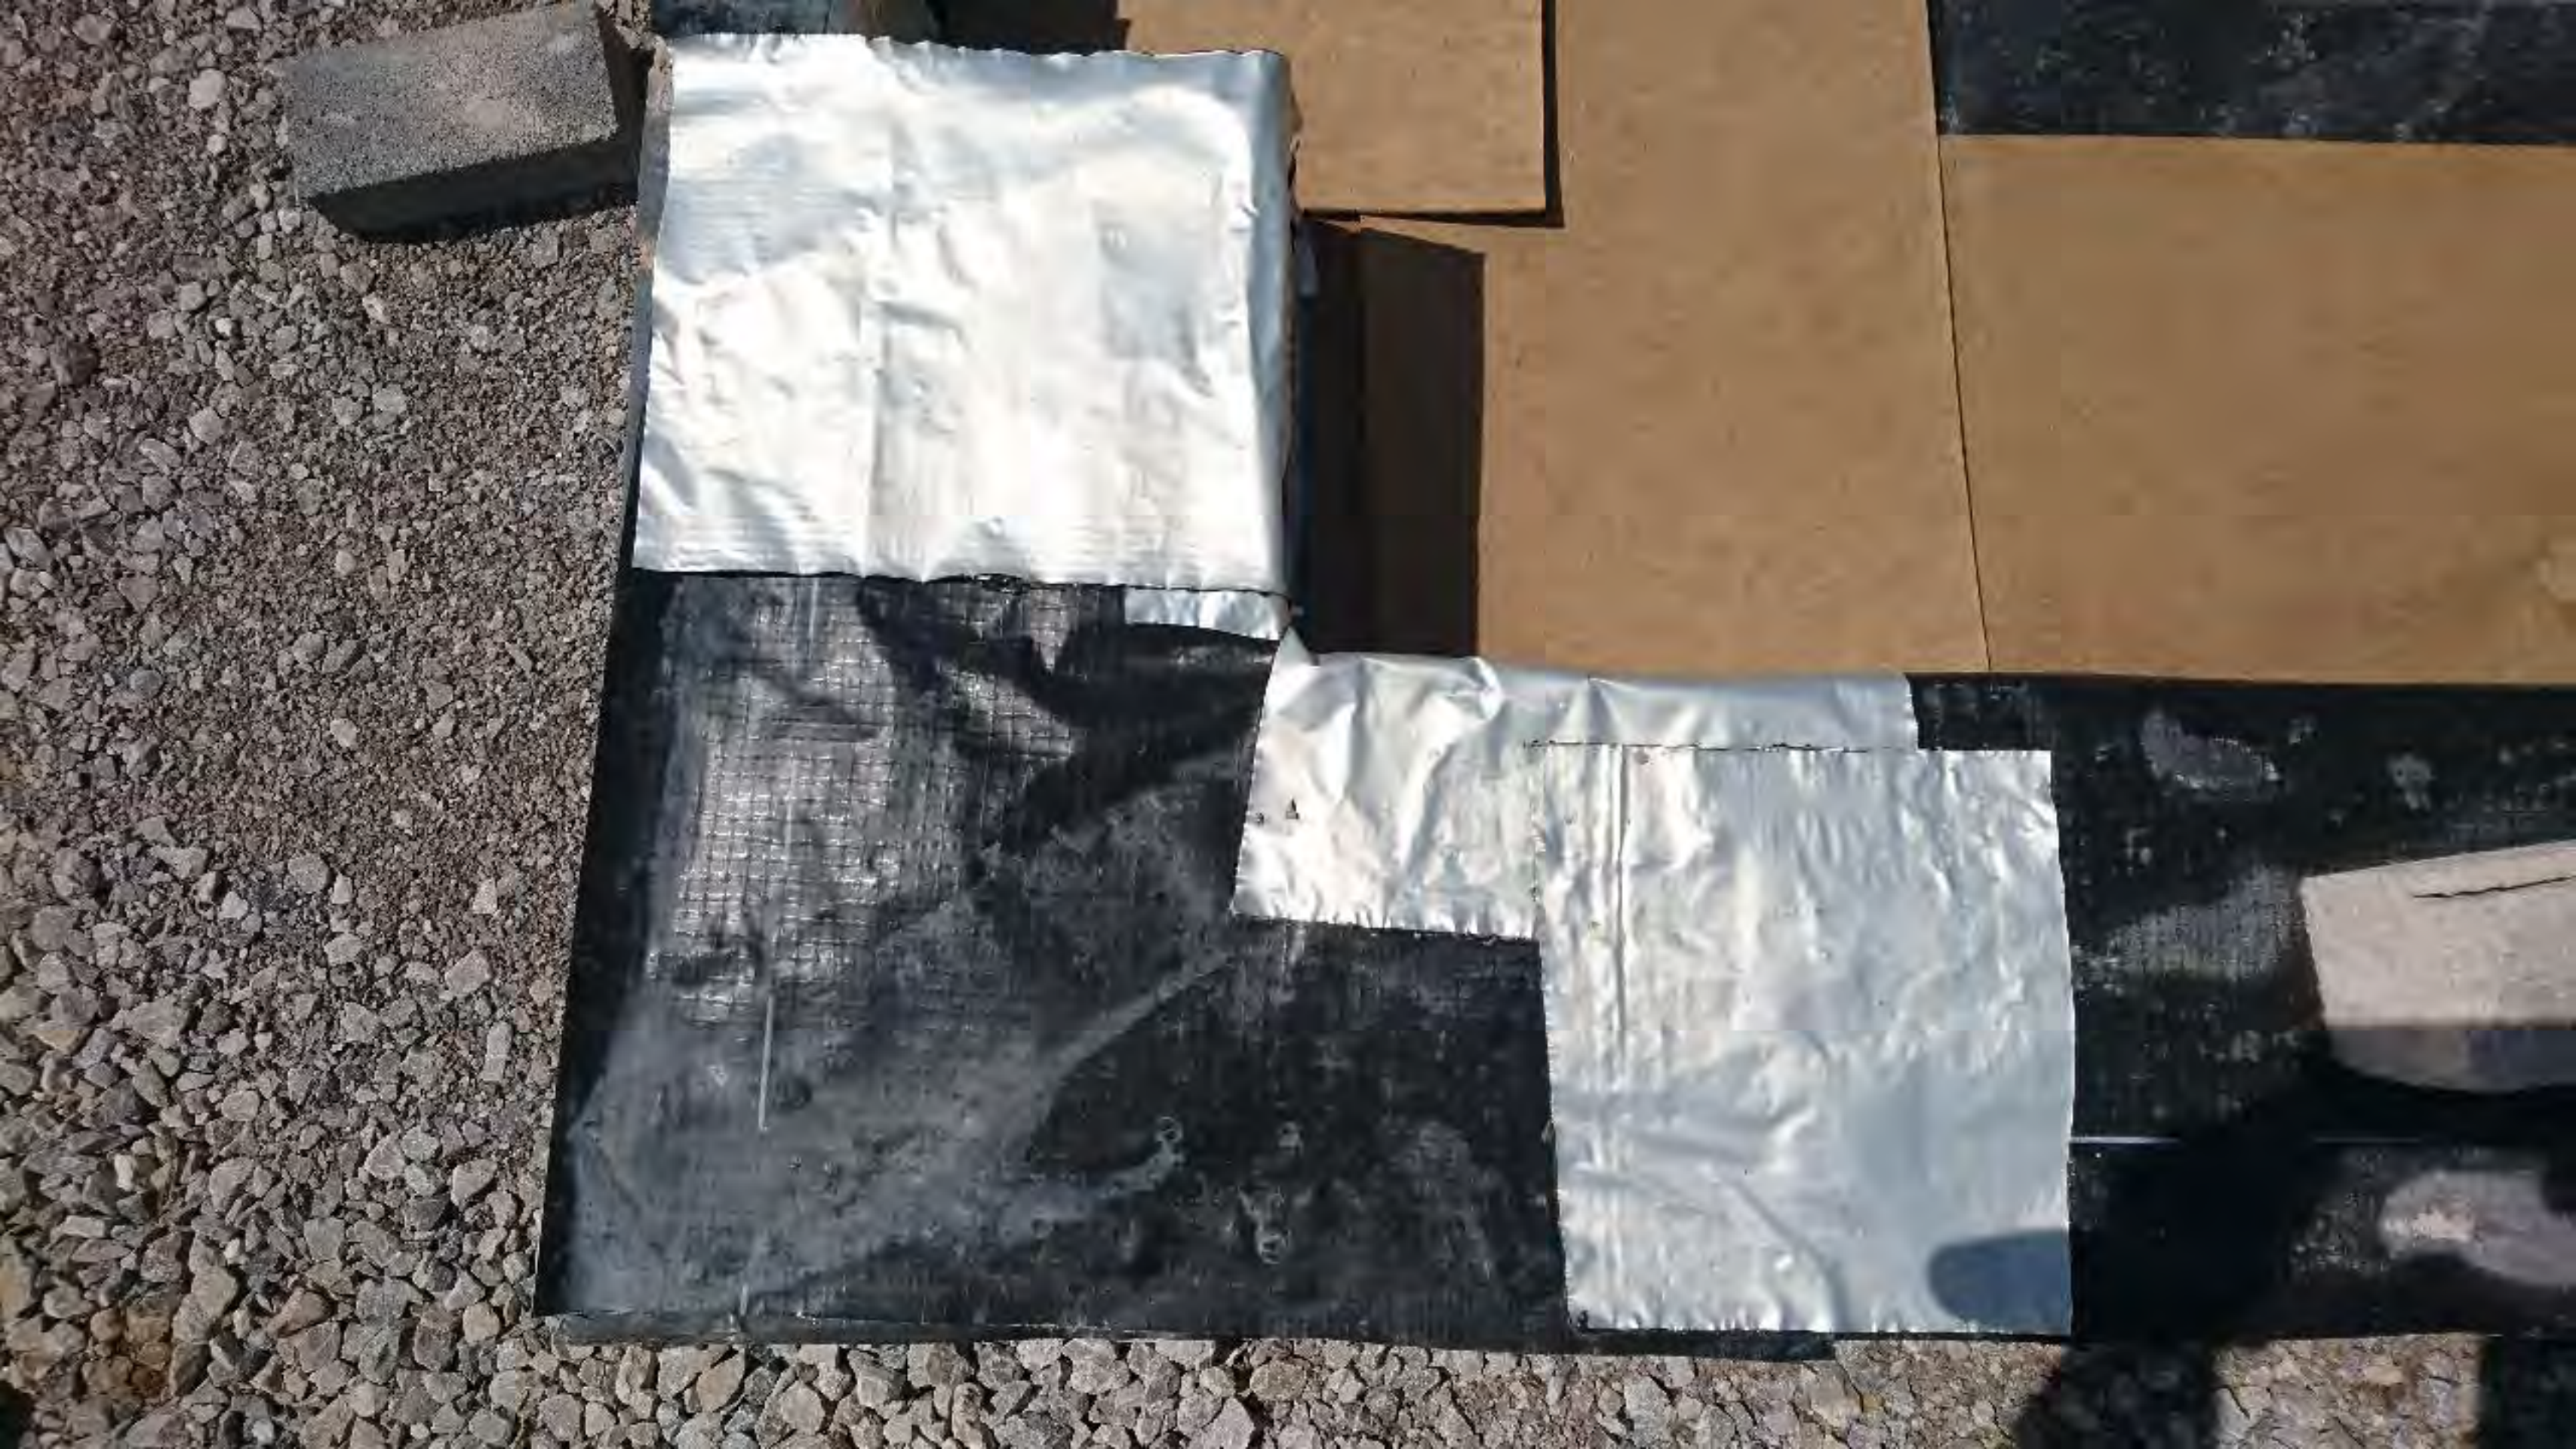
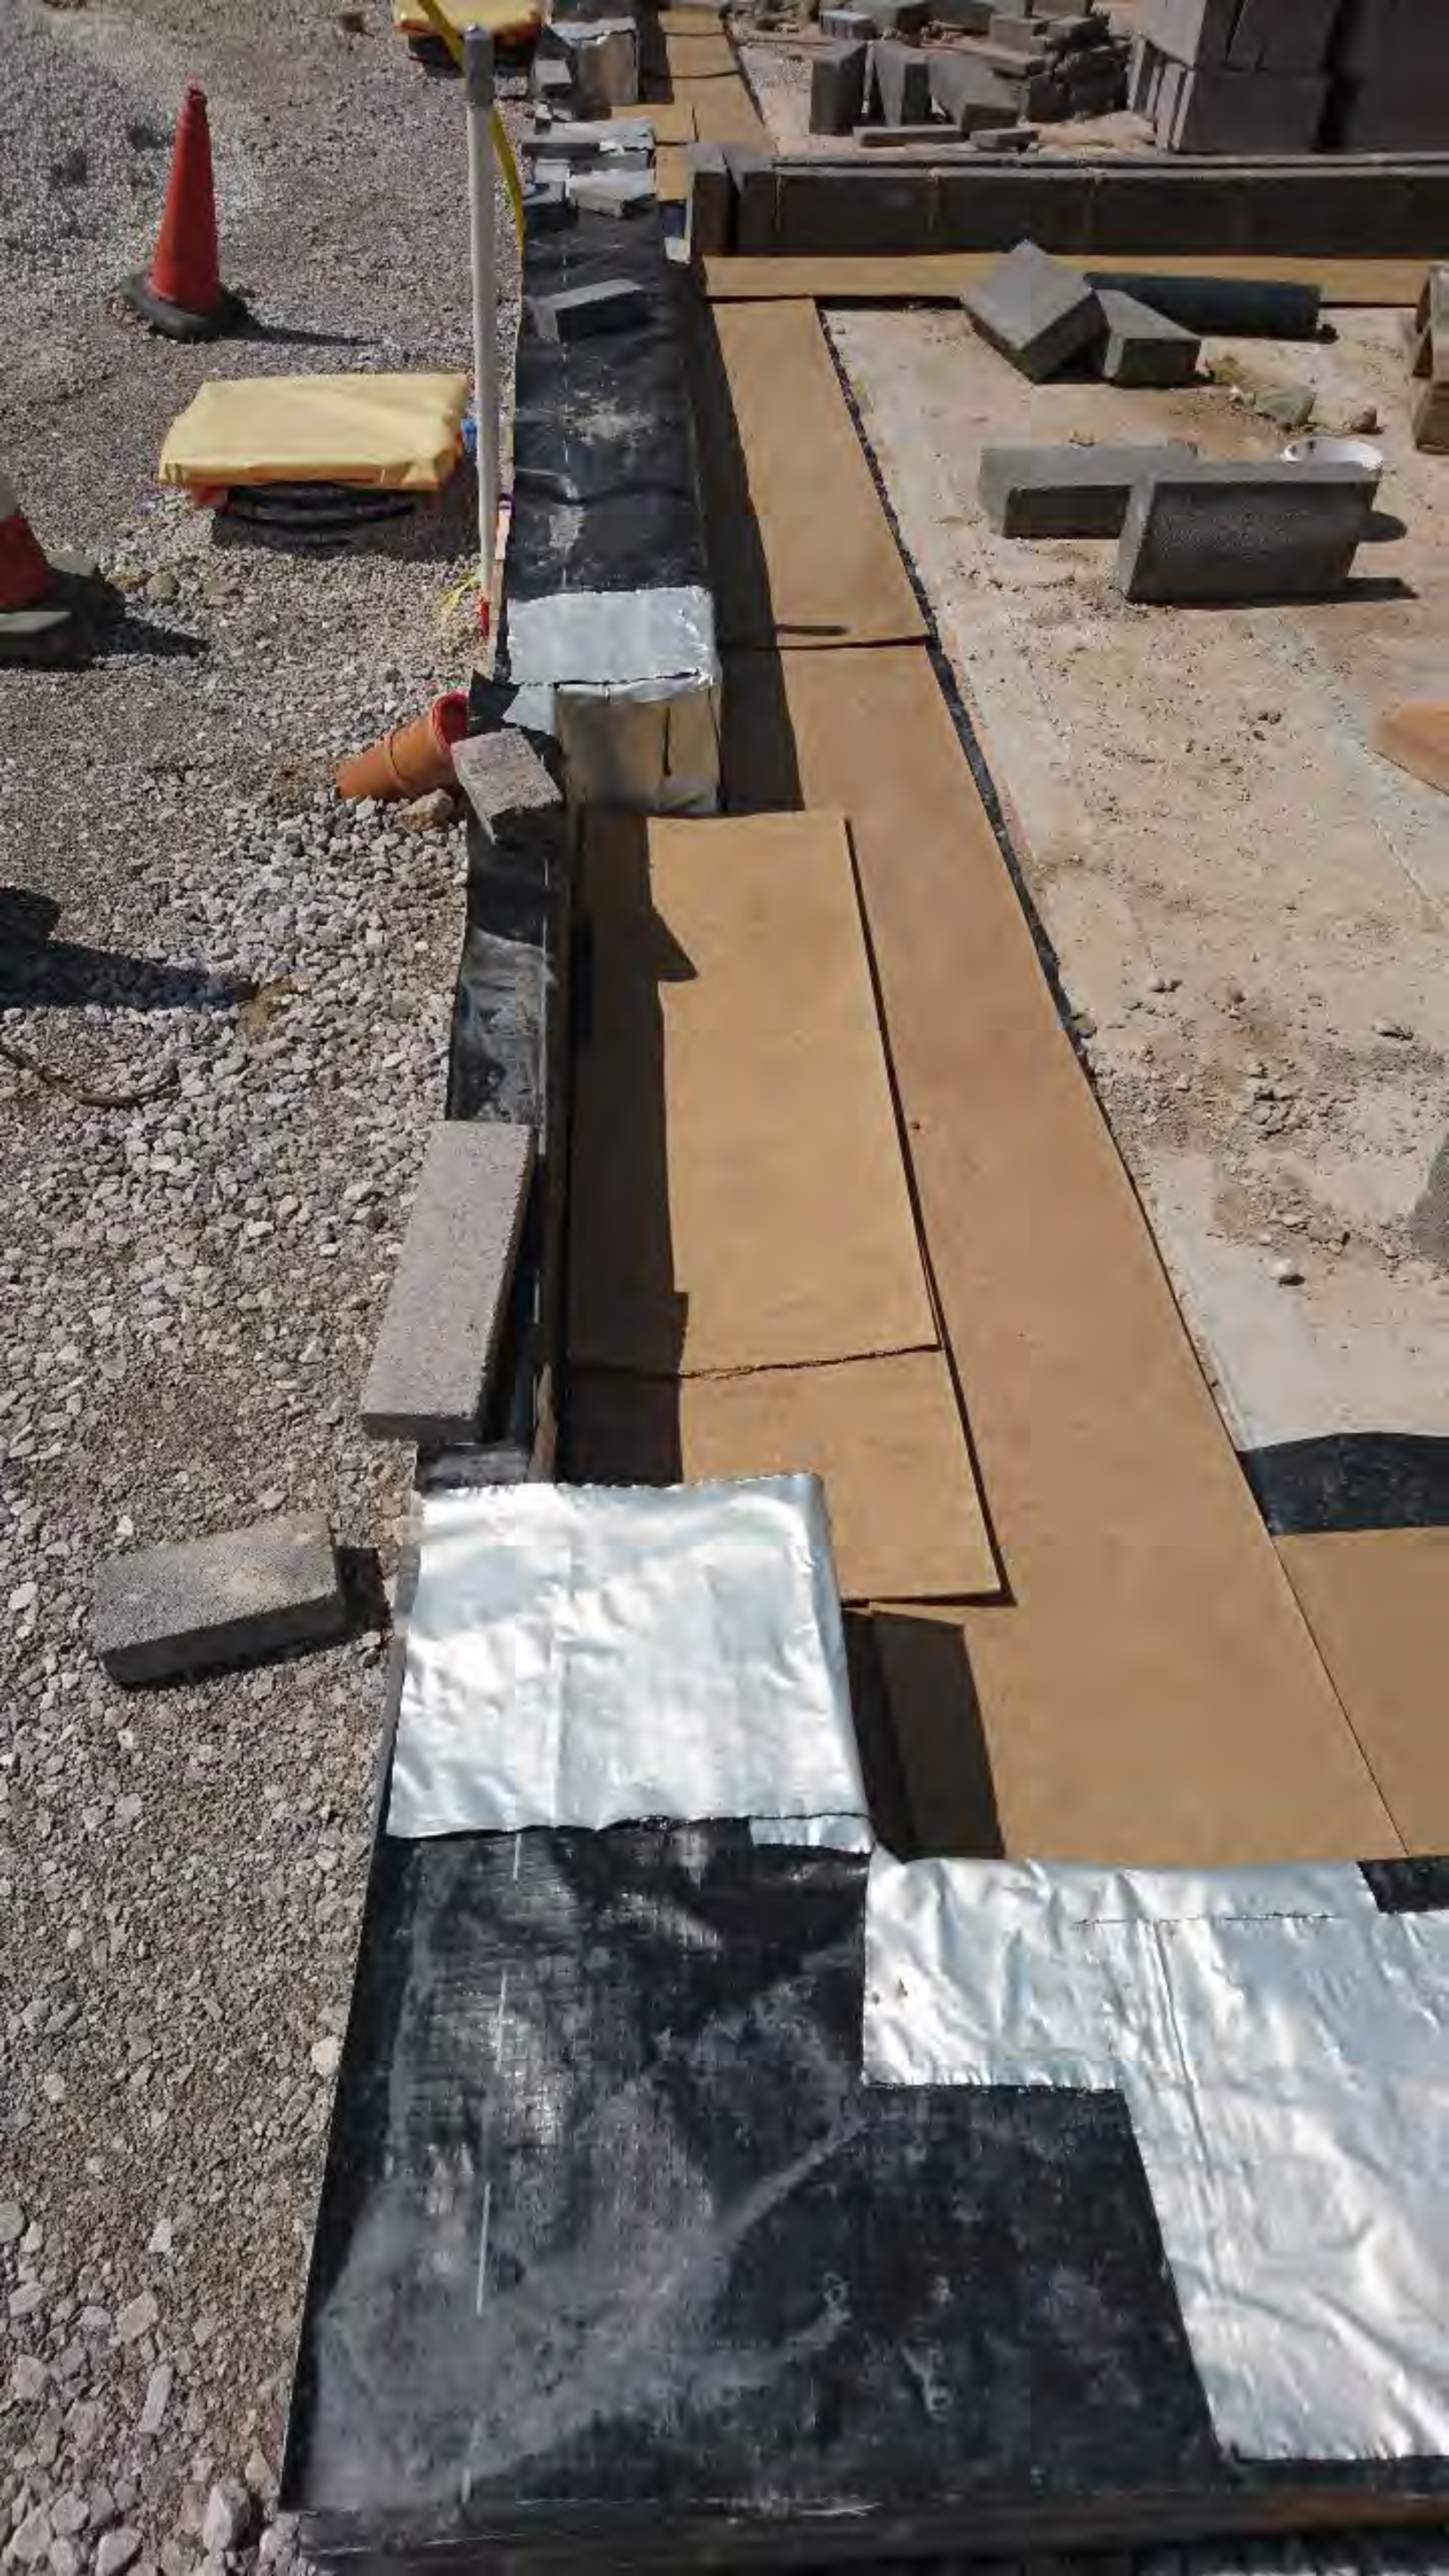
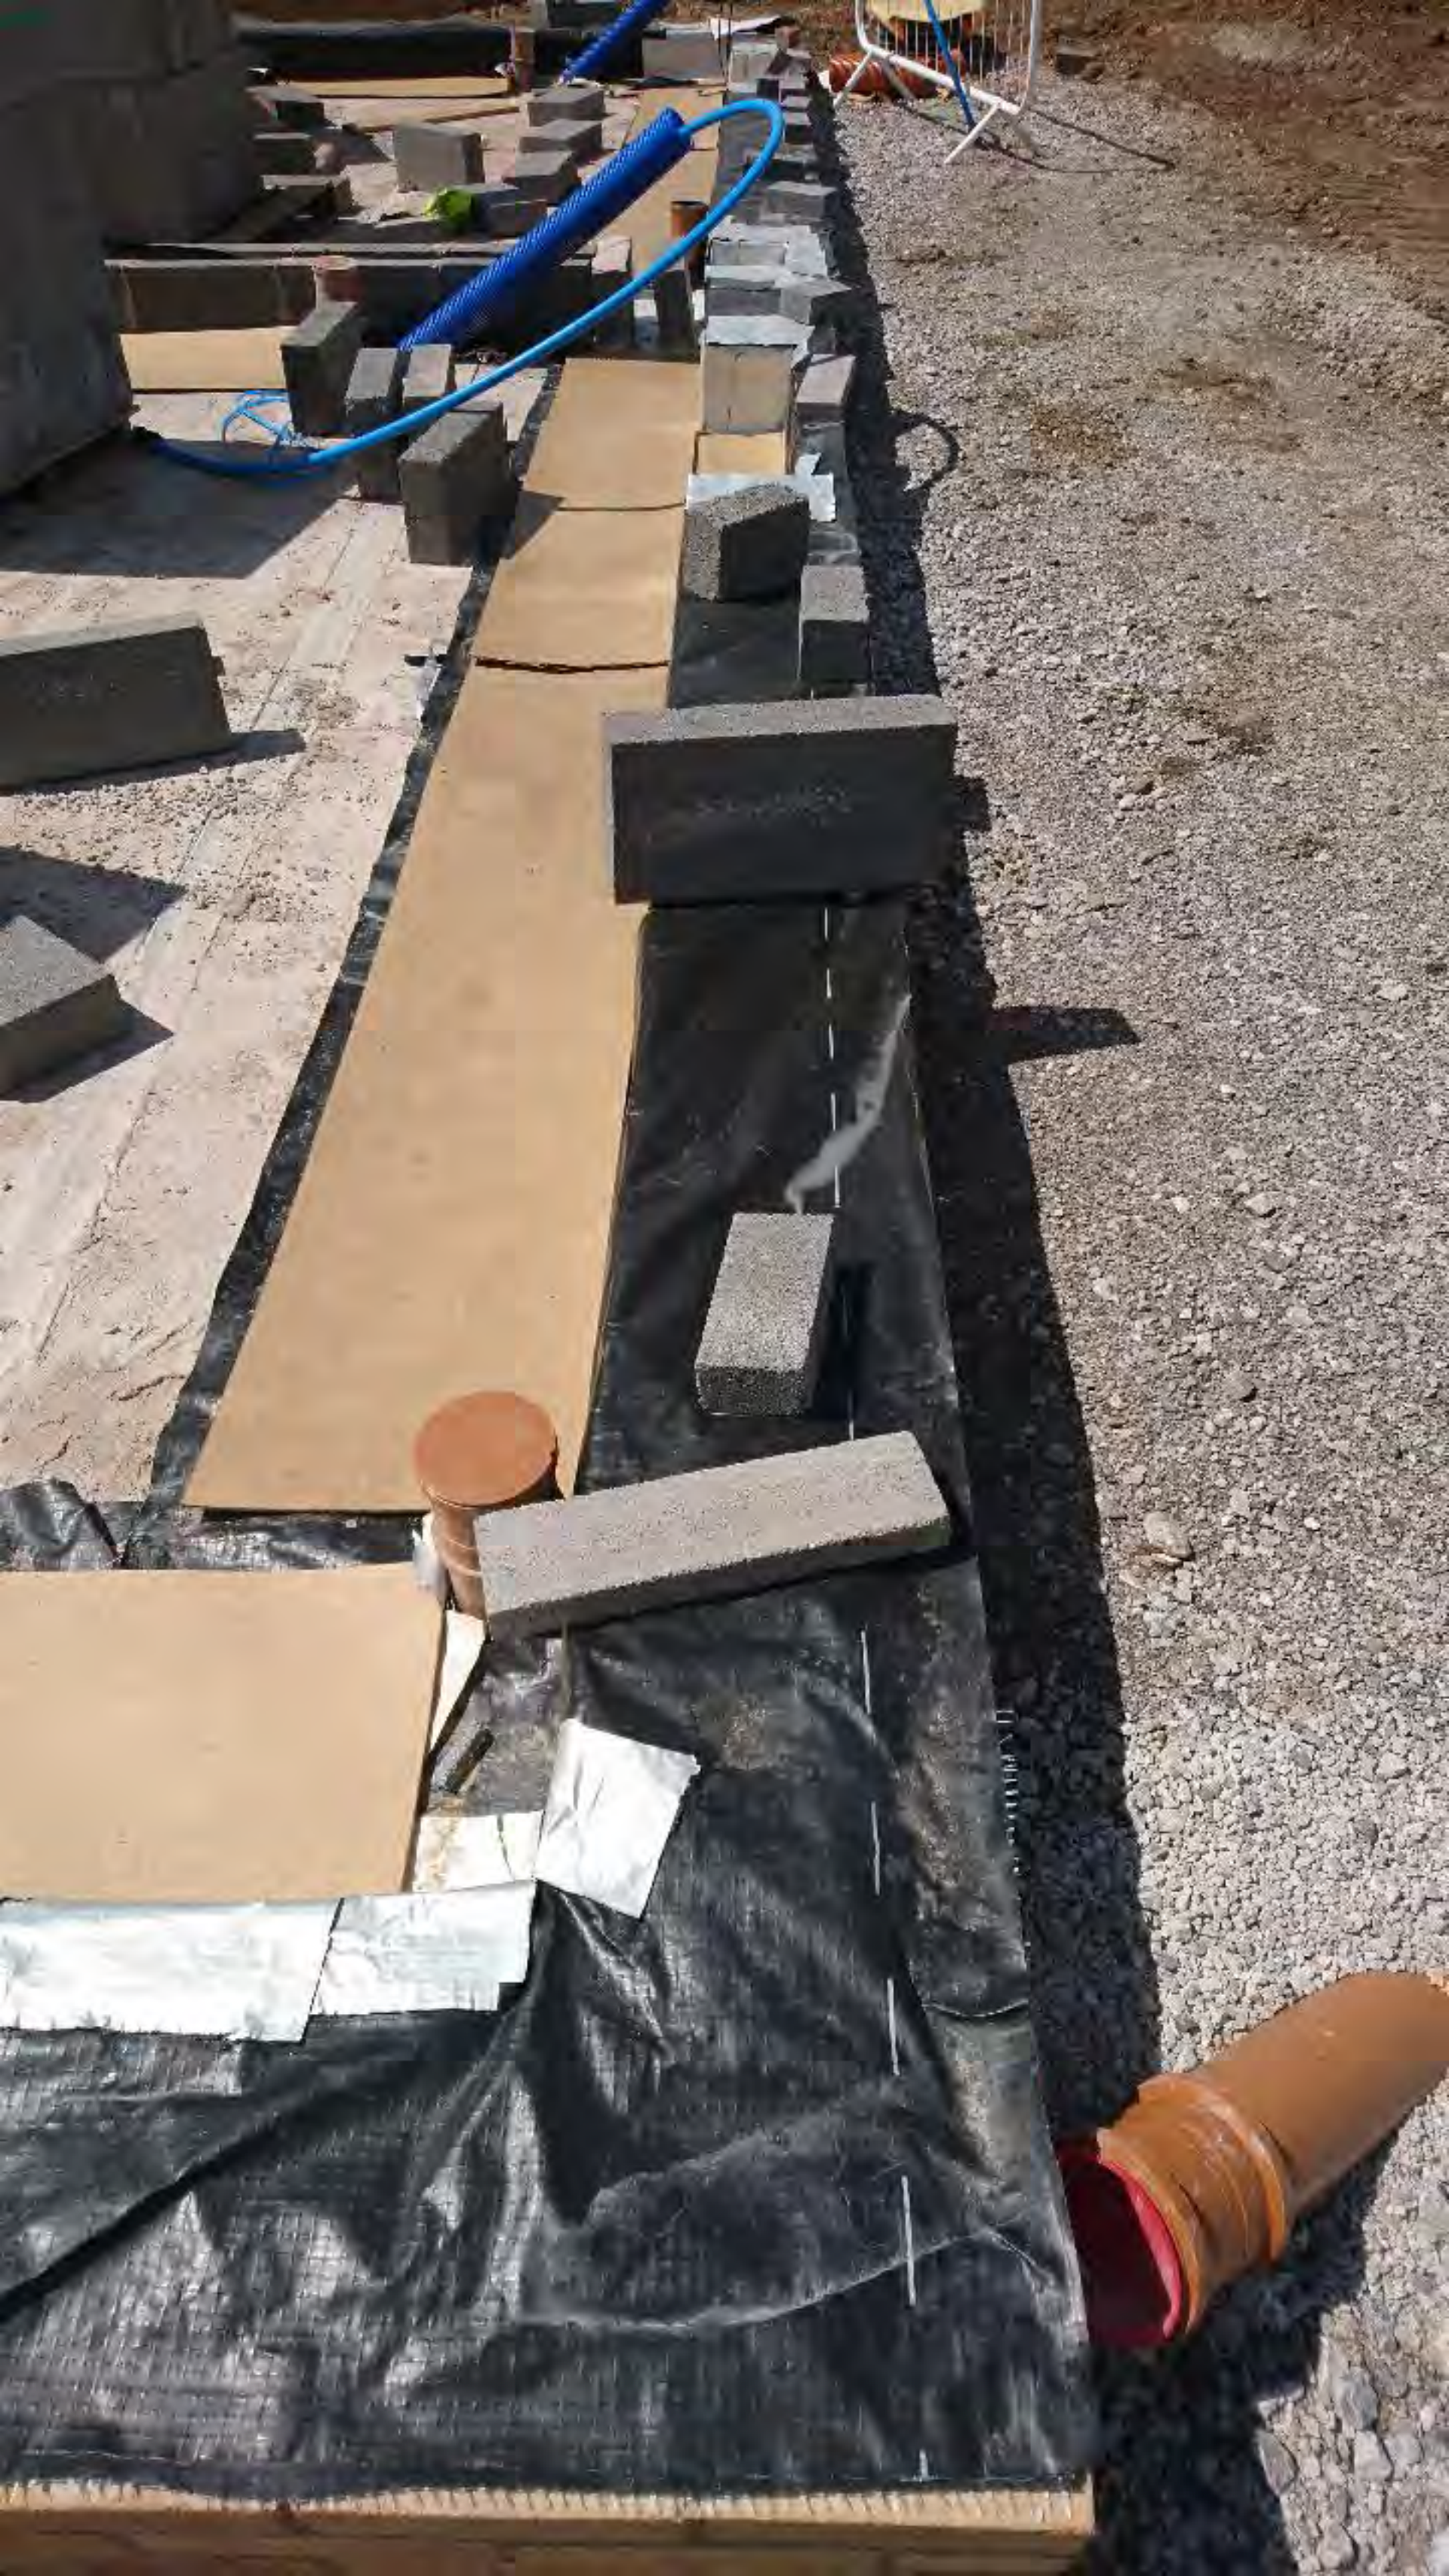
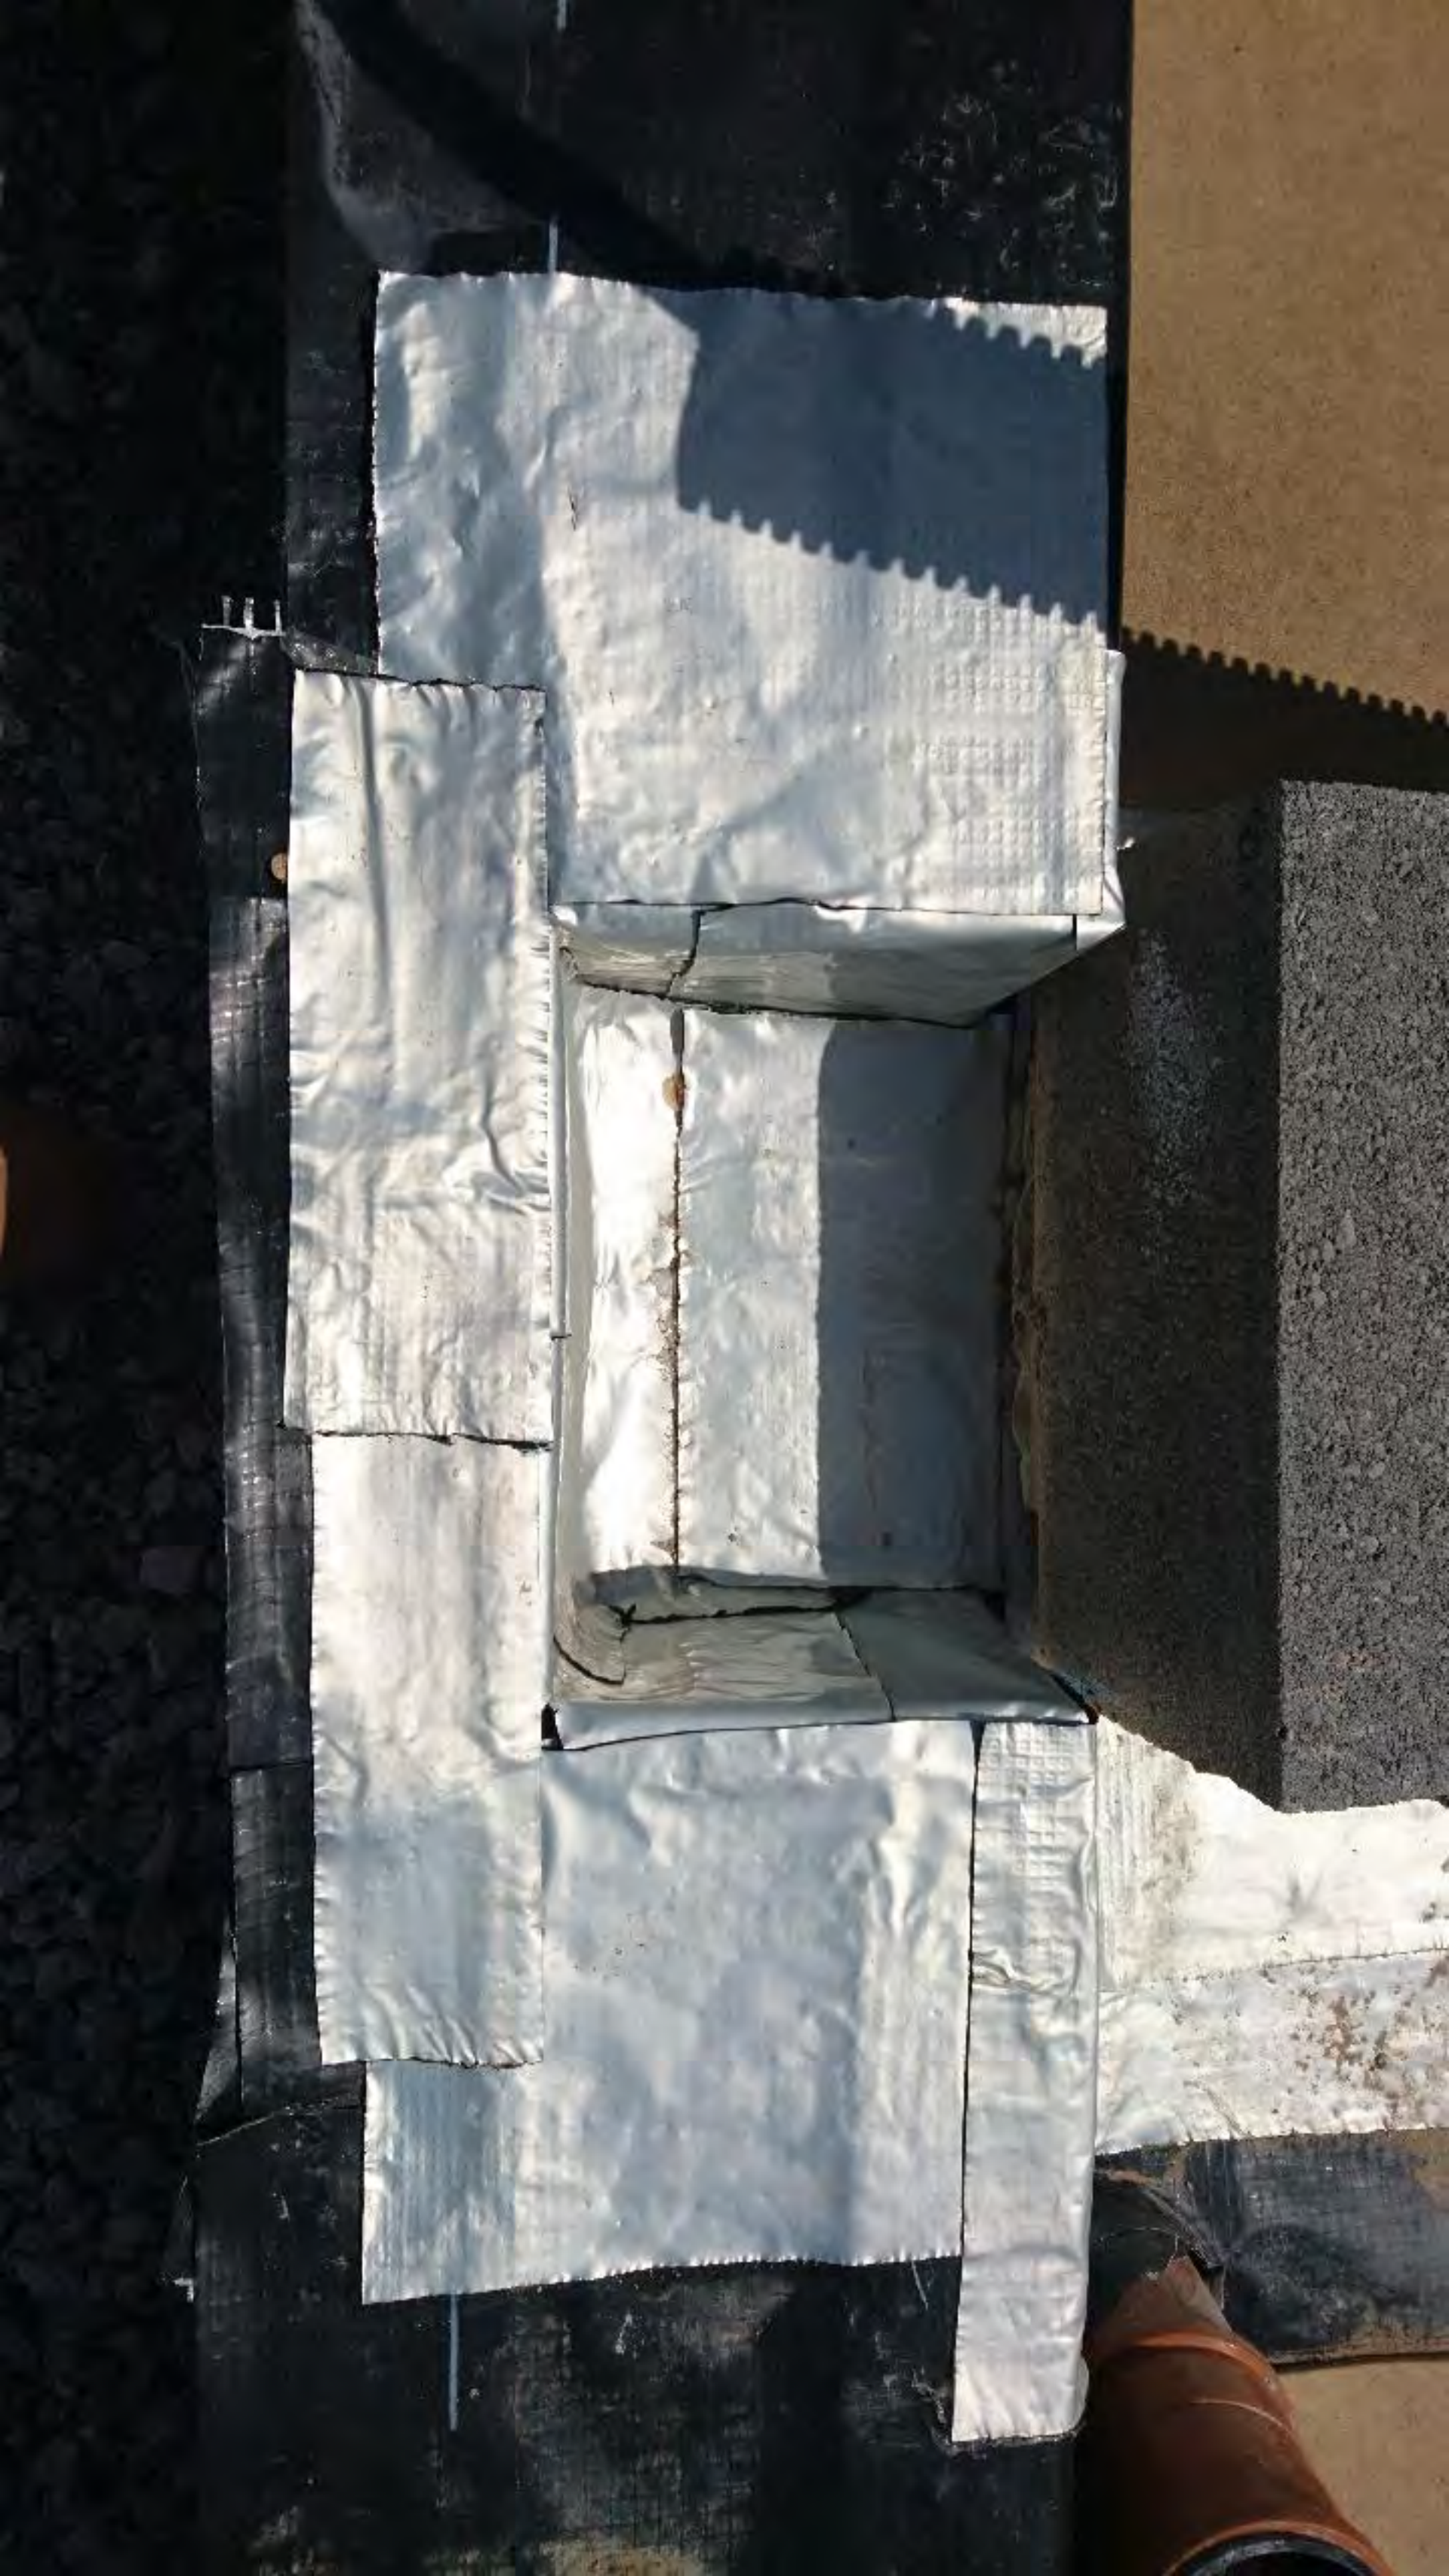
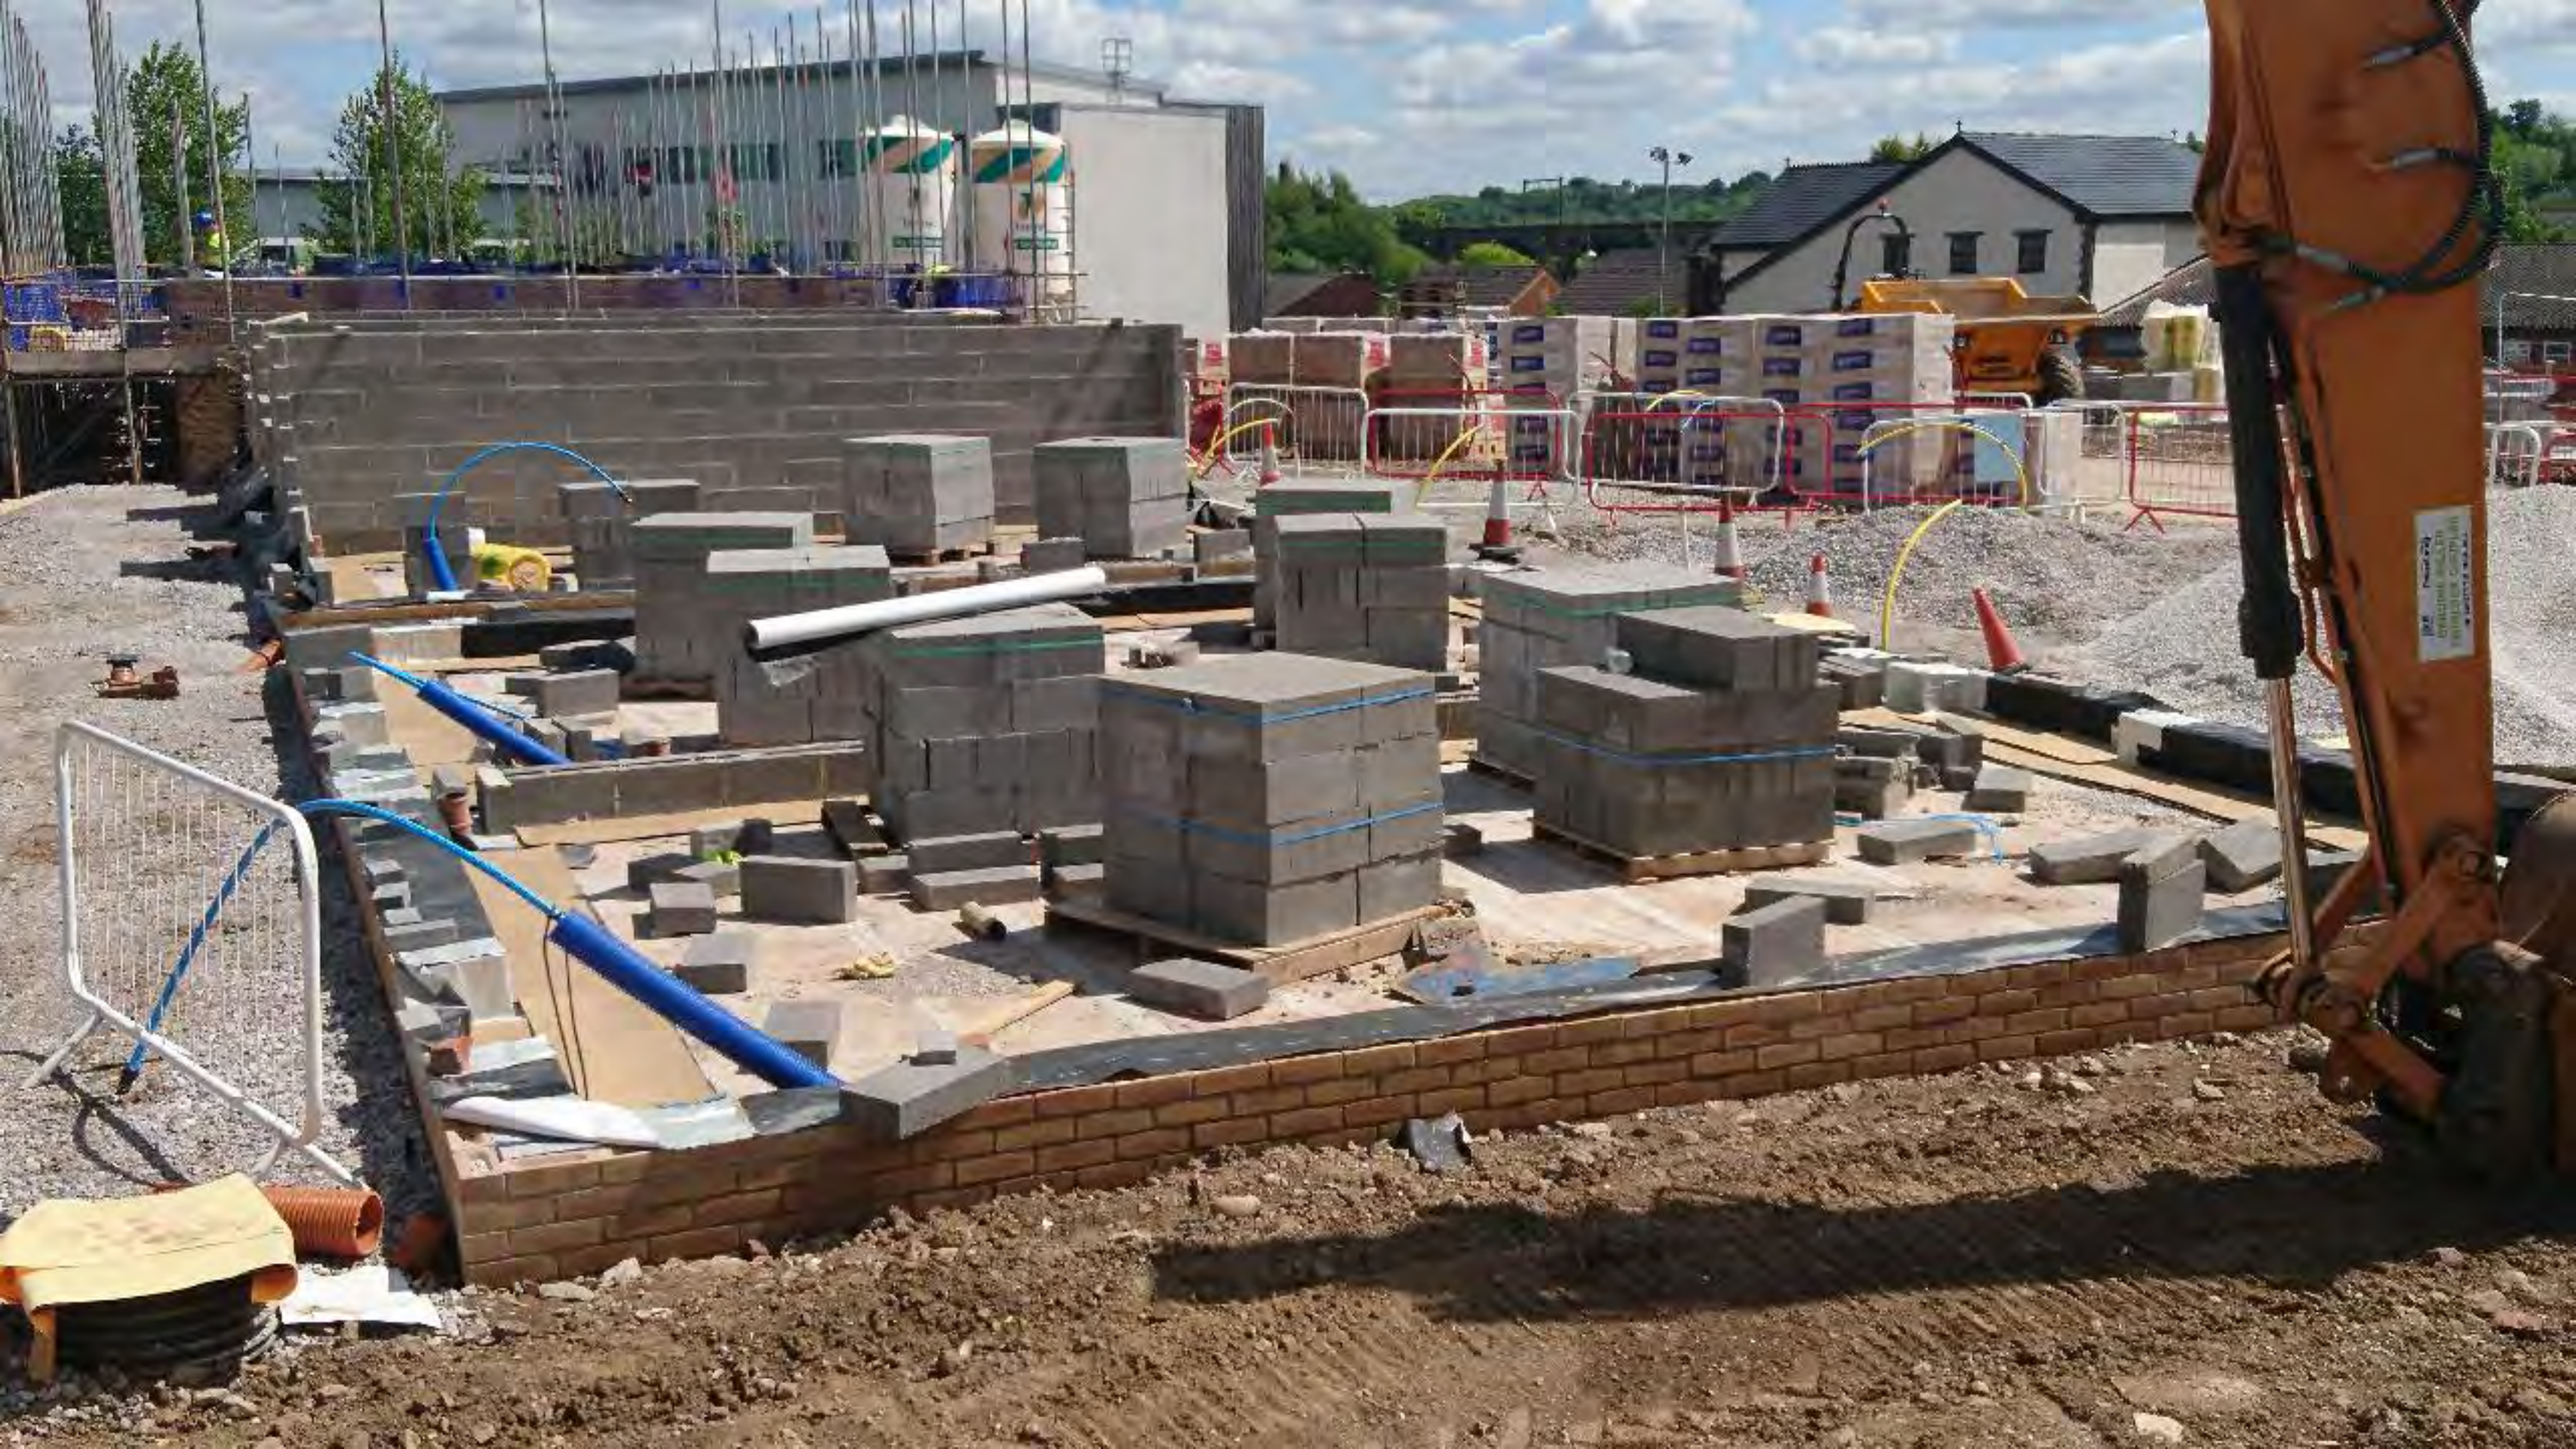
| 1.2 | External Wall Venting – cranked vent spacing | LESS THAN 2M – 1.8M |
| 2.2 | Condition of sub-grade & underside of gas membrane | ALL GOOD |
| 2.7 | Condition of joints/seals | ALL OK – 150mm OVERLAPS |
| 2.9 | Membrane steps/corner seals | GENERALLY ALL GOOD AND TIDY |
