This Record sheet is only applicable to block and beam floor slabs for Characteristic Situation 2 gas protection systems

Plot No.: 2

For Residential Development at New Church Street, Radcliffe.

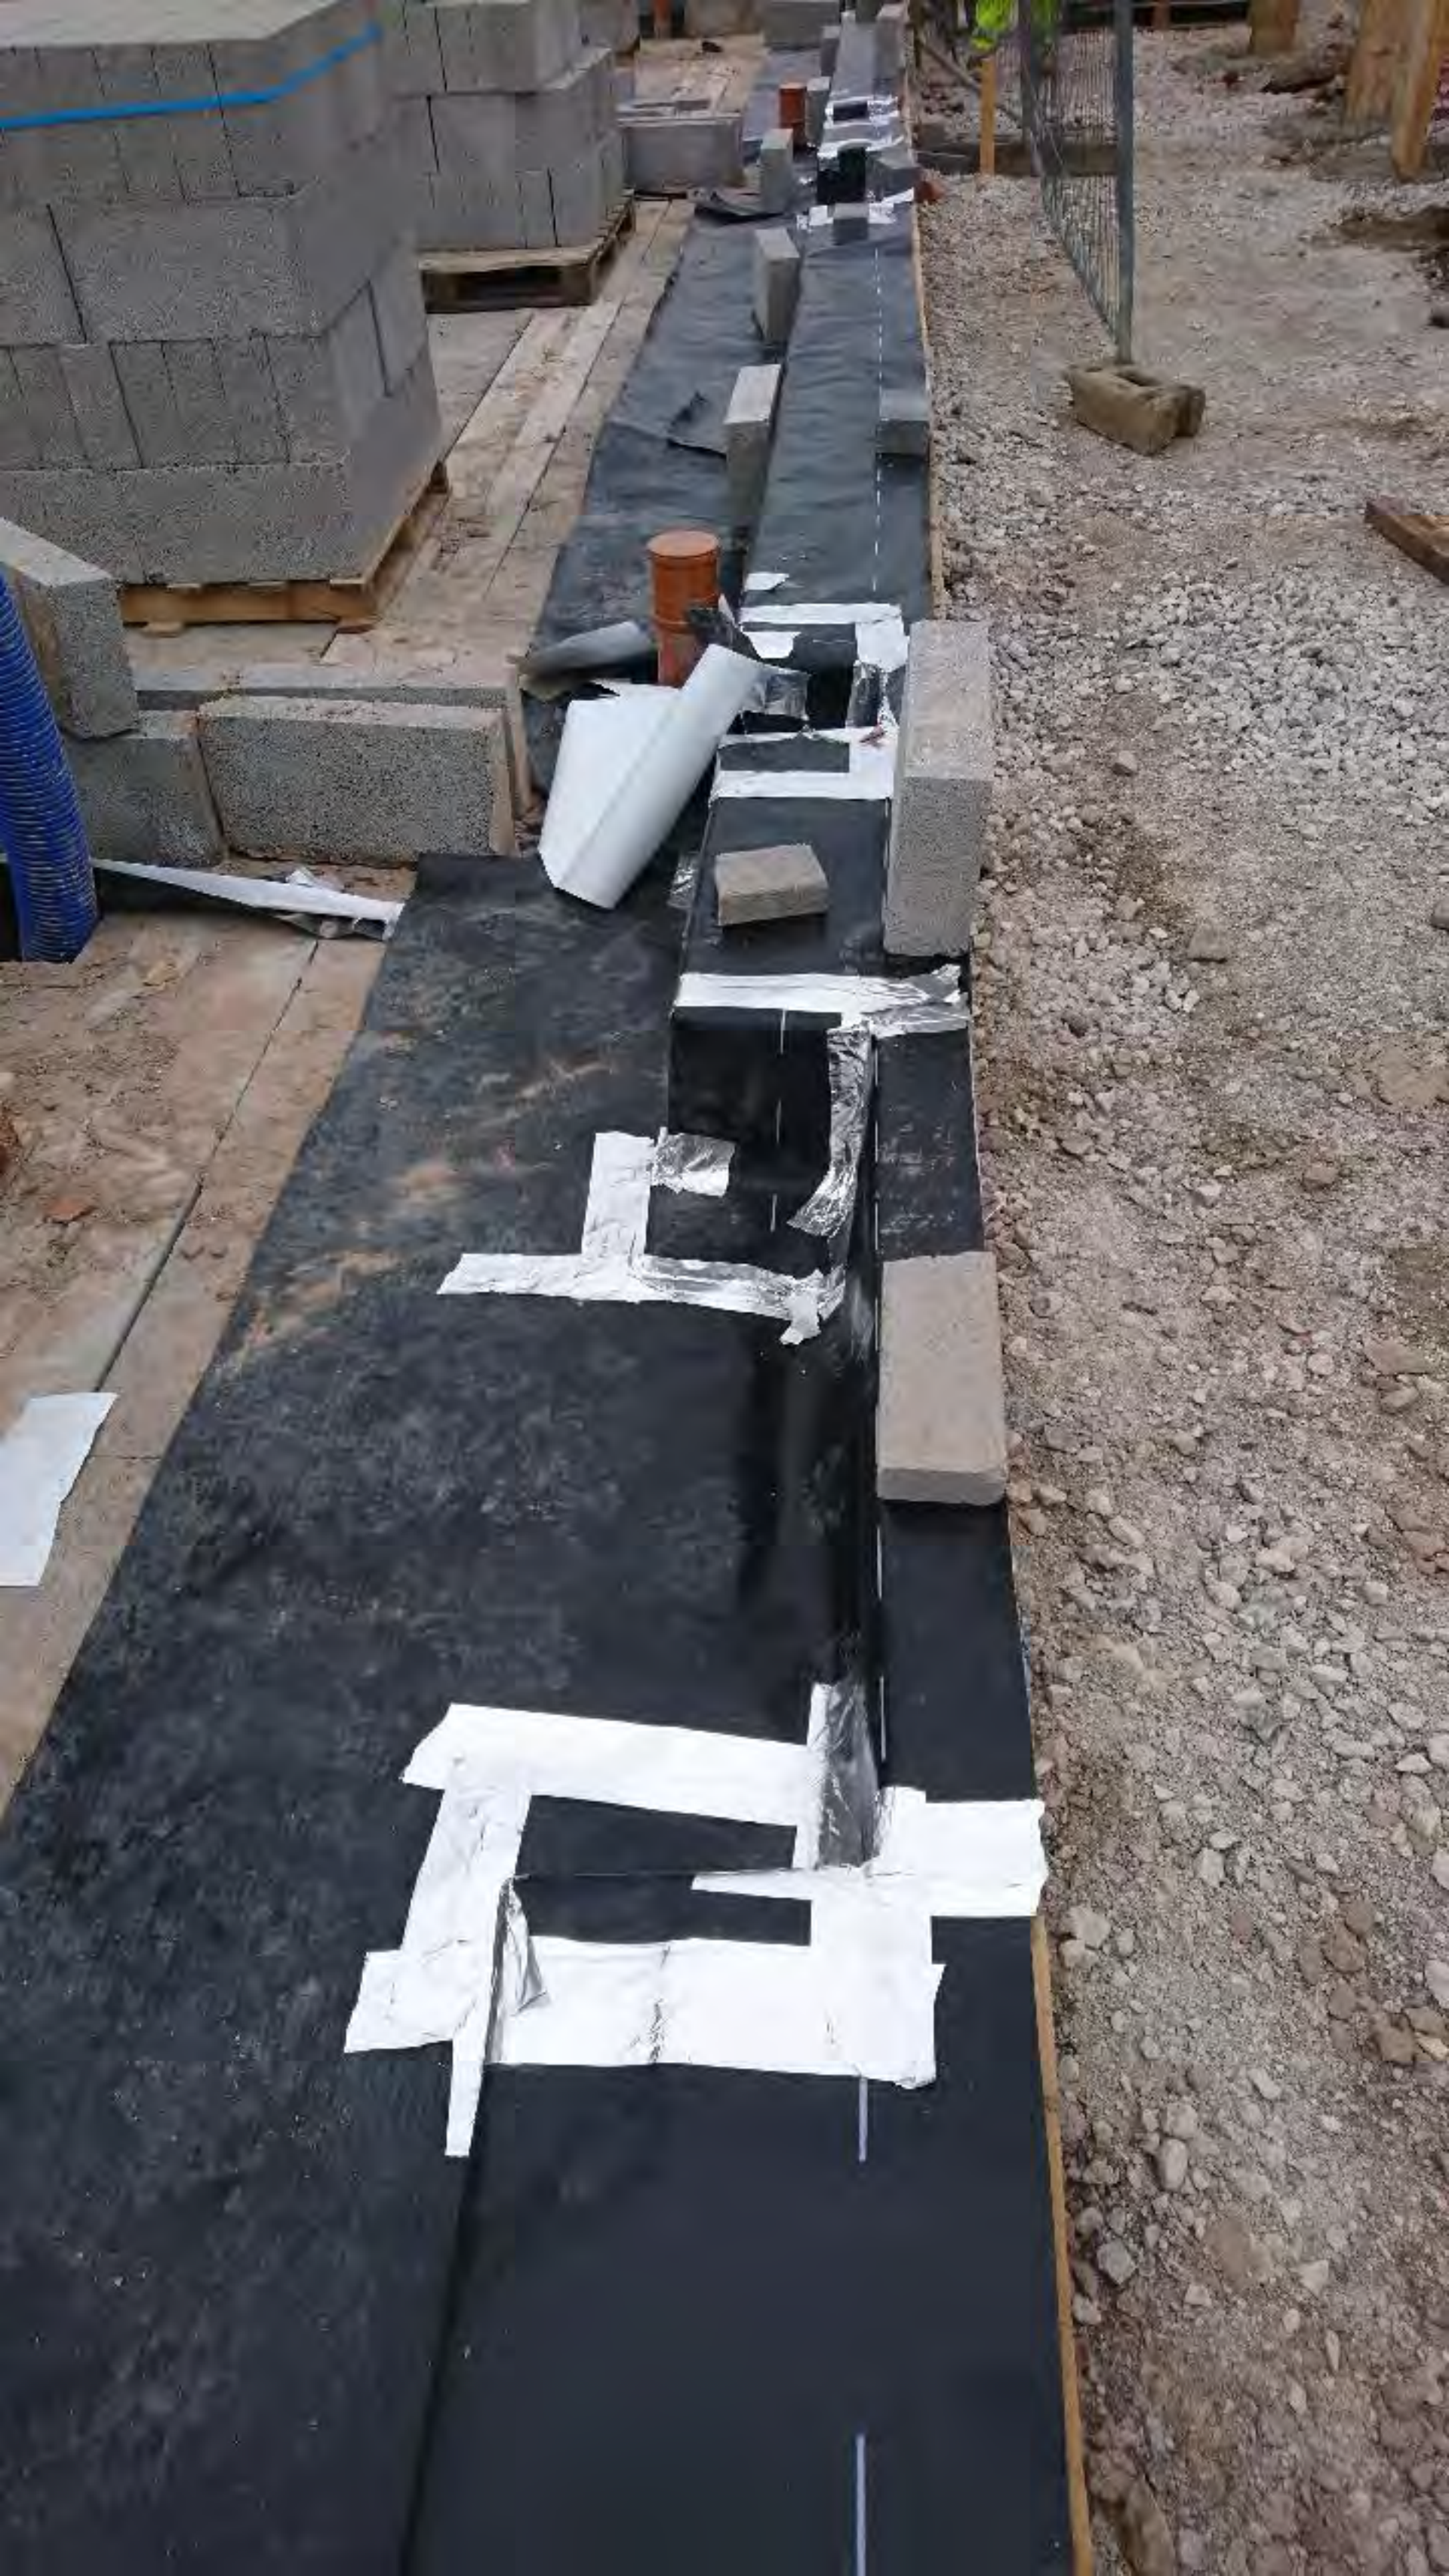
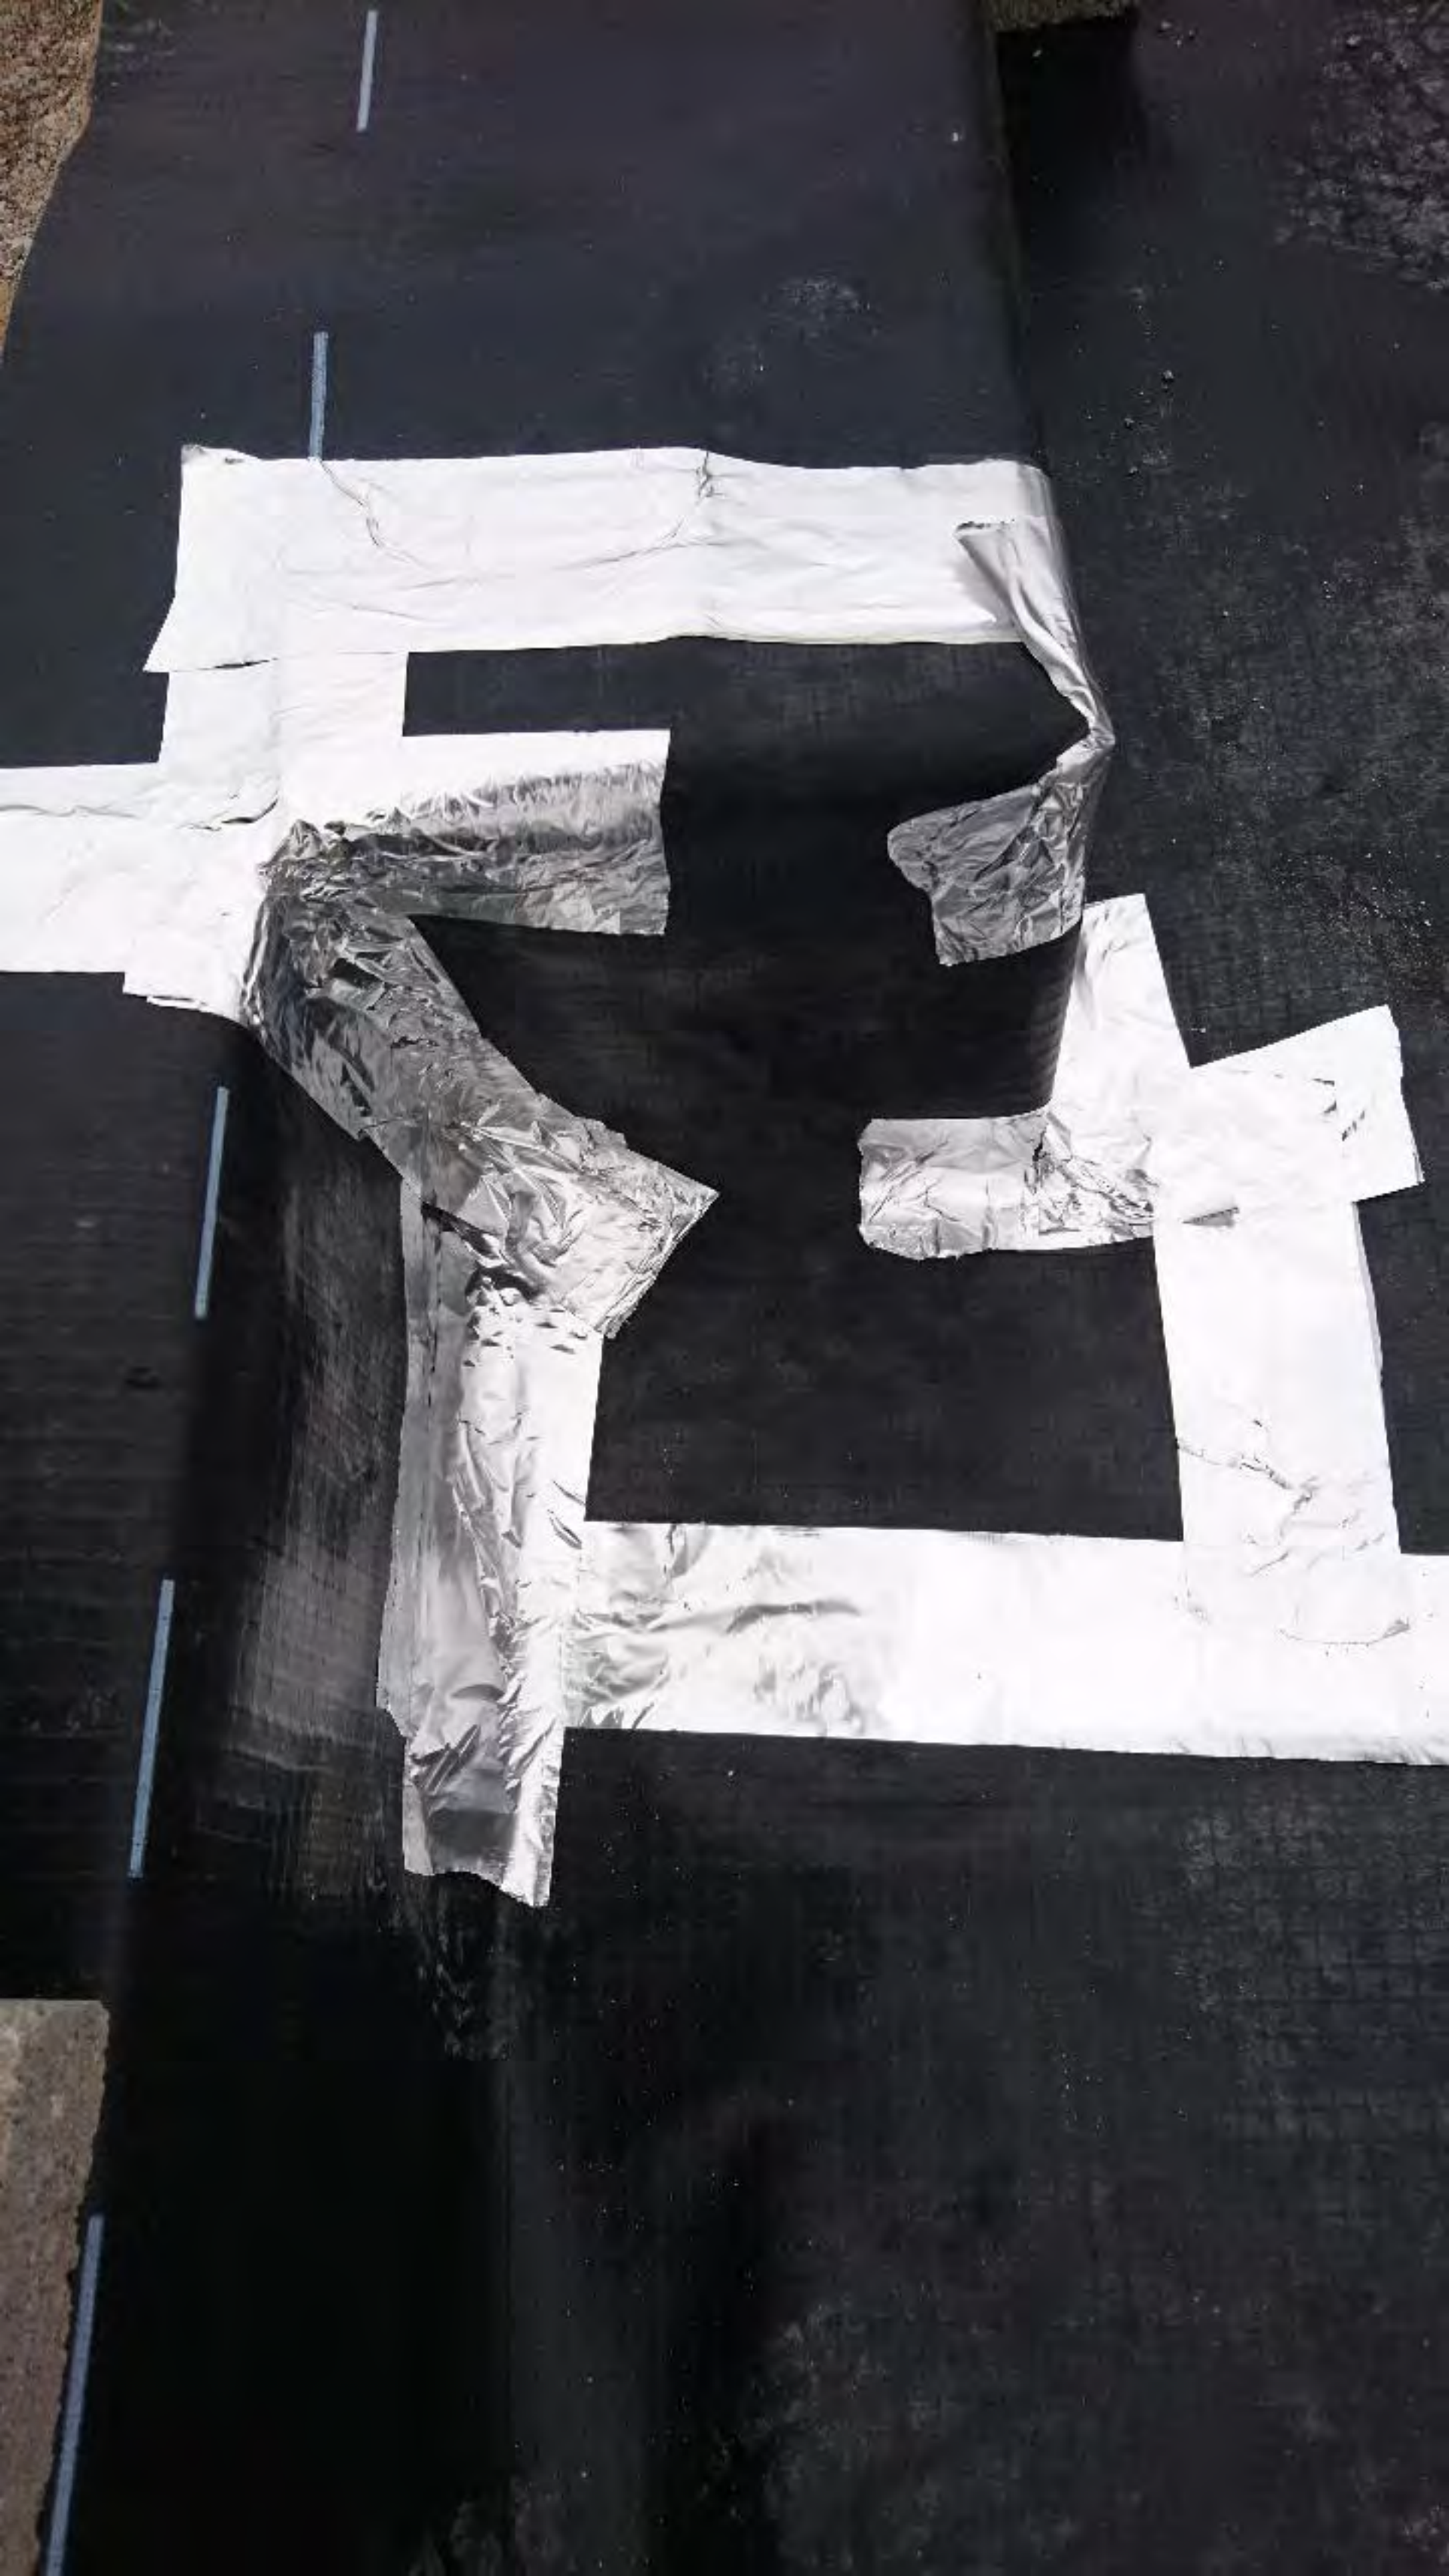
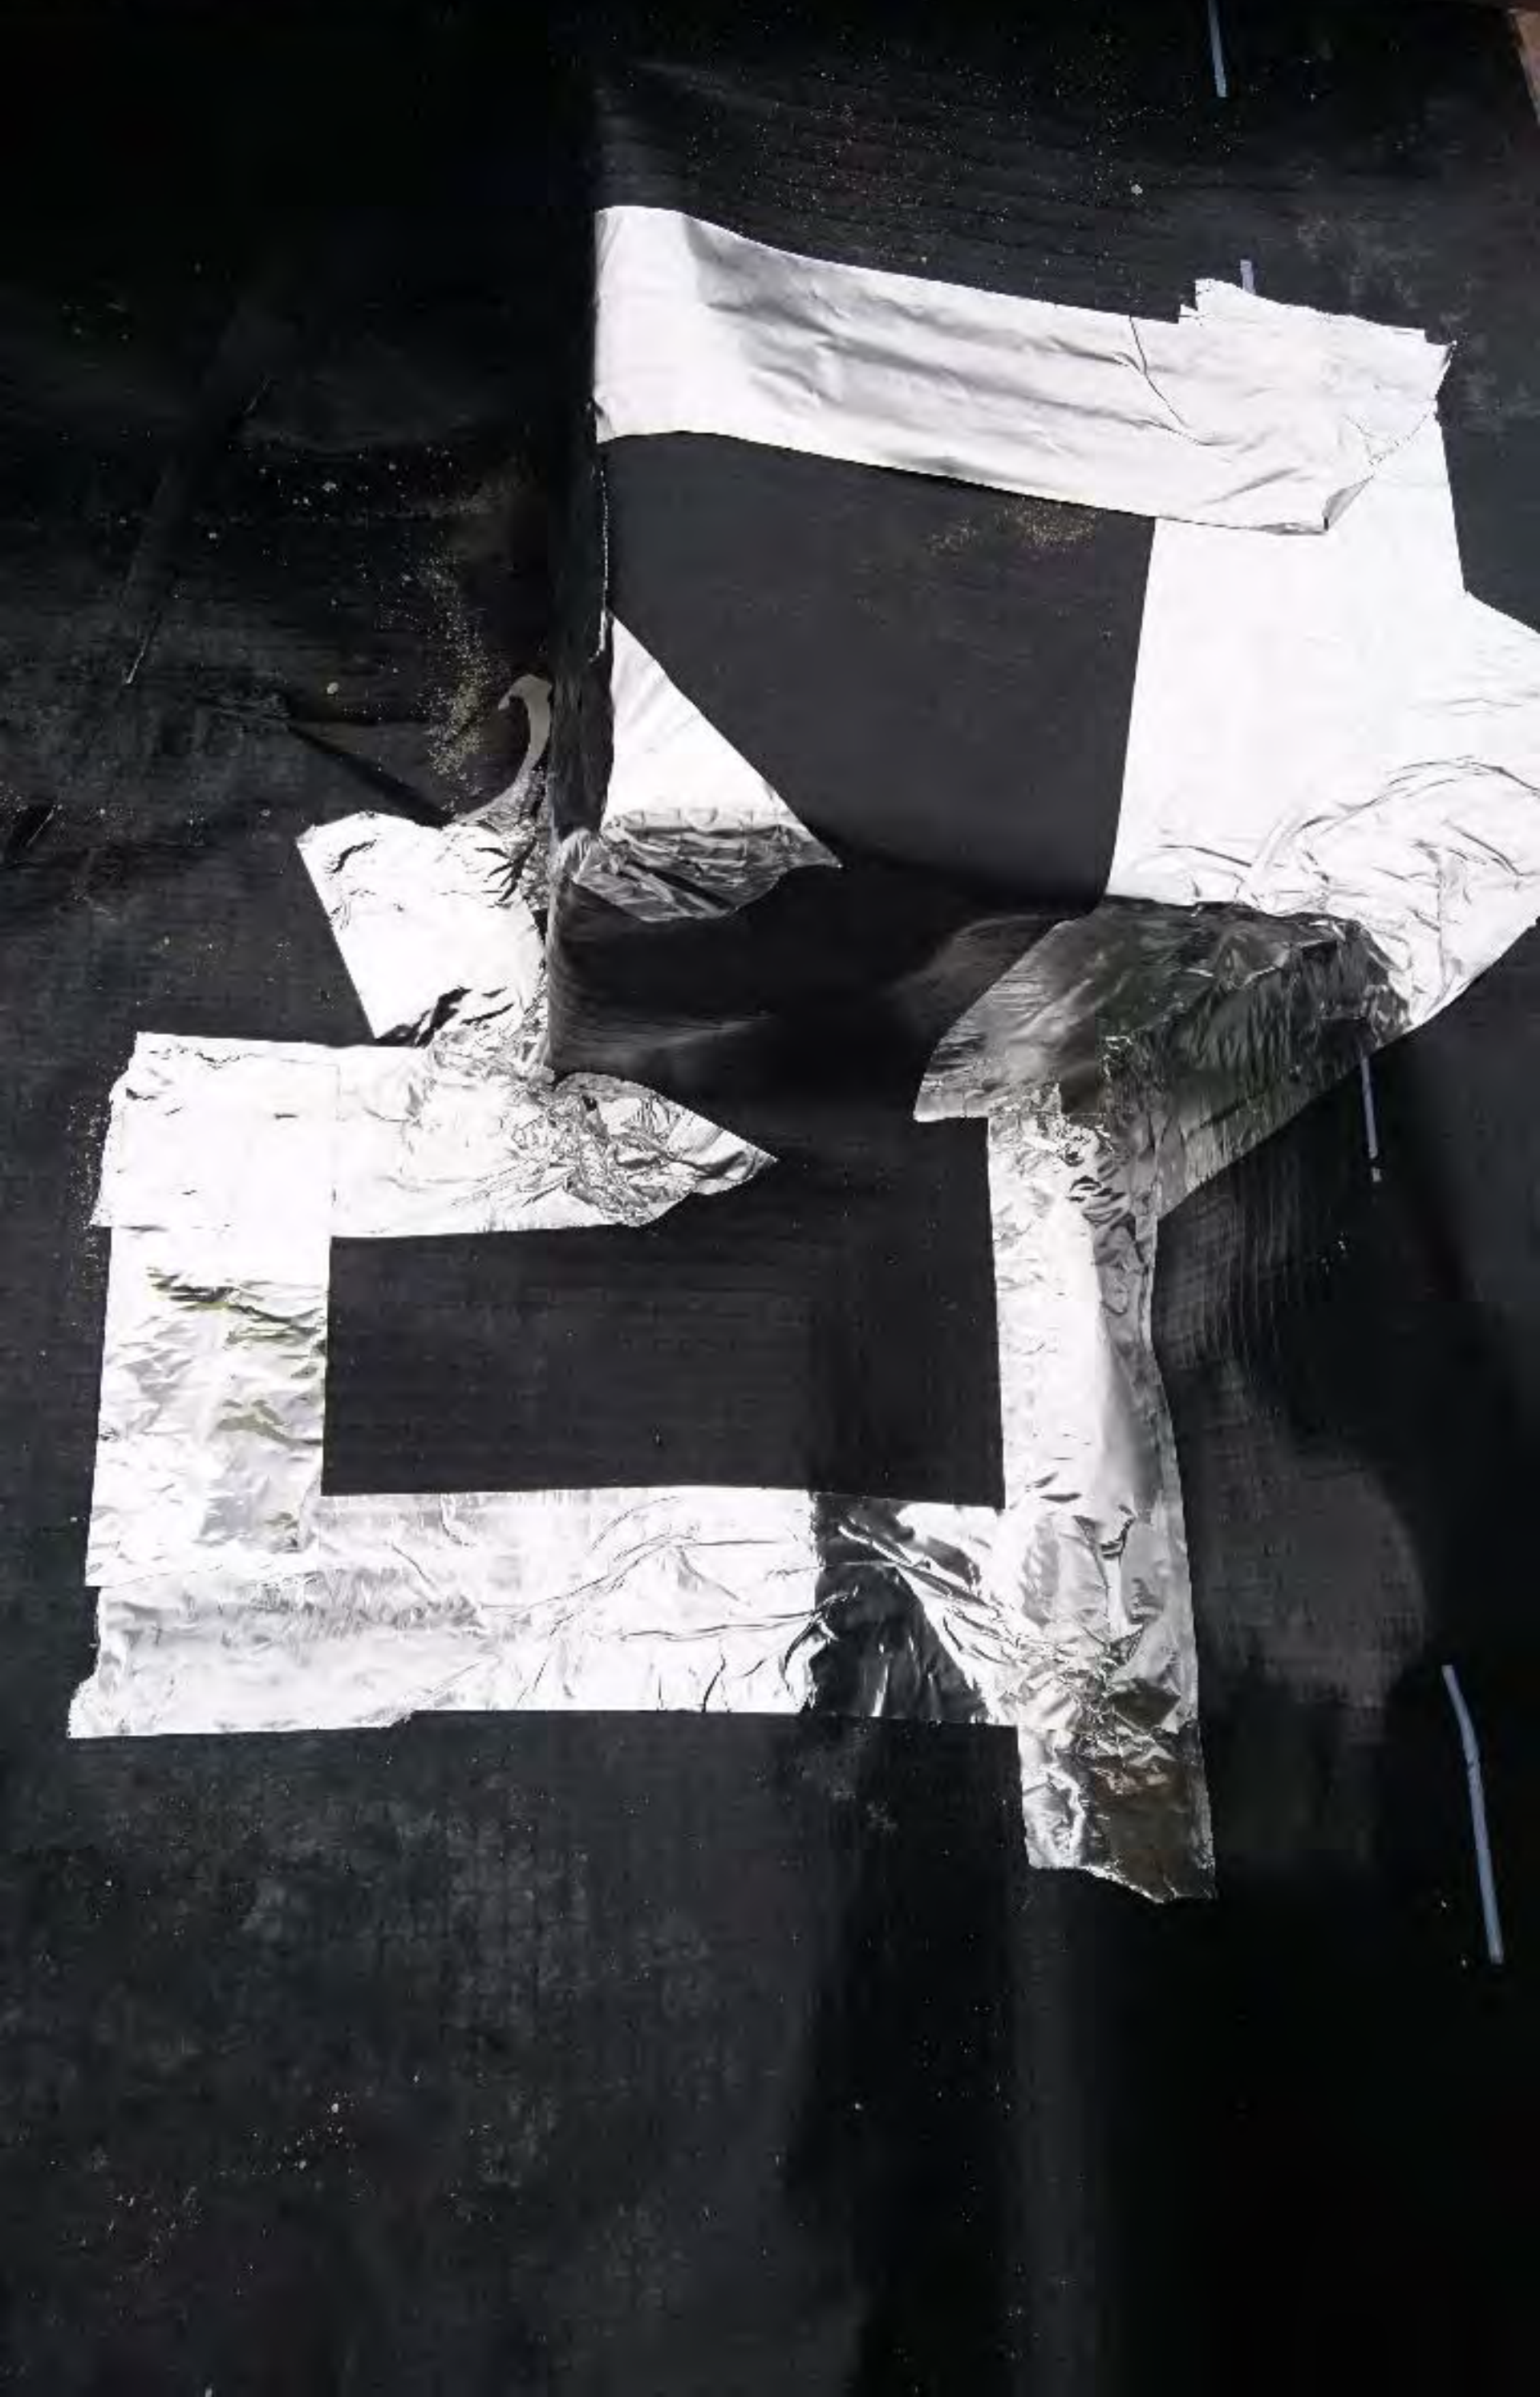
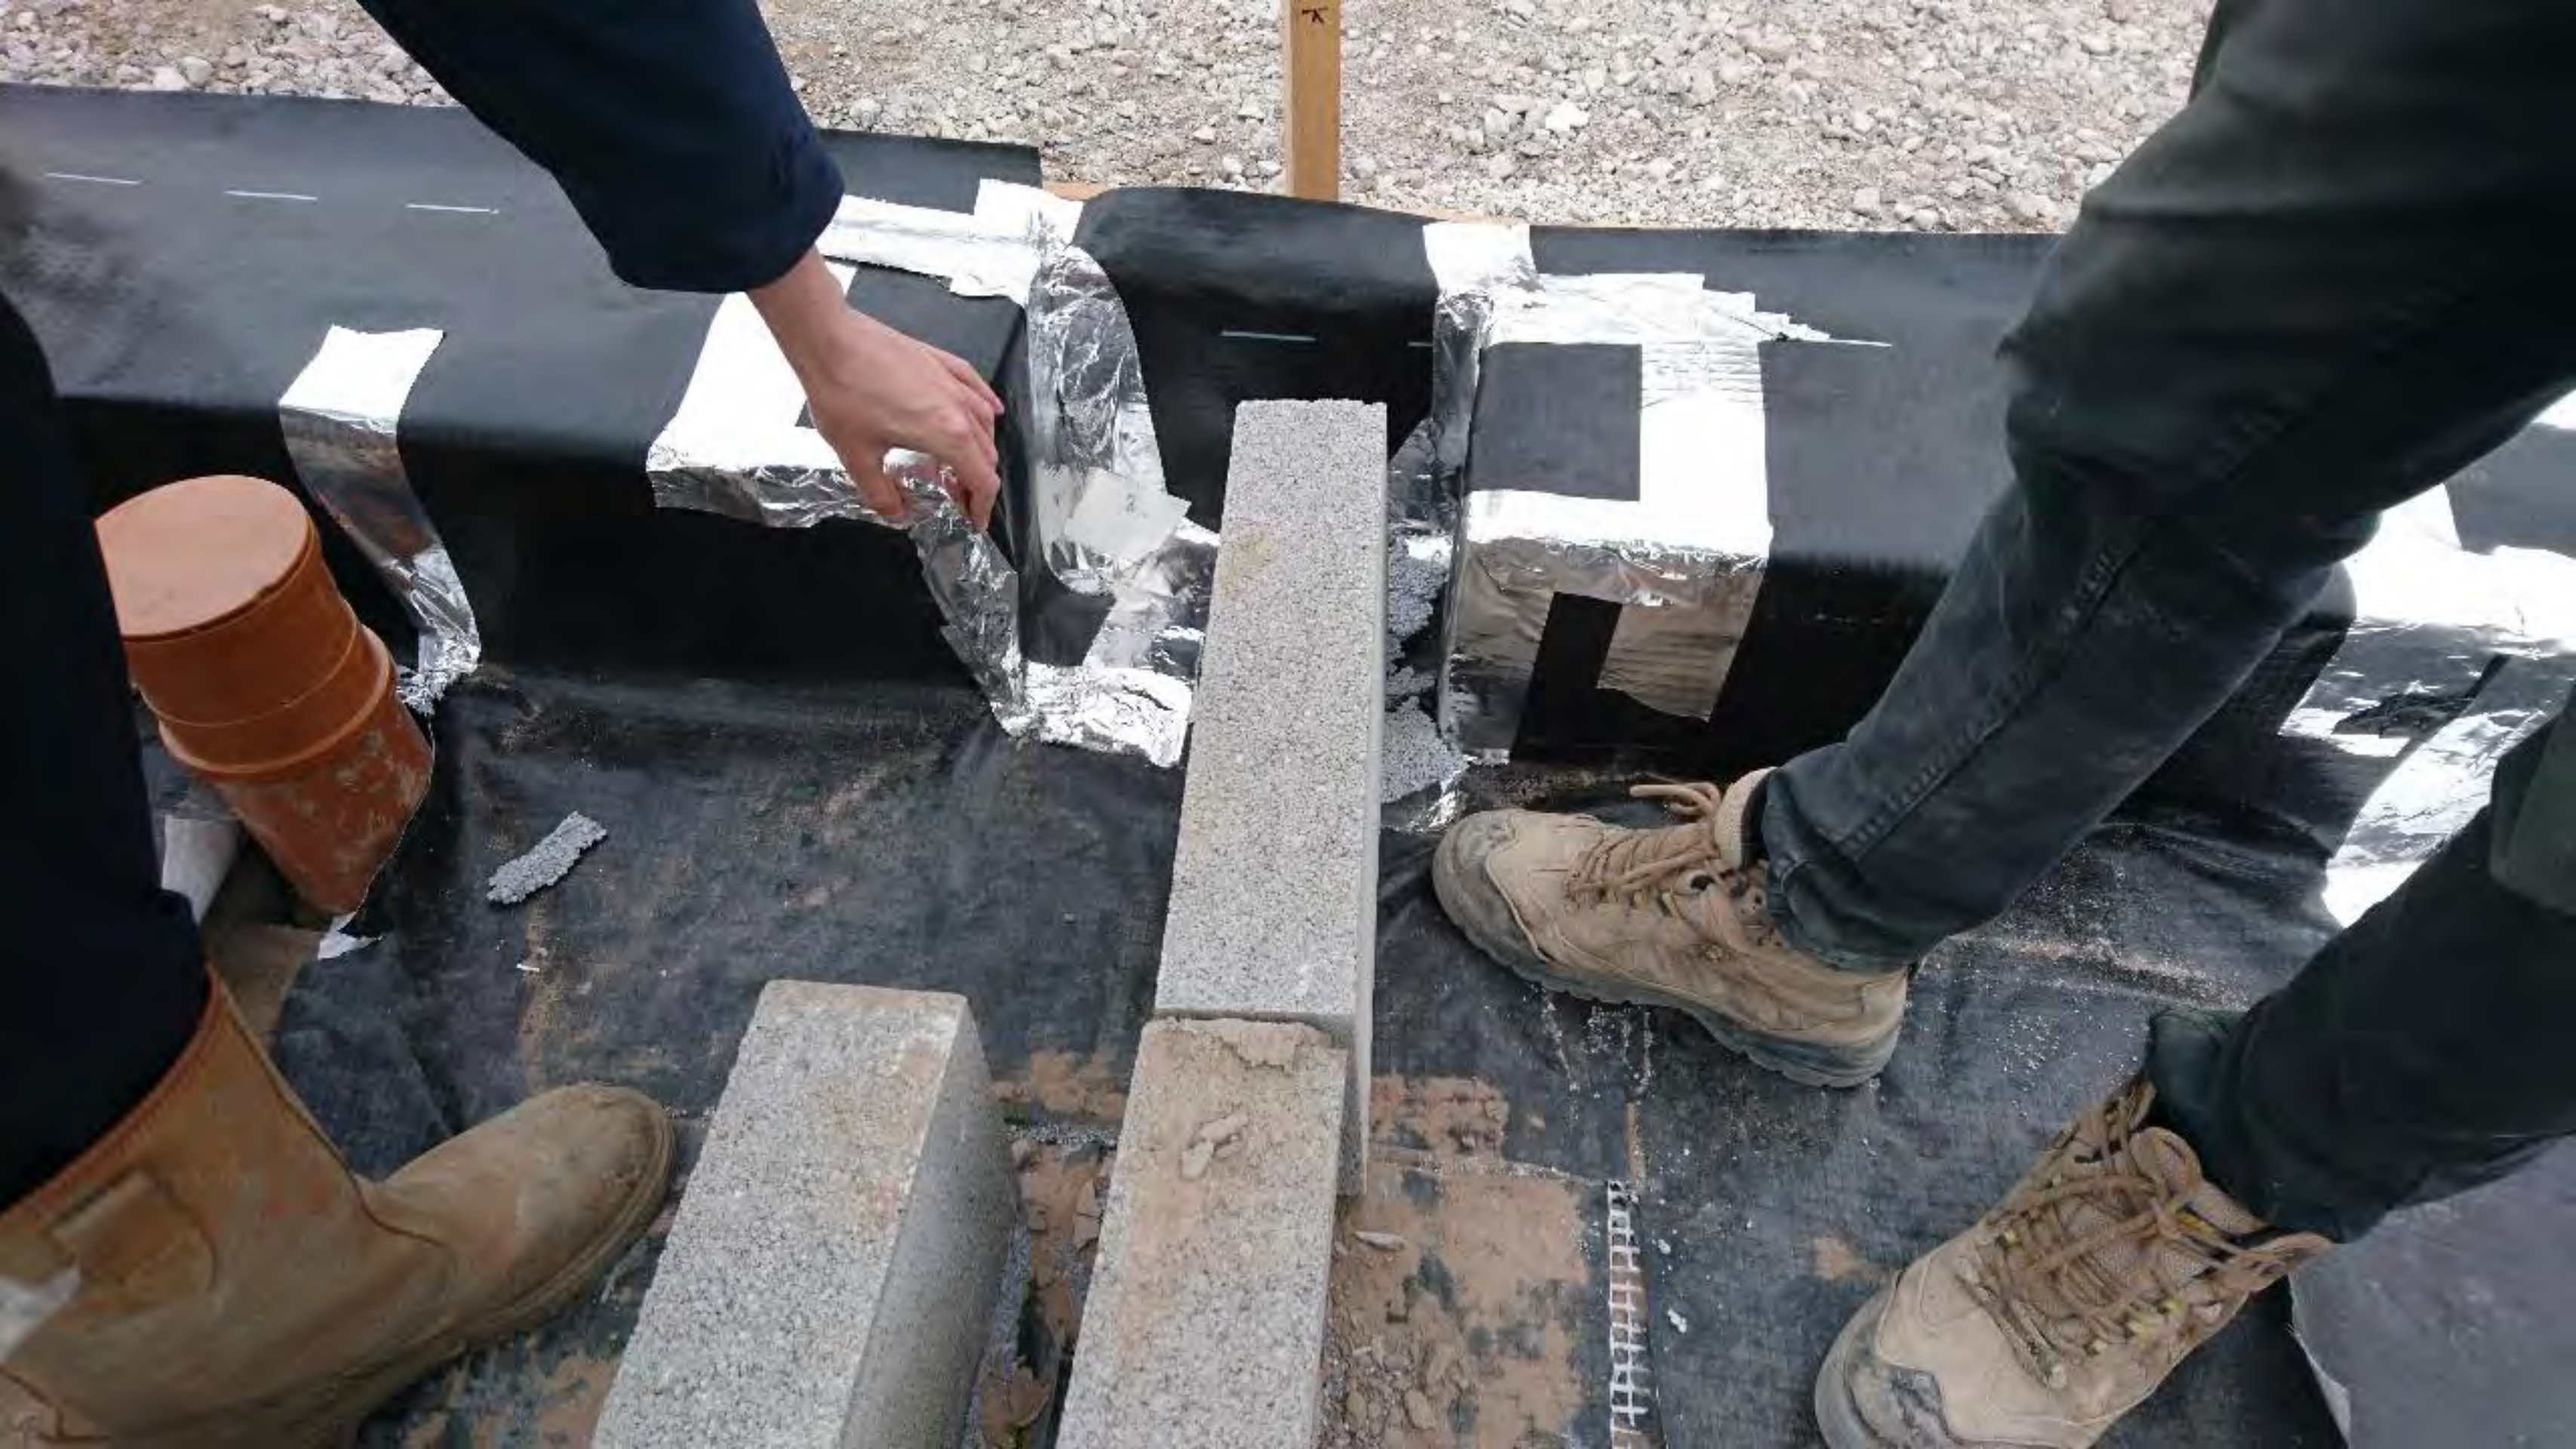
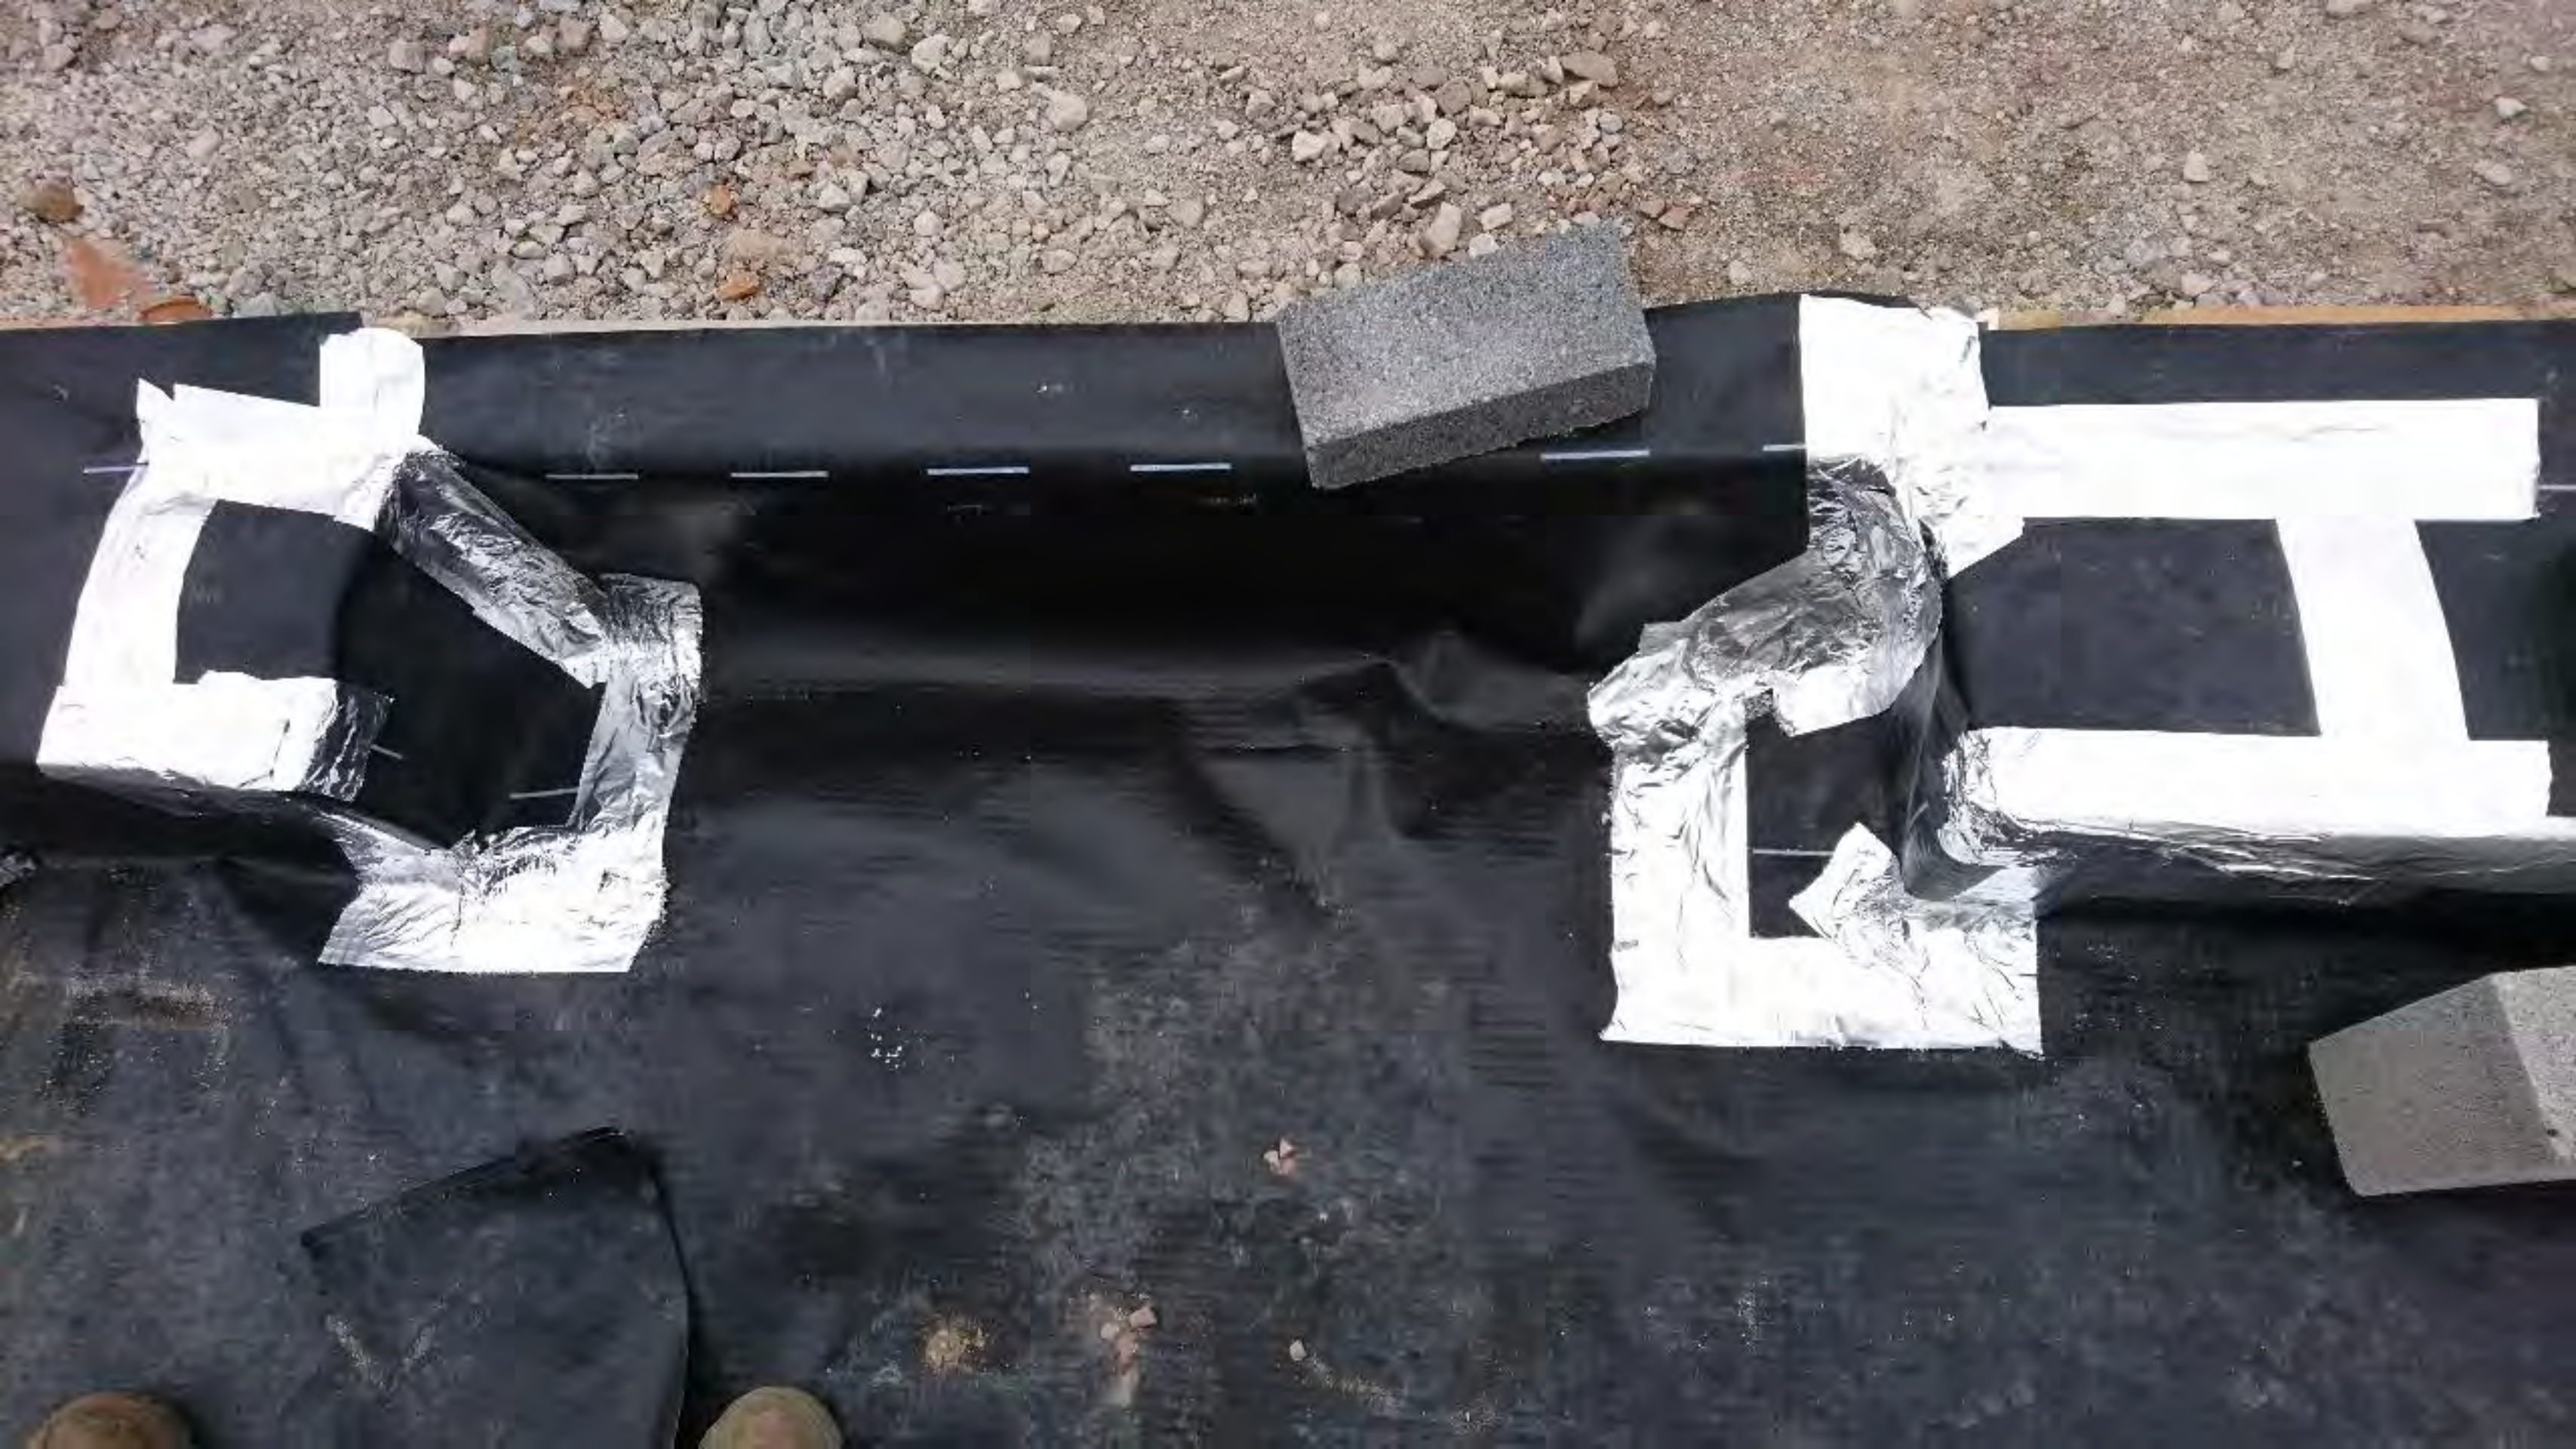
| 1.2 | External Wall Venting – cranked vent spacing | < 2m (1.8m) | | | | | |
| 2.2 | Condition of sub-grade & underside of gas membrane | GOOD - NO CONCERNS FOR WALL CAVITY | | | | | |
| 2.7 | Condition of joints/seals | GOOD > 150mm overlaps | | | | | |
| 2.9 | Membrane steps/corner seals | GOOD - FORMED CORNERS | | | | | |
