This Record sheet is only applicable to block and beam floor slabs for Characteristic Situation 2 gas protection systems

Plot No.: 2

For Residential Development at New Church Street, Radcliffe.

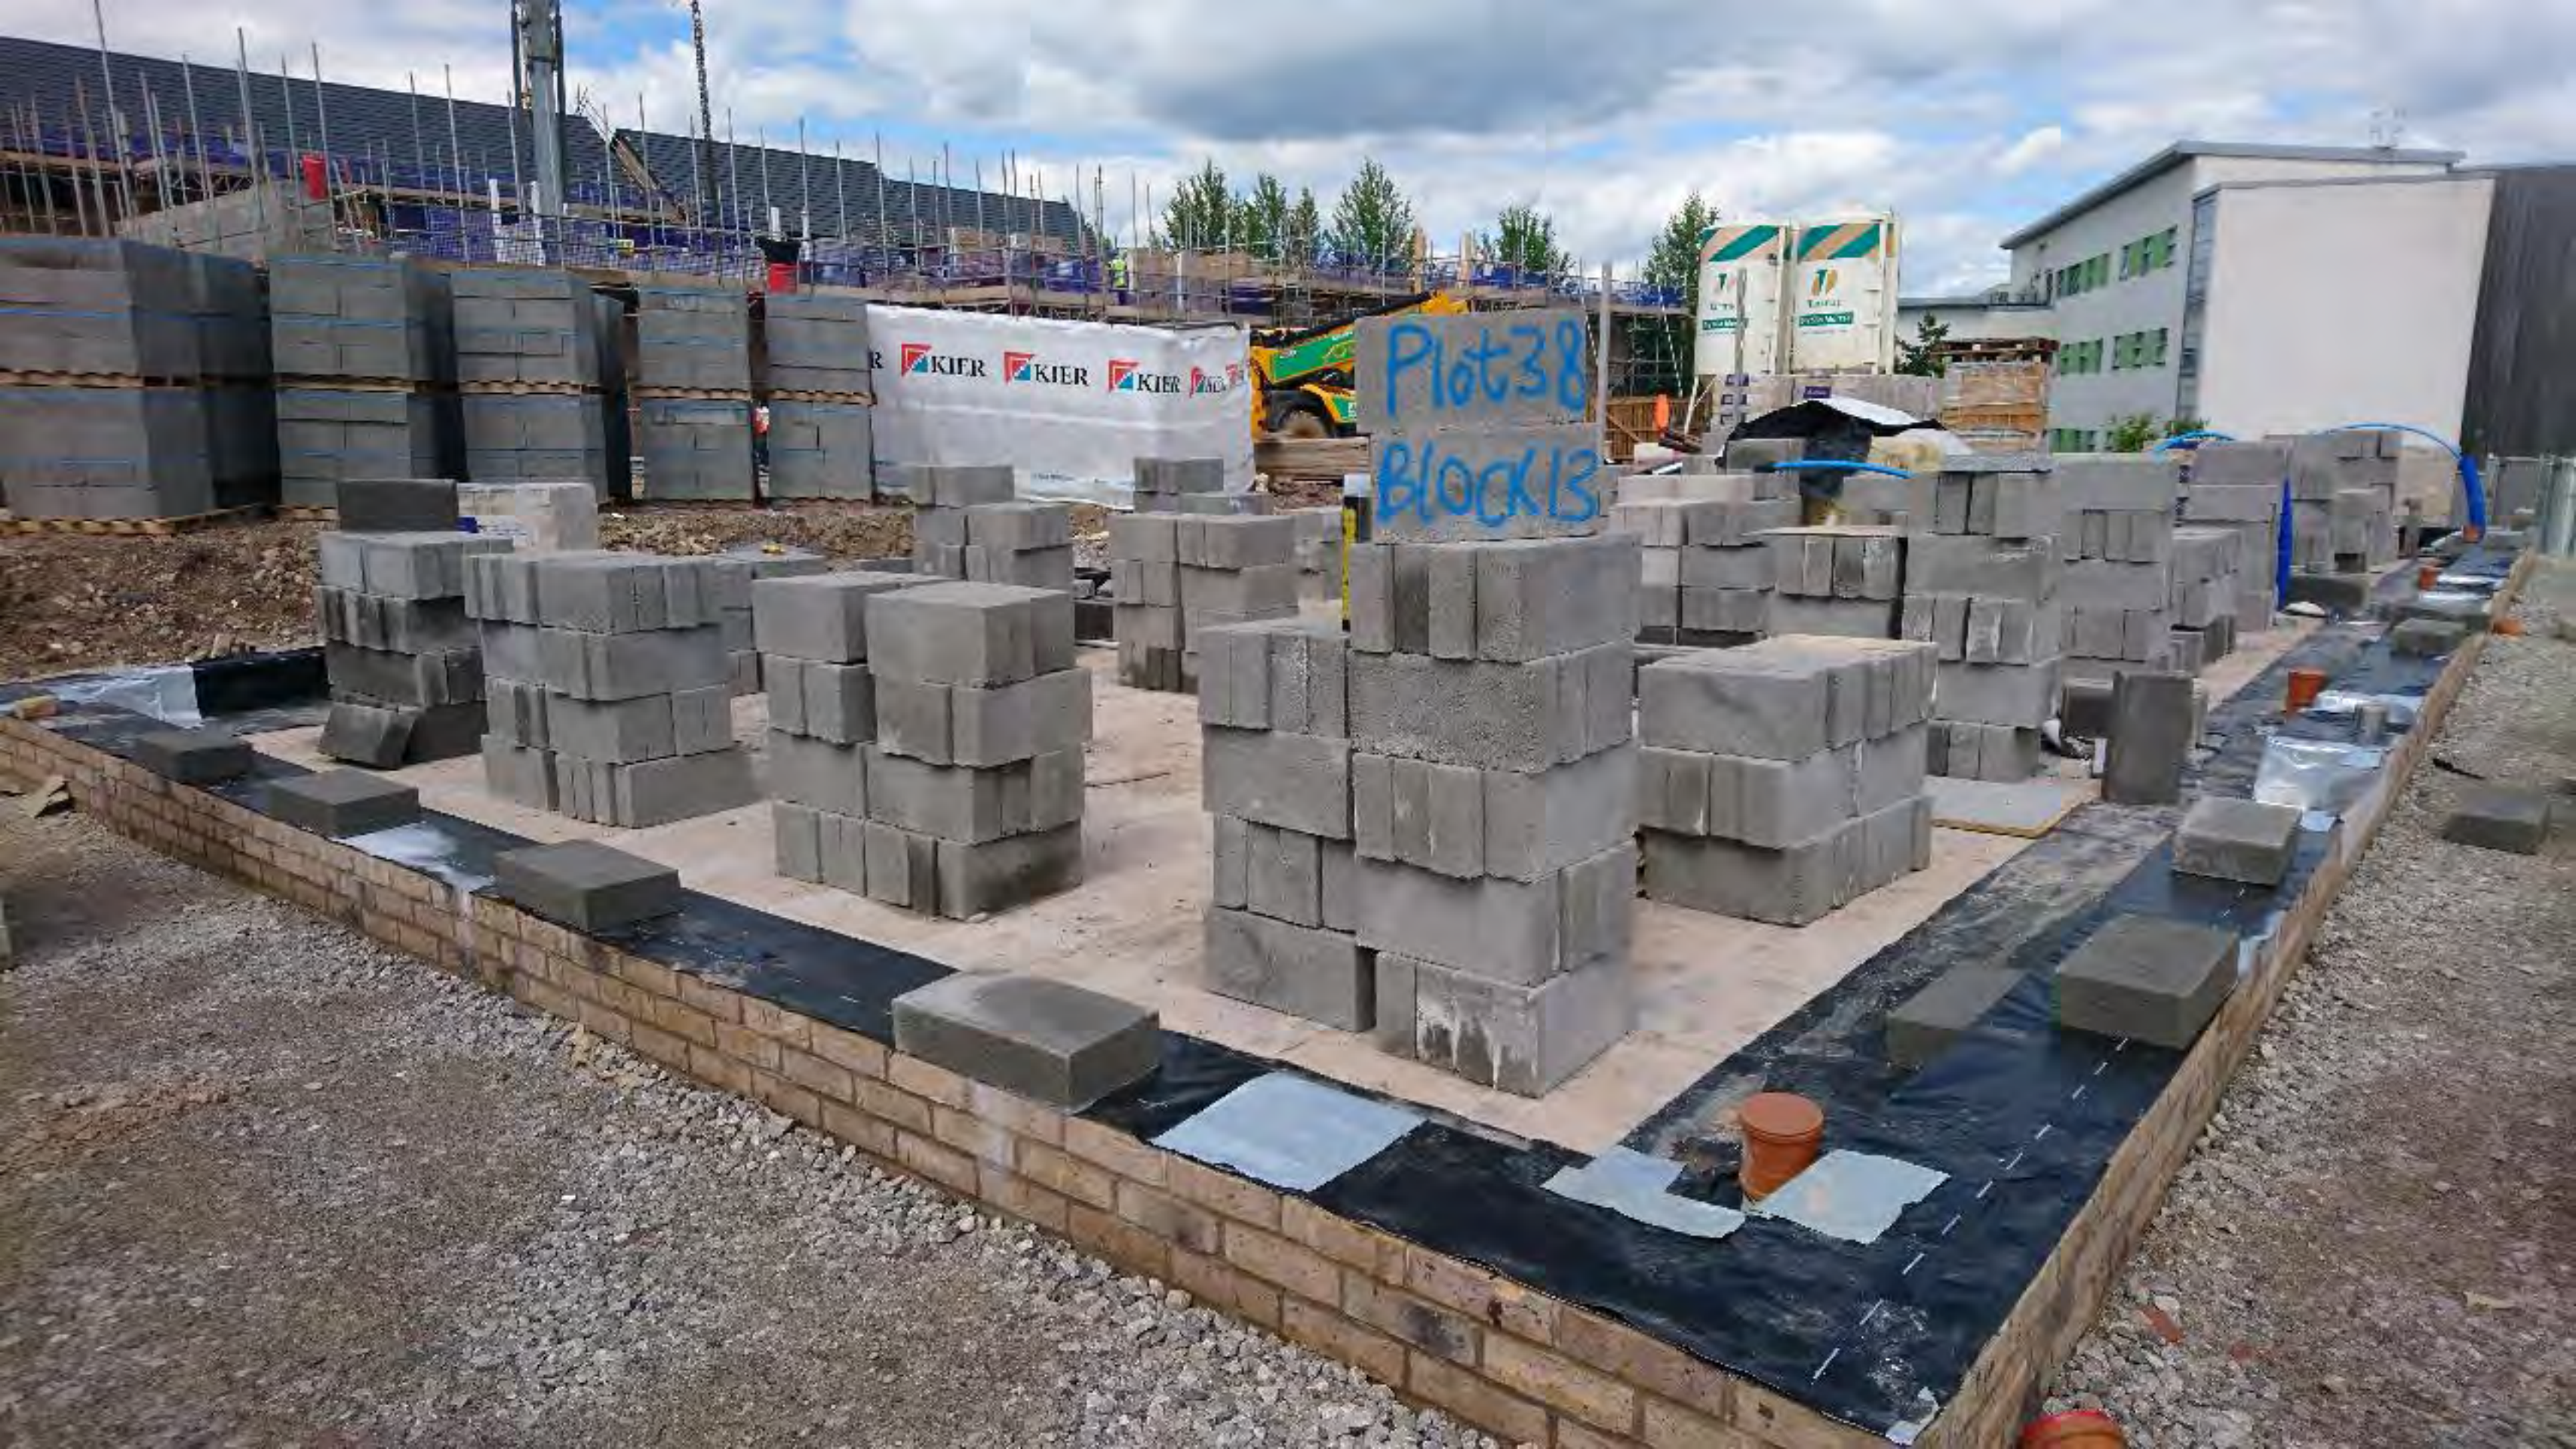
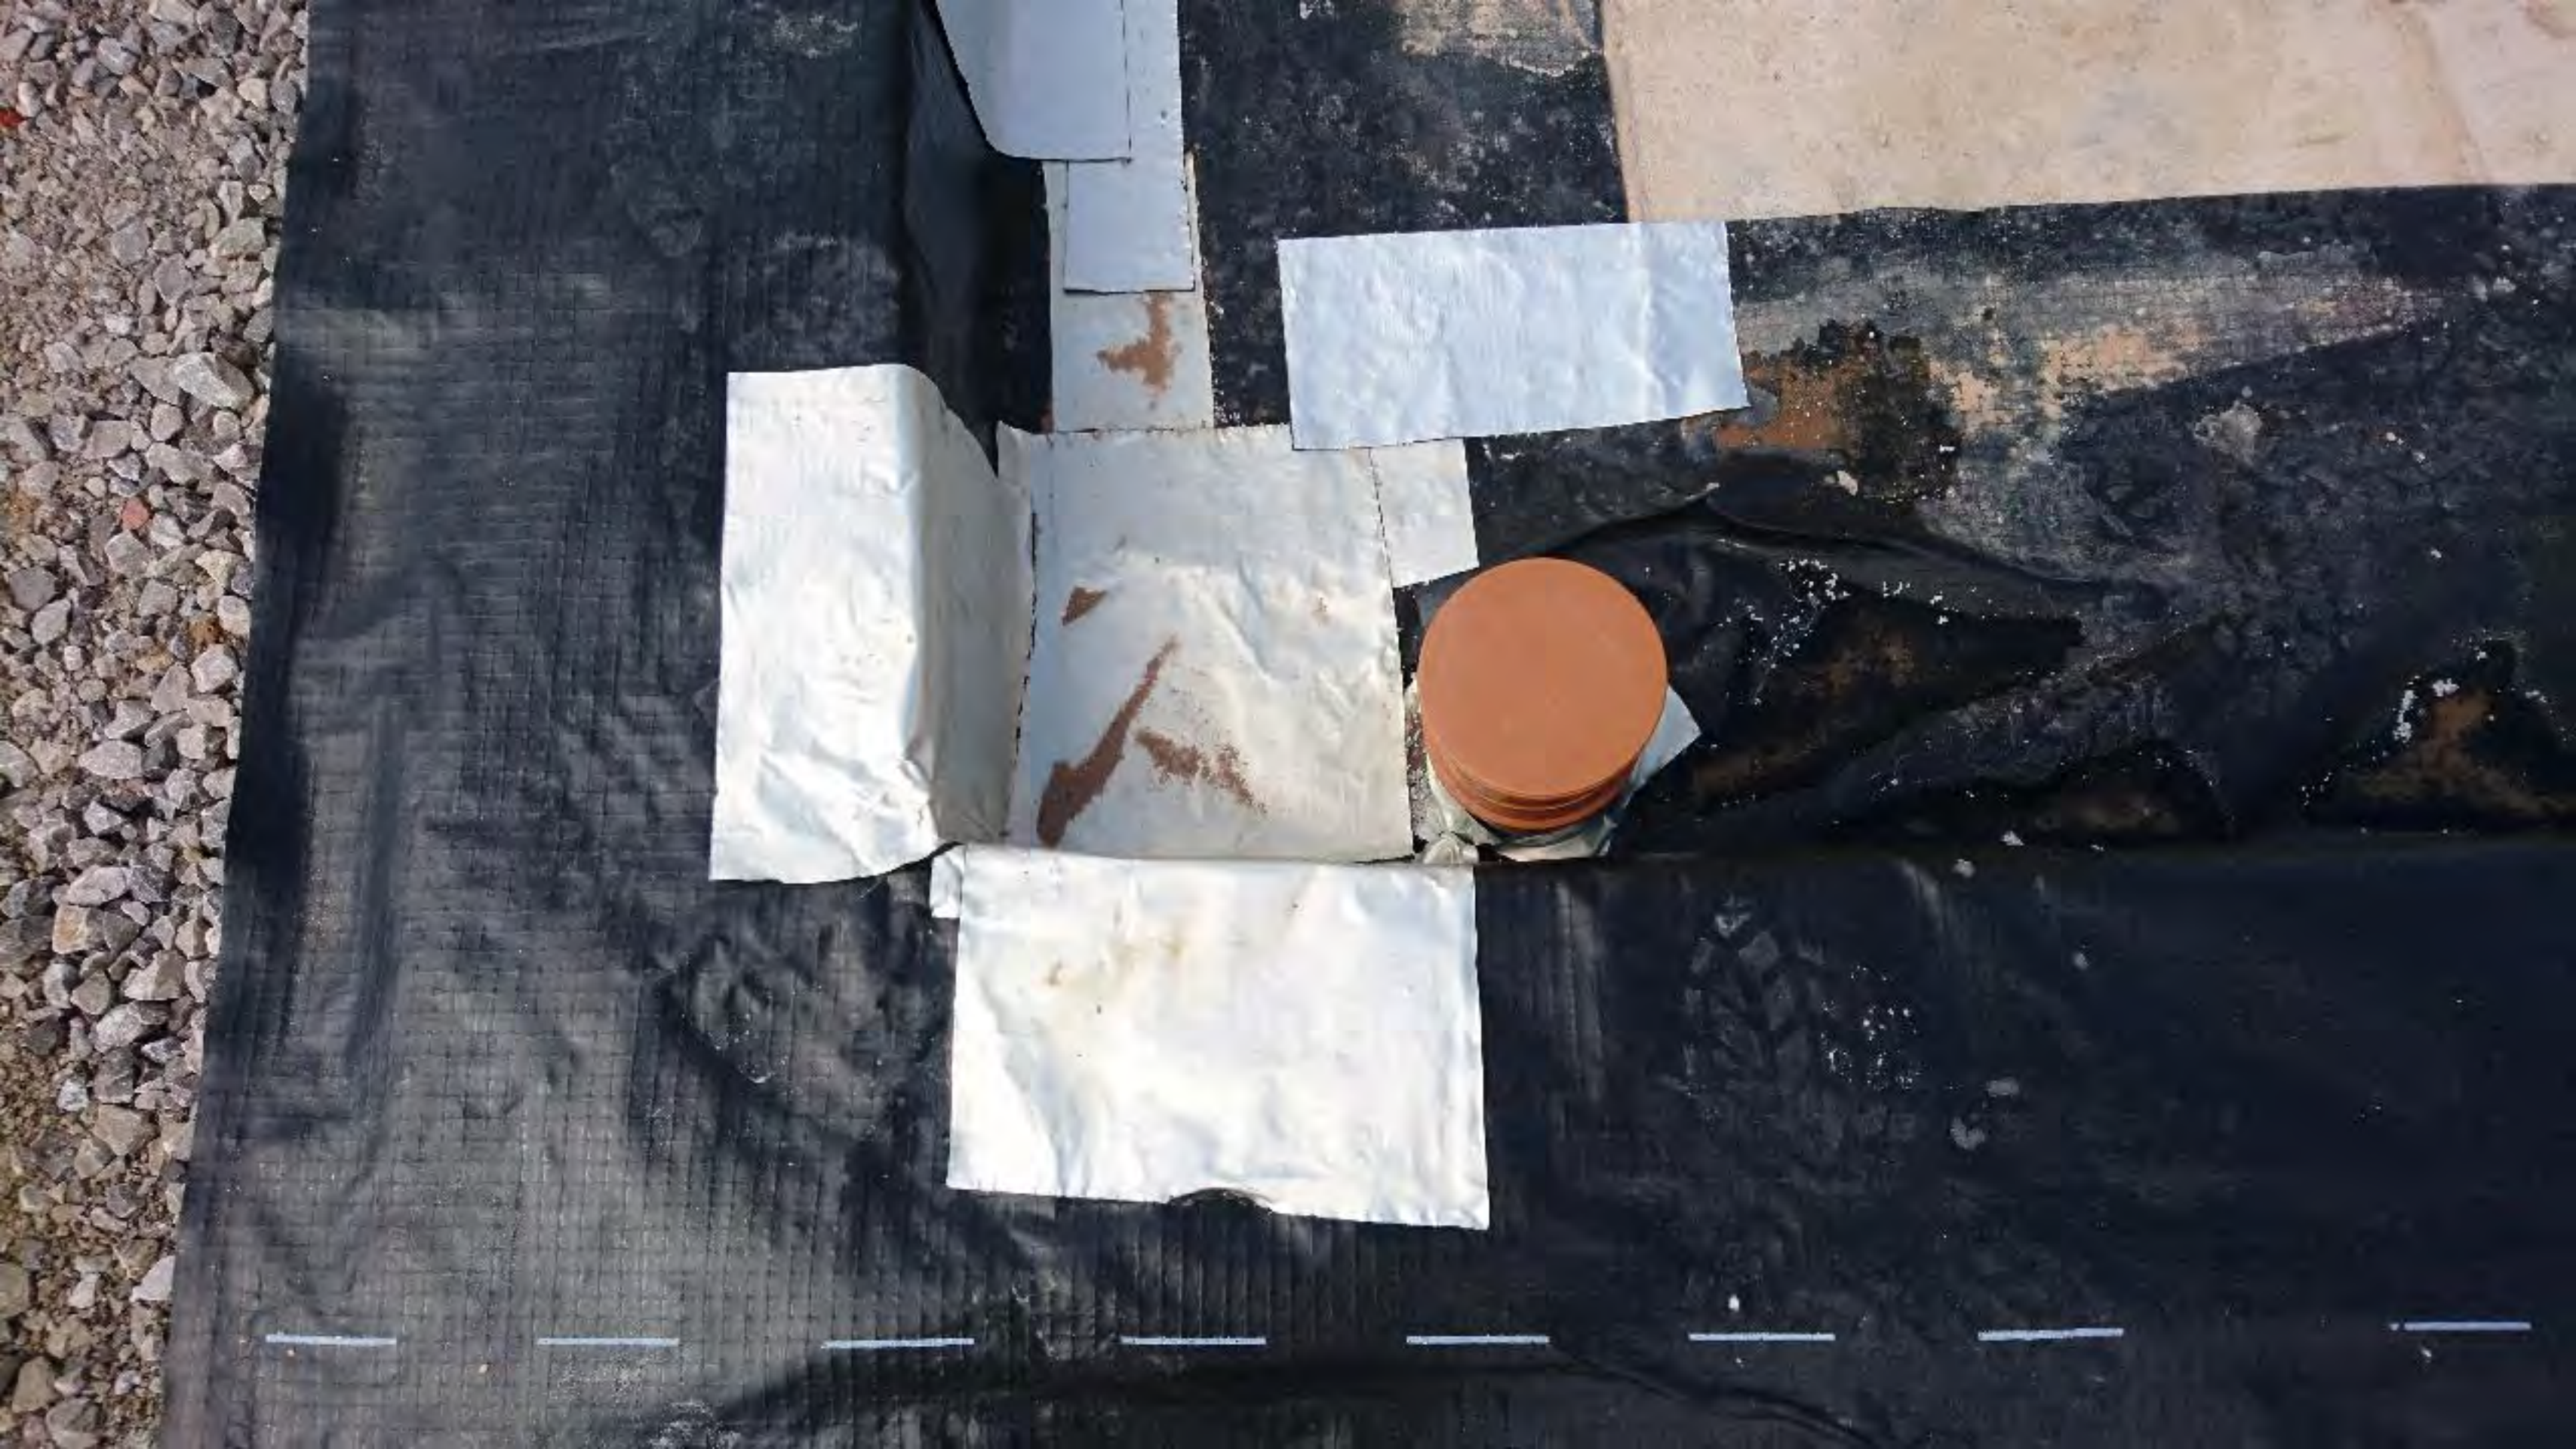
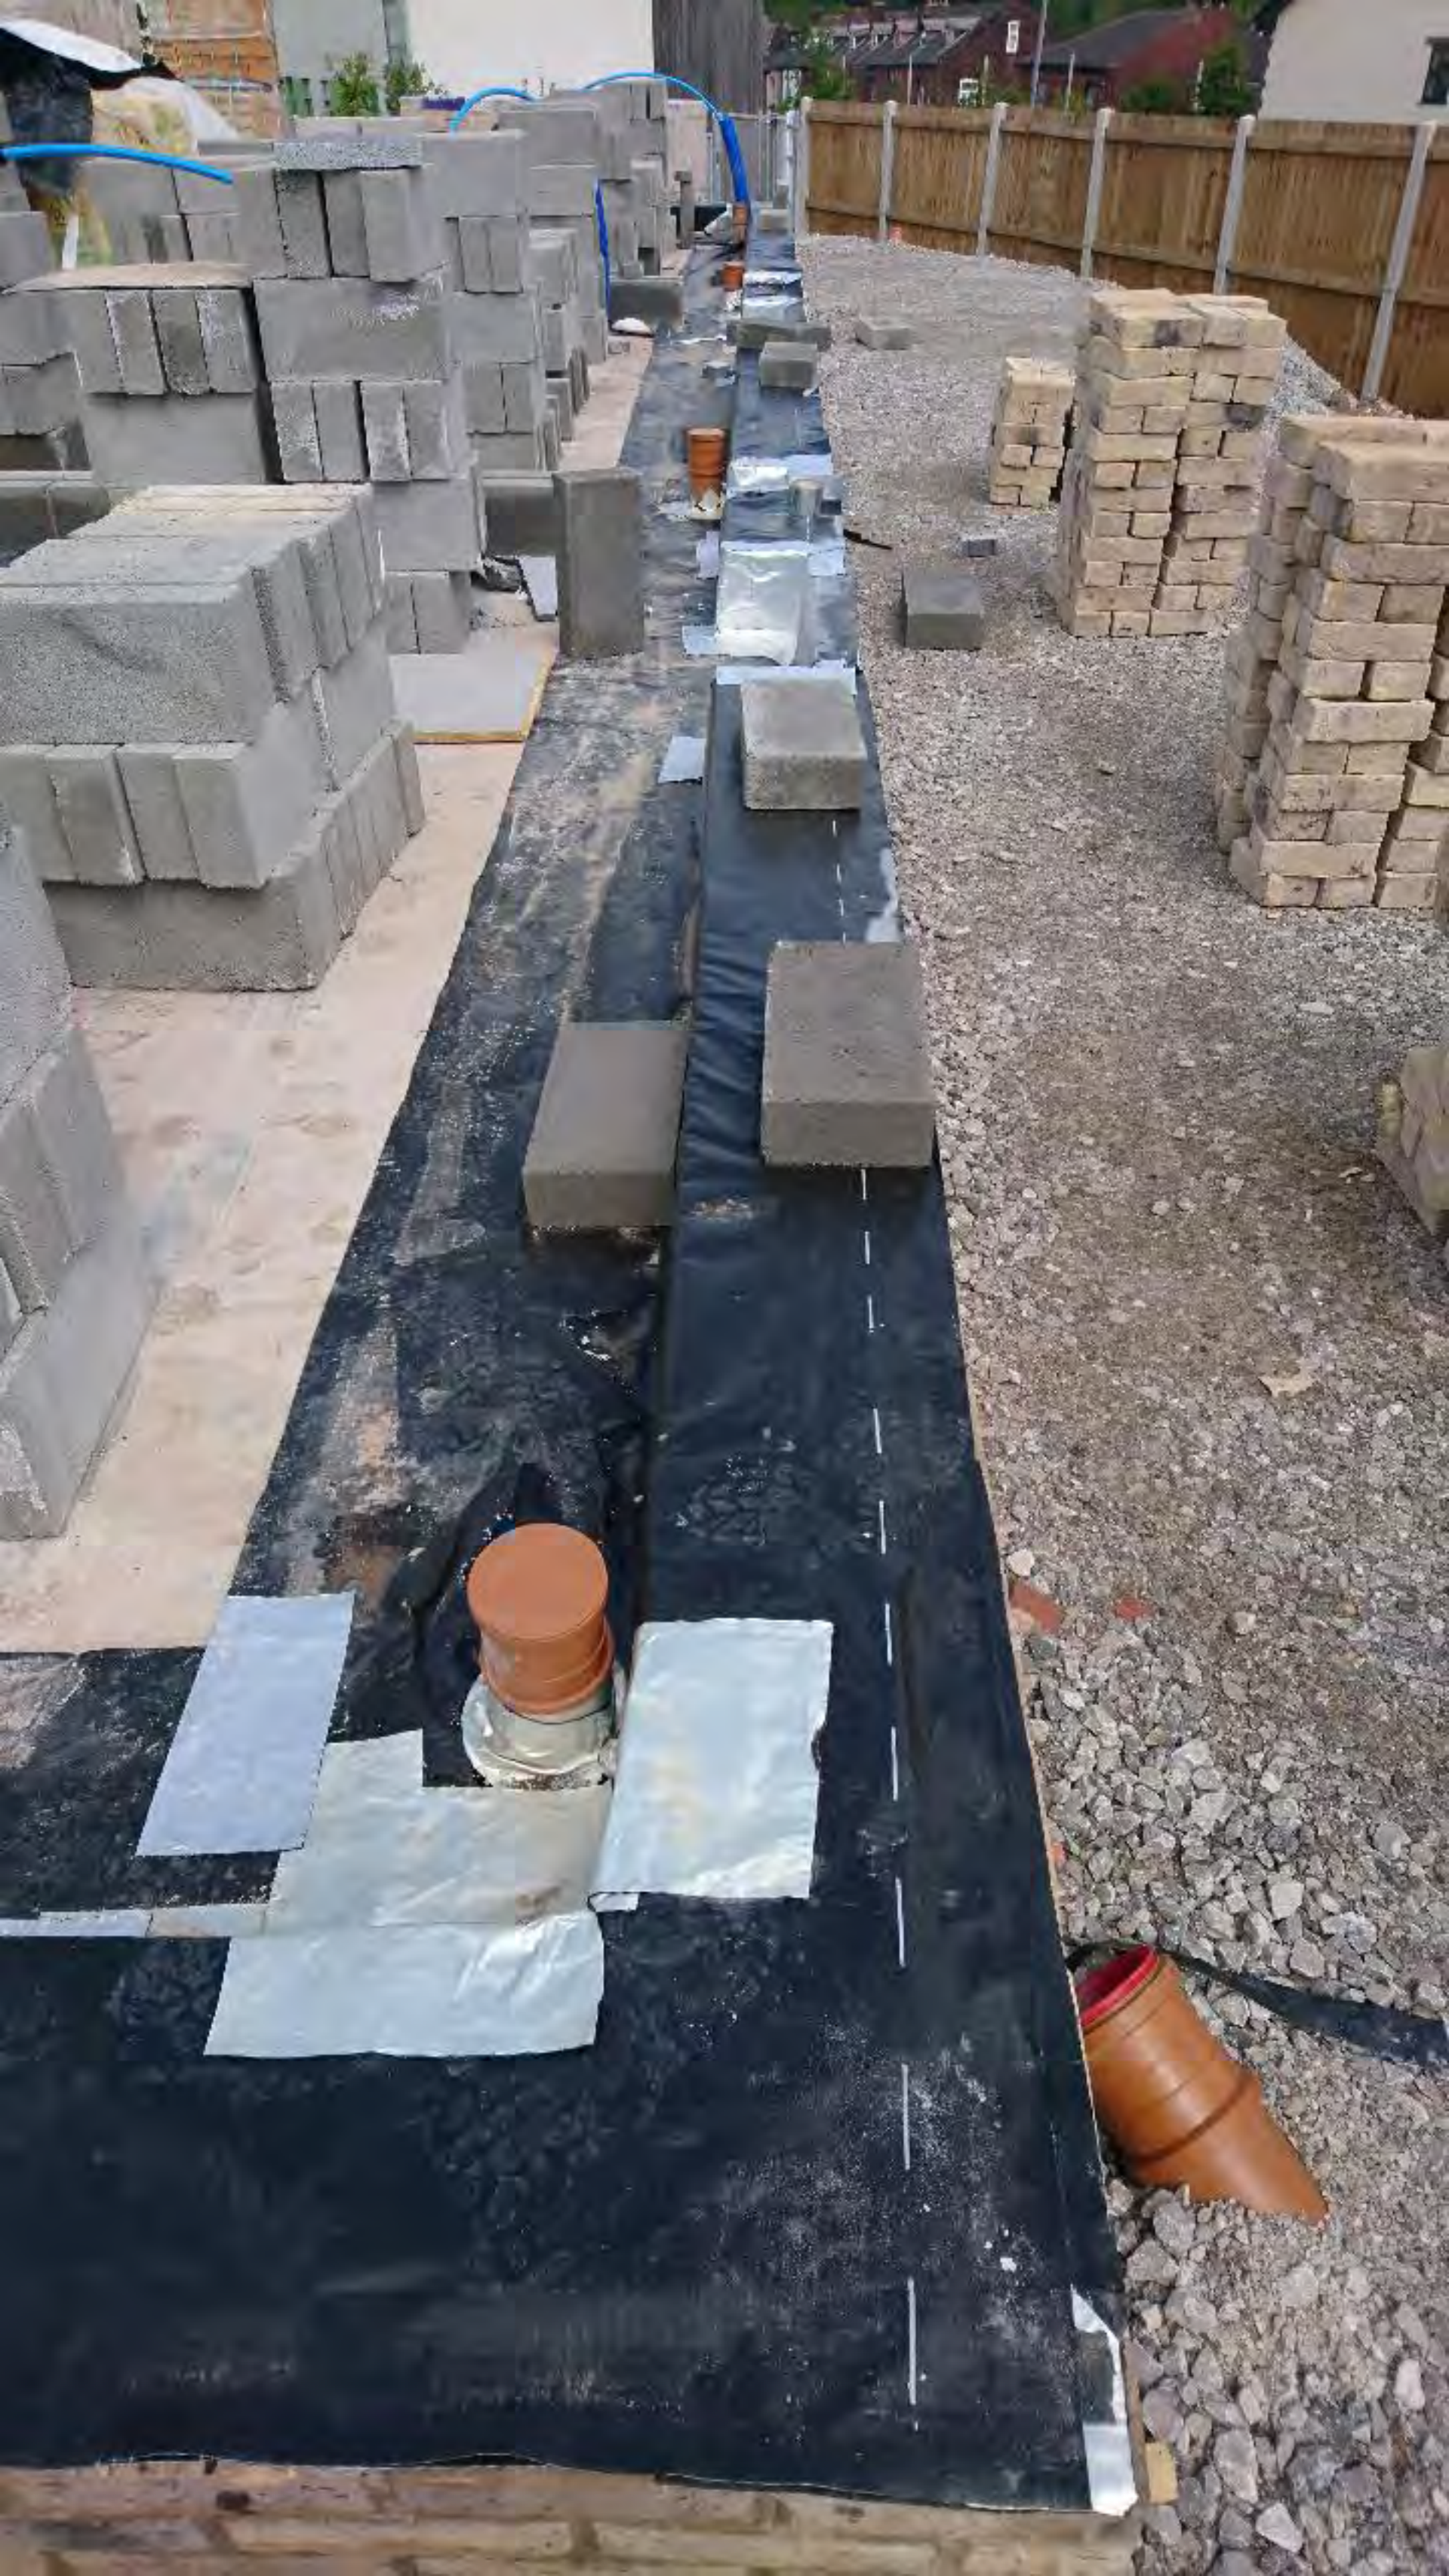
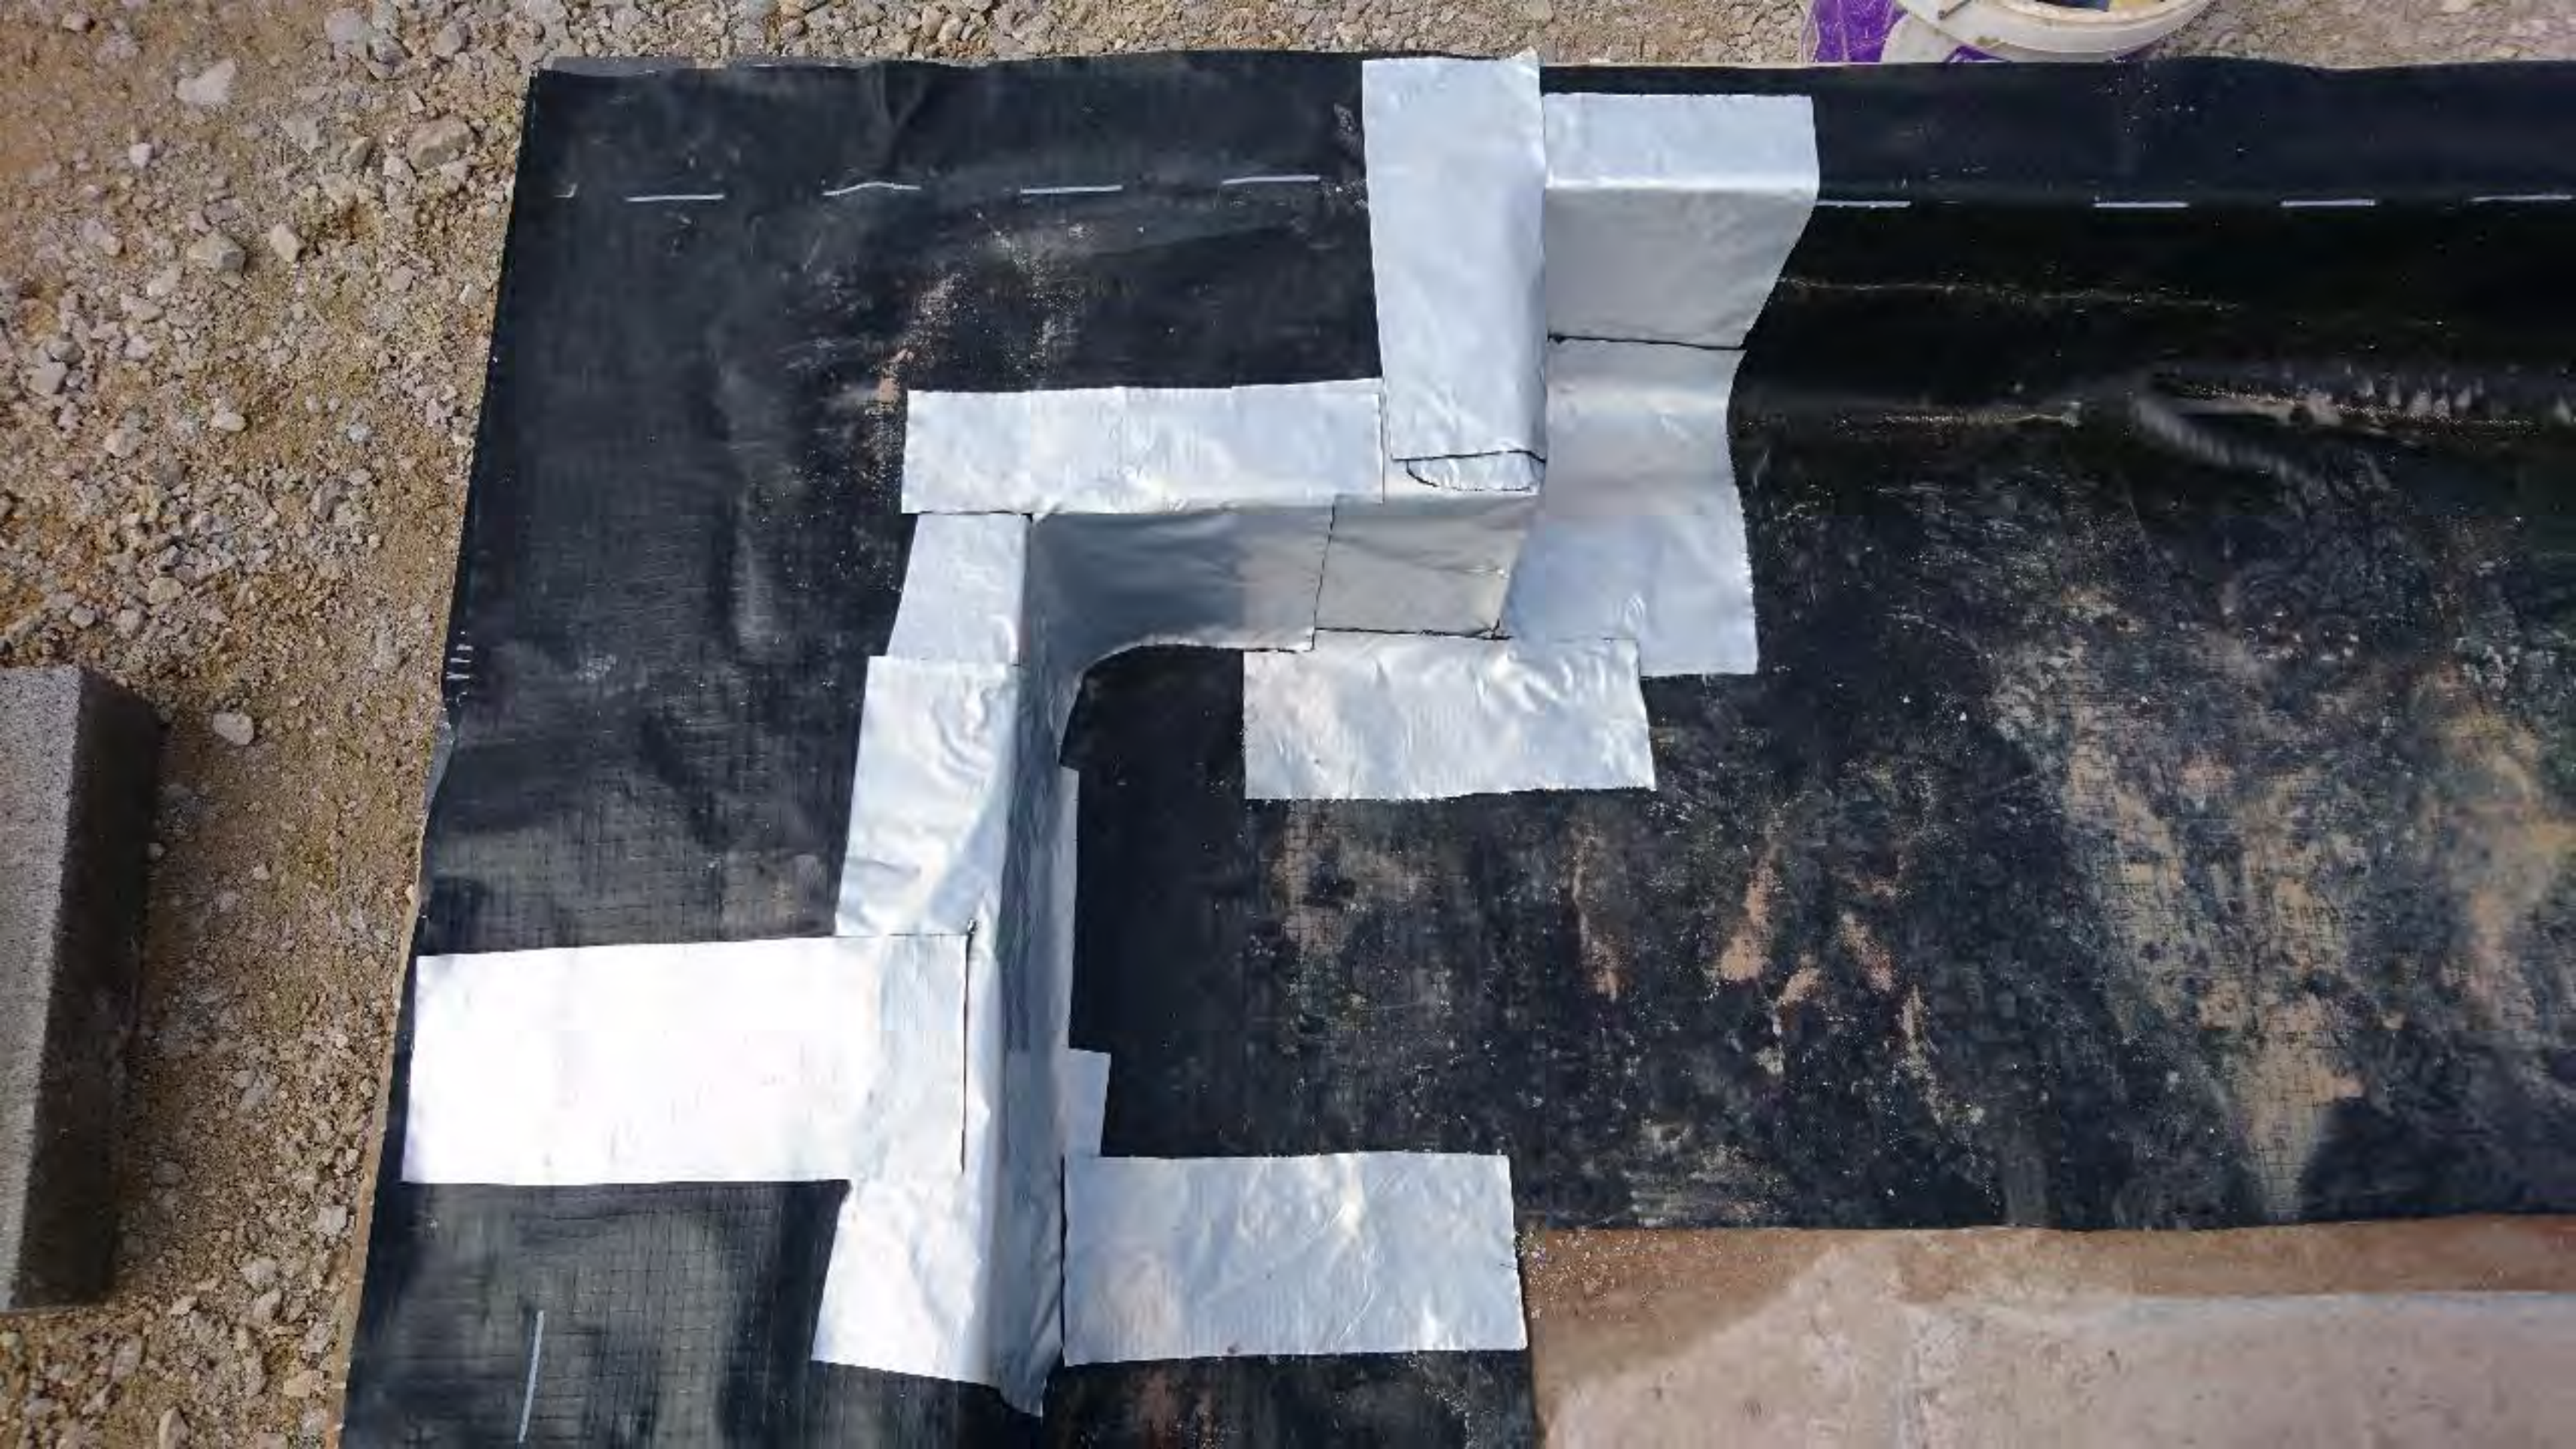
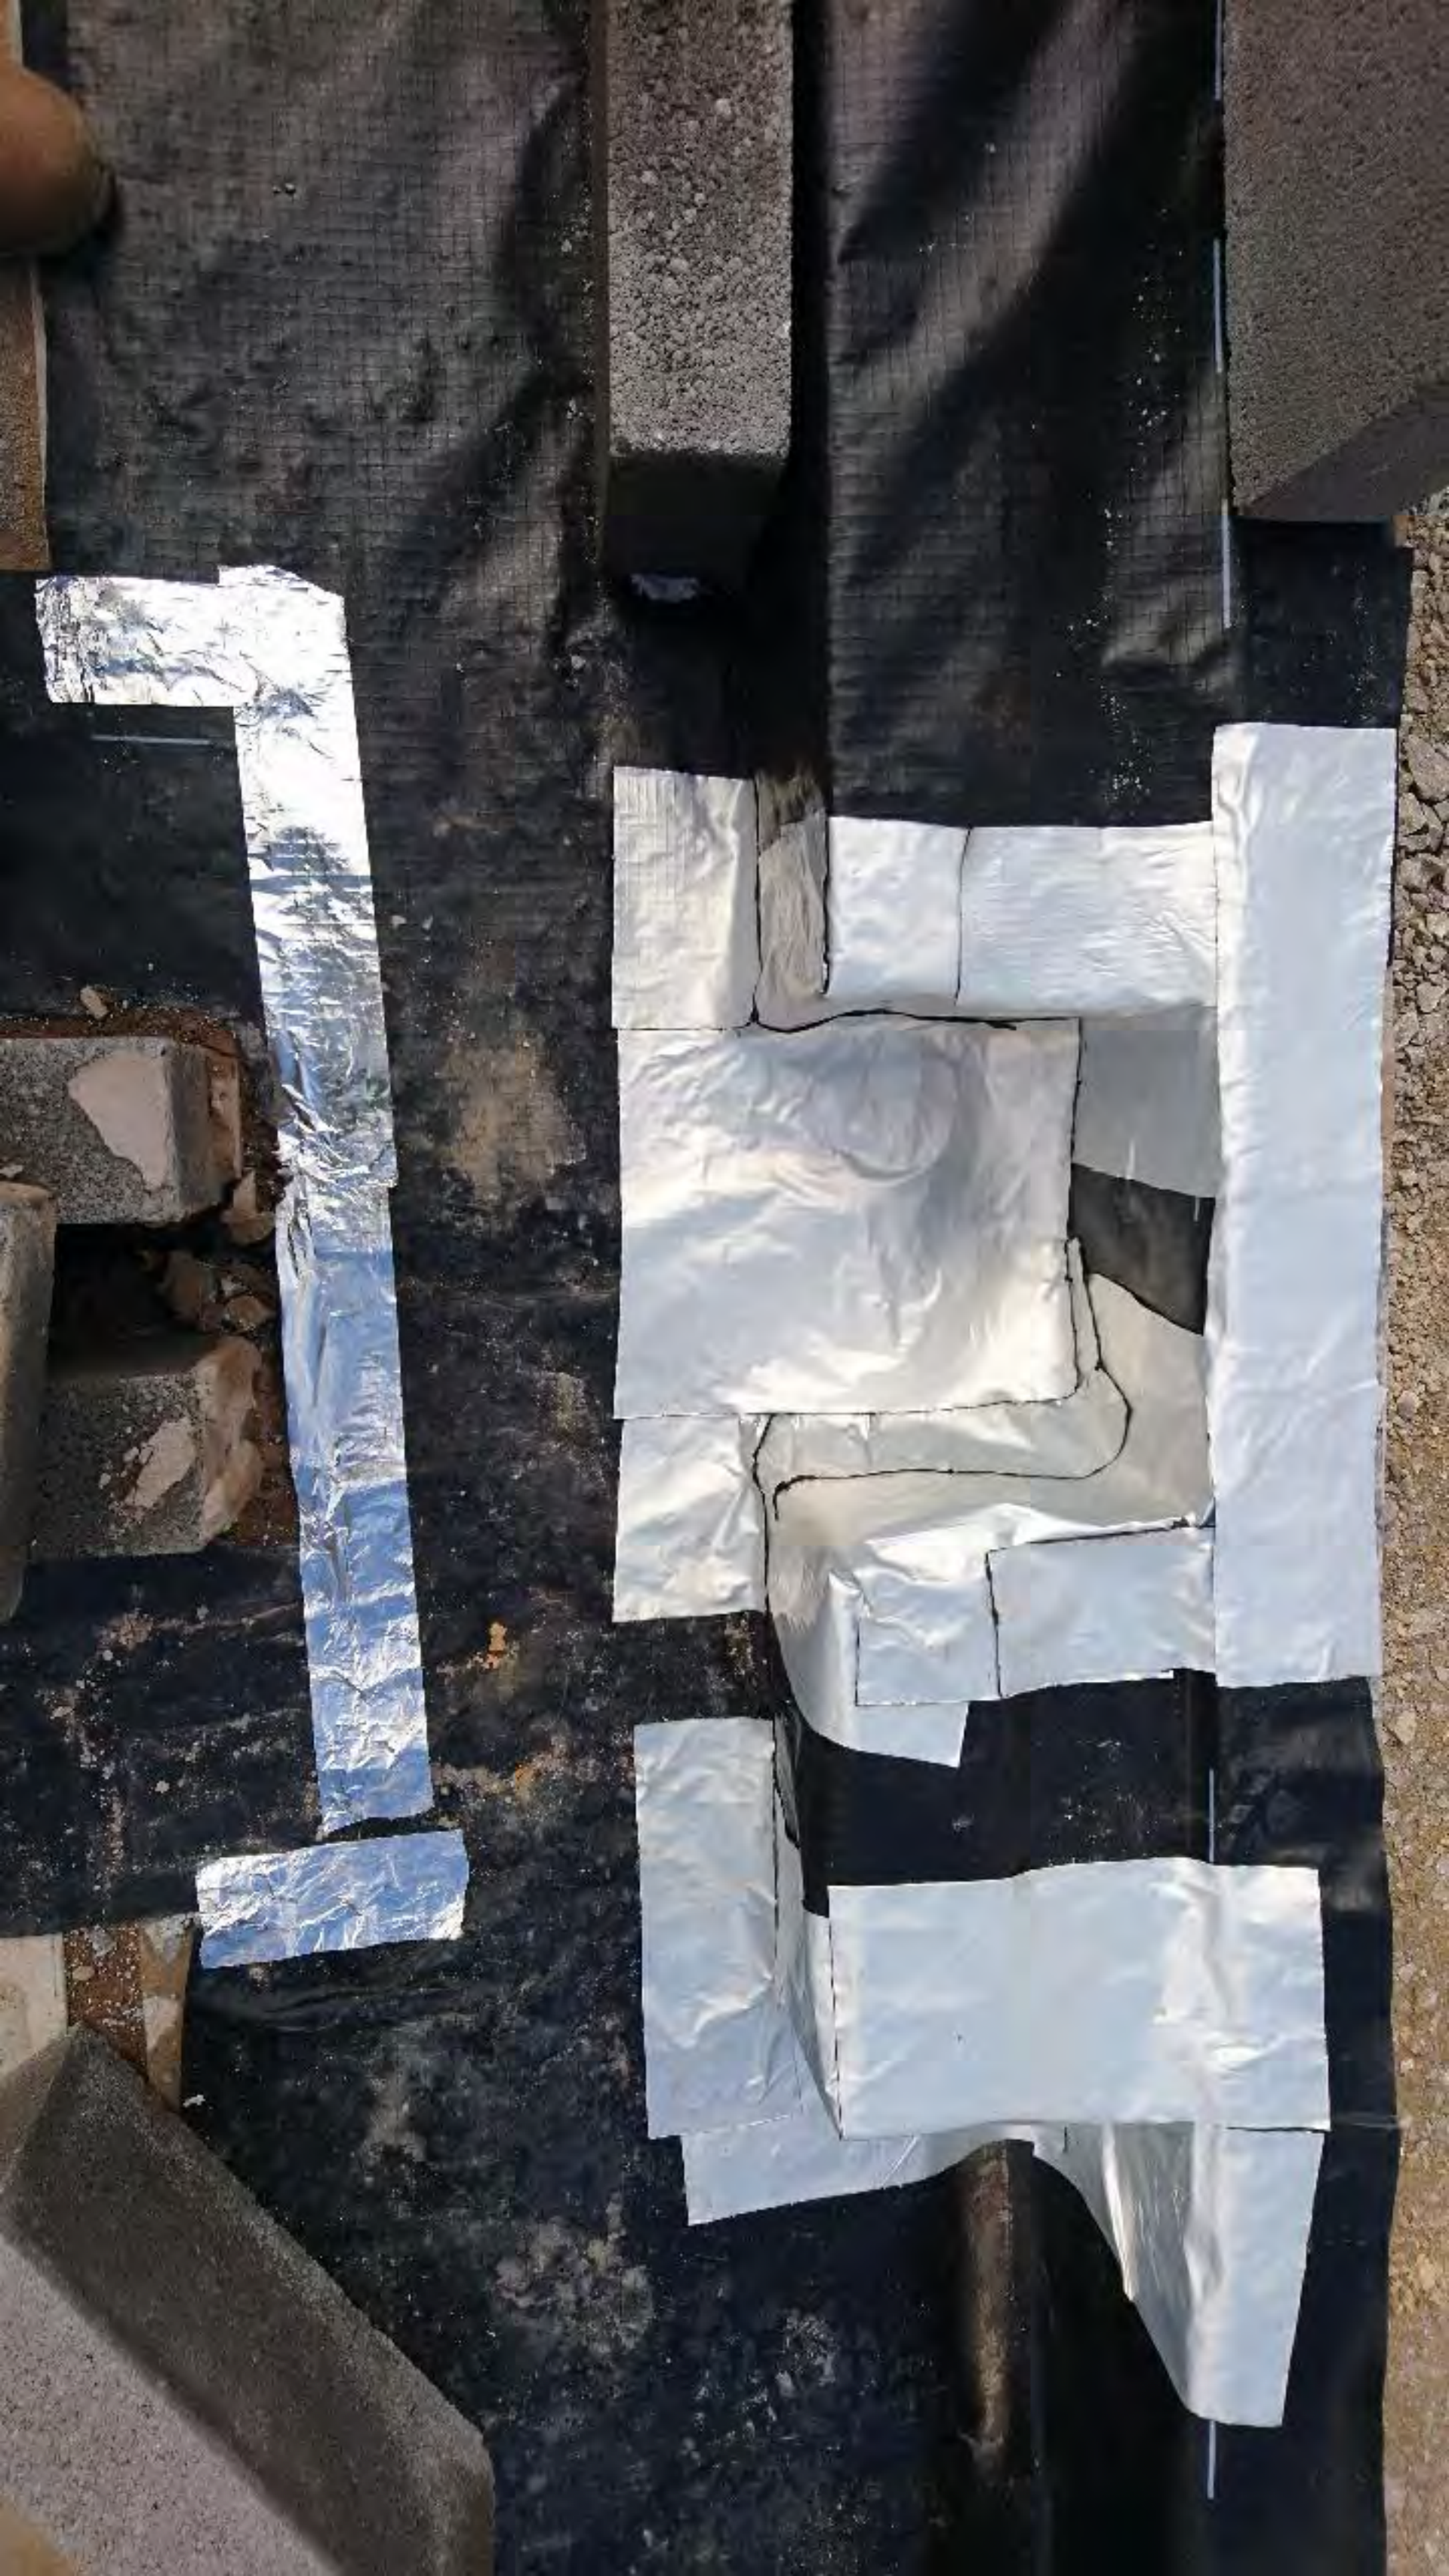
Plot 38  
Block 13

| 1.1 | Internal Wall Venting Pipes – size and spacing | N/A – FRONT, REAR + SIDE VENTS, AS PER PHOTOS. | | | | | |
| 1.2 | External Wall Venting – cranked vent spacing | LESS THAN 2M – 1.8M – SEE PHOTOS. | | | | | |
| 2.2 | Condition of sub-grade & underside of gas membrane | ALL GOOD | | | | | |
| 2.7 | Condition of joints/seals | ALL GOOD WITH 150mm OVERLAPS | | | | | |
| 2.9 | Membrane steps/corner seals | NEAT AND TIDY | | | | | |
