## Gas Protection - Validation Record Sheet

6654 Plot 37, Block 12

For Residential Development at New Church Street, Radcliffe.

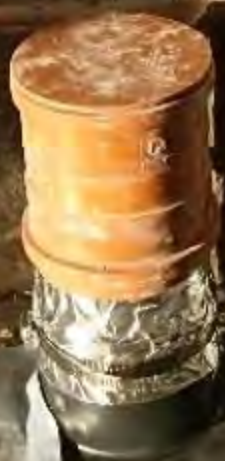
**PLOT 37**

| 2.2 | Condition of sub-grade & underside of gas membrane | FLOOR BRUSHED AND ALL TAPES APPLIED WELL SEALED TO A GOOD QUALITY | | | | | |
| 2.4 | Gas membrane condition and coverage | SEALED ON ALL FOUR SIDES – ALL GOOD | | | | | |
| 2.7 | Condition of joints/seals | VISIBLE OVERLAPS, ALL GOOD | | | | | |
| 2.8 | Number and condition of service entry seals | 3 NO TOPHATS FITTED WITH JUBILEE CLIPS, TAPES CHECKED, ALL OK | | | | | |

| 2.10 | Repairs or Corrections: | 1 NO REPAIR BY FRONT DOOR. USED 300mm WIDE RADBAR SIA DETAIL STRIP x 20m | | | | | |

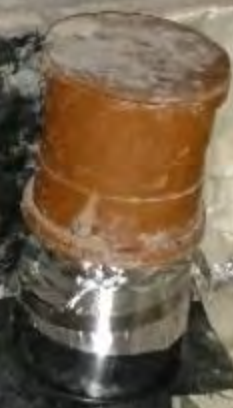
PLOT 38

| 2.2 | Condition of sub-grade & underside of gas membrane | SEALED TO A GOOD QUALITY, TAPES APPLIED WELL. FLOOR SWEEP CLEAN | | | | | |
| 2.4 | Gas membrane condition and coverage | ALL OK, SEALED ON ALL FOUR SIDES | | | | | |
| 2.7 | Condition of joints/seals | ALL GOOD, VISIBLE OVERLAPS | | | | | |
| 2.8 | Number and condition of service entry seals | 3 NO TOPHATS WITH SUBILEE CLIPS - ALL TAPED UP TO A GOOD STANDARD | | | | | |

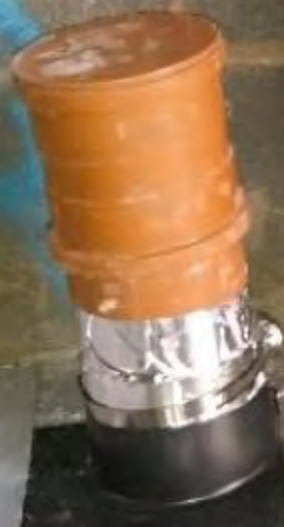
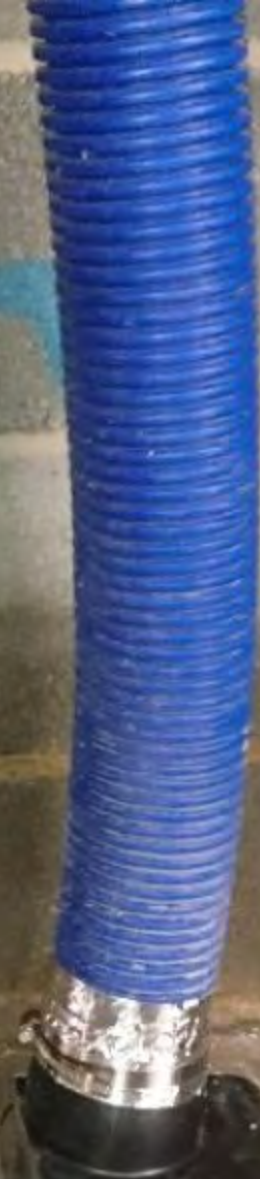
PLOT 39

| 2.2 | Condition of sub-grade & underside of gas membrane | SEALED TO A GOOD QUALITY AND FLOOR SWEEP CLEAN. TAPES APPLIED WELL | | | | | |
| 2.4 | Gas membrane condition and coverage | ALL OK, SEALED ON ALL FOUR SIDES | | | | | |
| 2.7 | Condition of joints/seals | ALL GOOD, VISIBLE OVERLAPS | | | | | |
| 2.8 | Number and condition of service entry seals | 3 NO. TOPHATS FITTED WITH SUBILEE CLIPS, TAPES CHECKED, ALL OK. | | | | | |

| 2.10 | Repairs or Corrections: | 2 PUNCTURES - REPAIRED USING 300x20mm RADBAR S/A DETAIL STRIP | | | | | |
