Ainsworth Care Home, Knowsley Road, Ainsworth, Bury, BL2 5PT

## RESULTS OF BAT ACTIVITY SURVEYS

September 2021

[ERAP (Consultant Ecologists) Ltd ref: 2021-117b]

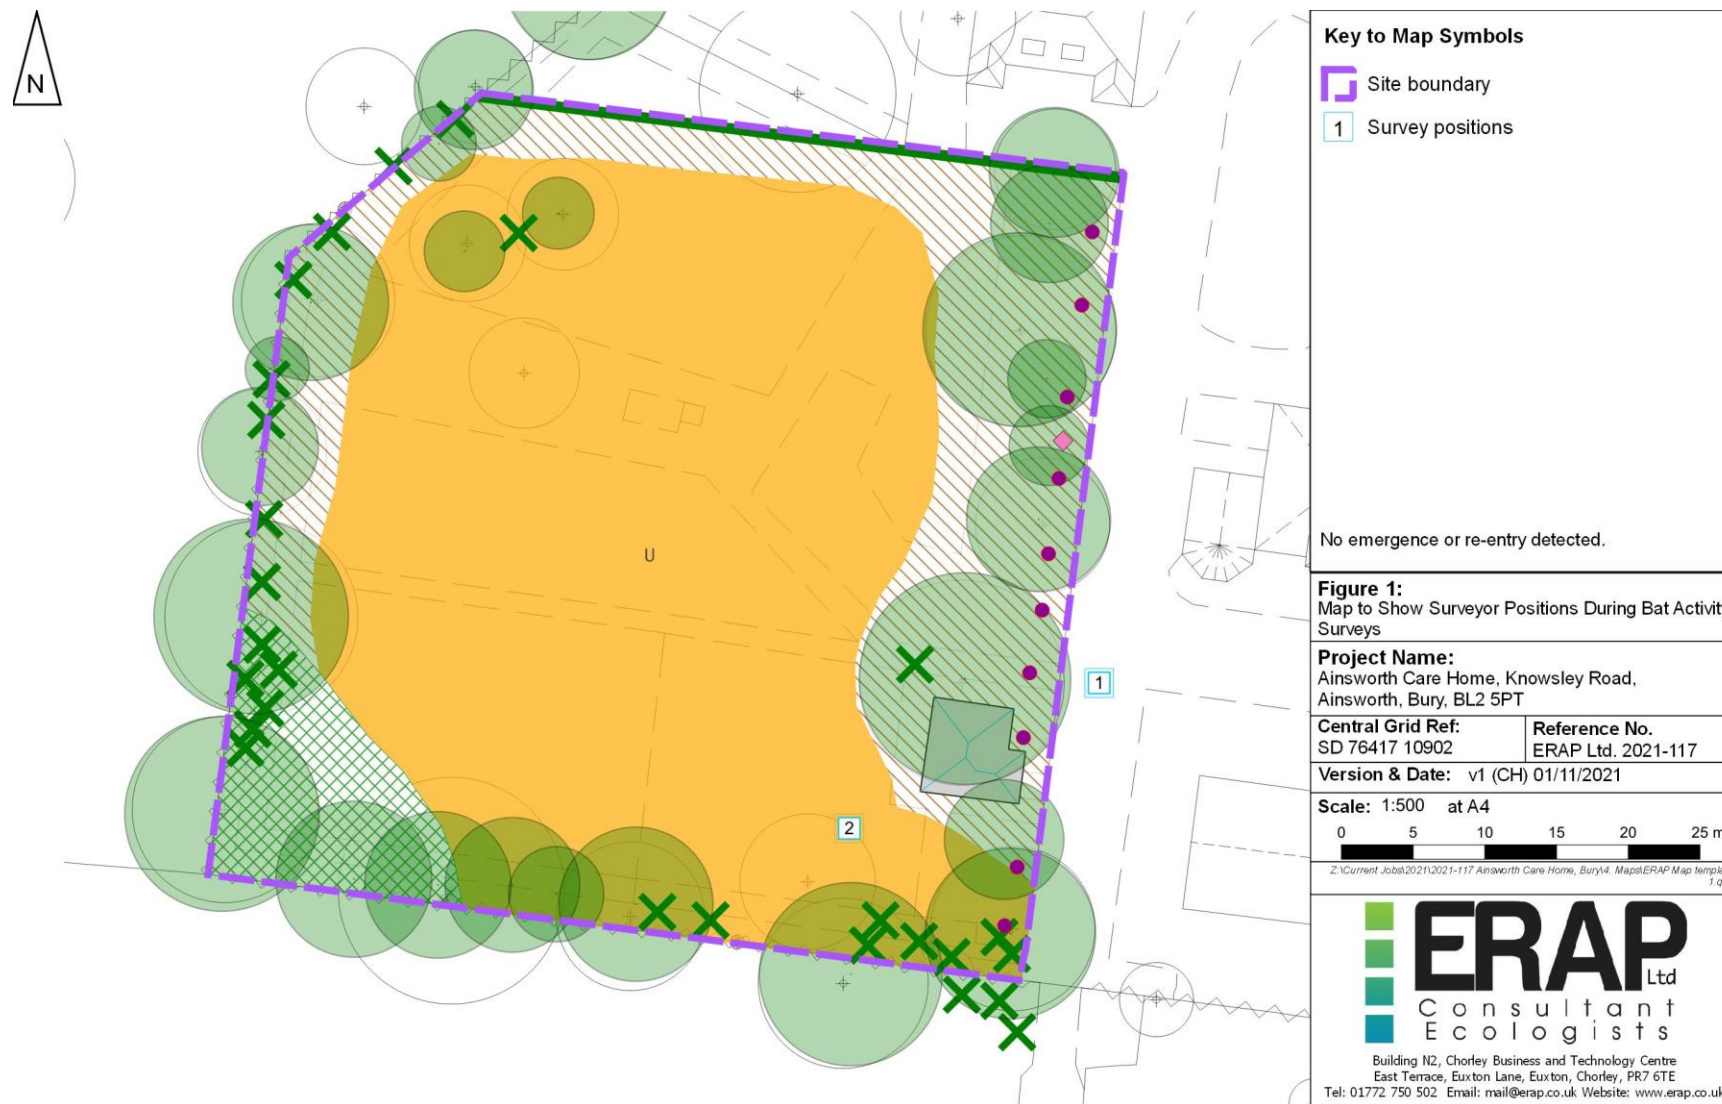
**Figure 1: Map to Show Bat Activity Surveyor Positions**

- 2.1.1 Two surveyors, experienced in conducting bat surveys, were positioned at suitable locations to maximise the coverage of the roof and elevation walls of the gate house (including all potential roost features identified during the daylight survey and assessment) to determine any emergence or re-entry into the building by roosting bats. Surveyor positions are presented at **Figure 1**.

- 2.1.5 The survey information is presented below. Surveyor positions are presented at **Figure 1**, appended.
