# **Whitefield Fire Station, Whitefield**

## **Phase 2 Geo-Environmental Investigation Report**

For: Greater Manchester Combined Authority (GMCA)

Ref: 3866a-02  
Job: 3866a  
Rev: A  
By: LM

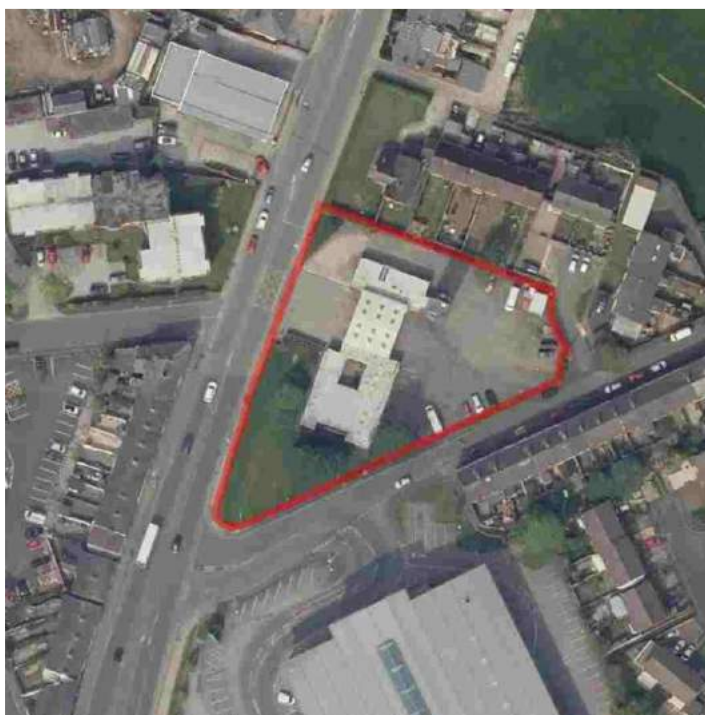
*Figure 1: Aerial image of the site dated March 2019. The approximate site boundary is highlighted in red.*

The site is currently occupied by a single-storey masonry fire station building with associated five-storey training tower, areas of hardstanding in the northern site section and soft landscaping in the southern site section. Access to the site is off Bury New Road along the western boundary of the site. The site is bound by residential dwellings to the north and east, Bury New Road to the west and a gym to the south. An aerial photo of the site is included below and a Site Location Plan is contained in Appendix 2.

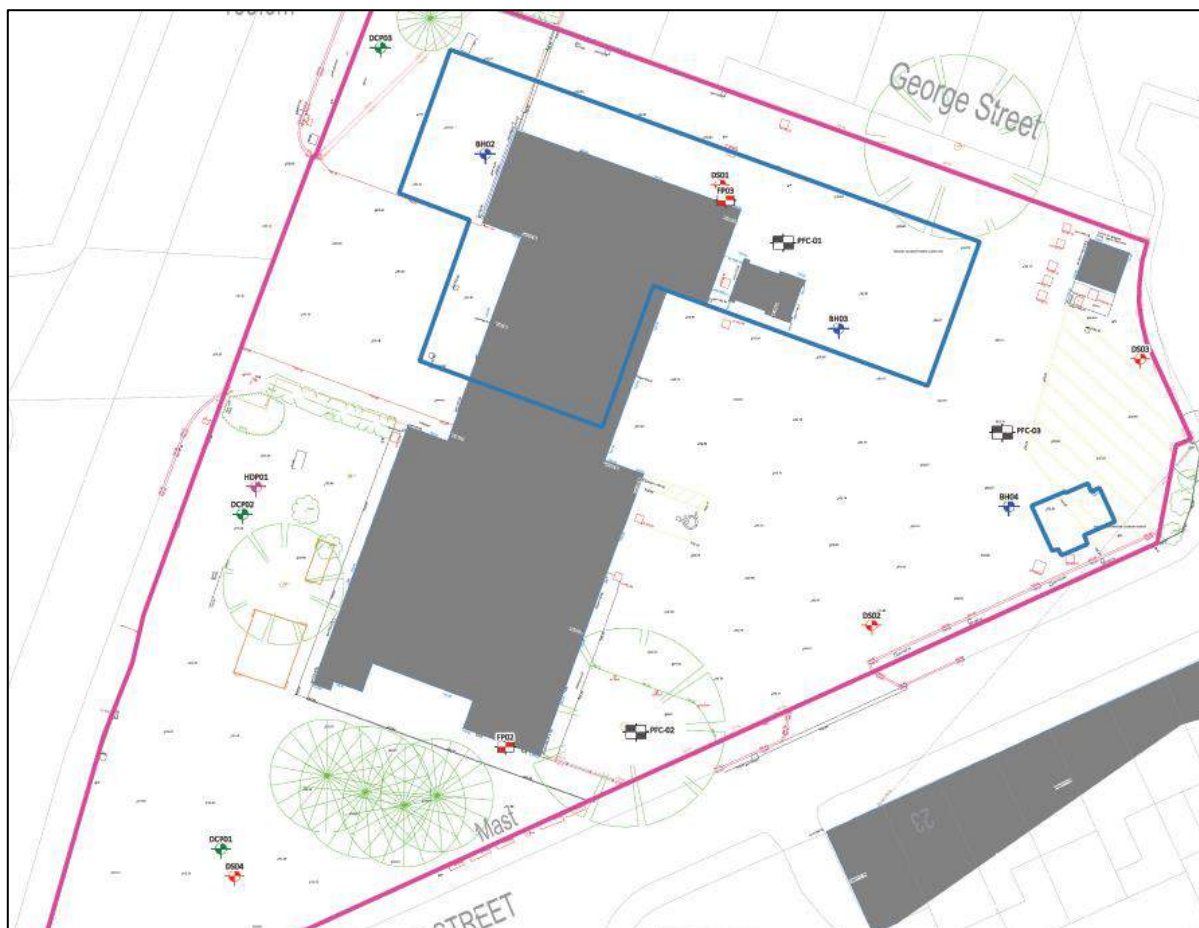
Figure 3: Exploratory Hole Location Plan extract. Taken from IGE Drawing SI-05 rev A.

An extract of the exploratory hole location plan is presented below as Figure 3, with the full plan contained in Appendix 2.

The foundation inspection pit locations are shown on the exploratory hole location plan in Appendix 2 and the exploratory hole logs are included in Appendix 5.

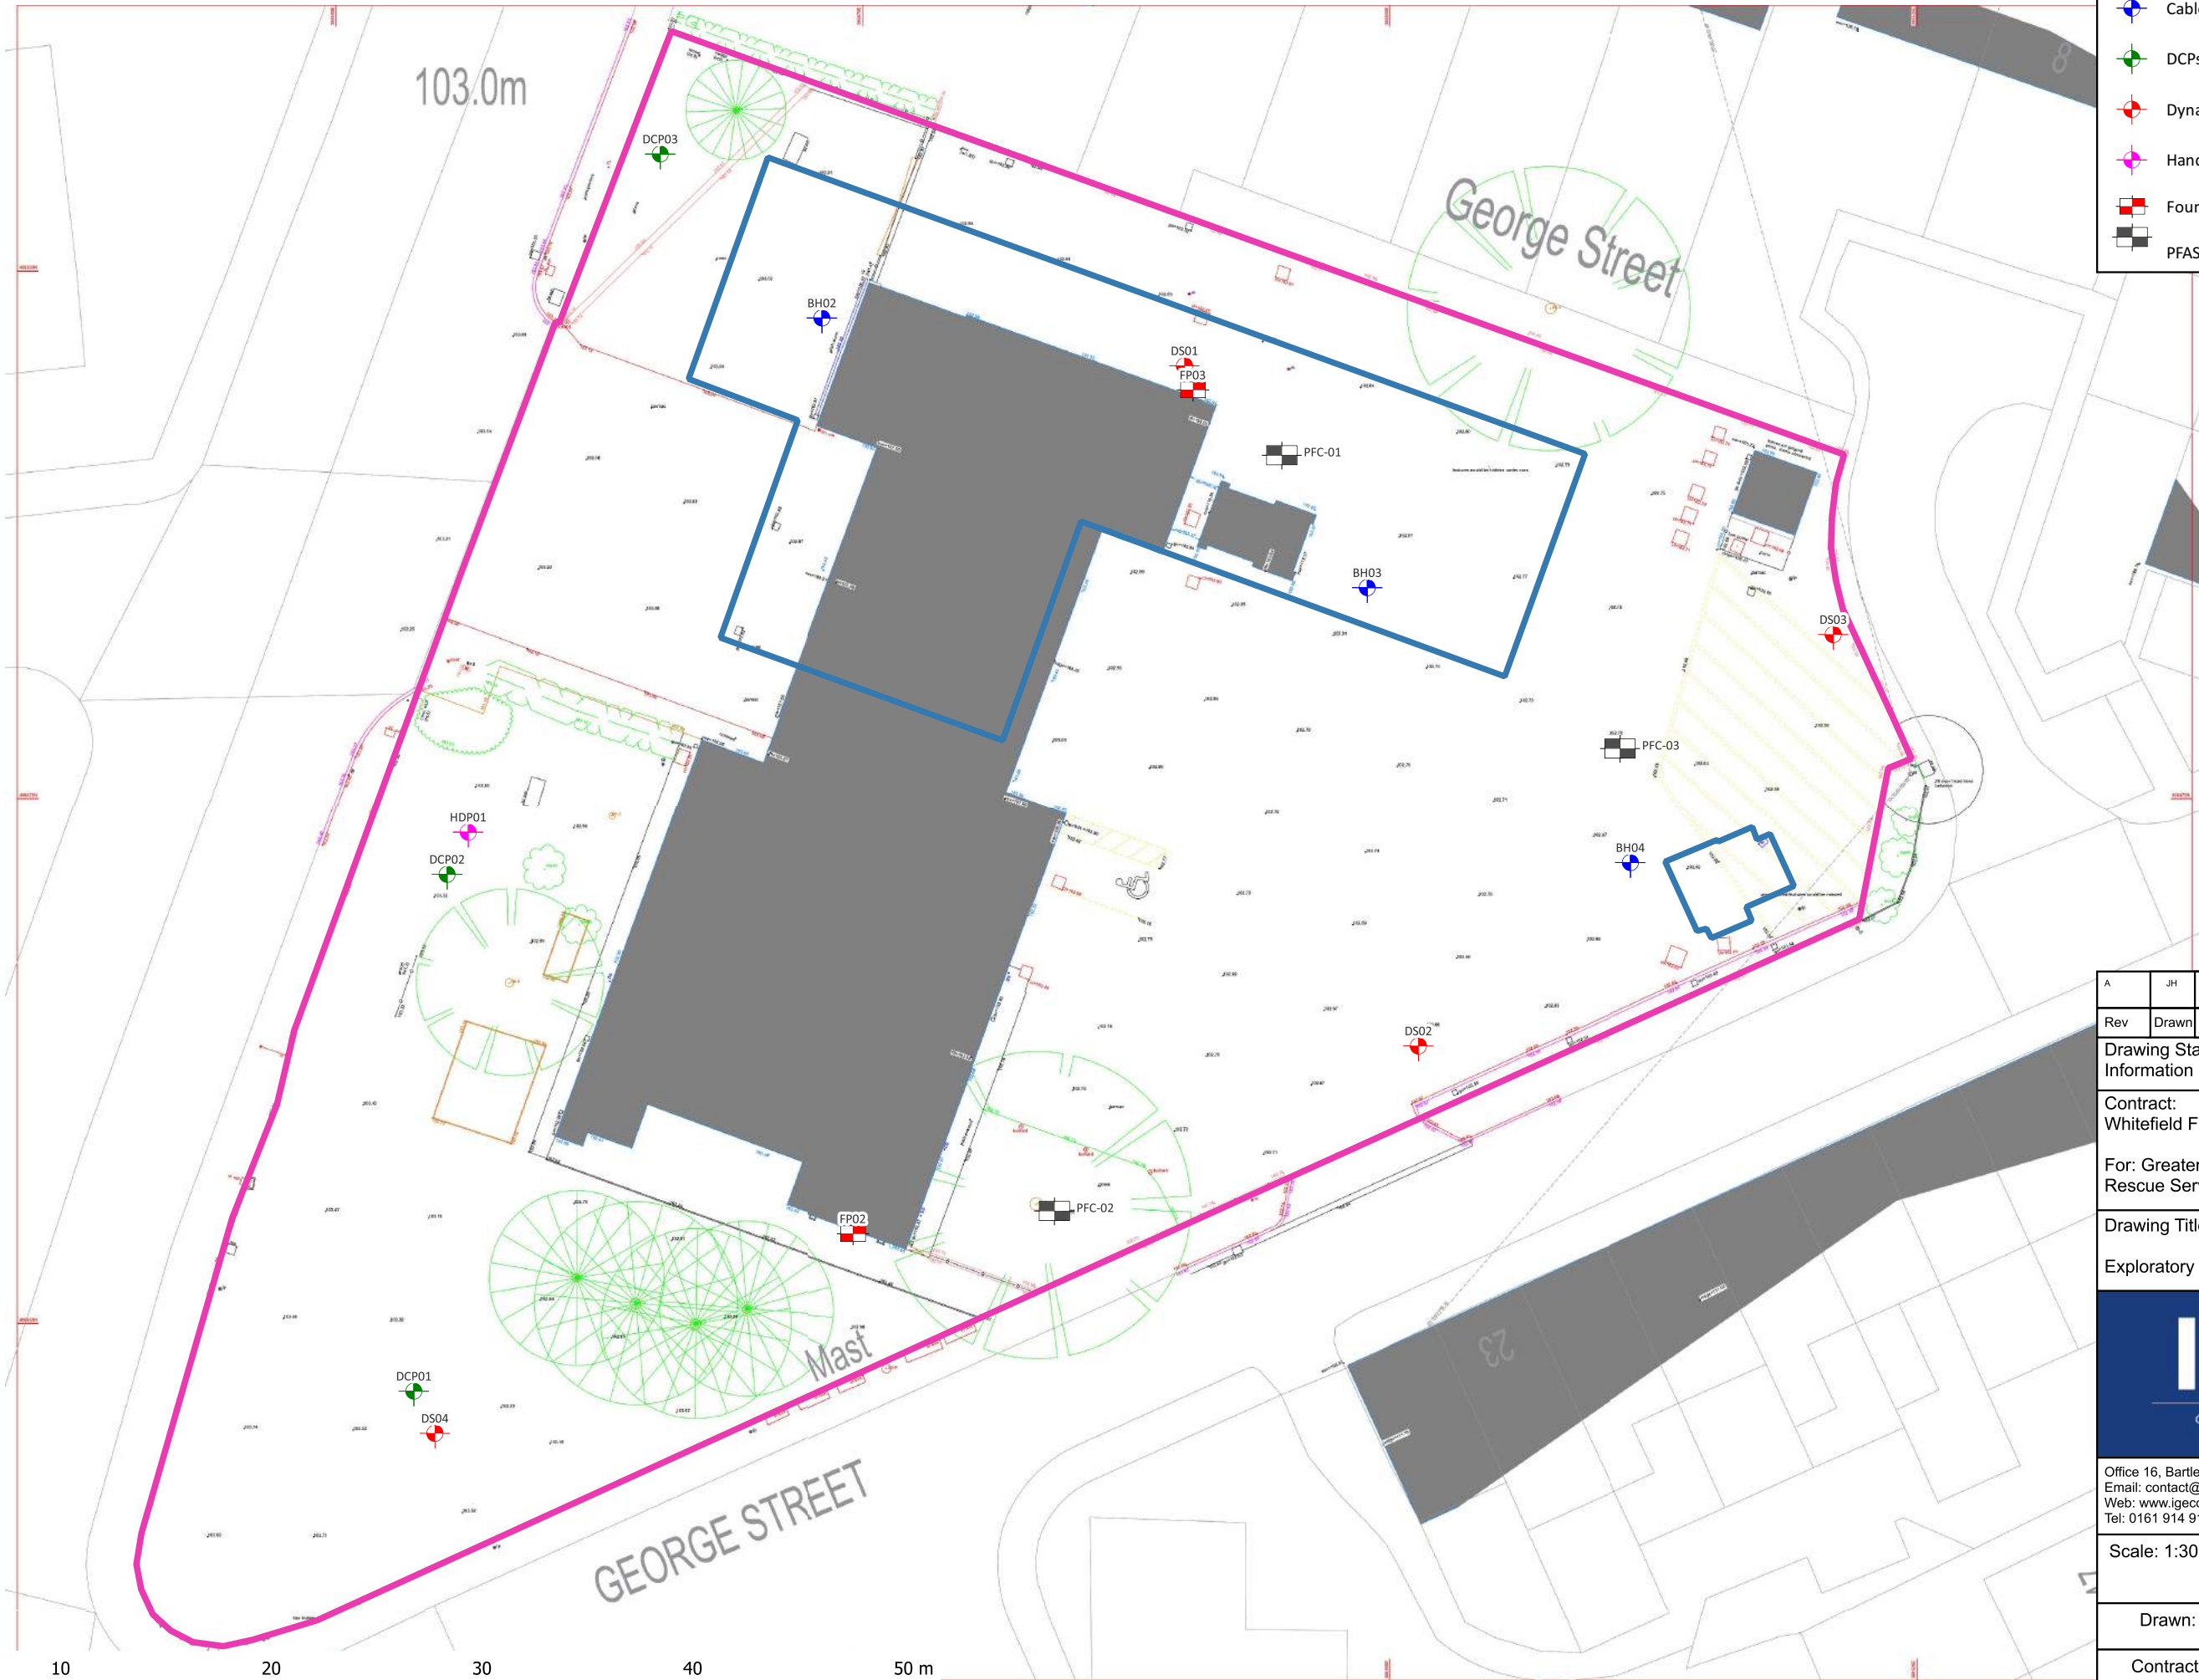
- Approximate Site Boundary
- Proposed
- Cable Percussive Boreholes
- DCPs
- Dynamic Sample Boreholes
- Hand Dug pit
- Foundation Inspection Pits
- PFAS Cores

| A | JH | 04/05 | oundation Inspection Pits & PFAS Cores | |
