# Land at Spring Vale Street, Tottington

## Phase 1 Geo-Environmental Investigation

For: Pavetec Solutions Ltd.

Date: April 2020

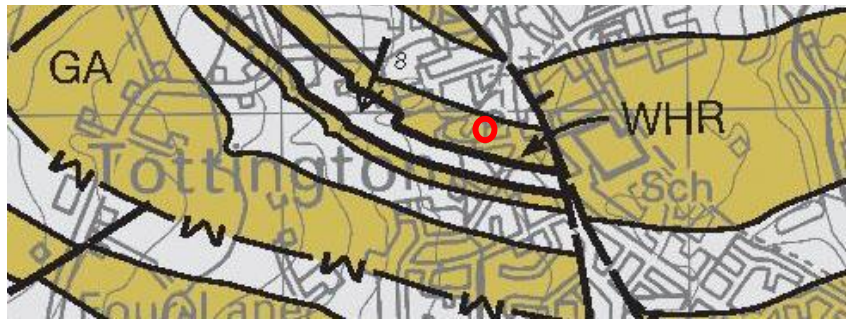
The BGS 1:50,000 'Solid' Geological Map of the area (Sheet Number: 85, dated: 2010), indicates that the site is underlain in turn by bedrock comprising the **Woodhead Hill Rock** (comprising sandstone) of the **Pennine Lower Coal Measures**, indicating that the site is within the coalfield. An extract of this map is shown below:

Figure 3 - Extract of the BGS 1:50,000 'Solid' geological map (sheet 85, 2010). Site circled in red. Brown = Woodhead Hill Rock (Sandstone). Grey = Pennine Lower Coal Measures (Mudstone). Black thick lines = coal outcrops. Black dashed lines = geological faults (tick marks on downthrow side).

A geological fault is recorded 127m north east of the site, trending north west to south, downthrowing to the east.

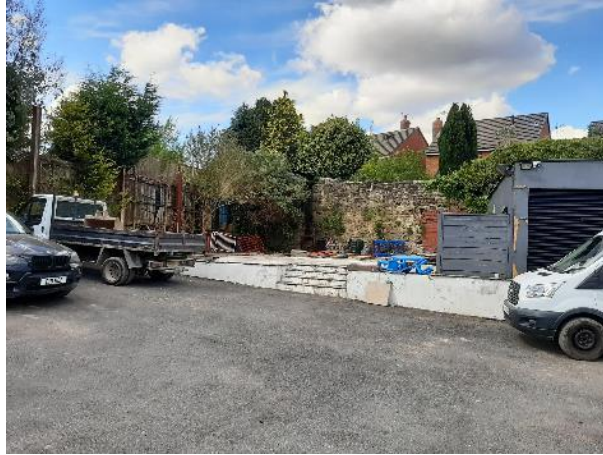
*Figure 1 - Looking north west showing a general view of the site and the site's sloping topography.*

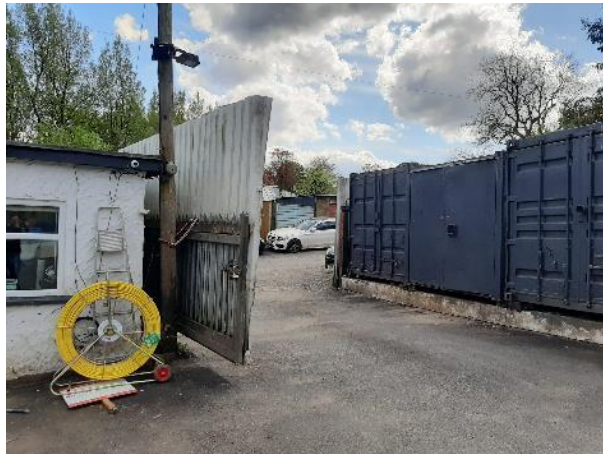
*Figure 2 - Looking south showing the site entrance and a concrete plinth in the south western site corner with 3 No. storage containers.*

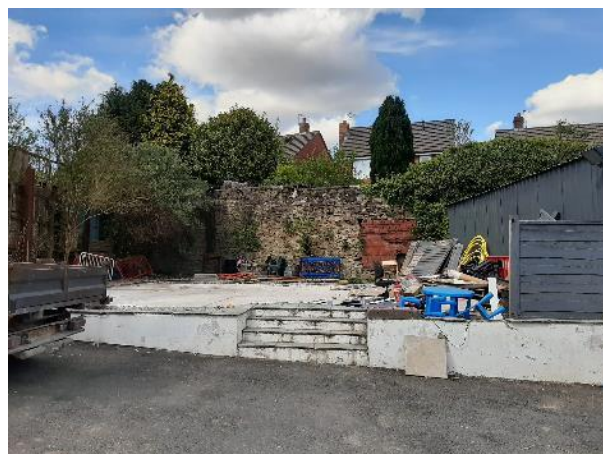
*Figure 3 - Looking north showing the flat concrete plinth in the northern site section and the retaining wall on the northern boundary.*

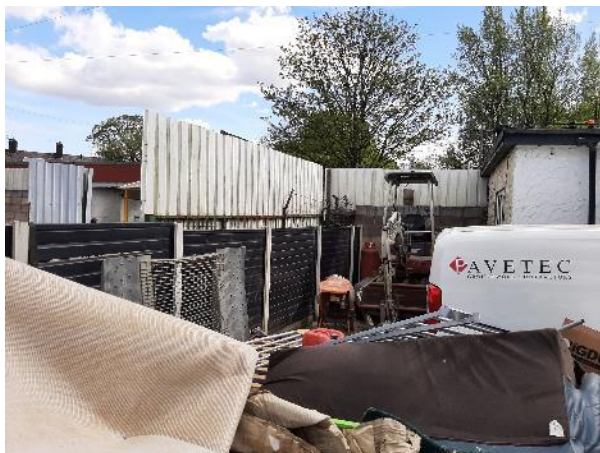
The site contains numerous vehicles and a small excavator, along with various stored / tipped materials. No evidence of contamination was noted on the site.

*Figure 6 - Looking south towards the south eastern site corner. Plant is stored and materials are stored / tipped.*

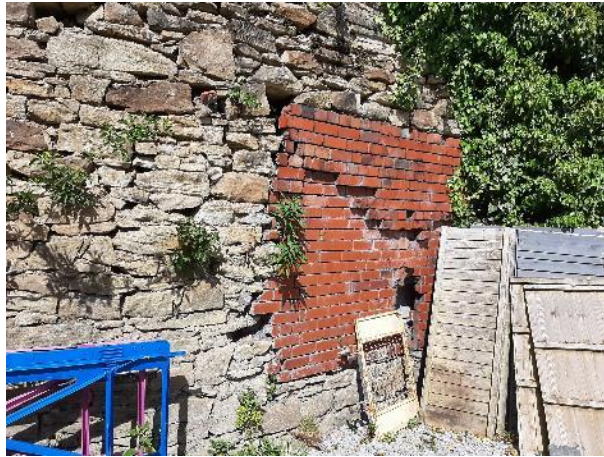
Numerous mature trees line the western boundary. The site is fenced along the eastern, southern and western boundaries. The northern boundary is defined by a retaining wall, c. 4m in height, but only retains c. 2.0-2.5m of material to its off-site (northern) elevation. The wall is of stone construction with brick repair patches and appeared to be in poor condition in places. Plants were noted to be growing on and out of the retaining wall. It is recommended that a survey of the retaining wall is undertaken by an appropriately qualified engineer.

| <b>Retaining Wall</b> | A retaining wall, which appears to be in poor condition, forms the northern site boundary. | There is a potential for collapse and significant ground movement if the retaining wall failed.<br><br>An assessment of this should be undertaken. | <b>UNKNOWN</b> |

*Figure 7 - Looking north; the northern site boundary is a retaining wall which appears to be in poor condition.*

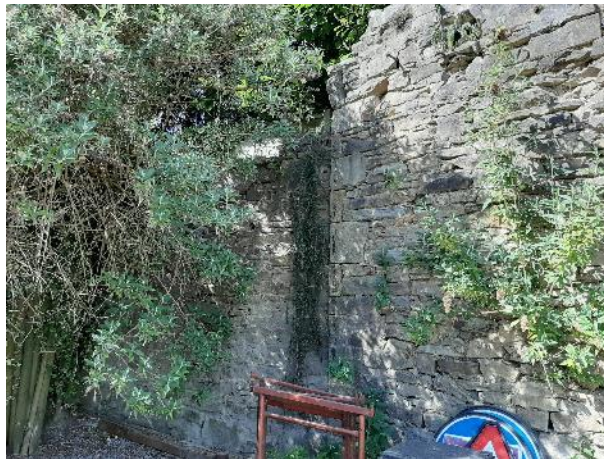
*Figure 8 - Looking north west at the north western site corner. The retaining wall is of stone construction and many plants are growing on / out of it.*
