# Land at Spring Vale Street, Tottington

## Phase 2 Geo-Environmental Ground Investigation Report

For: Pavetec Solutions Ltd.

Ref: 3388 - 02  
Job: 3388  
Rev: -  
By: JH

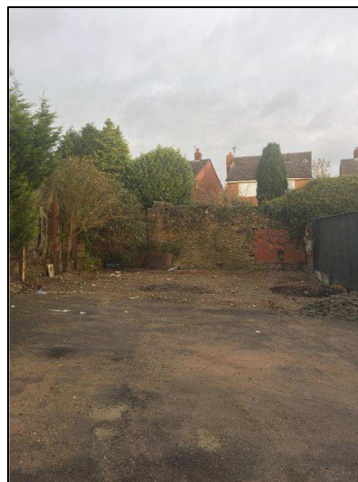
The northern boundary is defined by a retaining wall, c. 4m in height, but only retains c. 2.0-2.5m of material to its off-site (northern) elevation. The wall is of stone construction with brick repair patches and appeared to be in poor condition in places. Plants were noted to be growing on and out of the retaining wall.

*Figure 1: Looking north: site photo showing the north of site.*
