# AFFETSIDE CHAPEL, WATLING STREET, AFFETSIDE

## Nocturnal Bat Survey Report

*JUNE 2023*

*Project Name:* Affetside Chapel, Watling Street, Affetside, Bury  
*Project Reference:* CW20-681  
*Report Title:* Nocturnal Bat Survey Report  
*Report Reference:* CW20-681 RPT 002  
*Printing Instructions:* Print at A4 Portrait, Double Sided.

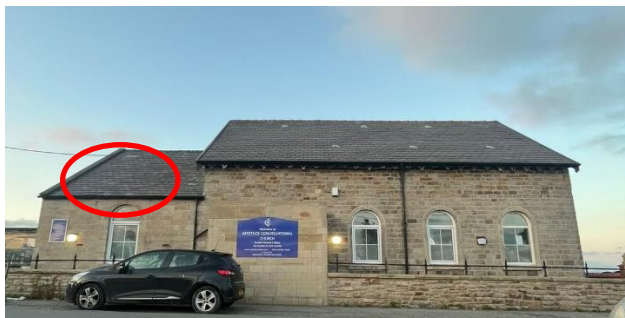
Table 3.1 Roost Locations

- 3.3.2. A total of one emergence location were observed, indicating that there is one common pipistrelle roosting in relation to the roof on the south-western aspect of the site. Please refer to Table 3.1 and Figure 3.1 for the emergence location. It is deemed that the bat is roosting between the tiles and roofing felt.

- 3.3.3. Based on one bat observed roosting during the first survey, but no bats being recorded during the second survey indicated that the roost is non-breeding summer roost for low numbers of common pipistrelle (peak count 1 bat). Bat roost categorisation was possible as surveys were completed during maternity roost season. As stated in the best practice guidelines (Collins, 2016) to determine the presence of a maternity roost surveys are to be carried out in the months of May to August. In addition, one emergence was only recorded on the first survey and there were none recorded in the second survey, providing confidence in the roost assessments.

| Roost | Photograph |
|---|---|
| Roost 1- observed on 31/05/2023 | |

- 4.2.3. **The roosts located on the building will be removed under the supervision of the registered licenced bat ecologist under the Natural England BMCL. No works to the building should be completed until the bat roosts have been destroyed under the BMCL. If works proceed without the BMCL, the client is at risk of breaching legislation.**

4.3.4. Once the selected features (i.e. the ridge and slate tiles at the emergence points) have been removed under supervision, works can proceed in the absence of the licenced ecologist, at their discretion. If a bat is discovered at any unsupervised time, work must cease immediately, and a licenced bat handler must be called for advice. This advice will include leaving the bat to disperse of its own accord or wait for the licenced ecologist to move the bat. Builders and contractors are explicitly forbidden from handling bats except in the case of finding a trapped or injured bat. In which case the bat may be moved into a safe and secure place (e.g. a box) and the registered ecologist must be contacted immediately.

4.4.2. To mitigate for the loss of bat roosts, one multipurpose bat boxes will be installed prior to the re-roofing of the building. The bat box is aimed at crevice-dwelling bats, such as common pipistrelle found to be roosting in the building. Box types such as Greenwood’s Ecohabitats – Two Crevice Bat Box (or of similar specification) would be suitable.
