# AFFETSIDE CHAPEL, WATLING STREET, AFFETSIDE

## Preliminary Ecological Appraisal Report

*December 2022*

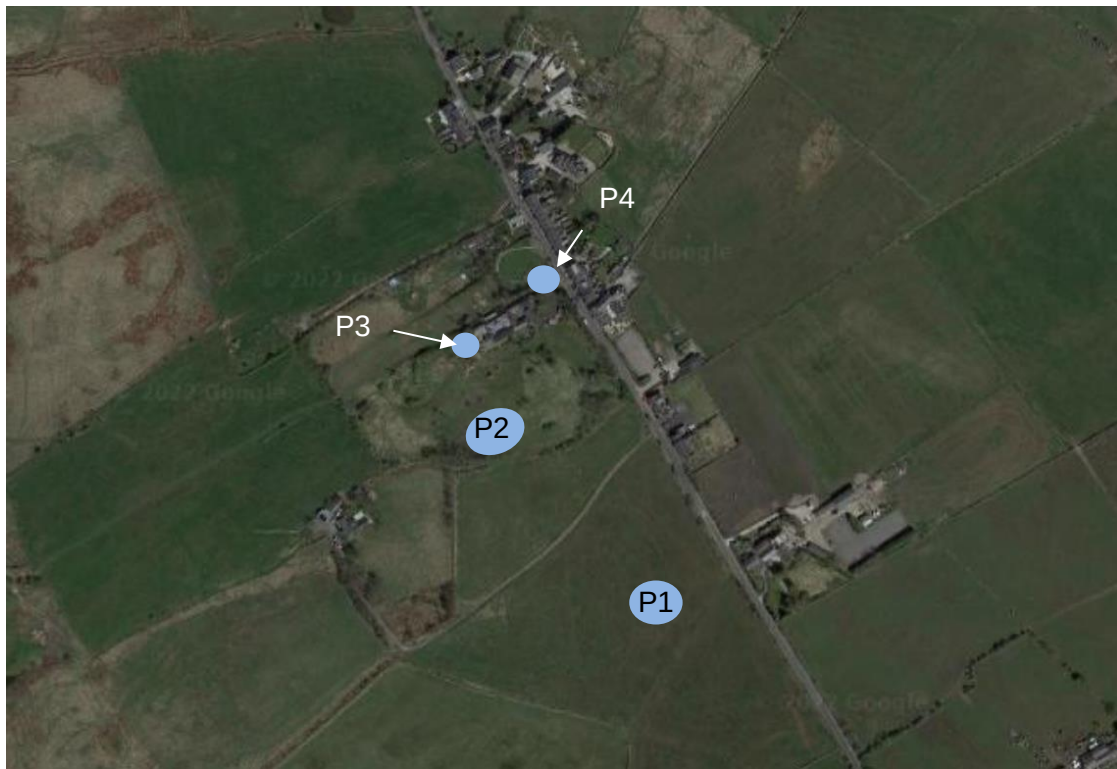
Map 2.2 Pond Locations

3.4.8. No ponds were located within the site, although 4 ponds were identified within 250m of the site boundary (P1, P2, P3 & P4). As great crested newts' upper dispersal limited is generally considered to be up to 250m from a water body (though occurrence of greater distances does exist), (English Nature, 2001).

3.5. P1 was found to be dry at the time of survey, comprising a shallow ditch colonised by grasses. It is likely this feature will fill with water during high periods of rainfall. A HSI assessment could not be undertaken.

3.7. P4 was found to be ornamental in nature and located within an area of POS. The pond was stocked with fish. P4 scored 0.33 Poor.

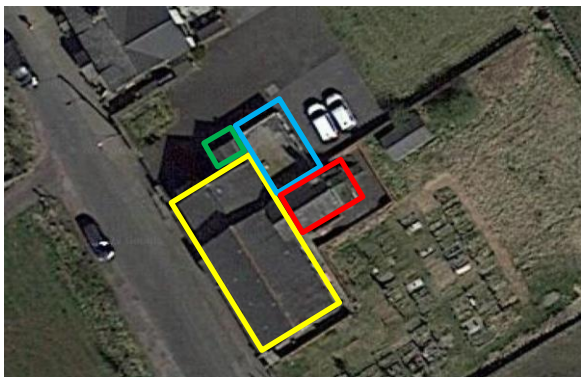
| Building Ref | Description | Photograph |
|---|---|---|
| | <p>Yellow= Main Building</p> <p>Red= Extension 1</p> <p>Blue= Extension 2</p> <p>Green= Extension 3</p> | |

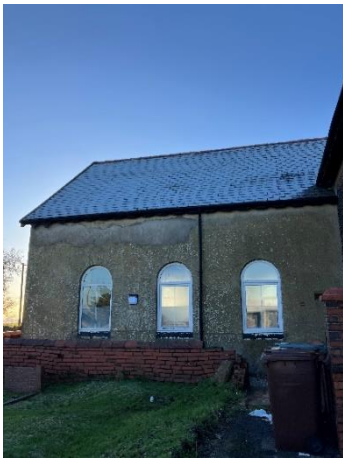
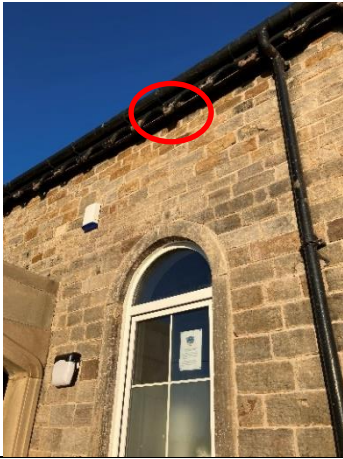
| Building Ref | Description | Photograph |
|---|---|---|
| Main Building<br>(External) | <p>The main building was made of stone on all aspects other than the north-eastern which had a rendered wall. All windows were well sealed with no gaps identified. It had a slate roof which has slipped tiles and gaps on all aspects of the main building. These are anticipated to be potential roosting features. Potential gaps were identified on the mortar on the main building.</p> <p>It should be noted that a historic birds nest was located on the southwest of the building which has been outlined within the photographs.</p> | |

3.8.11. The building was found to provide **moderate bat roosting potential** based on criteria outlined in Collins (2016). A number of potential roost features were identified throughout the external of the building which could support crevice dwelling bats. In addition, the cellar could not be accessed and it is unknown if the cellar provides value for maternity or hibernating bats.

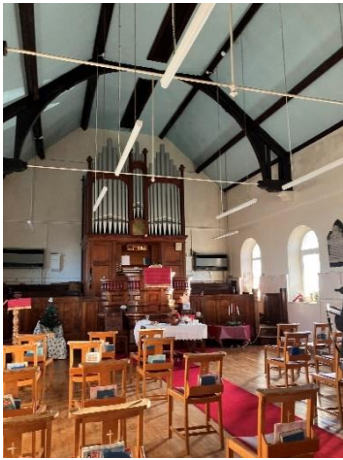
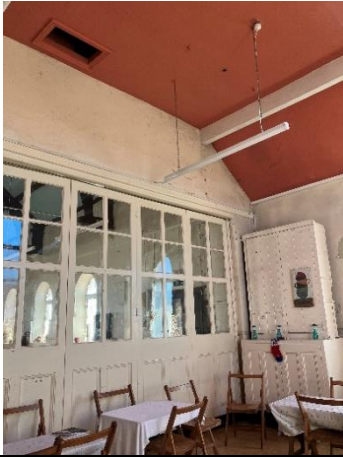
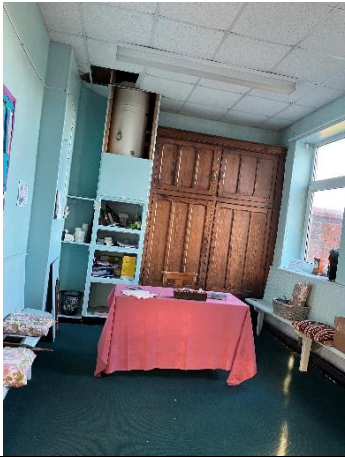
| Main building (Internal) | <p>The main building consisted of a main commonly used chapel, a common room, an office space, and toilets. All rooms were painted and plastered throughout with single glazed windows. It should be noted that the office space consisted of false ceiling. There were no gaps or crevices throughout the internal aspect of the building.</p> <p>It should also be noted that an unused cellar was located underneath the main building which could not be accessed, according to the client the cellar is well sealed.</p> | <br> |

- 5.1.2. In addition, the cellar should be accessed to determine suitability for hibernating bats. If found to be suitable, a static bat detector should be installed between December – February to determine presence/ absence of hibernating bats.

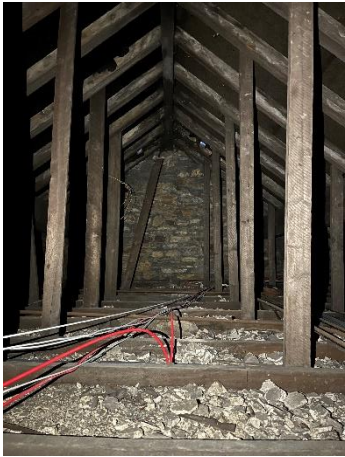
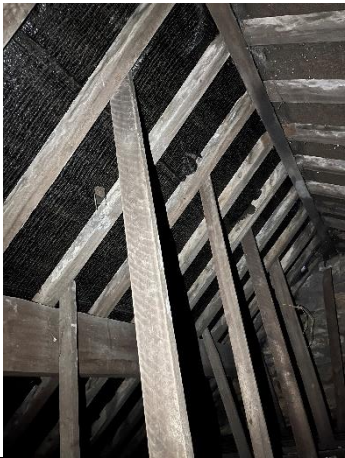
| Loft Space in Main Chapel | The internal aspect of the loft space consisted of two gaps allowing natural light located on the north-western aspect of the site. Holes were also identified within the roofing felt which was located on the western on the aspect of the loft space. | |

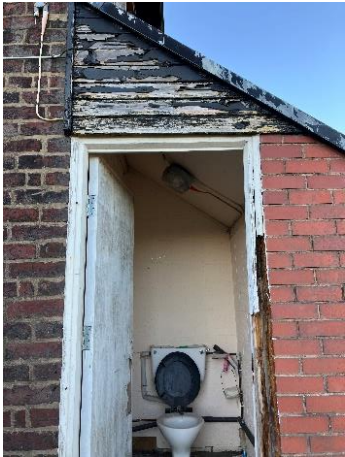
| Extension 1 on eastern aspect (External) | Extension 1 consisted of small extensions located on the north-eastern aspect of the building made up of red brick. The brickwork was in good condition with no gaps identified throughout. There were no gaps on the lower part of the extension. Although, on the upper level of the building a gap was identified on the mortar. | |

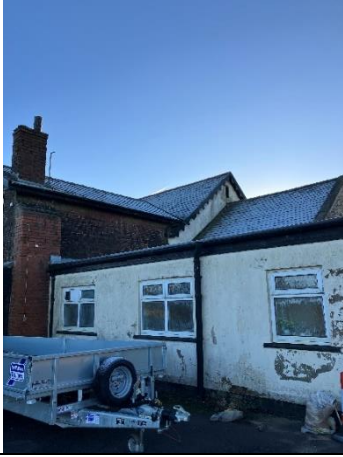
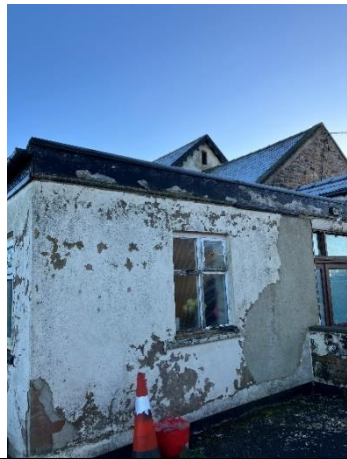
| Extension 2 | <p>Extension 2 consisted of a renovated building with a flat roof with a fascia board all of which was well sealed. No gaps were identified throughout Extension 2.</p> <p>The internal aspect of the property could be accessed through the main building and was commonly used and no PRFS were identified.</p> | |

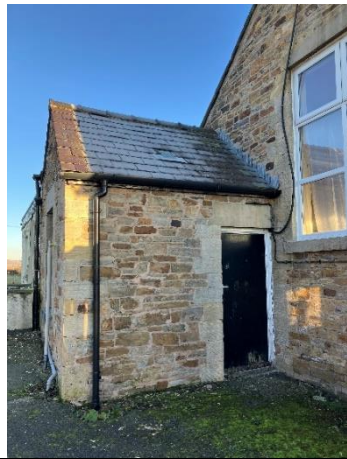
| Extension 3 | Extension 3 was found to have no gaps within the brickwork, however slipped tiles were identified on the roof of the extension. | |

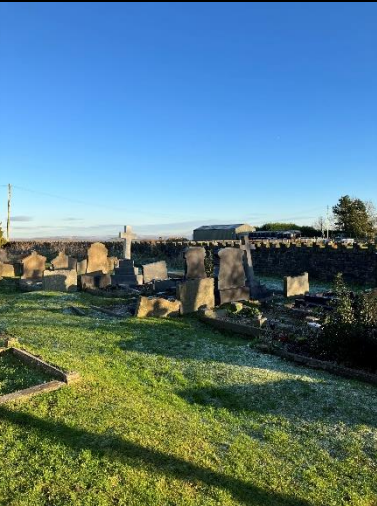
| Feature | Photograph | |
|---|---|---|
| Modified grassland with gravestones. | | |

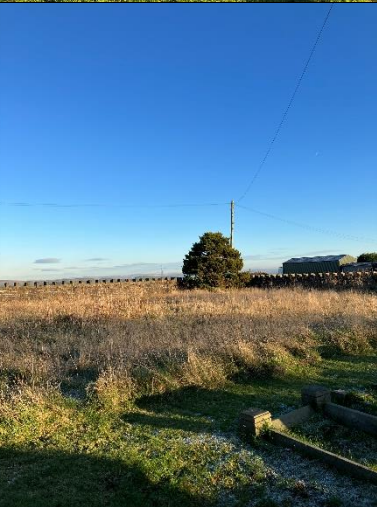
| Feature | Photograph | |
|---|---|---|
| Poor Semi-neutral Grassland with conifer tree. | | |

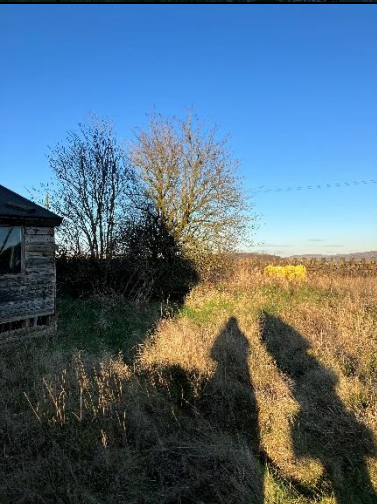
| Feature | Photograph | |
|---|---|---|
| Poor Semi-neutral Grassland and hawthorn tree. | | |

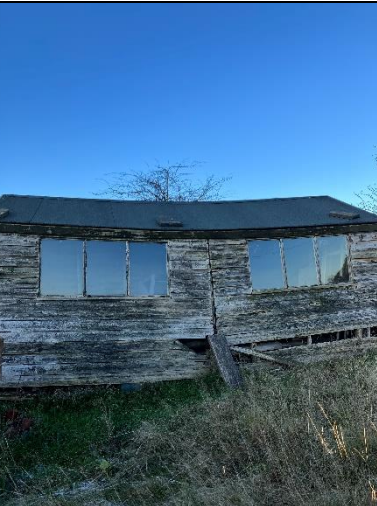
| Wooden shed on eastern aspect. | | | |

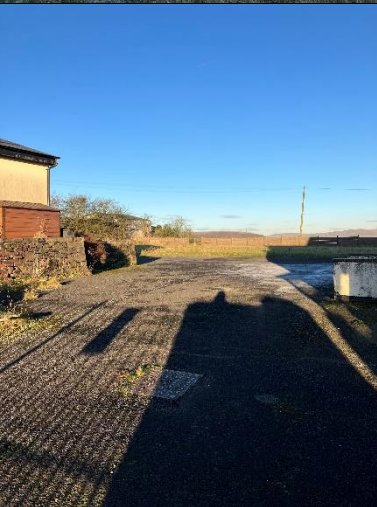
| Hardstanding ground with poor semi-neutral grassland. | | | |

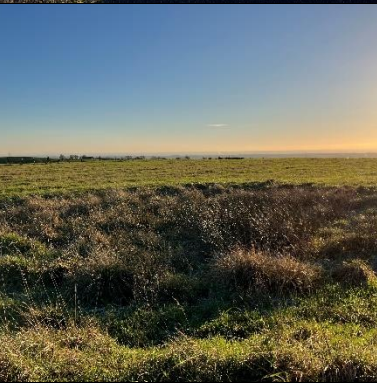
| Pond 1 (Dried up) | | | |

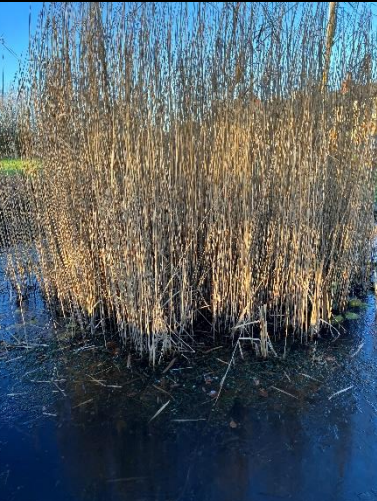
| Pond 4 | | | |
