## Preliminary Ecological Appraisal and Roost Assessment

2 Delamere Avenue, Whitefield, Manchester, Bury, Greater Manchester, M45 7WJ

This report is prepared to inform a planning application with the Bury Metropolitan Borough Council. The proposal is described as:  
Demolition of existing three-bedroom domestic dwelling. Construction of new build three-bedroom domestic dwelling.

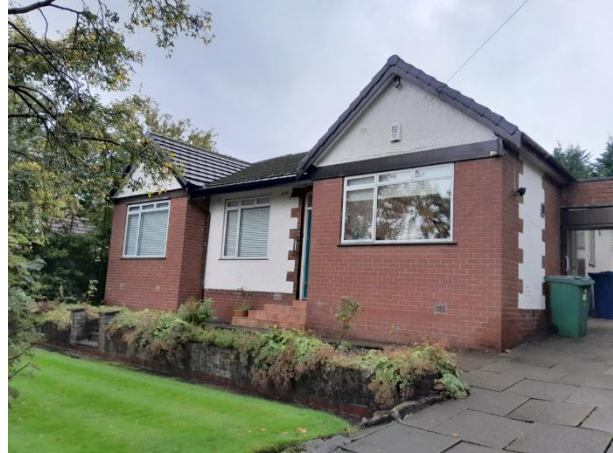
| <p><i>Summary</i></p> <p>B1 is a single storey, residential dwelling, with a hipped roof and two gables to the north of the building. The roof is constructed of cement tiles, with a brick and rendered walls. There is a plastic sheeting lean to on the west of the building. A small flat roof section is on the southern elevation, with a bitumen lined roof. There is one loft space present within the building. ~50 droppings were found on external walls below a gap in the soffit on B1.</p> <p>The building has <b>high habitat value and is a confirmed roost.</b></p> | | | |

| <i>Recommendations</i> | <p><b>Roosting habitat [Buildings]</b><br/><b>B1:</b> Three bat emergence/re-entry surveys are required on B1 during the active bat season (May – September) to confirm presence/likely-absence of bats roosting in or on the building.<br/>These survey visits should be completed during the optimal survey period mid-May to August inclusive. The survey visits should be at least three weeks apart.<br/>Sub-optimal: early May and September. Would require greater justification of timing e.g., weather conditions, known local bat activity.<br/>Three surveyors are required to provide full coverage of the building's elevations to look for emerging/re-entering bats. An infrared camera should also be employed at each position as part of the survey to see where any specific roost locations are located.<br/>Lighting mitigation may be required based on the outcome of the night bat survey(s).<br/>An EPSL application to Natural England will be required. The EPSL application requires that all surveys have been undertaken within the most recent active bat season and planning permission must have been granted and all relevant wildlife-related conditions have been discharged prior to submission.</p> <p><b>B2:</b> Two bat emergence/re-entry surveys are required on B2 during the active bat season (May – September) to confirm presence/likely-absence of bats roosting in or on the building.<br/>These survey visits should be completed during the optimal survey period mid-May to August inclusive. The survey visits should be at least three weeks apart.<br/>Two surveyors are required to provide full coverage of the building's elevations to look for emerging/re-entering bats. An infrared camera should also be employed at each position as part of the survey to see where any specific roost locations are located.</p> |

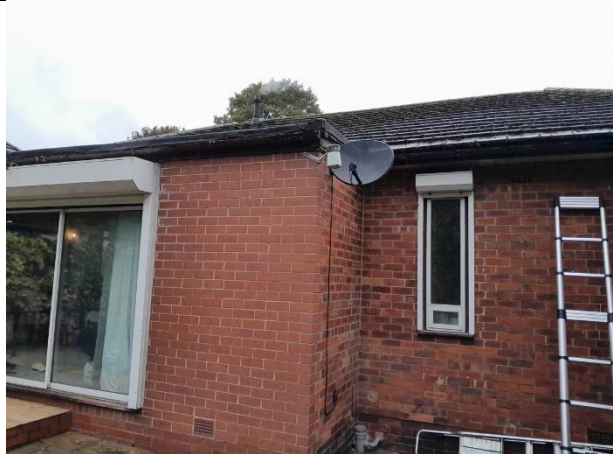
| Walls | Render and brick | <p><b>Condition/description</b></p> <p>The walls are well sealed with no observed cracks or crevices.</p> <p><b>Suitability/access/evidence of bats</b></p> <p>No observed roosting features for crevice dwelling bats.</p> | | |

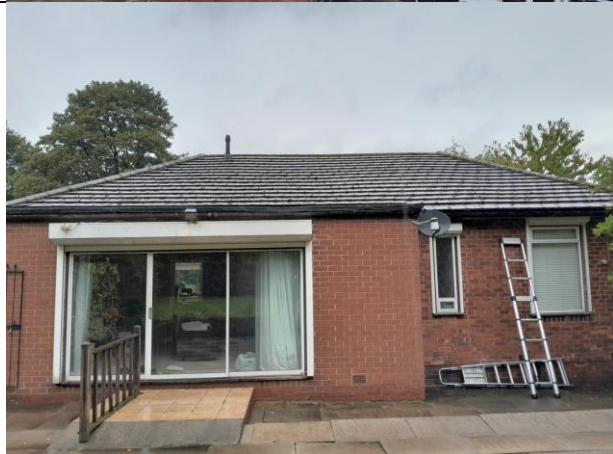
| Roof | Cement | <p><b>Condition/description</b></p> <p>The roof is overall well sealed, with tiles lying flush together. There are occasional lifted tiles to the north and the south of the building. The observed gaps are typically observed to be too small to offer roosting features for bats.</p> <p><b>Suitability/access/evidence of bats</b></p> <p>The gaps between the tiles are considered too small to offer roosting features for bats.</p> | | |

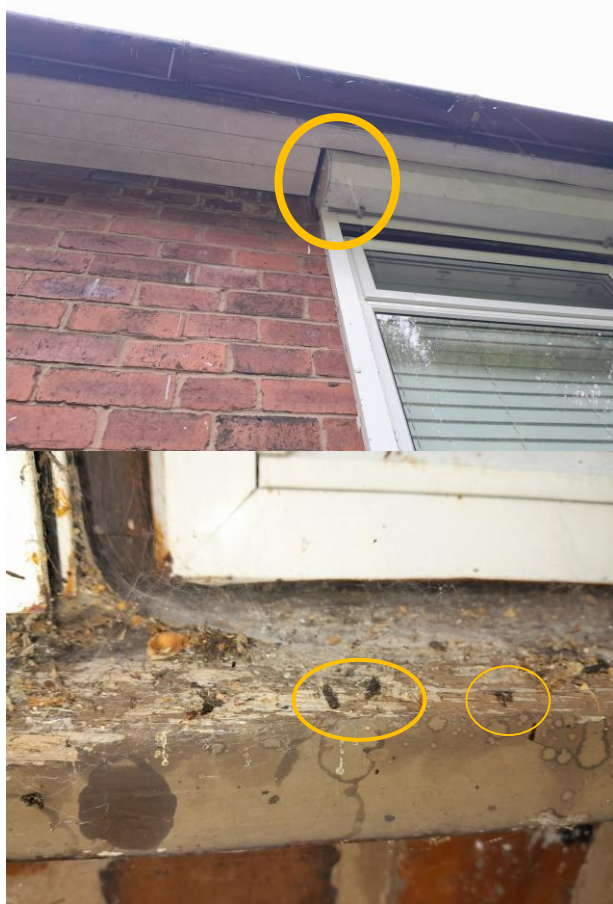
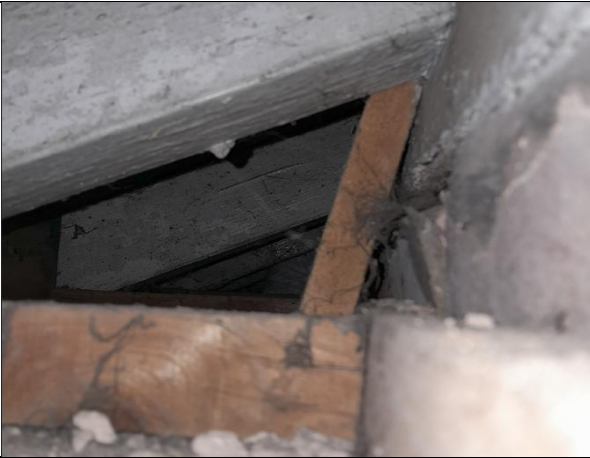
| Eaves | Overhanging | <p><b>Condition/description</b></p> <p>There is a gap in the eaves to the left of the top of the window on the southern elevation. This gap is observed to lead further into the roof space.</p> <p><b>Suitability/access/evidence of bats</b></p> <p>The gap allows internal access into the roof space. There are ~50 bat droppings below this feature, on the walls and the window which suggest recent use of this feature by bats.</p> | |

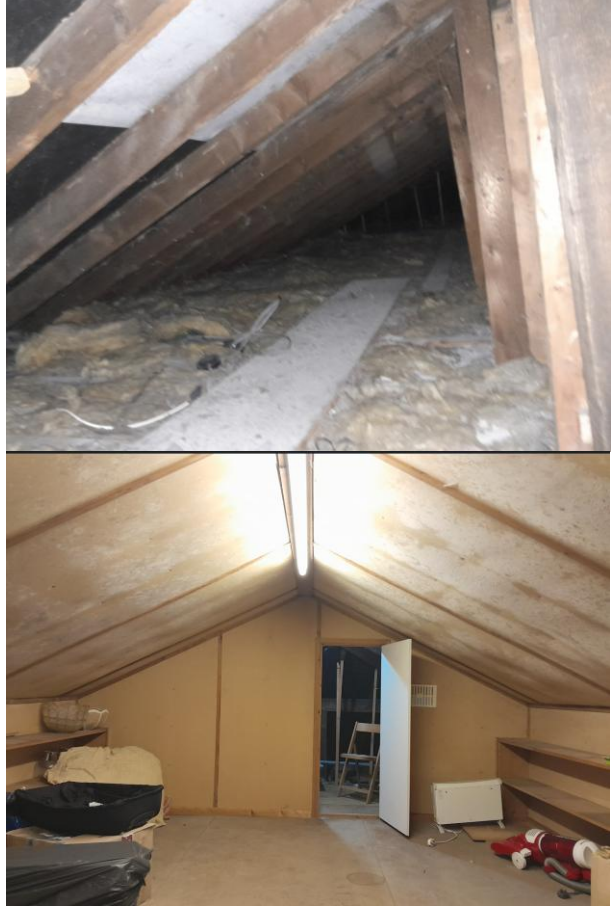
| Internal voids | Timber rafters and ridge beam. | <p><b>Condition/description</b></p> <p>The loft is separated into two voids via wooden boarding and a doorway.</p> <p>Void 1: walls are wooden, with a wooden boarding on the ceiling and wooden boarded floors. This void is utilised for storage and has artificial lighting present. The void is ~8m long, ~2.3m height and ~6.4m in width.</p> <p>Void 2: the second void is unboarded, with exposed beams and lining. The lining present is a mix of breathable membrane and bitumen felt. The insulation is mineral wool and is located along the floor of the void. The void further wraps around the building. Measurements are ~2.4m in height, ~10m in width (widest point) and ~12.7m length (longest point).</p> <p>The average temperature internally was ~21°C and 76% humidity.</p> <p><b>Suitability/access/evidence of bats</b></p> <p>There are sections of sagging in the lining present within the loft space which would allow ingress into the void for bats. Furthermore, void 2 has uncluttered space with no storage items present that would allow flight room for bats. No evidence such as droppings or bats themselves were observed internally.</p> | |

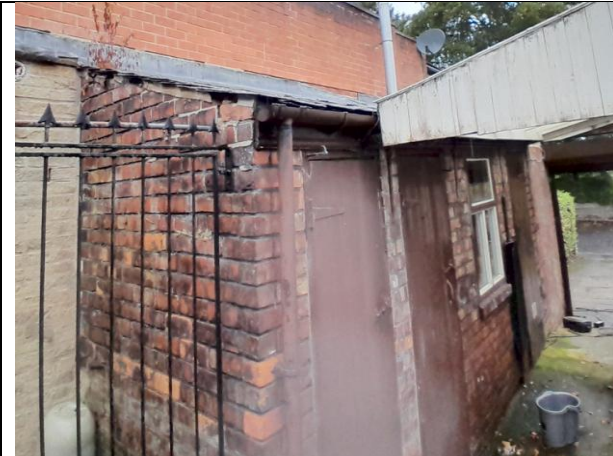
B2 is a small single storey outbuilding, with a sloped roof. The roof is slate tiles, the walls brick and the doors are wooden. There are no loft spaces present.

B2 is **moderate** for roosting bats.

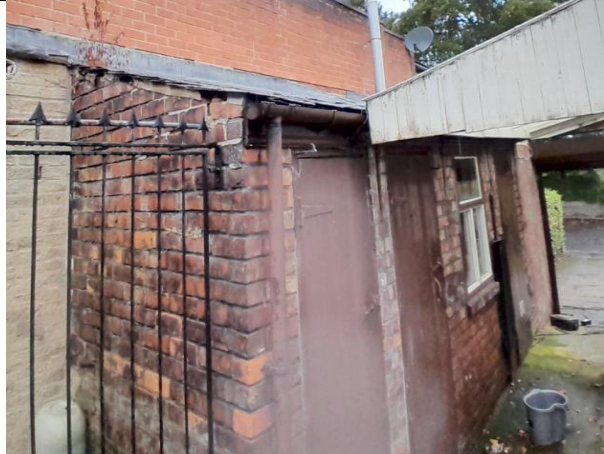
| Roof | Slate | <p><b>Condition/description</b><br/>There are several lifted tiles throughout the roof on B2.</p> <p><b>Suitability/access/evidence of bats</b><br/>The lifted tiles allow ingress internally and allow for crevices suitable for low number of bats. There is no lining present below the tiles and therefore the tiles do not lead to a large void for a large number of bats.</p> | | |

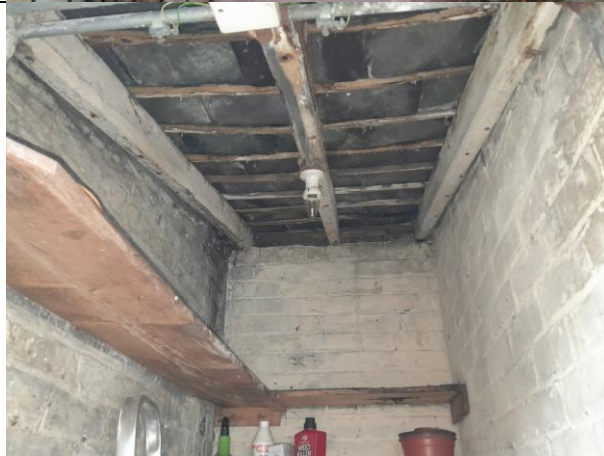
| Internal voids | Timber rafters and ridge beam. Open floor to ridge. | <p><b>Condition/description</b><br/>The internal of B2 is utilised for storage, with unlined roof and brick walls. There is damage present to the roof of B2 which allows ingress into the building. There are 3 internal voids of B2, with each void measuring ~1m wide, ~1.4m in length and ~2m in height. The internal measures ~14°C and 66% in humidity.</p> <p><b>Suitability/access/evidence of bats</b><br/>The roof allows ingress into the building, with the space not regularly disturbed which allows suitable roosting habitat for void dwelling bats.</p> | | |

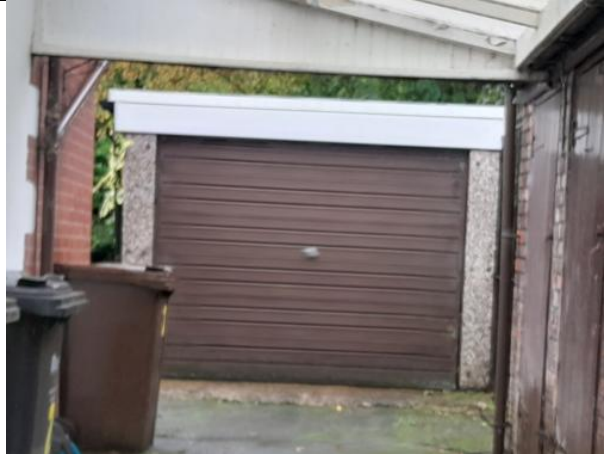
| <p><i>Summary</i></p> <p>B3 is a single storey garage, with a large garage door on the north of the building, The walls are pebble dashed, with plastic bargeboard. There is ivy present on the west of the building.</p> <p>B3 is <b>low</b> for roosting bats.</p> | | | | |

| | <p><b>B3:</b> One bat emergence/re-entry surveys are required on B3 during the active bat season (May – September) to confirm presence/likely-absence of bats roosting in or on the building.</p> <p>These survey visits should be completed during the optimal survey period mid-May to August inclusive. The survey visits should be at least three weeks apart.</p> <p>Sub-optimal: early May and September. Would require greater justification of timing e.g., weather conditions, known local bat activity.</p> <p>One surveyor and one unmanned infrared camera are required to provide full coverage of the building's elevations to look for emerging/re-entering bats. An infrared camera should also be employed at each position as part of the survey to see where any specific roost locations are located.</p> <p><b>Roosting habitat [Trees]</b></p> <p>In the unlikely event that a bat or evidence of bats is discovered during the development all work must stop and a bat licensed ecologist contacted for further advice.</p> <p><b>Foraging and commuting habitat</b></p> <p>No further surveys are required.</p> <p><b>Artificial lighting</b></p> <p>A low impact lighting strategy will be adopted for the site during post-development which outlines the areas of the site that will be retained as dark corridors. Parameters can be found on the Bat Conservation Trust website:<br/> <a href="https://www.bats.org.uk/our-work/buildings-planning-and-development/lighting-2">https://www.bats.org.uk/our-work/buildings-planning-and-development/lighting-2</a></p> <p><b>Suggested biodiversity enhancements</b></p> <p>Enhancements are dependent on the outcome of further surveys.</p> |

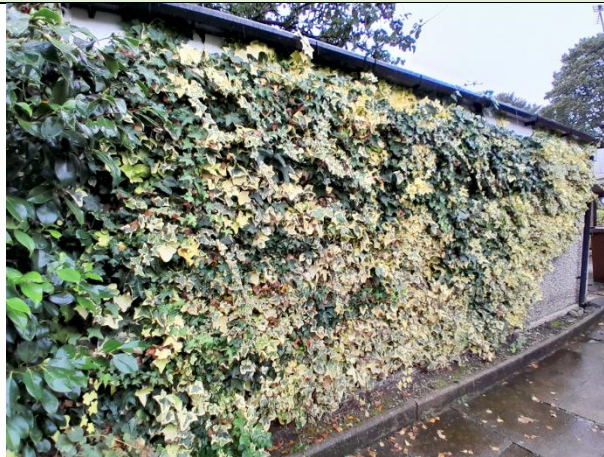
| <p><i>Summary</i></p> <p>B3 is a single storey garage, with a large garage door on the north of the building, The walls are pebble dashed, with plastic bargeboard. There is ivy present on the west of the building.</p> <p>B3 is <b>low</b> for roosting bats.</p> | | | | |
|---|---|---|---|--|
| Walls | Pebble dash | <p><b>Condition/description</b></p> <p>There are no observed roosting features on the wall of the building. However, there is a high level of ivy on the east of the building that may obscure features.</p> <p><b>Suitability/access/evidence of bats</b></p> <p>The ivy on the eastern elevation may observed suitable roosting features or may offer a roosting feature for bats.</p> | | |

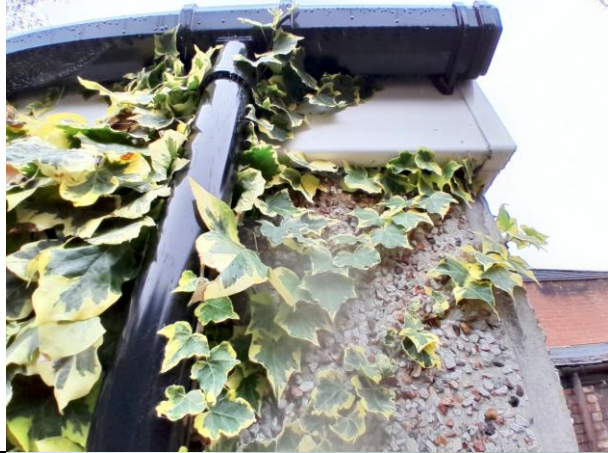
| Eaves | Plastic | <p><b>Condition/description</b><br/>No observed gaps or crevices below the bargeboard on B3.</p> <p><b>Suitability/access/evidence of bats</b><br/>No observed roosting features within the eaves on B3.</p> | |

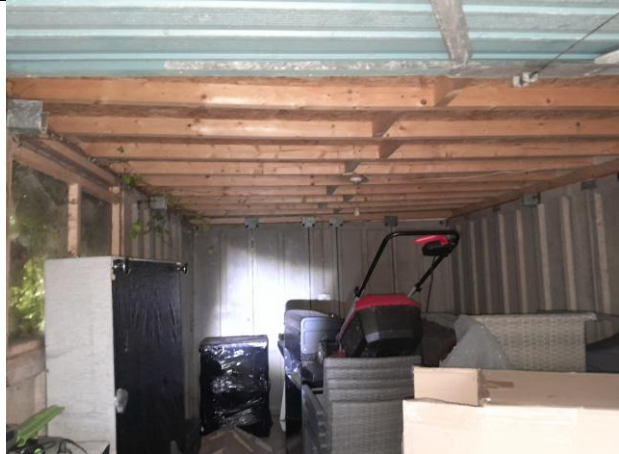
| Internal voids | Timber boarding | <p><b>Condition/description</b><br/>No observed ingress points observed internally. The void is measured to be ~7m long, ~4m wide and ~2.5m in height. The internal is measured to be 14°C and 67% humidity.</p> <p><b>Suitability/access/evidence of bats</b><br/>No observed points of ingress observed internally for bats. There is a large window on the eastern elevation which allows in high levels of sunlight which would likely deter bats from utilising the interior for roosting.</p> | |

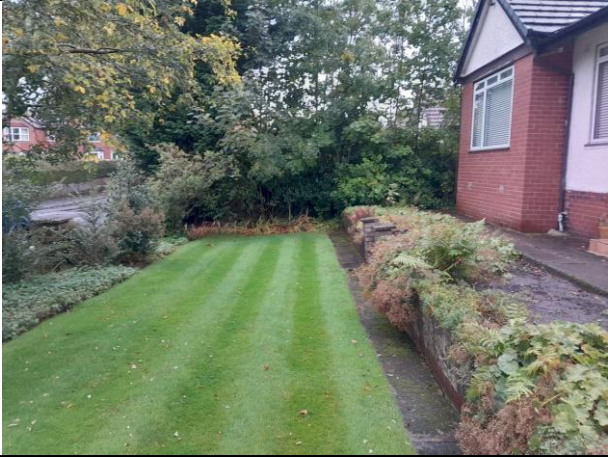
| <b>Vegetated garden</b> | |
|---|---|
| | Fig 1 – the northern garden onsite. |

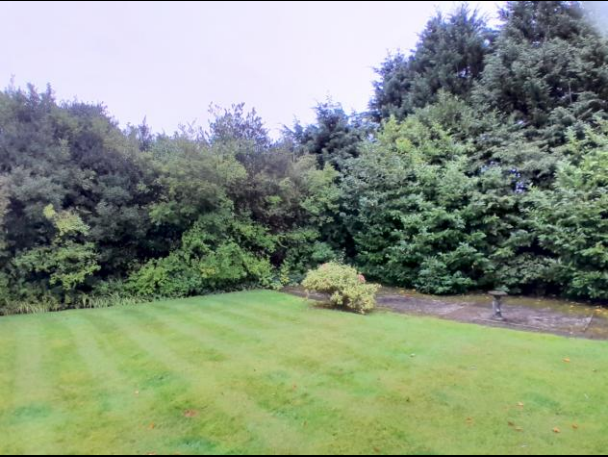
| <b>Vegetated garden</b> | |
|---|---|
| | Fig 2 – the lines of trees surrounding the southern garden. |

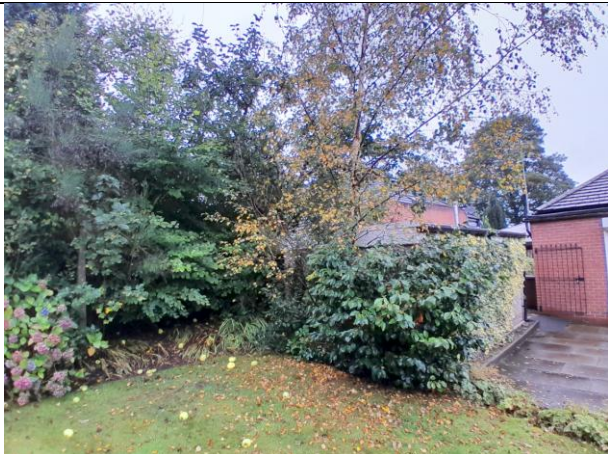
| | | Fig 3 – example of scattered tree to the south of B3. | |

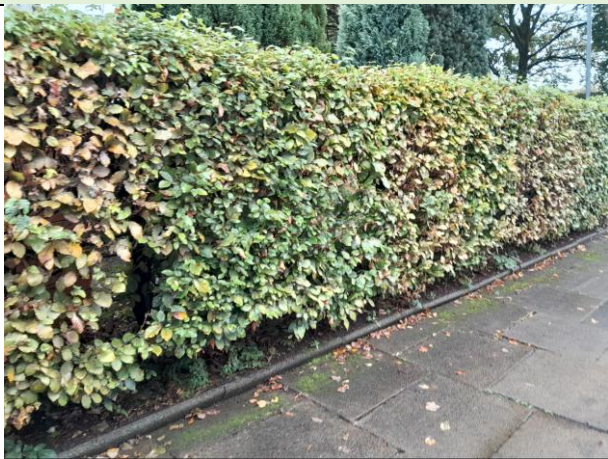
| | | Fig 4 – non native beech hedgerow to the north. | |
