# HOLLINS HOUSE FARM, BURY

## PHASE 2 GEO-ENVIRONMENTAL INVESTIGATION, RISK ASSESSMENT AND REMEDIATION STRATEGY

**Job Number:** LKC 21 1391  
**Date:** December 2022  
**Client:** Mr Nield

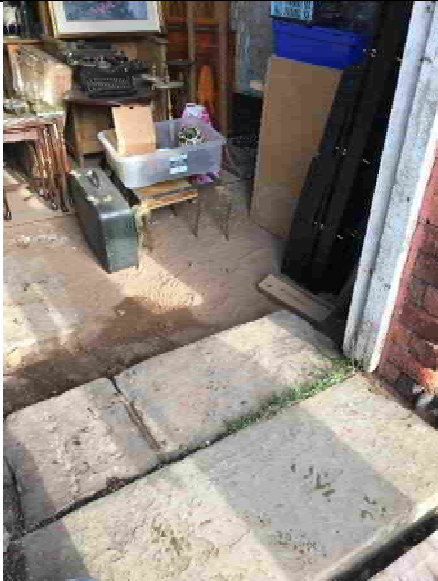
Sand was present at shallow depth in the location of the foundations. The current (and proposed) garden where exposed, appeared to comprised topsoil of approx. 0.2m over sand.

| Photo 1. Existing Building with sand present at surface. | Photo 2. Small area of landscaping in the NE corner. |

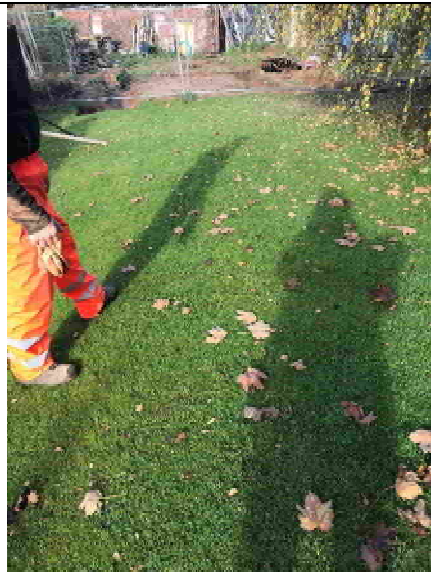
| Photo 3: Current / proposed garden with exposed foundations in the background. | Photo 4: Exposed foundations with cobbled drive / yard in the background. |

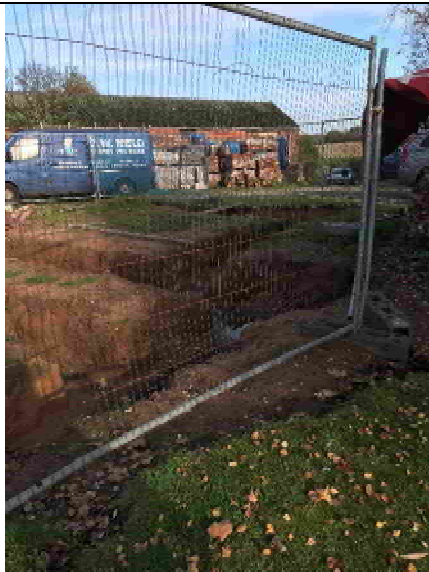
There are areas where cobbles are present in the driveway and yard to the east of the development area which will remain in place post development. The former well is anticipated to be below the existing cobbles driveway / yard.

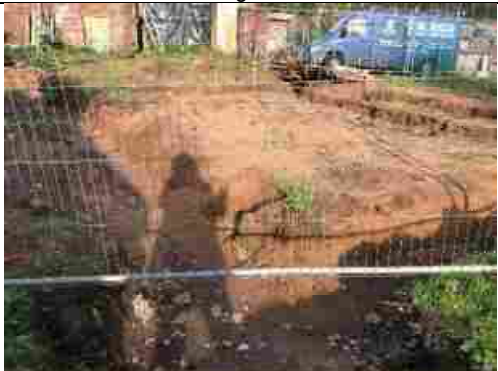
| Photo 5: Exposed foundations showing natural sand at shallow depth. | Photo 6: Current / proposed garden with exposed foundations. |

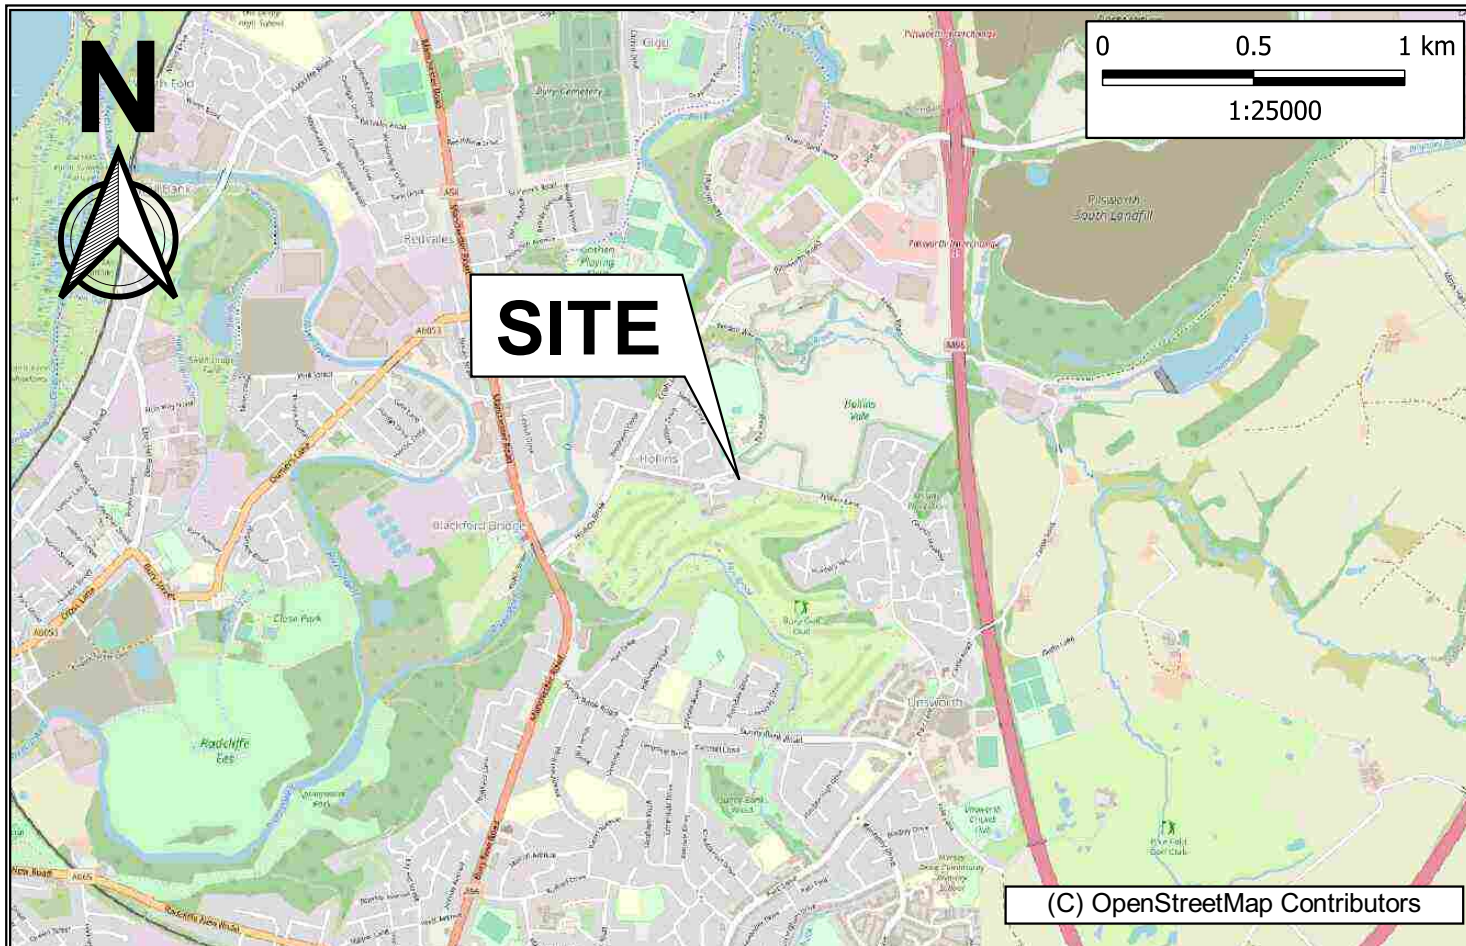
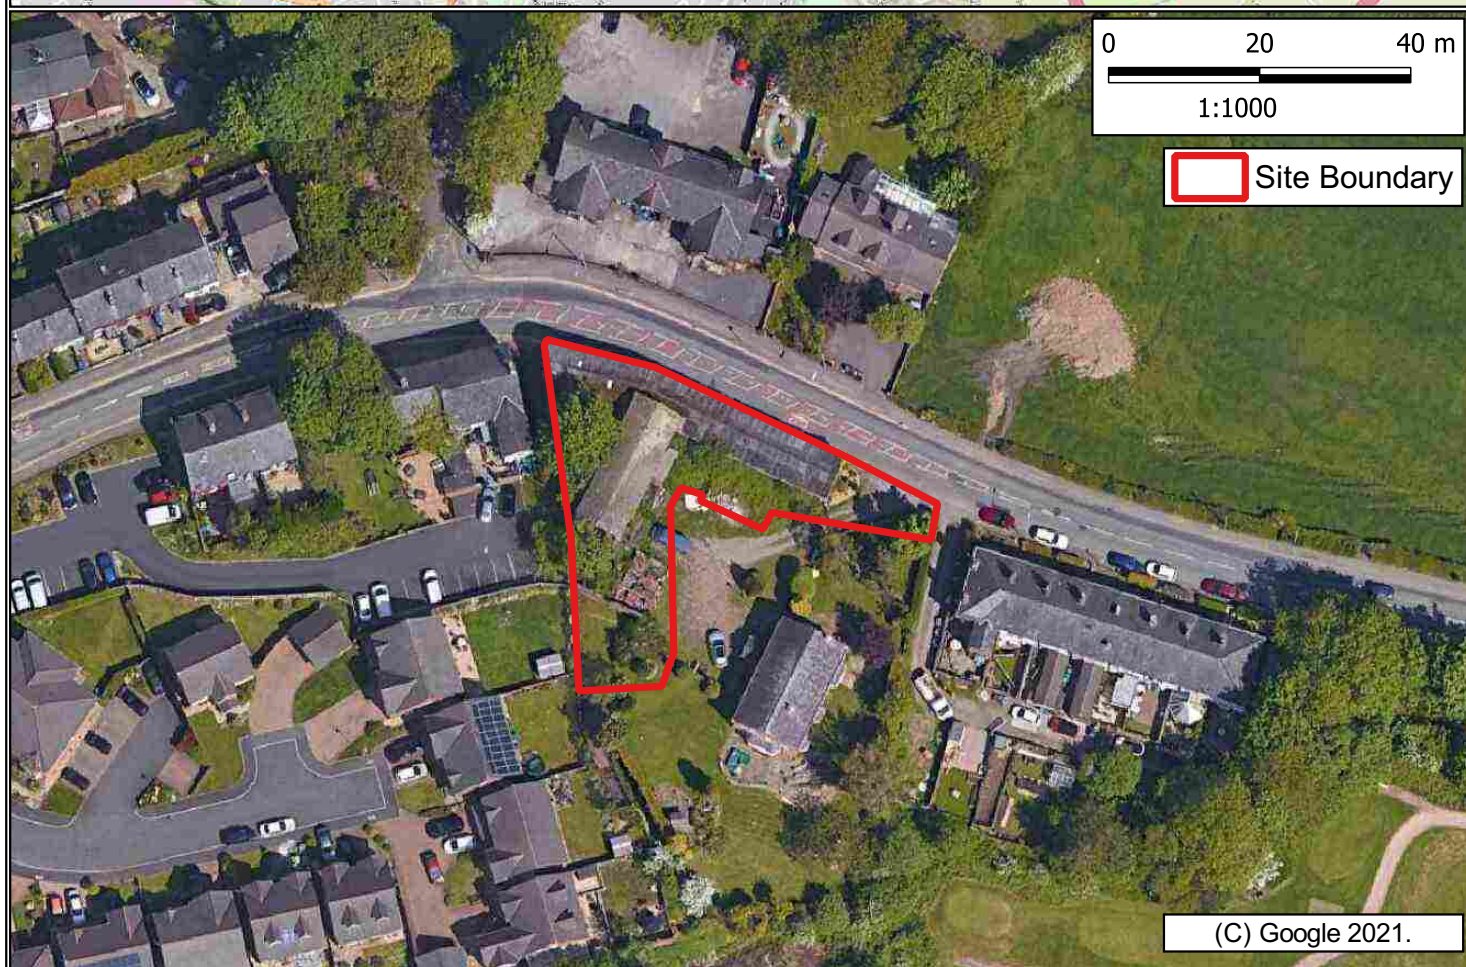
| Client:<br><br>Mr Nield | | | | Title:<br><br>Site Location &<br>Boundary Plan | | | |
| Site:<br><br>Hollins House Farm | | | | Scale (see scale bar):<br>1:25,000 &<br>1:1,000 @ A4 | | | |

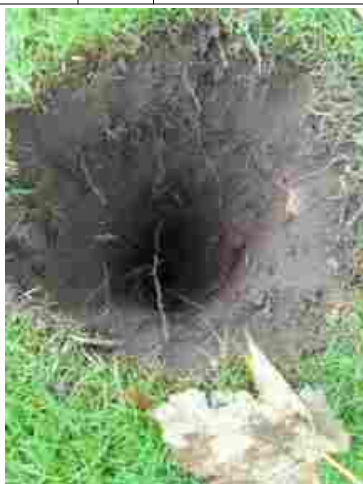
**Remarks**Grid reference estimated using [www.gridreferencefinder.com](http://www.gridreferencefinder.com)  
Elevation estimated using [www.freemaptools.com/elevation-finder.htm](http://www.freemaptools.com/elevation-finder.htm)  
Hand excavated trial pit dry and stable.**Scale (approx)**

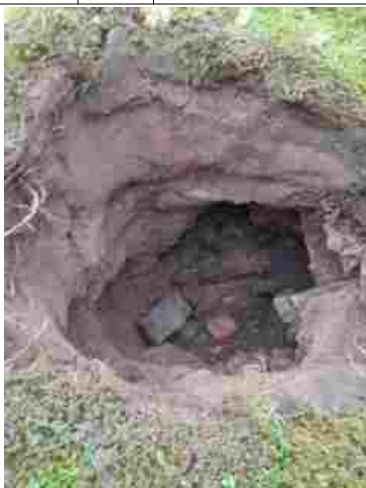
**Remarks**

Grid reference estimated using [www.gridreferencefinder.com](http://www.gridreferencefinder.com)  
Elevation estimated using [www.freemaptools.com/elevation-finder.htm](http://www.freemaptools.com/elevation-finder.htm)  
Hand excavated trial pit dry.  
Hand excavated trial pit unstable, collapse at 0.75mbgl. Pit backfilled.

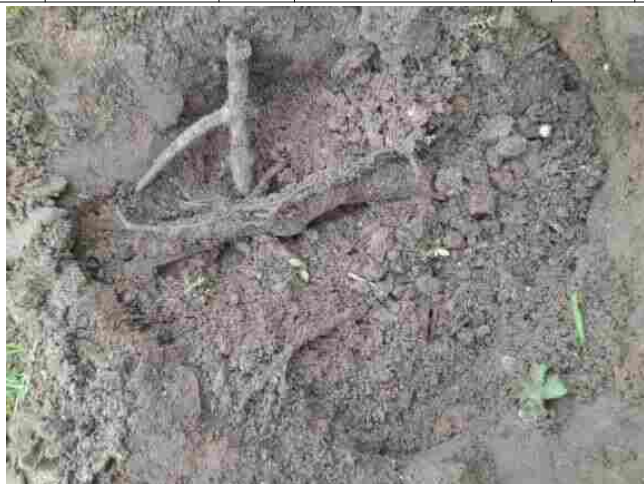
| Depth<br>(m) | Sample / Tests | Water<br>Depth<br>(m) | Field Records | Level<br>(mOD) | Depth<br>(m)<br>(Thickness) | Description | Legend | Water |
|---|---|---|---|---|---|---|---|---|
| 0.00-0.20 | ES | | | 100.80 | (0.20)<br>0.20 | MADE GROUND: Brown gravelly SAND with frequent roots, rootlets, occasional brick fragments, clinker and rare ceramic fragments. Sand is fine to coarse. Gravel is fine to coarse, subangular to subrounded.<br><br>Complete at 0.20m | | |

**Remarks**Grid reference estimated using [www.gridreferencefinder.com](http://www.gridreferencefinder.com)  
Elevation estimated using [www.freemaptools.com/elevation-finder.htm](http://www.freemaptools.com/elevation-finder.htm)  
Hand excavated trial pit dry and stable.  
Refusal at 0.20mbgl on tree root.**Scale (approx)**

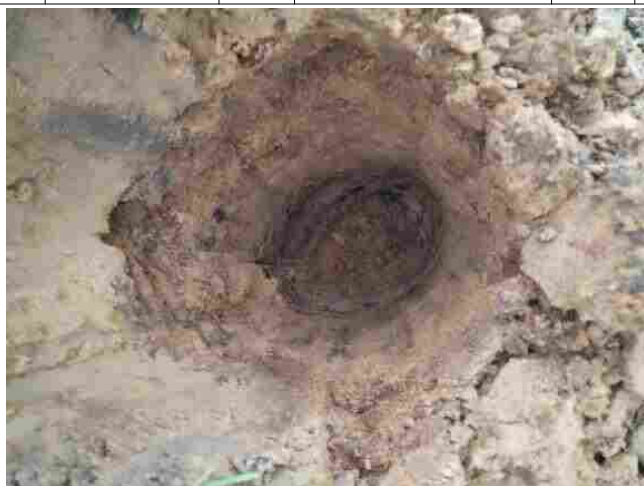
| Depth<br>(m) | Sample / Tests | Water<br>Depth<br>(m) | Field Records | Level<br>(mOD) | Depth<br>(m)<br>(Thickness) | Description | Legend | Water |
|---|---|---|---|---|---|---|---|---|
| | | | | | (0.55) | Brown SAND with occasional silt lenses. Sand is fine to coarse. | | |

**Remarks**Grid reference estimated using [www.gridreferencefinder.com](http://www.gridreferencefinder.com)  
Elevation estimated using [www.freemaptools.com/elevation-finder.htm](http://www.freemaptools.com/elevation-finder.htm)  
Hand excavated trial pit dry and stable.**Scale (approx)**

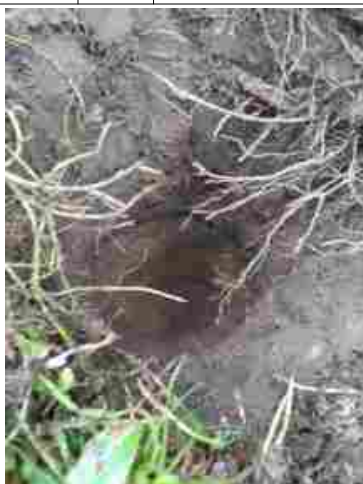
**Remarks**Grid reference estimated using [www.gridreferencefinder.com](http://www.gridreferencefinder.com)  
Elevation estimated using [www.freemaptools.com/elevation-finder.htm](http://www.freemaptools.com/elevation-finder.htm)  
Hand excavated trial pit dry and stable.**Scale (approx)**

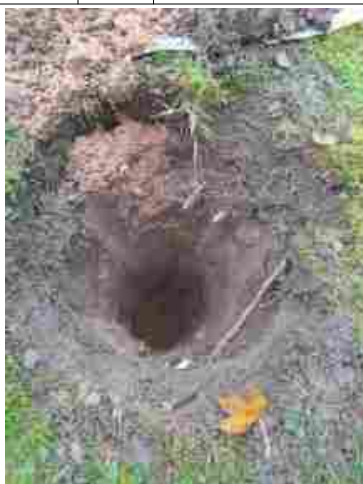
| Depth (m) | Sample / Tests | Water Depth (m) | Field Records | Level (mOD) | Depth (m) (Thickness) | Description | Legend | Water |
|---|---|---|---|---|---|---|---|---|
| 0.45-0.70 | ES | | | 100.55 | 0.45 | Brown SAND with occasional silt lenses. Sand is fine to coarse. | | |

Grid reference estimated using [www.gridreferencefinder.com](http://www.gridreferencefinder.com)  
Elevation estimated using [www.freemaptools.com/elevation-finder.htm](http://www.freemaptools.com/elevation-finder.htm)  
Hand excavated trial pit dry and stable.
