## **Halter Inn Development, Holcombe Brook Controlled Waters Risk Assessment**

**Job Number**  
**LKC261240**

**Report Date**  
**20<sup>th</sup> May 2026**

| <b>Report Title</b> | Controlled Waters Risk Assessment |

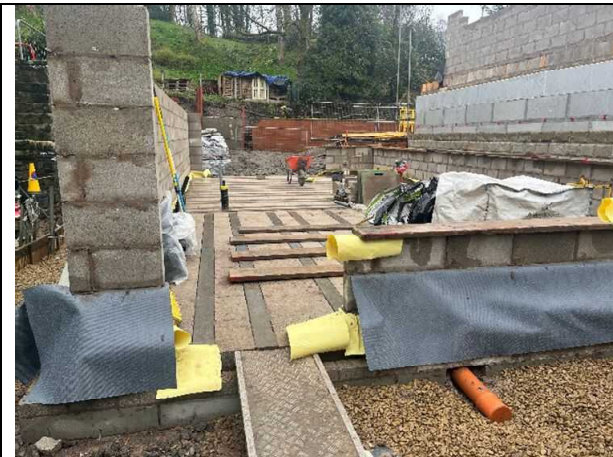
Photo 1. Taken at the front of Plot 3, facing west.

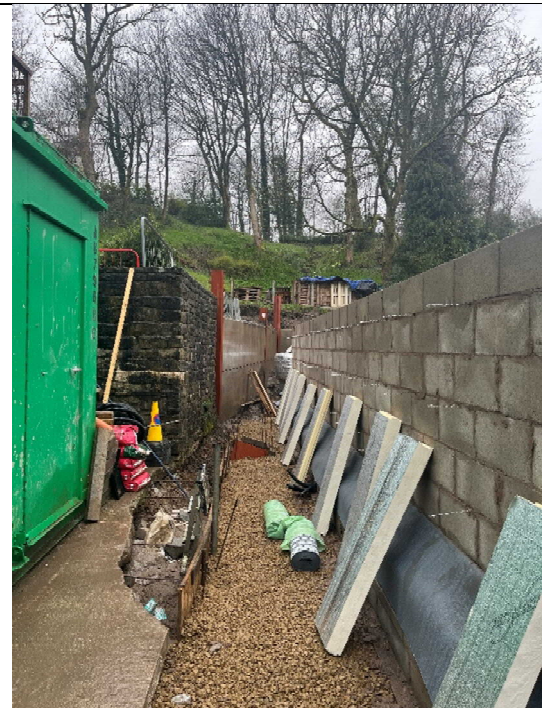
Photo 2. Southern site boundary showing old and new retaining wall, facing west.

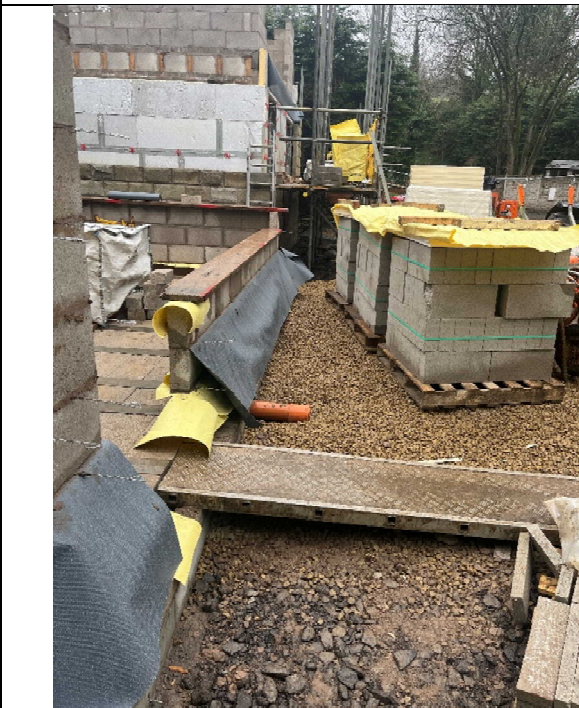
Photo 3. Front of Plots 1-3, facing north.

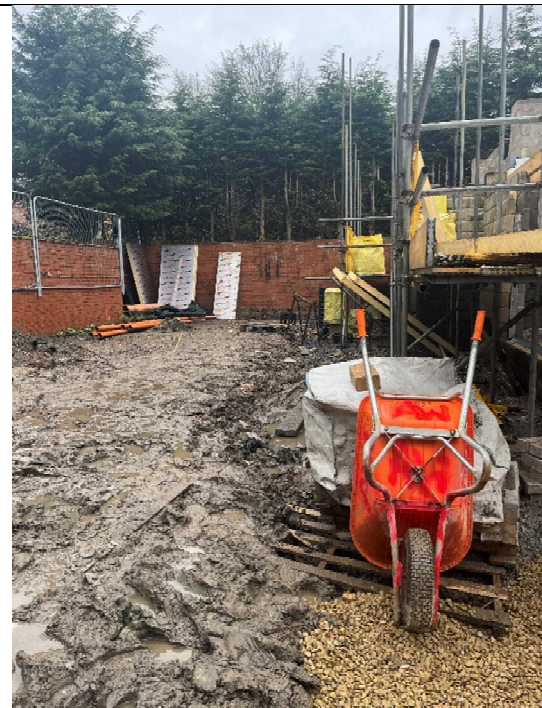
Photo 3. Rear of Plots 1-3, facing north.
