1978.35-4  
Greater Manchester Fire and Rescue

## **Whitefield Fire Station Outline Drainage Strategy**

April 2023

## **Phase 2 Geo-Environmental Investigation Report**

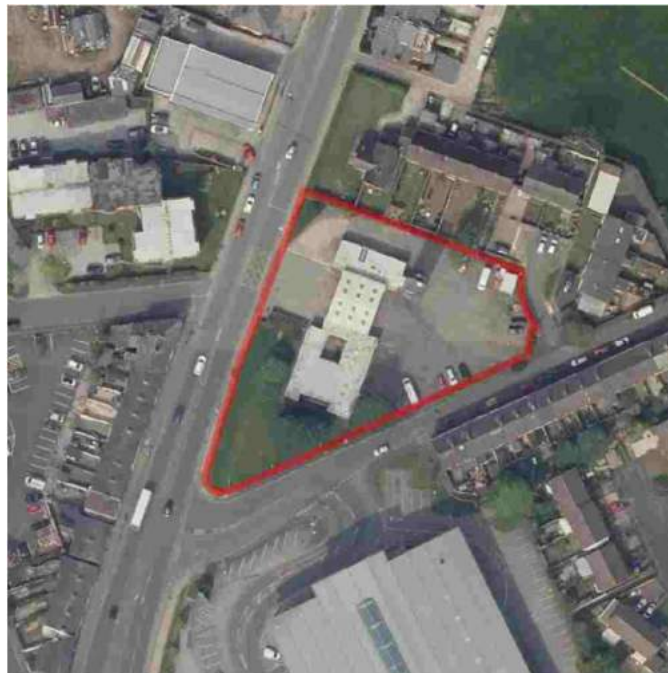
*Figure 1: Aerial image of the site dated March 2019. The approximate site boundary is highlighted in red.*

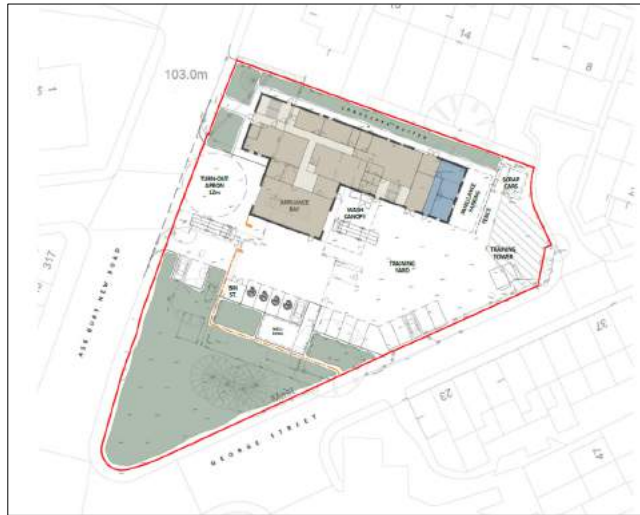
Figure 2: Proposed development layout

A proposed development plan (including floor plans) is contained in Appendix 2 with an extract below as Figure 2.

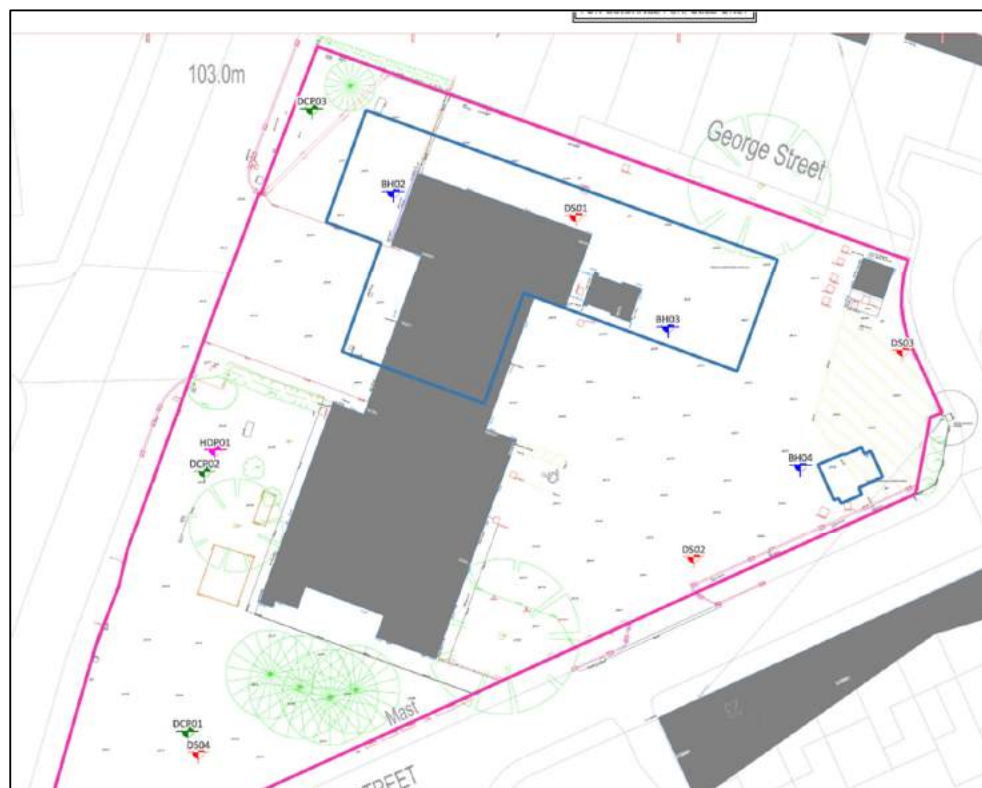
Figure 3: Exploratory Hole Location Plan extract. Taken from IGE Drawing SI-05.

An extract of the exploratory hole location plan is presented below as Figure 3, with the full plan contained in Appendix 2.
