## Phase 1 GeoEnvironmental Desk Study

Bury New Road

Ramsbottom

Hodson Homes

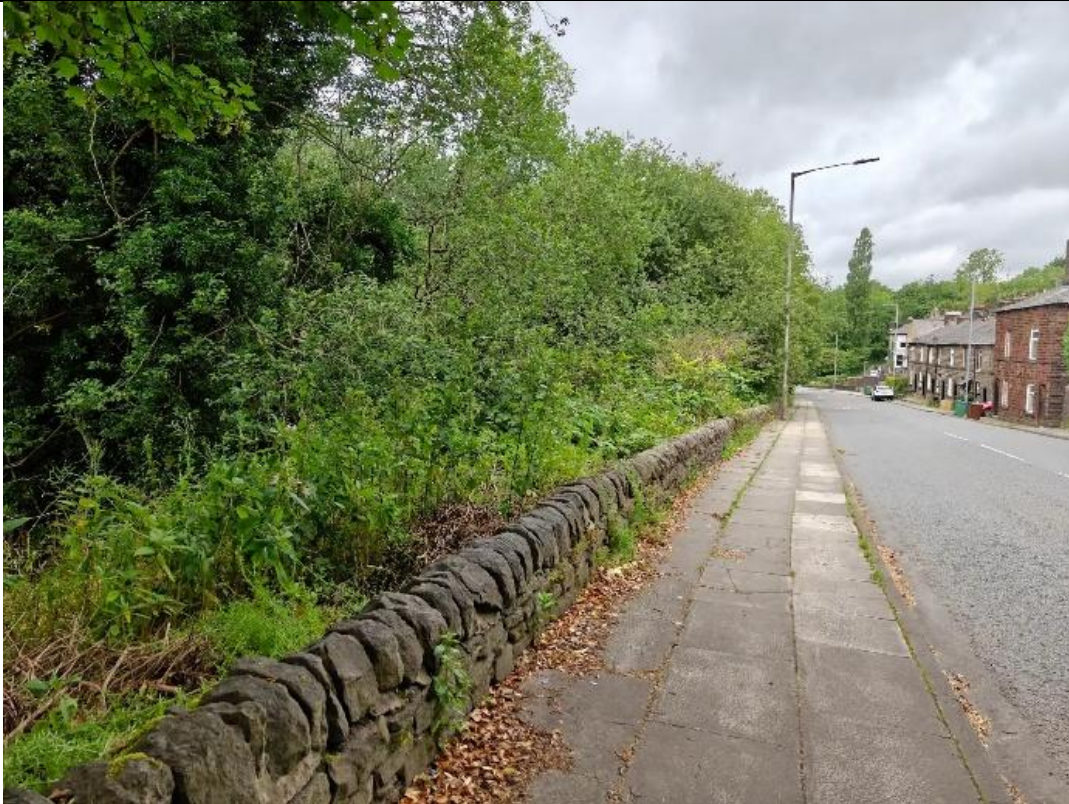
**Figure 2: General Site Photographs**

The site is below the level of the adjacent Bury New Road, which runs adjacent to the eastern boundary and has a gradient that generally slopes downwards towards the north. However, part of the southern area was noted to slope upwards towards the south.

Photograph facing, showing the site slope down from the adjacent road

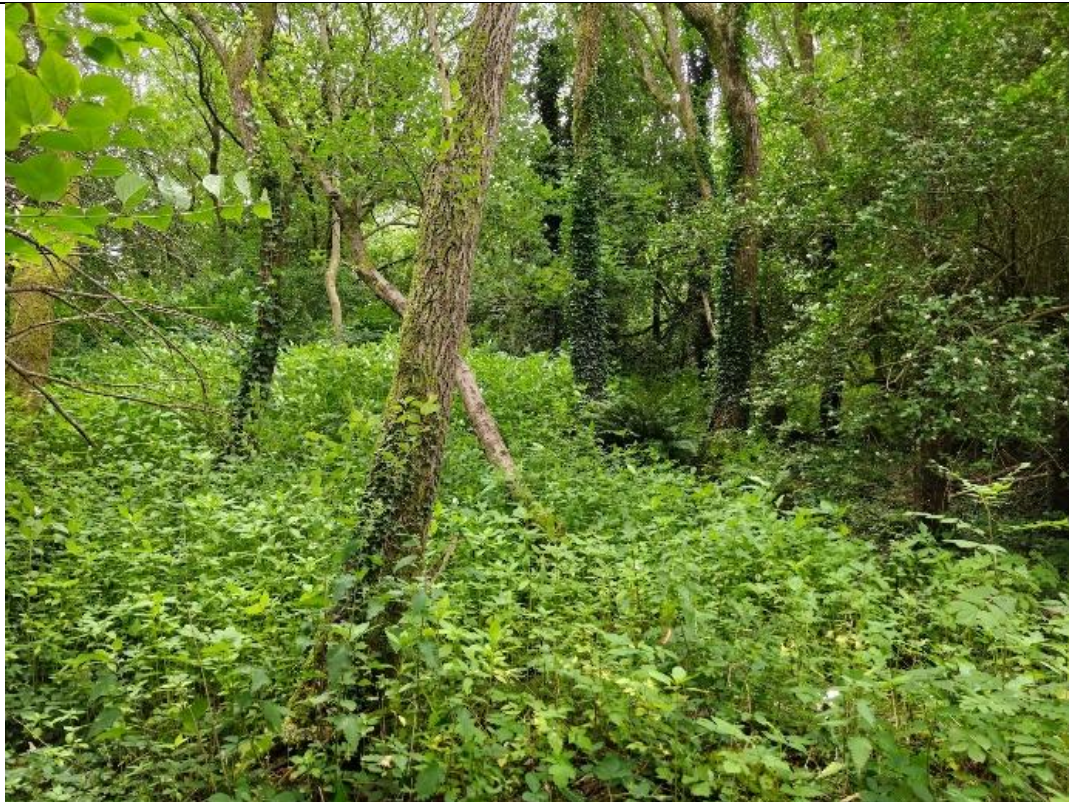
Photograph facing southeast, showing dense vegetation and slope up to the south

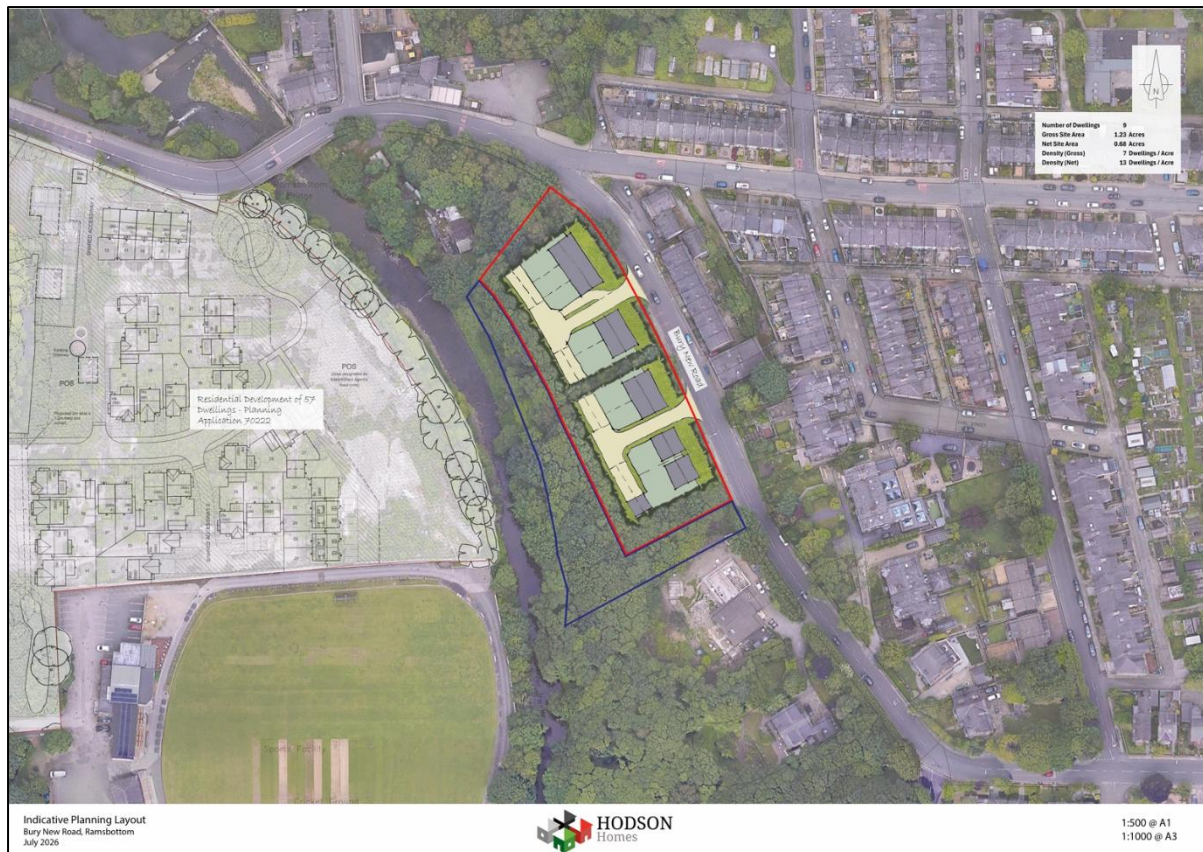
**Figure 3: Indicative Planning Layout**

It is understood that the client proposes to erect up to 9no. new residential dwellings. As the client is applying for permission in principle, no finalised proposed development plans were available for the site at the time of authoring this report.

An indicative Planning Layout is shown in Figure 3 below.

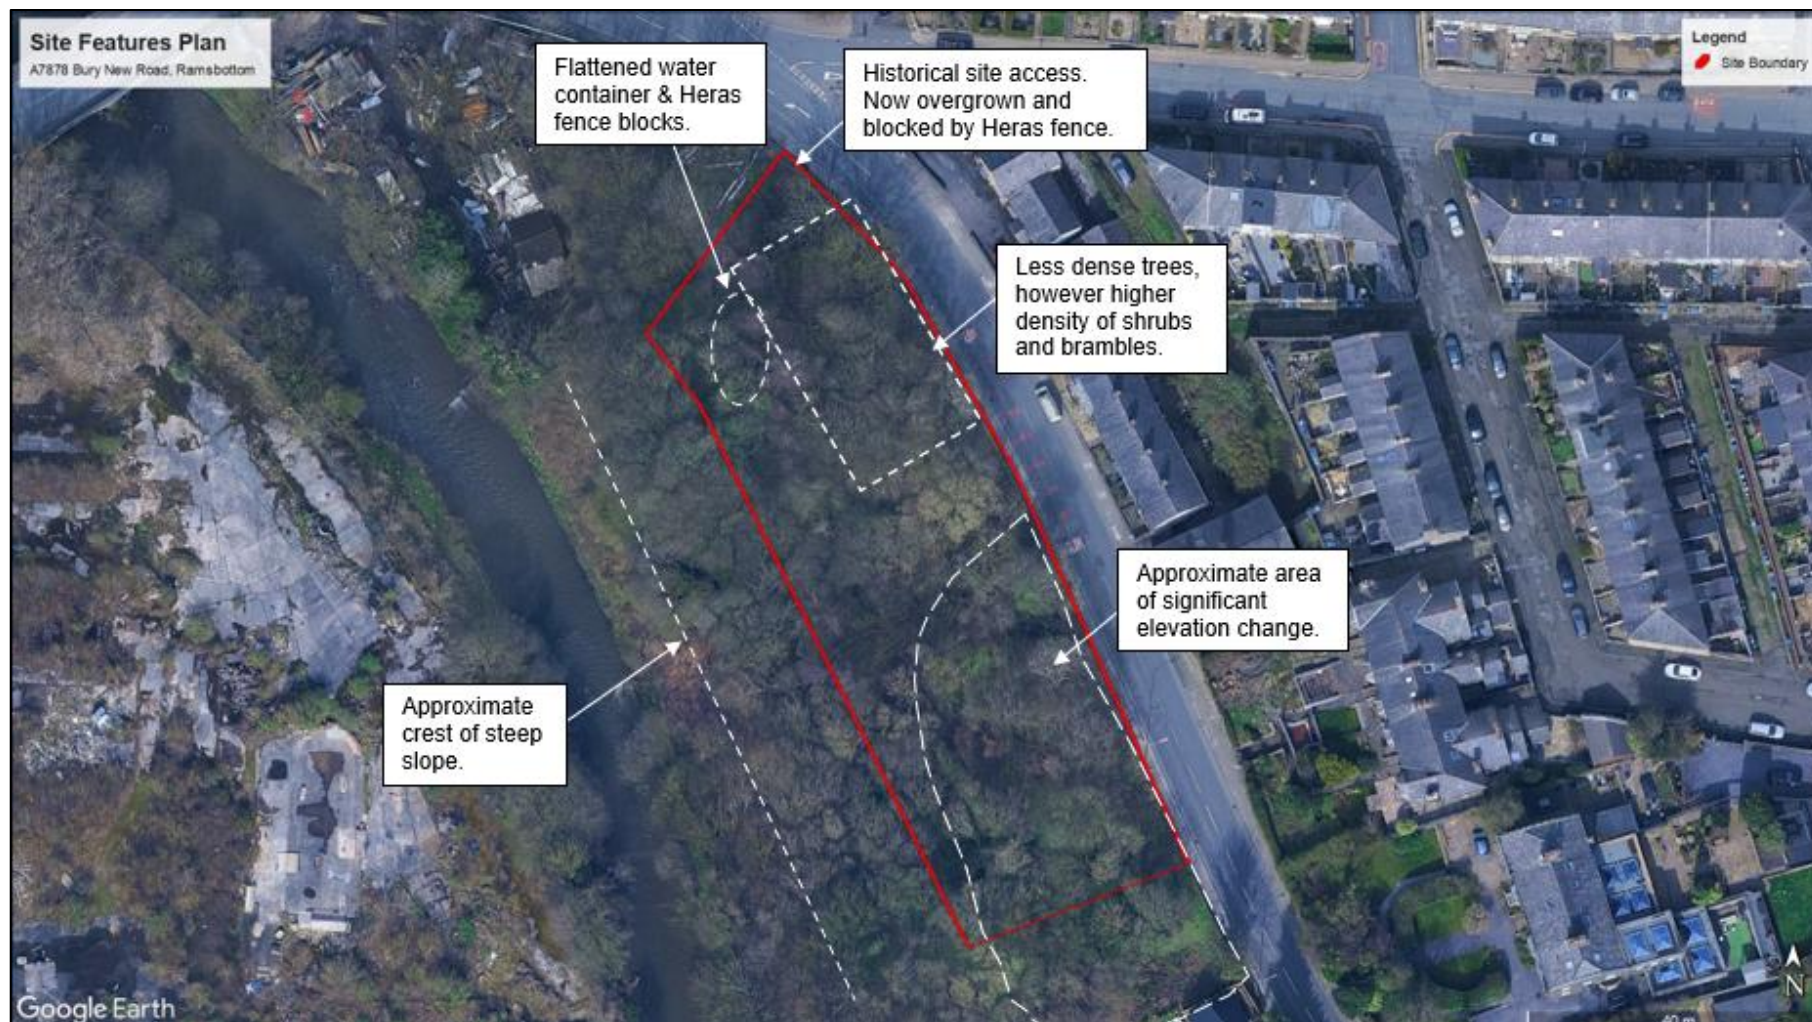
Figure 10: Site Features Plan

The site is generally situated in a residential area, with the previously vacant plot of land to the west of the River Irwell currently being developed into a residential housing estate.

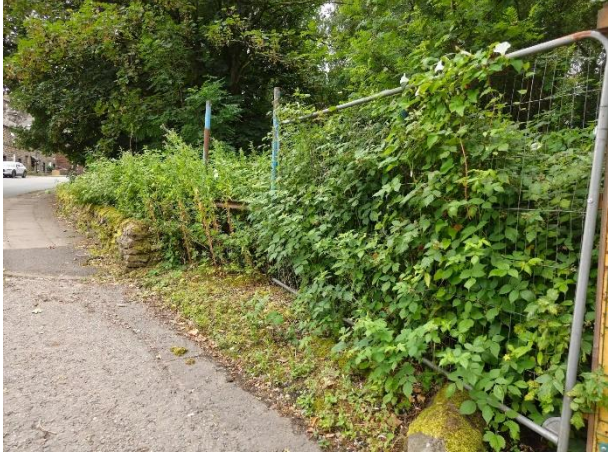
| <p><b>Plate 1 View facing south showing historical site entrance</b></p> | <p><b>Plate 2 View facing north showing dry stone wall boundary</b></p> |

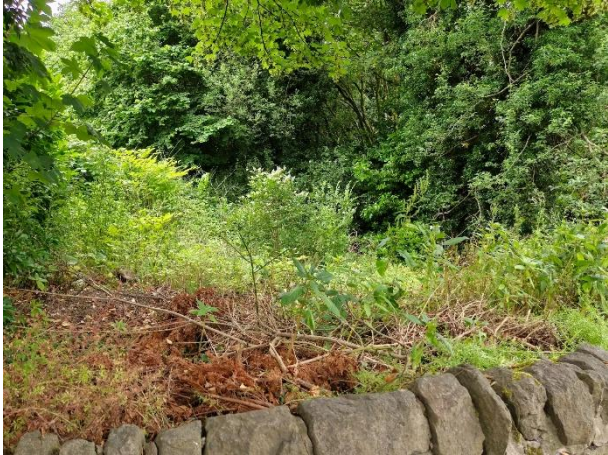
| <p><b>Plate 3 View facing northwest showing southeast site corner</b></p> | <p><b>Plate 4 View facing north showing slope of adjacent road</b></p> |

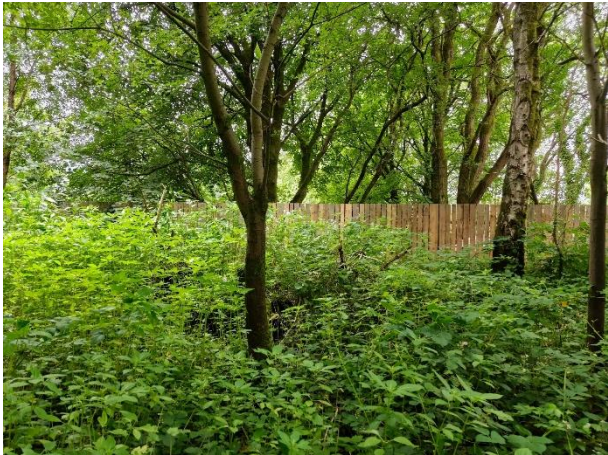
| <p><b>Plate 5 View facing north showing northern site boundary</b></p> | <p><b>Plate 6 View facing north showing gap in northern boundary fence, providing foot access</b></p> |

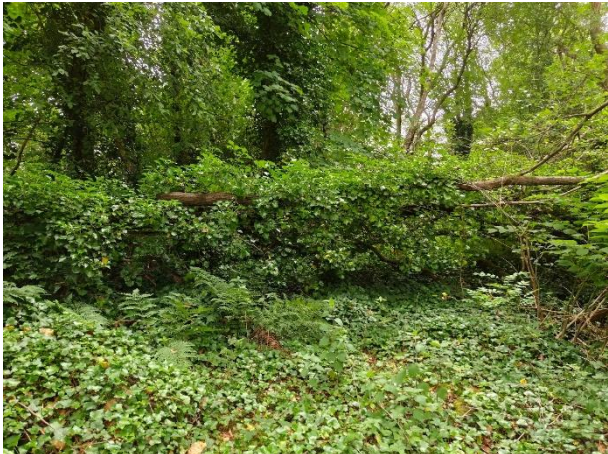
| <p><b>Plate 7 View facing southeast showing fallen trees</b></p> | <p><b>Plate 8 View facing southwest showing crest of slope</b></p> |

| Desk Study features checked during site visit | Feature and Information required | Present | Description / Comments |
|---|---|---|---|
| Access / Further Investigations | If a Phase 2 Investigation is likely to be required, describe any access problems including headroom where relevant, services, overhead cables, restricted access areas, confined spaces, trafficked areas, etc that are likely to affect investigation scope/techniques. | | No current, viable access point for vehicles or machinery. A Phase 2 investigation would not be viable at the site in its current condition.<br><br>Should also be highlighted that due to the elevation differences across the site, removal of the existing trees <i>may</i> destabilise the site/ slopes. |

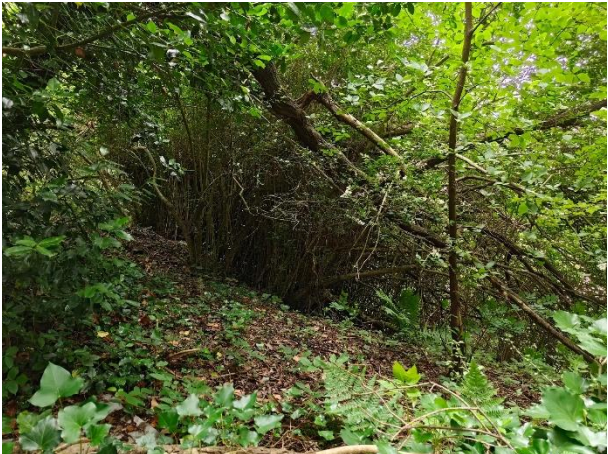
The site is not within an area that is considered to be significantly affected by geotechnical hazards, including shrink/ swell clays and ground dissolution of soluble rocks. However, due to the topography of the area and the steep slopes that exist on site, there is a risk of landslips especially along the western site section.

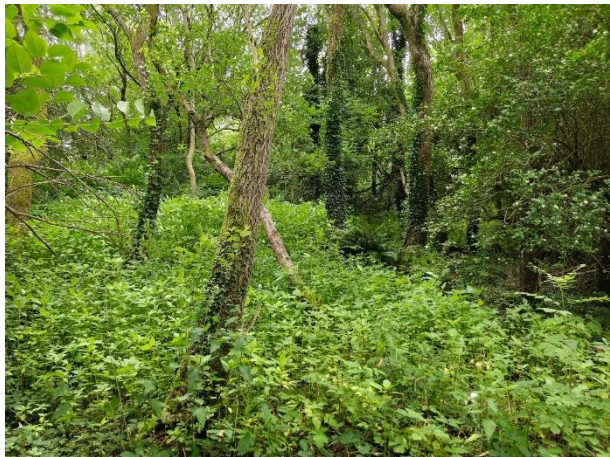
| <p><b>Plate 9 View facing southeast showing site sloping up to the south</b></p> | <p><b>Plate 10 View facing northwest showing fence blocks</b></p> |
