## GeoEnvironmental Site Investigation Report

3 Sunningdale Avenue

Whitefield

**Report Ref: A6184/24/SI**

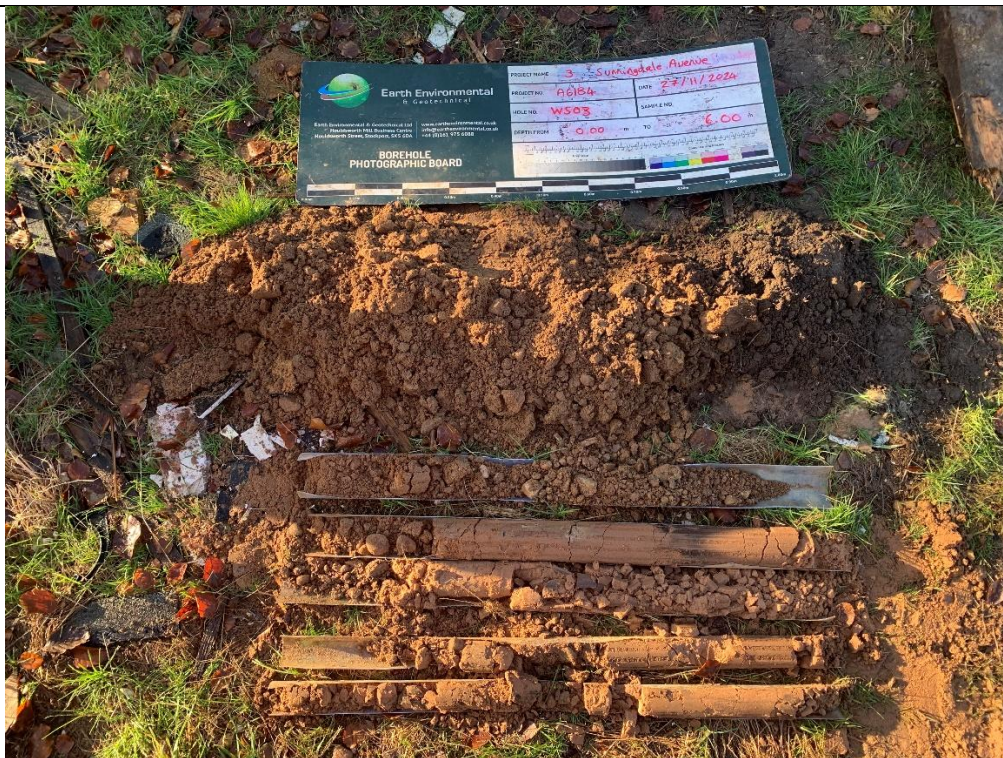
## Figure 2: General Site Photographs

Photograph showing representative soils (WS03)

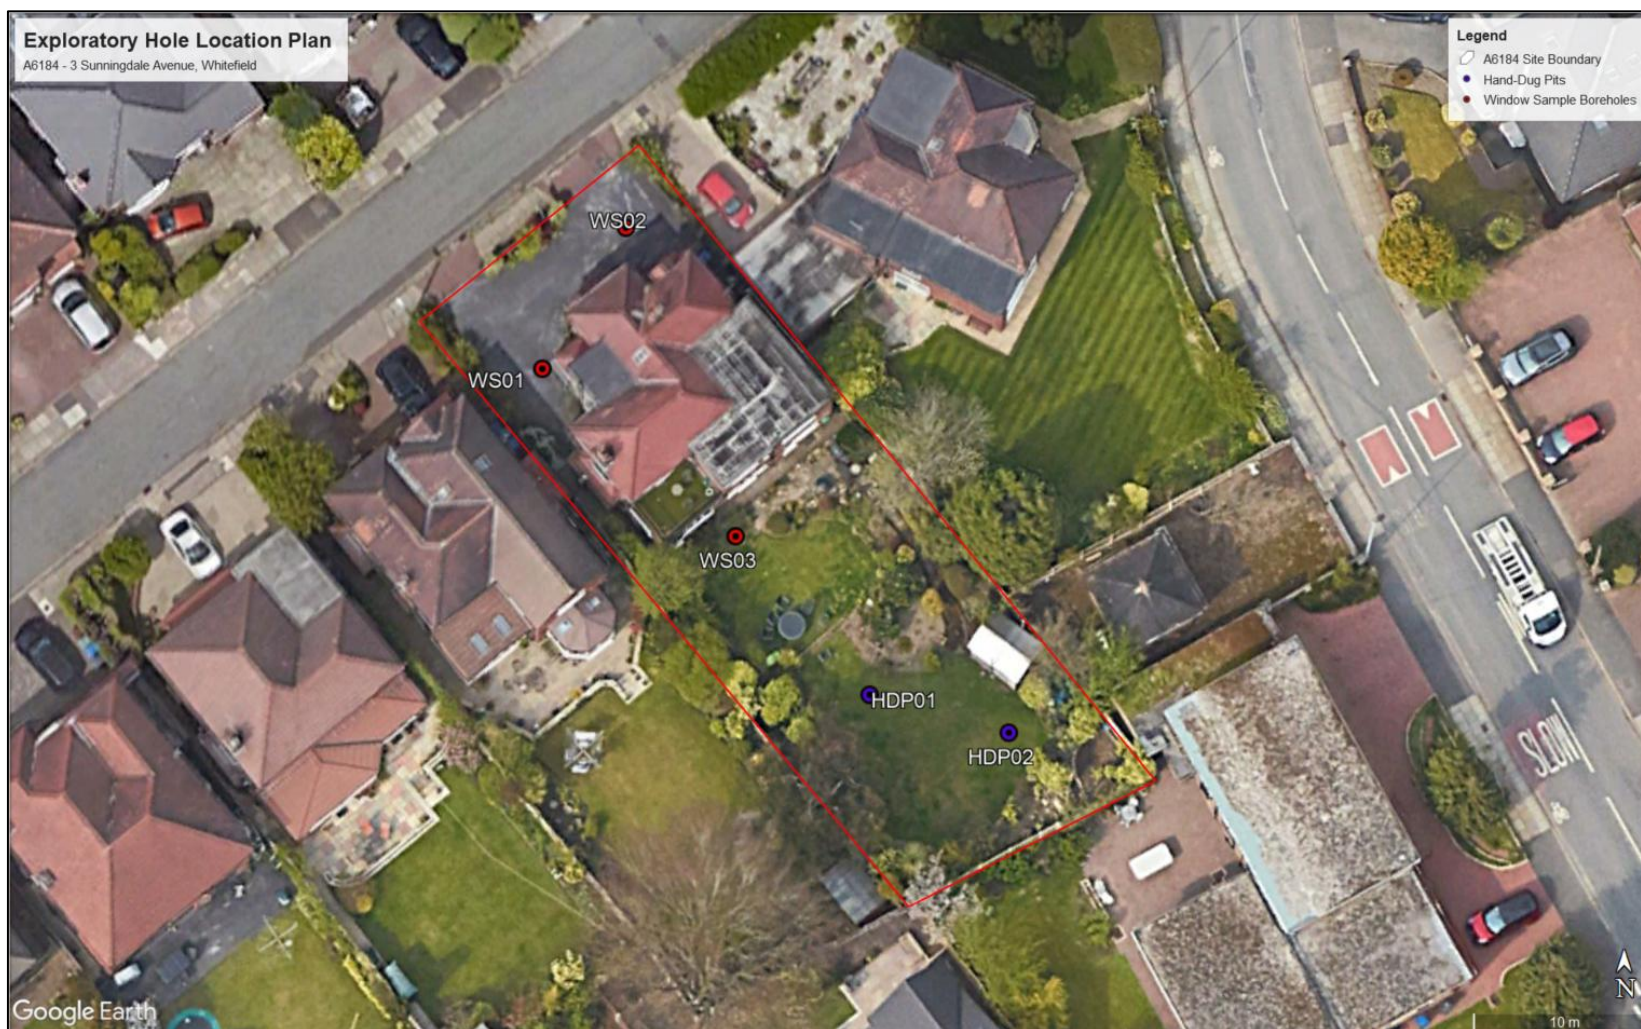
Figure 4: Exploratory Hole Location Plan

An Exploratory Hole Location Plan is presented as Figure 4, overleaf.
