## **Westchurch Homes Limited**

### **A Feasibility Study for Development of Soccer Pitches on Land Adjacent to Radcliffe Moor Road, Bradley Fold, Bury.**

**O/002/RMR/1721/R-PL/210917**

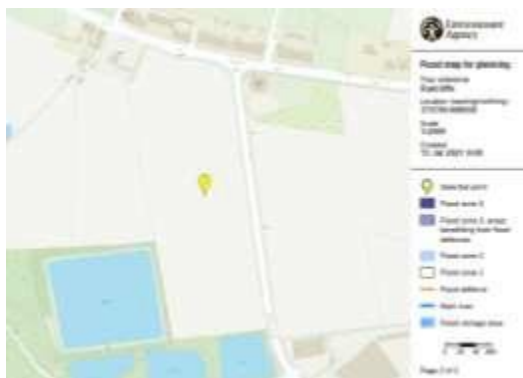
Figure 2: Flood Zone 1

Based on information obtained from the EA, the site is located within Flood Zone 1 (Fig. 2) i.e., low risk, and is not in an area effected by flooding from rivers or reservoirs (Fig. 3 & 4).

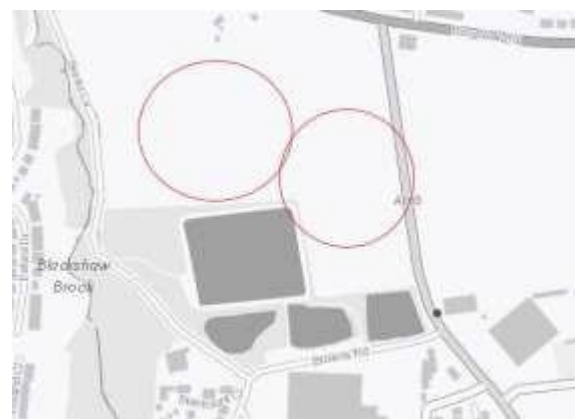
Figure 5: Historical Landfill

The site is not shown to be located in an area formerly used for landfill (Fig. 5) although the GIR records an area on the site was used for a period of time for a refuse tip. This area will need to be inspected during the bulk earthworks operations and potentially some material may require disposing off-site.

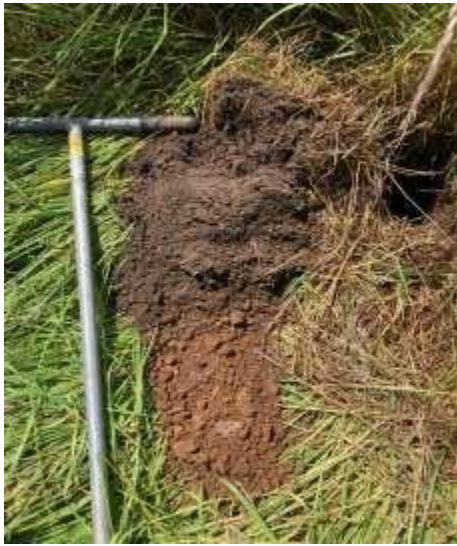
**SP1** was excavated towards the northern end of the site and was characterised by a 225mm thick brown sandy clay loam in a well-structured condition (crumb/granular), a well-developed root system throughout the topsoil depth and the occasional worm present. It was slightly stony with occasional well-rounded pebbles/stones. A pale brown consolidated sandy clay was below the topsoil (225-750mm) which contained small fragments of sandstone. No iron staining or mottling indicative of reduced permeability was observed.

*Plate 2 - SP1 - 225mm thick well-structured topsoil overlying a slightly stony sandy clay.*

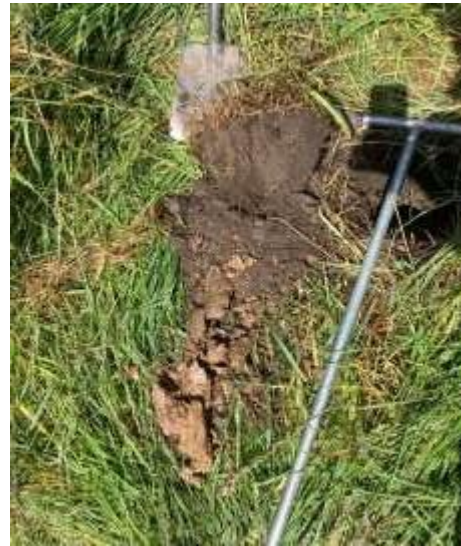
**SP2** was characterised by the same topsoil layer as SP1 and also contained sandstone fragments. Occasional rusty mottling was observed on root channels. An orangery pale brown relatively dense clay was present from 220–750mm with mottling evident in the upper layer and a more greyish colouration at depth. Distinct iron and manganese deposits were observed in the subsoil which was generally stoneless at the depth examined.

*Plate 3 - SP2 - 225mm thick well-structured topsoil overlying a silty clay.*

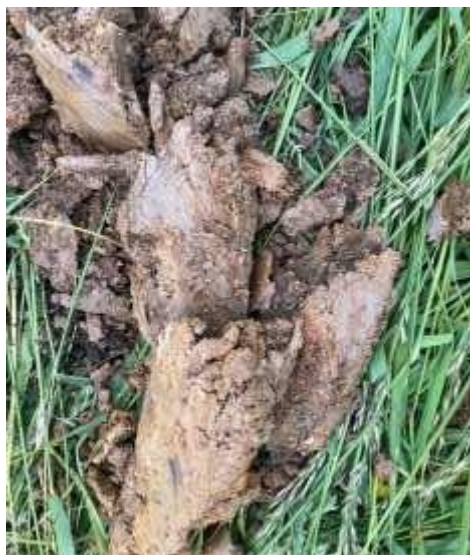
*Plate 4 - Silty clay subsoil dominating majority of site*

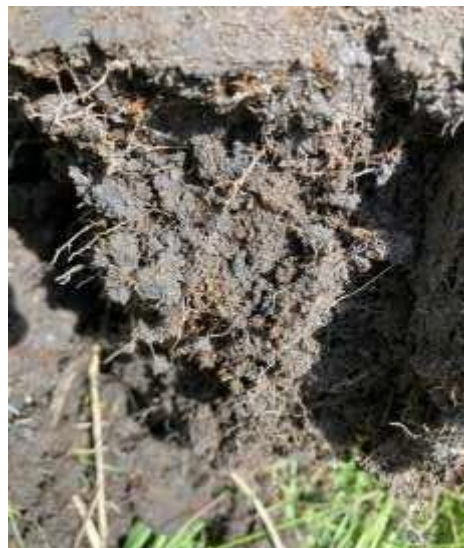
*Plate 5 - Strong mottling/iron staining in topsoil present over much of site centre and southern area indicating wet ground conditions/poor drainage.*

Site observations confirm the presence of the Brickfield 3 Association with a loamy topsoil containing sandstone fragments towards the northern end and a more clayey profile towards the mid-point and southern end of the site. The majority of profiles, although possessing topsoil in a well-structured condition presumably due to minimum activity, were characterised by impeded drainage which has resulted in surplus water sheading downslope to the pond along the southern edge. There was standing water in several areas at the southern end due to the slope being less and the underlying clay restricting gravitational discharge.

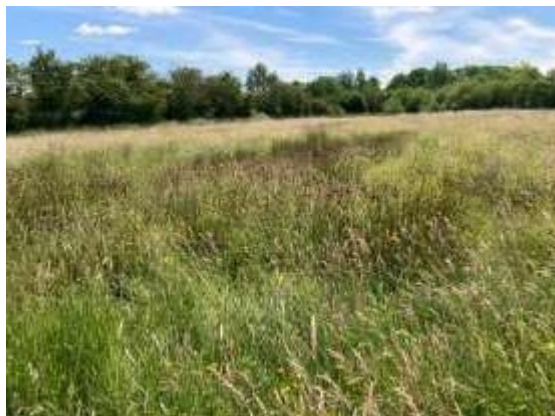
There were broadleaved weeds present, notably creeping buttercup which is a characteristic of wet ground. There was a higher proportion of buttercup towards the southern end indicating increased wetness. Rushes/sedges and increasing amounts of bent grass at the south end also confirmed the increasing soil wetness level.

*Plate 6- Vegetation typical of wet ground conditions at the southern end of the site.*

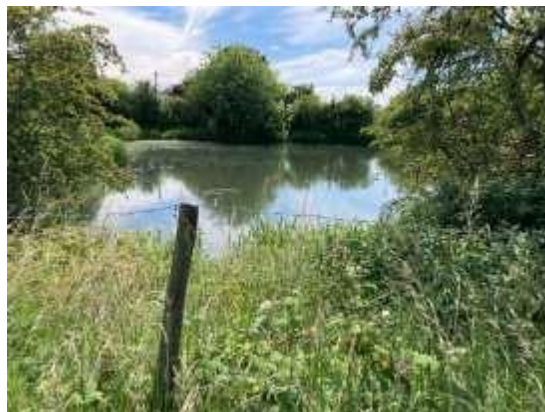
*Plate 7 - Pond immediately outwith the southern boundary.*

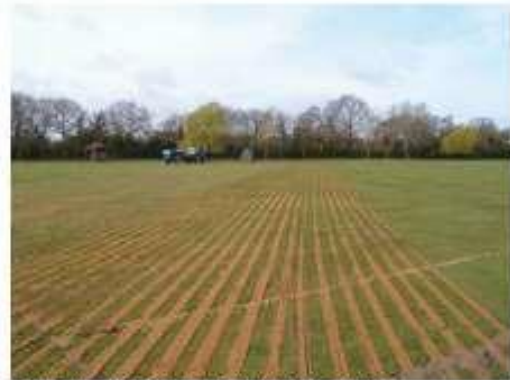
Sand grooves installed at 260 mm centres

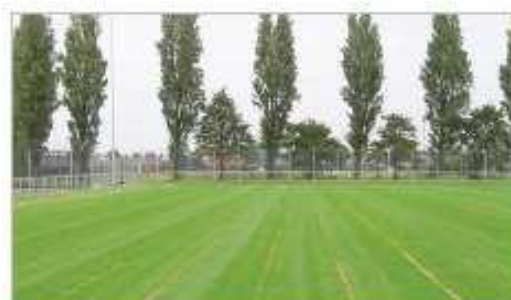
Combined pipe and slit drainage will significantly improve the drainage of most pitches

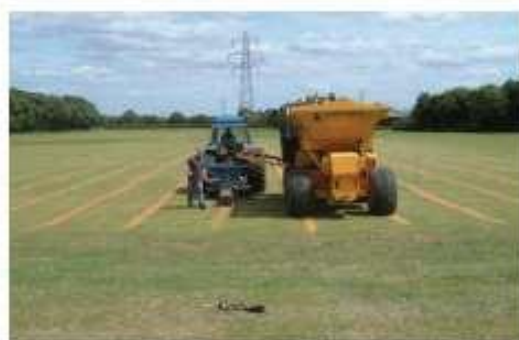
Where coarse porous backfill material is used, it may be necessary to include a 50 mm deep blinding layer of coarse sand or grit to prevent ingress of rootzone into the porous backfill

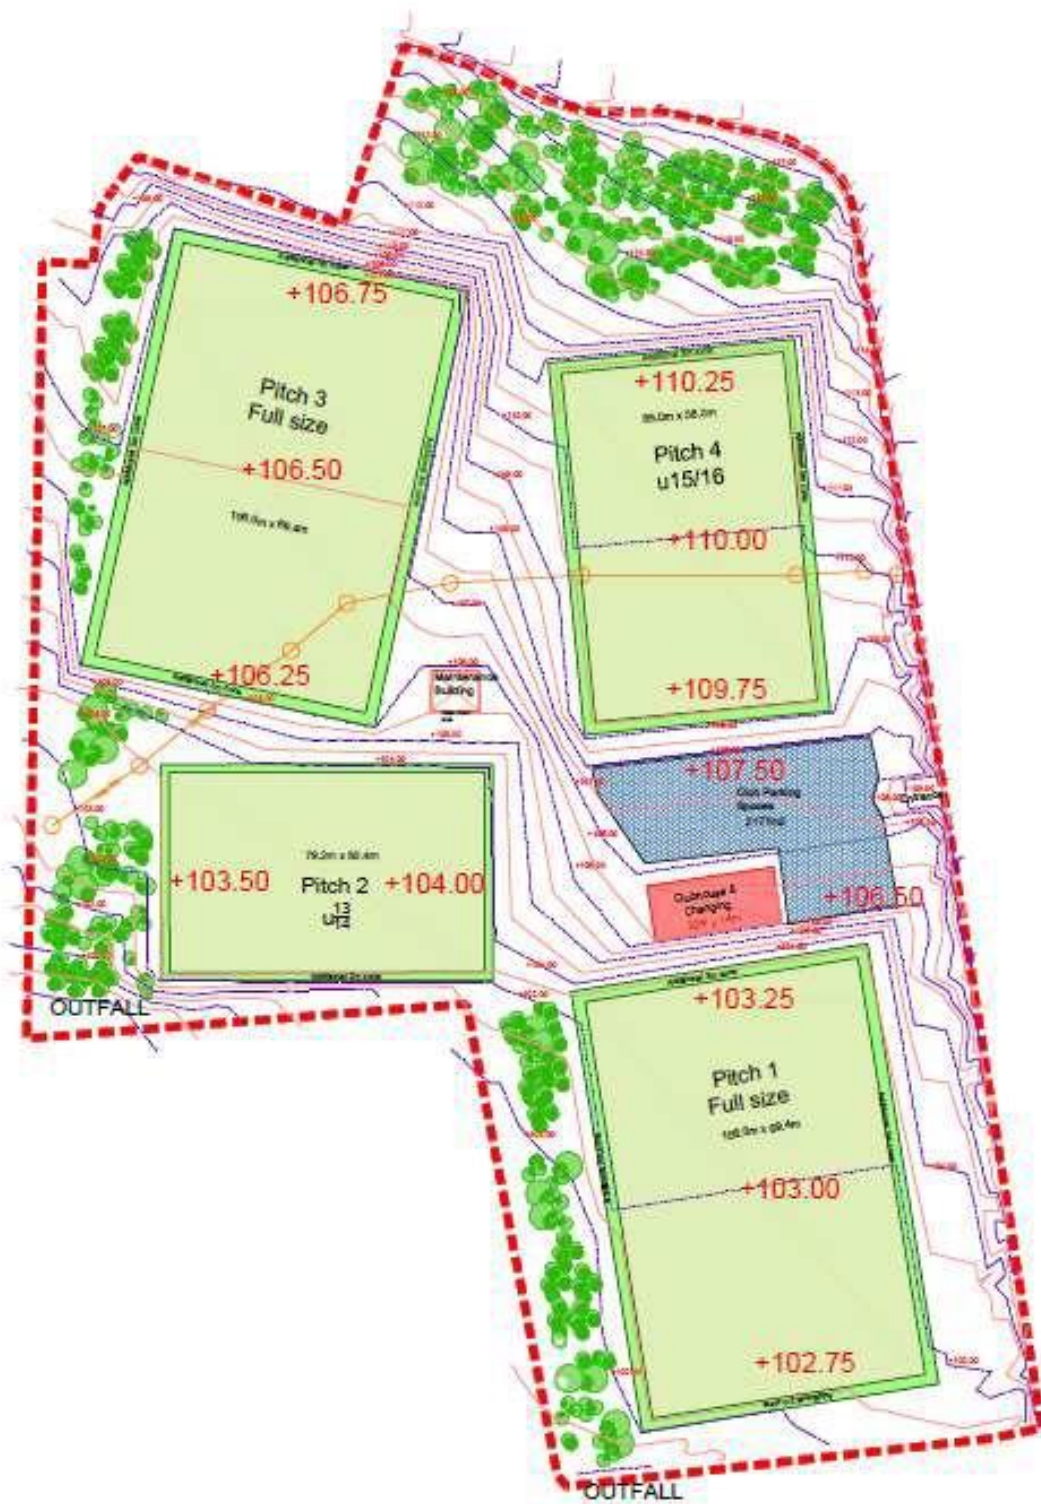
### RADCLIFFE MOOR ROAD PROPOSED LAYOUT/LEVELS

| | PROPOSED FOOTBALL PITCHES,<br>RADCLIFFE MOOR ROAD BURY | PROPOSED LAYOUT | June 2021 |
