# Kingfisher Survey Report

(Technical Appendix II)

Project: BRY0021 Aesthetics Screening  
Pimhole Business Park  
Bury

**United Utilities Aesthetics Screen Development Project BRY0021**  
**Pimhole Business Park, Bury – Technical Appendix II – Kingfisher Survey Report**

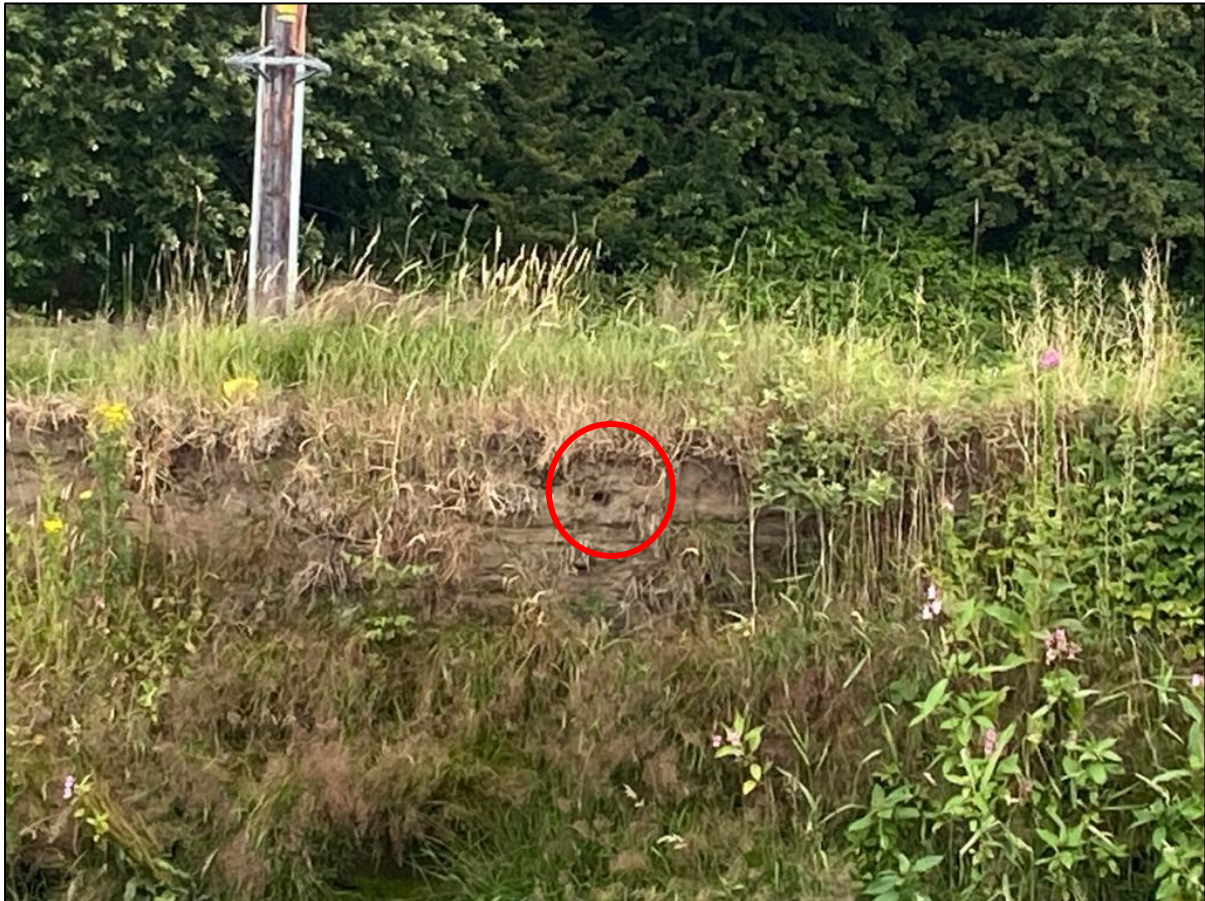
**Figure 1.1** – *Identified burrow*

- 1.1 As part of the United Utilities Aesthetics Screen Development Project **BRY0021**, Tyrer Ecological consultants were commissioned by Emerald Green Environmental Management Services Ltd. on behalf of Bethell Group PLC to undertake breeding kingfisher surveys of the River Roch (refer to **Figure 1.1**).

- 1.2 The kingfisher survey has been commissioned after the discovery of a suitable burrow during the updated EAR in July 2023 and subsequent activity in the vicinity of the burrow observed during the updated water vole and otter assessment (see **Technical Appendix I**).
- 1.3 The proposed development plans have indicated that there is potential to impact upon kingfisher and their habitat, should the species be found to be present in a breeding capacity.
- 1.4 The information from the survey will be used to assess the potential risks of the proposed works disturbing nesting kingfishers within a 50-100m buffer of the proposed outfall.
- 1.5 The results of the kingfisher surveys have been provided in **Section 4.0**.

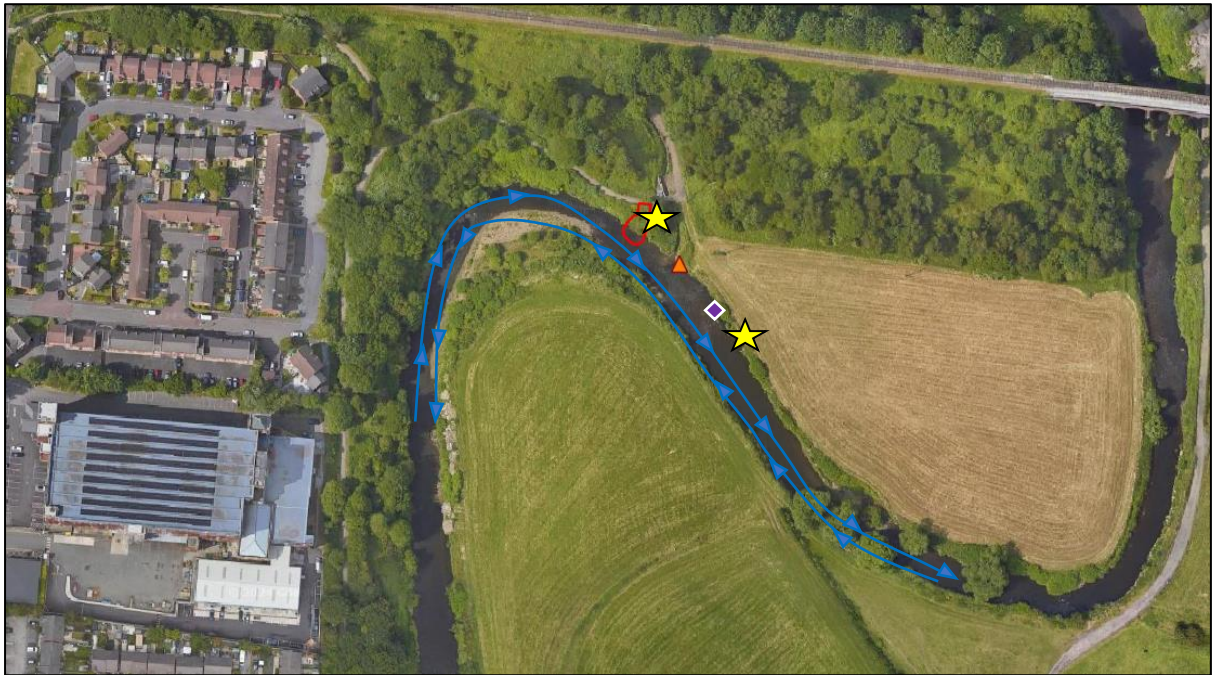
Figure 4.2 – Kingfisher survey No. 1 - 24/03/2024

| No. | Survey Date | Timings | Activity |
|---|---|---|---|
| 1. | 24/03/2024 | 06:15– 08:45 | <p><b>Summary: A total of 5 passes along this stretch of the River Roch were observed by kingfisher with a maximum of 2 individuals observed at any one time. No activity was observed at the burrow and no nesting/breeding behaviour was observed.</b></p> <p>0701hrs: Kingfisher flew up stream past burrow (W-E)</p> <p>0702 hrs: Second Kingfisher flew upstream past burrow (W-E).</p> <p>0716hrs: Kingfisher flew down stream and landed in small willow on the northern bank, and then returned upstream.</p> <p>0712hrs: Kingfisher flew downstream past burrow calling (E-W).</p> <p>0745hrs Kingfisher flew upstream calling (E-W).</p> |

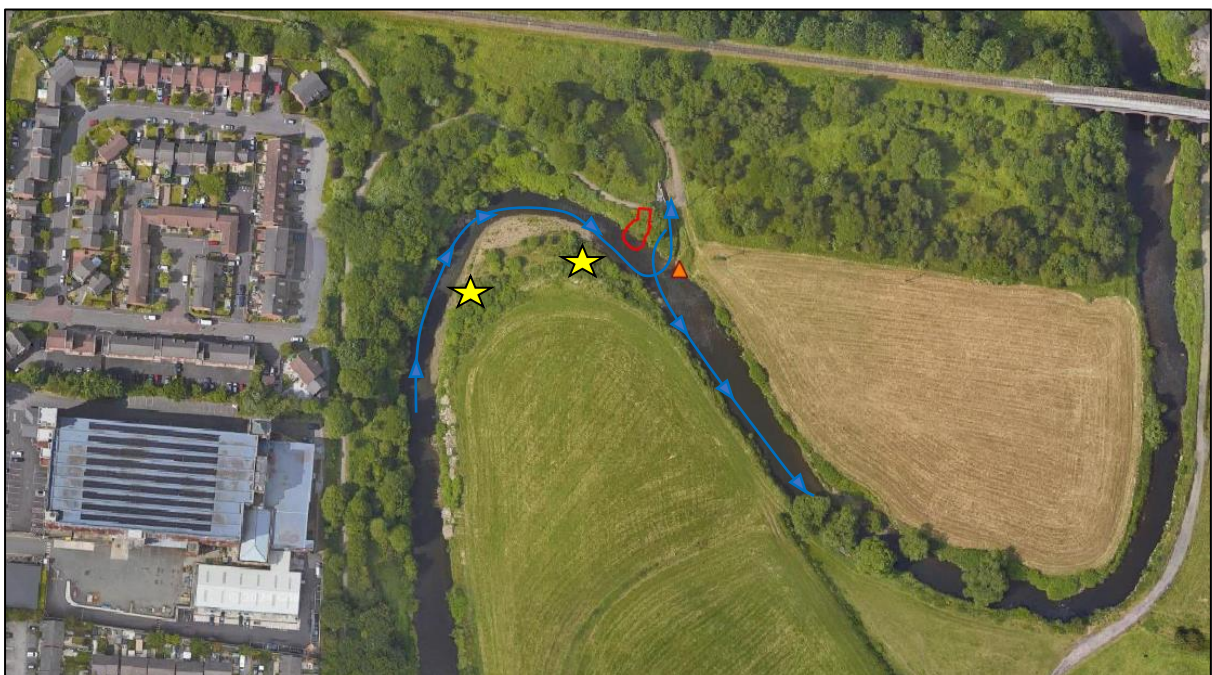
Figure 4.3 – Kingfisher survey No. 2 - 10/04/2024

| No. | Survey Date | Timings | Activity |
|---|---|---|---|
| 2. | 10/04/2024 | 06:40– 09:10 | <p><b>Summary: Kingfisher seen entering and existing the tributary. Dipper observed frequently entering and exiting the tributary throughout the duration of the survey.</b></p> <p>0645hrs: A Dipper (<i>Cinclus cinclus</i>) was observed entering the tributary to the west of the burrow carrying food and exited a moment later and continued upstream. This behaviour was repeated for the duration of the survey.</p> <p>0705hrs: Kingfisher flew up the tributary and out of site.</p> <p>0708hrs: Kingfisher exits tributary and flies upstream.</p> <p>0731hrs: Kingfisher enters tributary and hovers briefly before continuing up the tributary and out of site.</p> <p>0742hrs: Kingfisher heard but not seen.</p> |

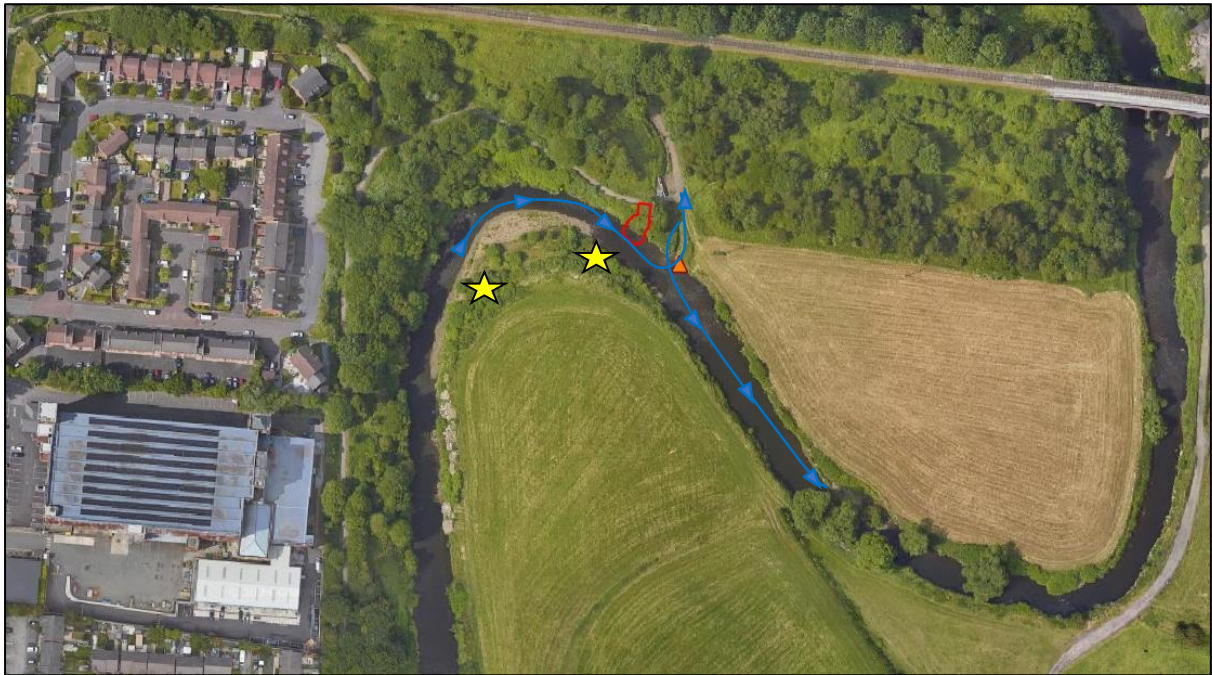
Figure 4.4 – Kingfisher survey No. 3 - 02/05/2024

| No. | Survey Date | Timings | Activity |
|---|---|---|---|
| 3. | 02/05/2024 | 05:40– 07:55 | <p><b>Summary: Kingfisher entered and exited tributary.</b></p> <p>0709hrs: Kingfisher entered the tributary to the west of the burrow.</p> <p>07014hrs: Kingfisher exited the tributary and commuted along the River Roch upstream.</p> |

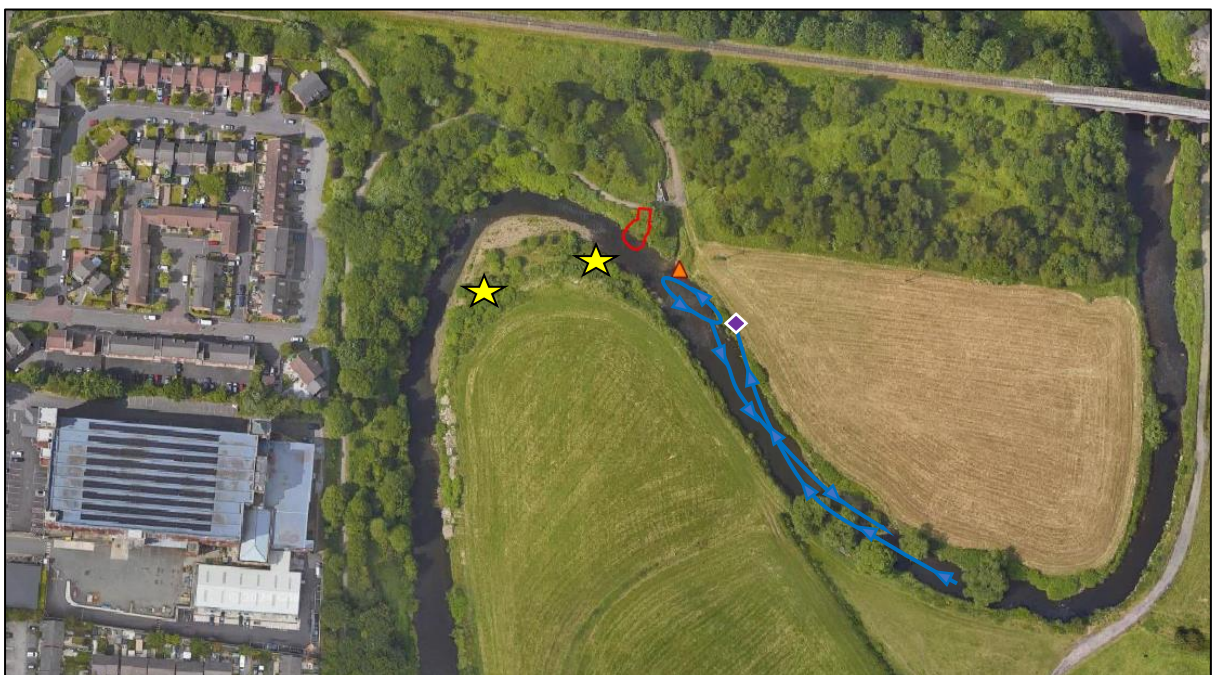
Figure 4.5 – Kingfisher survey No. 4 - 17/05/2024

| No. | Survey Date | Timings | Activity |
|---|---|---|---|
| 4. | 17/05/2024 | 04:50– 07:25 | <p><b>Summary: Kingfisher commuted from downstream to small willow and then circled over river before returning upstream.</b></p> <p>0715hrs: Kingfisher observed flying downstream (W-E) and landing in willow</p> <p>0717hrs: Kingfisher flew towards burrow but then hovered over water's surface before returning to the willow and then heading down stream (E-W).</p> |

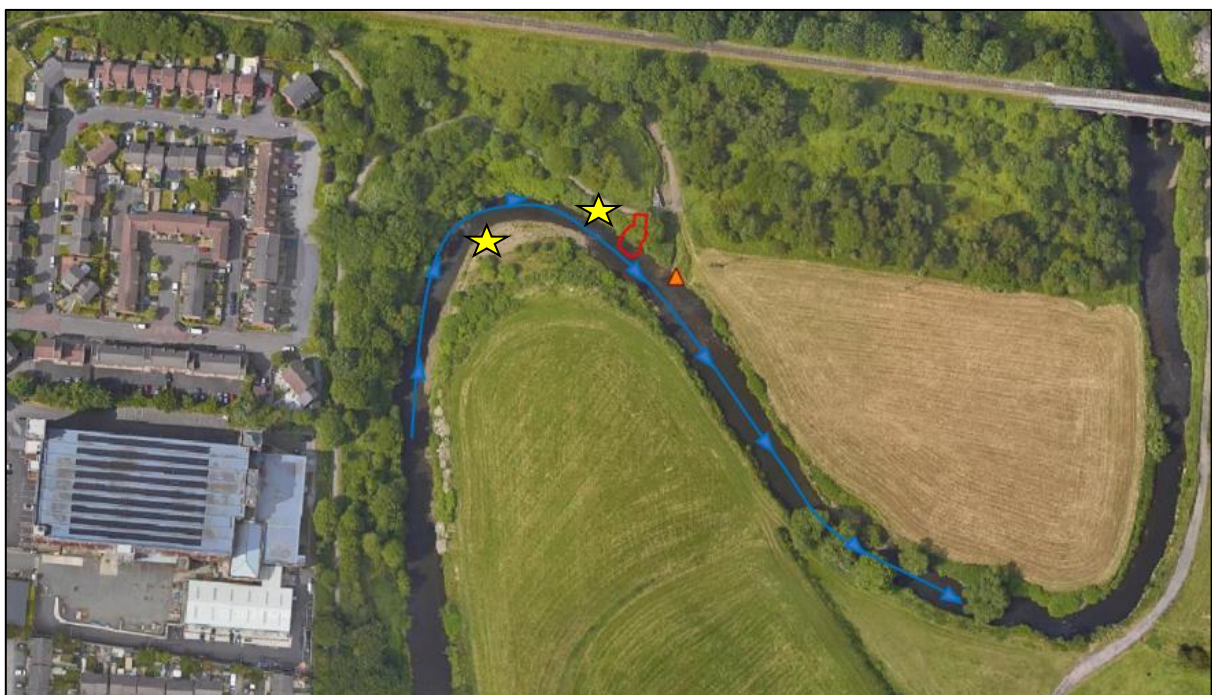
Figure 4.7 – Kingfisher survey No. 6 - 20/06/2023

| 6. | 20/06/2023 | 04:00 – 6:30 | <p><b>Summary: Single kingfisher pass flying upstream (E-W)</b></p> <p>0531hrs: Kingfisher flew upstream (E-W).</p> |

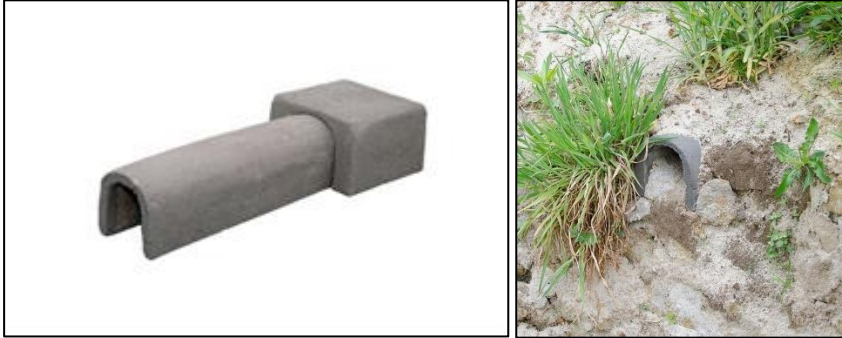
The Woodstone Kingfisher Nest Tunnel should be fitted with the bank side of the River Roch located a minimum of 1 metre above the water level and 0.5 metres below the top of the bank. The tunnel should be placed at a downwards angle of 10-20° to allow for drainage, and with a small 'bowl' of earth in the chamber for the eggs to lie in. Two nest tunnels should be placed within the bank approximately 2 metres apart.
