**REMEDIATION STRATEGY  
FOR LAND AT  
LOWERCROFT ROAD  
BURY**

**February 2024  
Ref: GSI 1923 LD RS Report V1**

| Quality Assurance | |
|---|---|
| Project Name | Lowercroft Road, Bury |
| Report Type | Remediation Strategy |

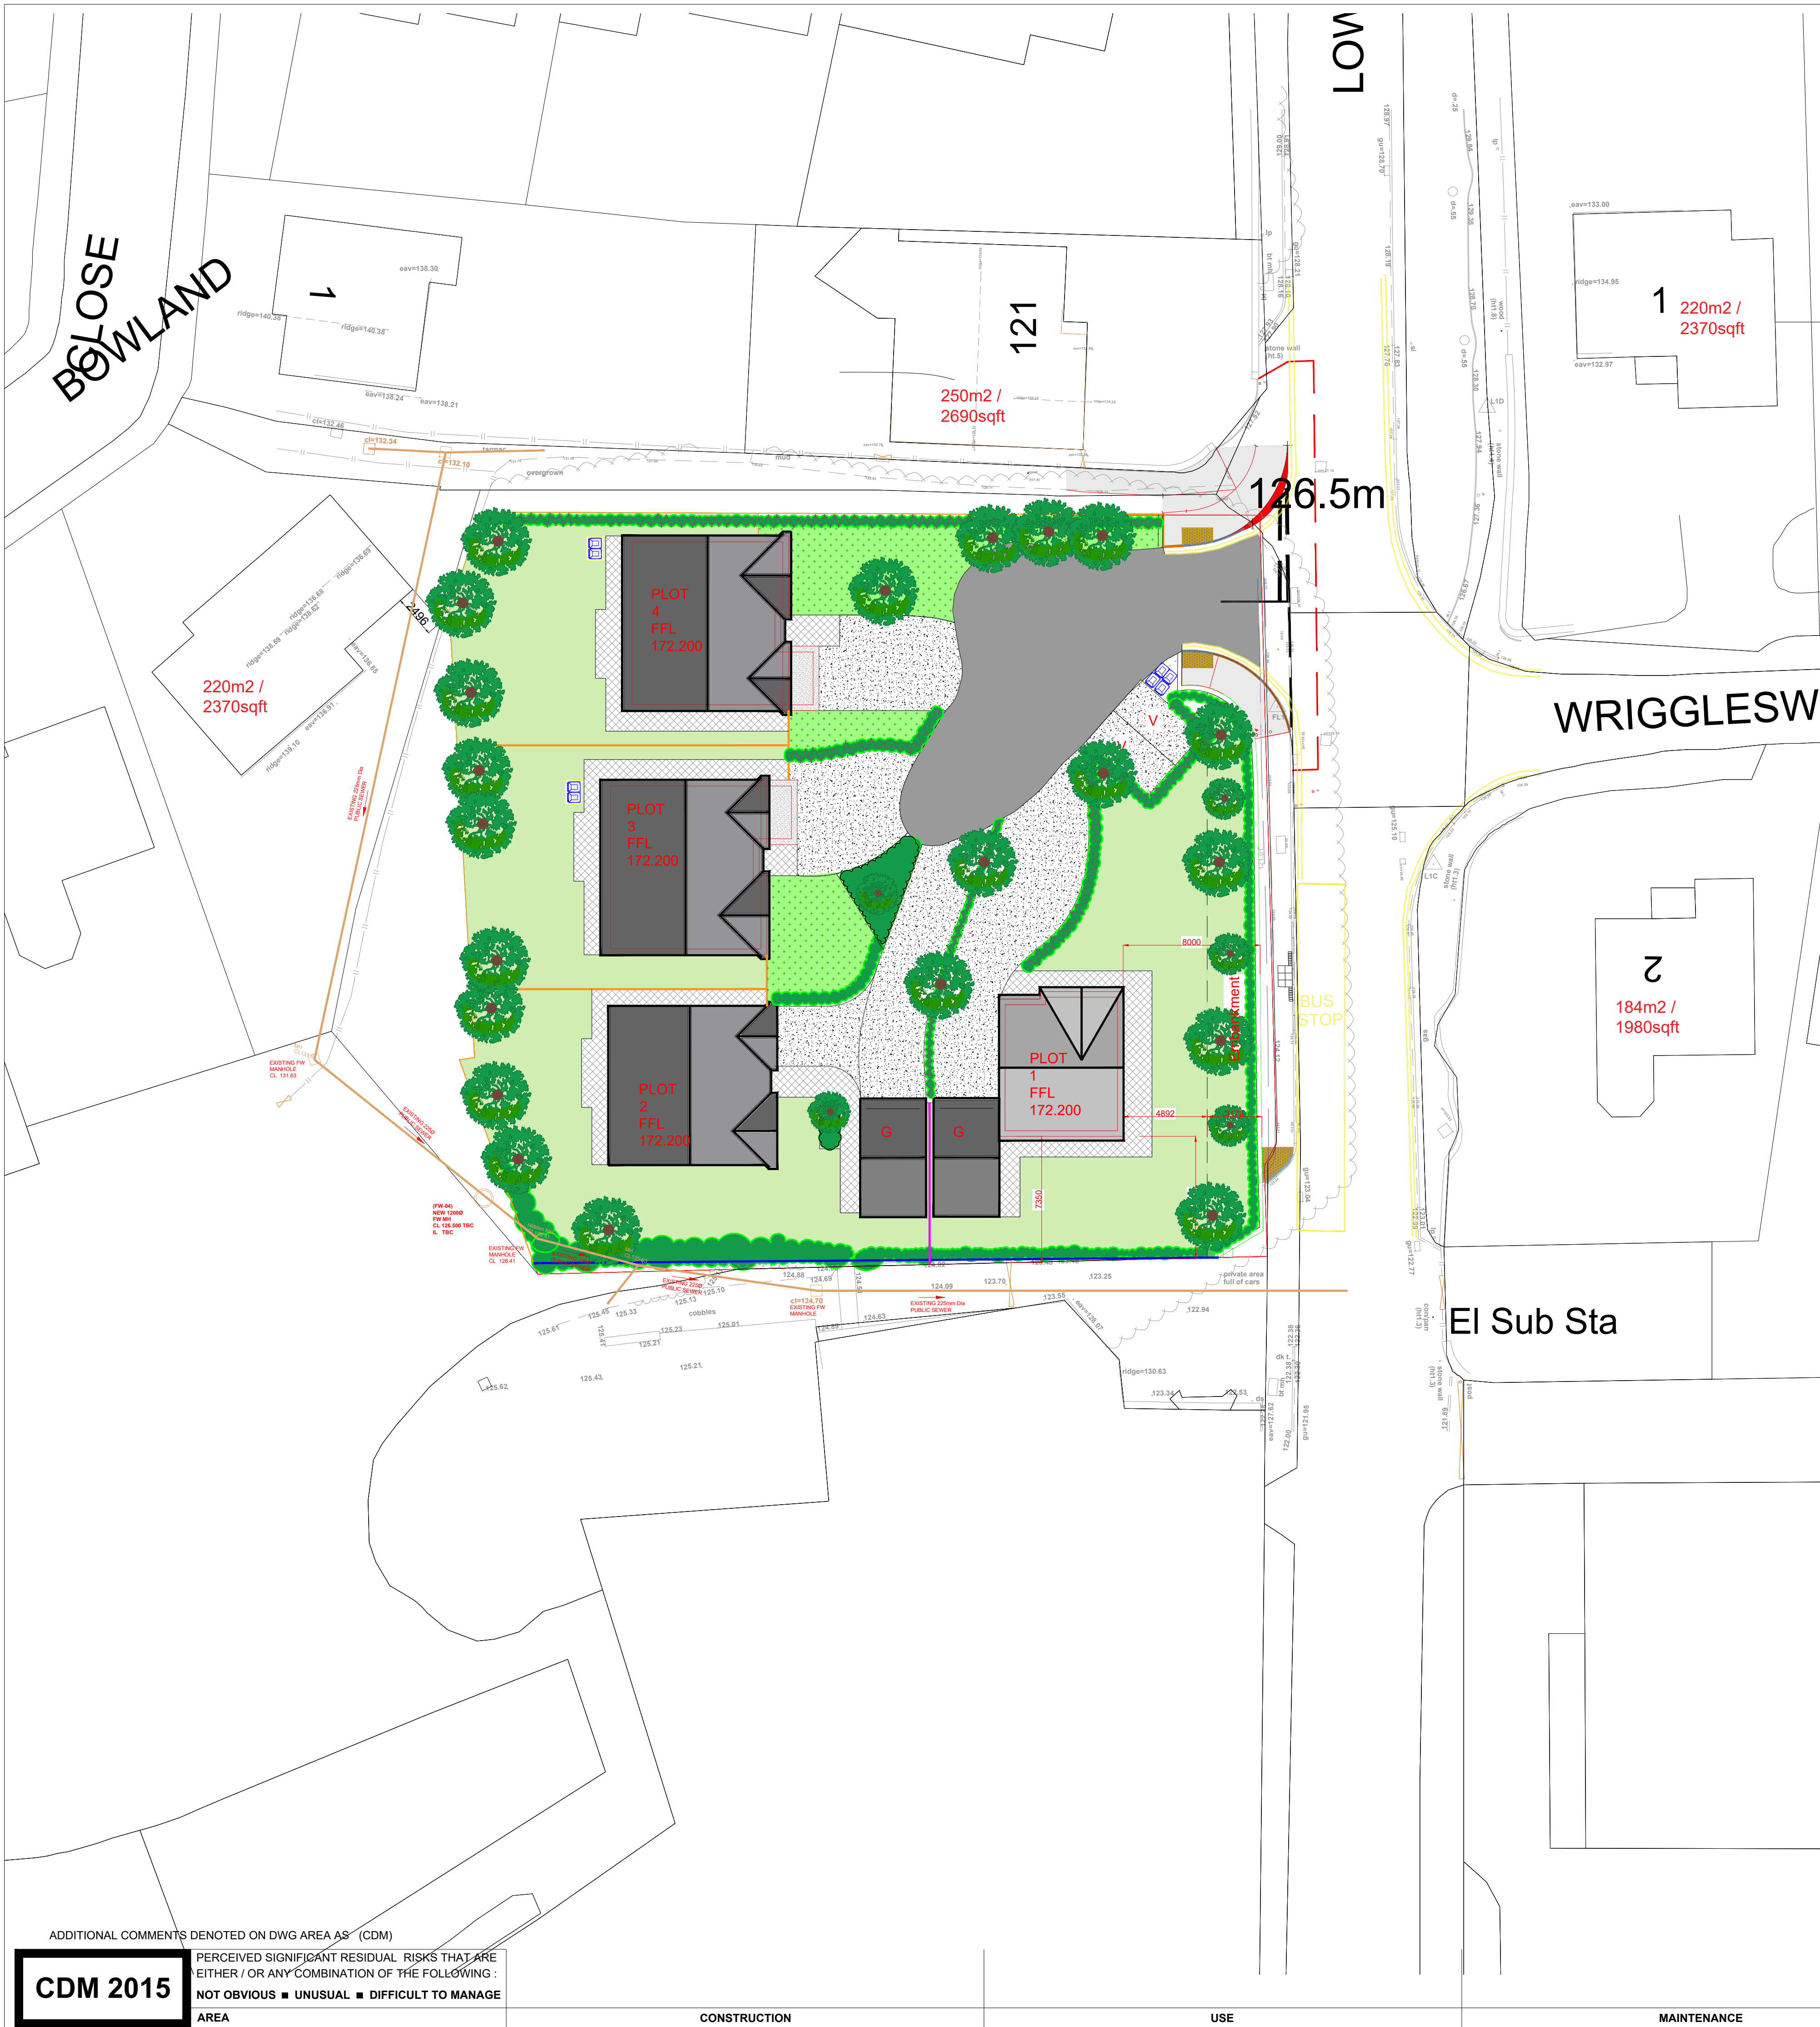
| TITLE | Site Plan |

Boundary Treatments : Scale @1:50 A1
