## ARBORICULTURAL REPORT (BS 5837:2012)

FOR  
PROPOSED DEVELOPMENT

FORMER WATERSIDE PUB  
KAY STREET  
SUMMERSEAT  
BURY

February 2023

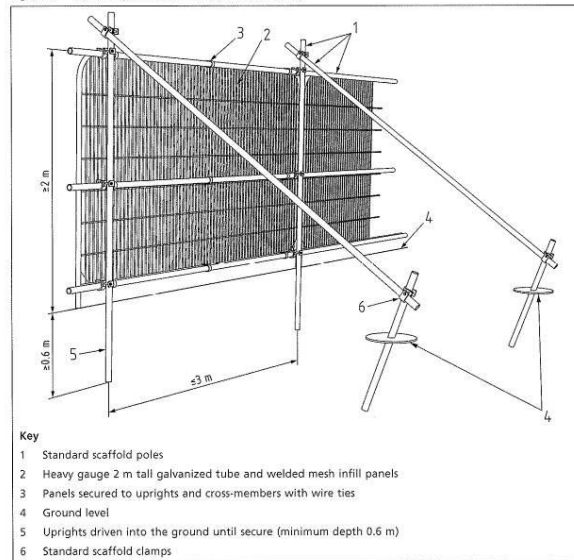
Figure 2 Default specification for protective barrier

6.2.3 In this circumstance the location for the protective fencing should be as shown on the Tree Protection Plan of Appendix G and of the following specification:

6.2.1 All fencing used on the site should fully comply with *BS 5837:2012 Trees in relation to design, demolition and construction – Recommendations*.

6.2.2 The fencing should be strong and suitable for local conditions. It should also take into account the degree of construction activity on the site.

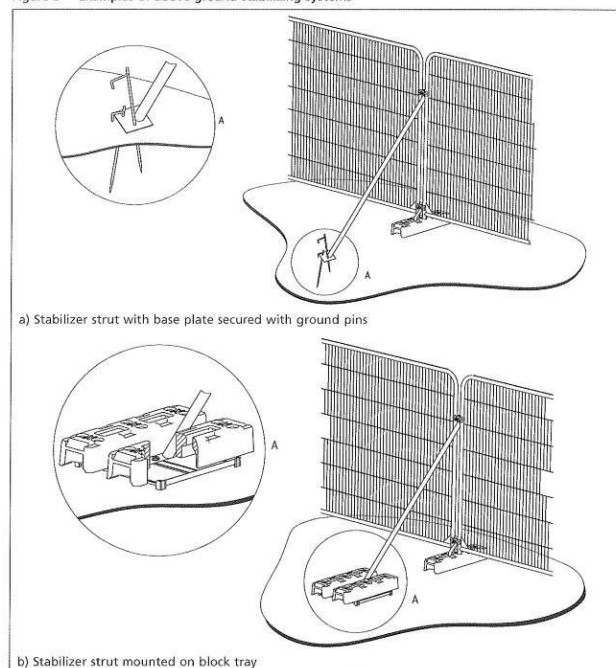
Figure 3 Examples of above-ground stabilizing systems

**Heras type temporary fencing can sometimes be acceptable with the bases pinned to the ground securely. This needs be checked with the Local Planning Authority.**

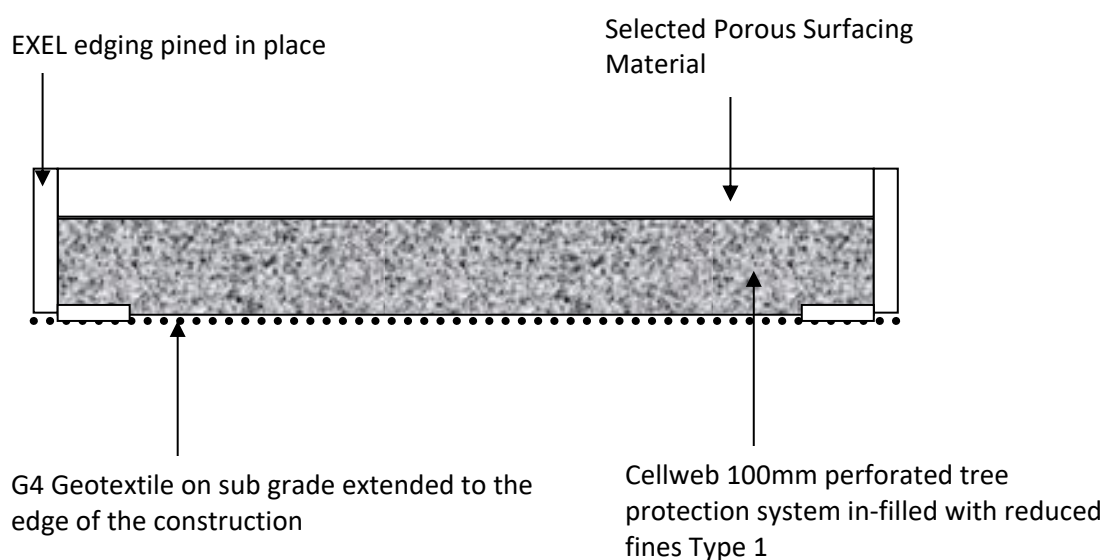
#### CELLWEB BASED SPECIAL SURFACE CONSTRUCTION – (INDICATIVE ONLY)

The following methodology supports the below drawing indicating the construction of the proposed 'no dig' surfaced area as mentioned in section 5.2.3 above with regard to T7 (see Appendix F and G). The methodology is prepared on the basis of the sequence of operations necessary to complete the construction of the hard surfaces with the minimum damage to the trees proposed for retention.

- Position EXEL metal edging pinned in place. This may also not be necessary for a temporary surface.
- Extend the Cellweb 100mm perforated tree root protection system over the area to be surfaced.
- Fill the voids within the Cellweb with reduced fines Type 1 material working into the site over the top of the Cellweb.
- Surface over the Cellweb such that the construction binds itself together.

- 5.2.3 There is new surfacing proposed within the RPA of T7 (Goat Willow). In this area it is proposed to employ the use of geo-textile materials, such as 'Geoweb' and 'Cellweb' to construct a permanent 'no dig' surfacing. In this instance the existing levels should allow this type of construction to be used. An example of this can be found in Appendix F of this report.

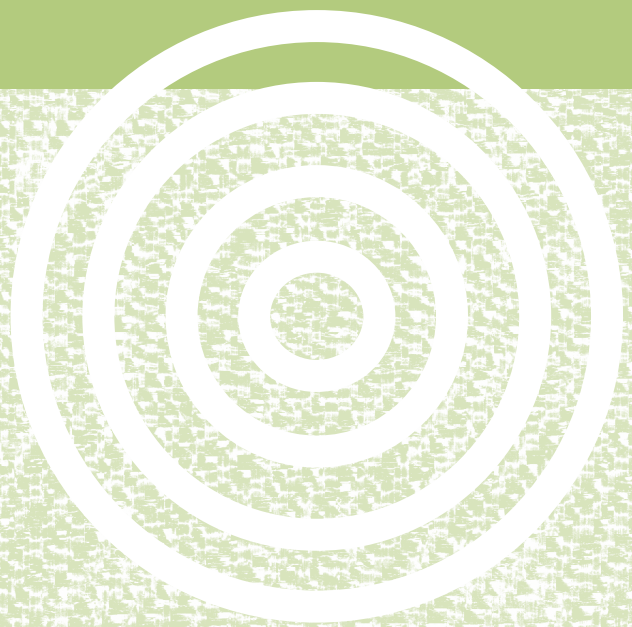
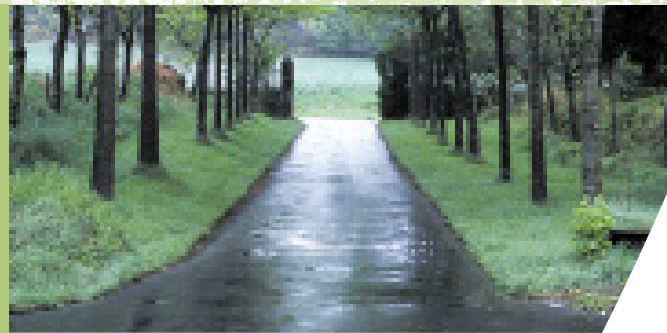
### **Example of Special Surface Construction**

CellWeb TRP<sup>®</sup>

Tree Root Protection Guaranteed

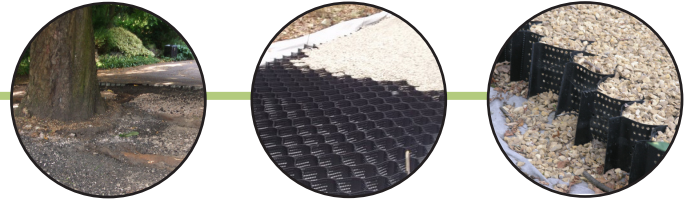
## Geosynthetics CellWeb TRP® System

## The Solution According to BS 5837:2012

"Appropriate sub-base options for new hard surfacing include three-dimensional cellular confinement systems ....."

CellWeb TRP® is the market leader in the United Kingdom and Ireland for tree root protection. CellWeb TRP® cellular confinement system protects tree roots from the damaging effects of compaction and desiccation, while creating a stable, load bearing surface for vehicular traffic. CellWeb TRP® complies with BS 5837:2005 and APN 1. It provides a no-dig solution, is tried and tested having been used successfully since 1998. It is the only tree root protection system which has been independently tested and it is the only tree root protection system which is guaranteed for 20 years. See page 6 for the full terms and conditions of the guarantee.

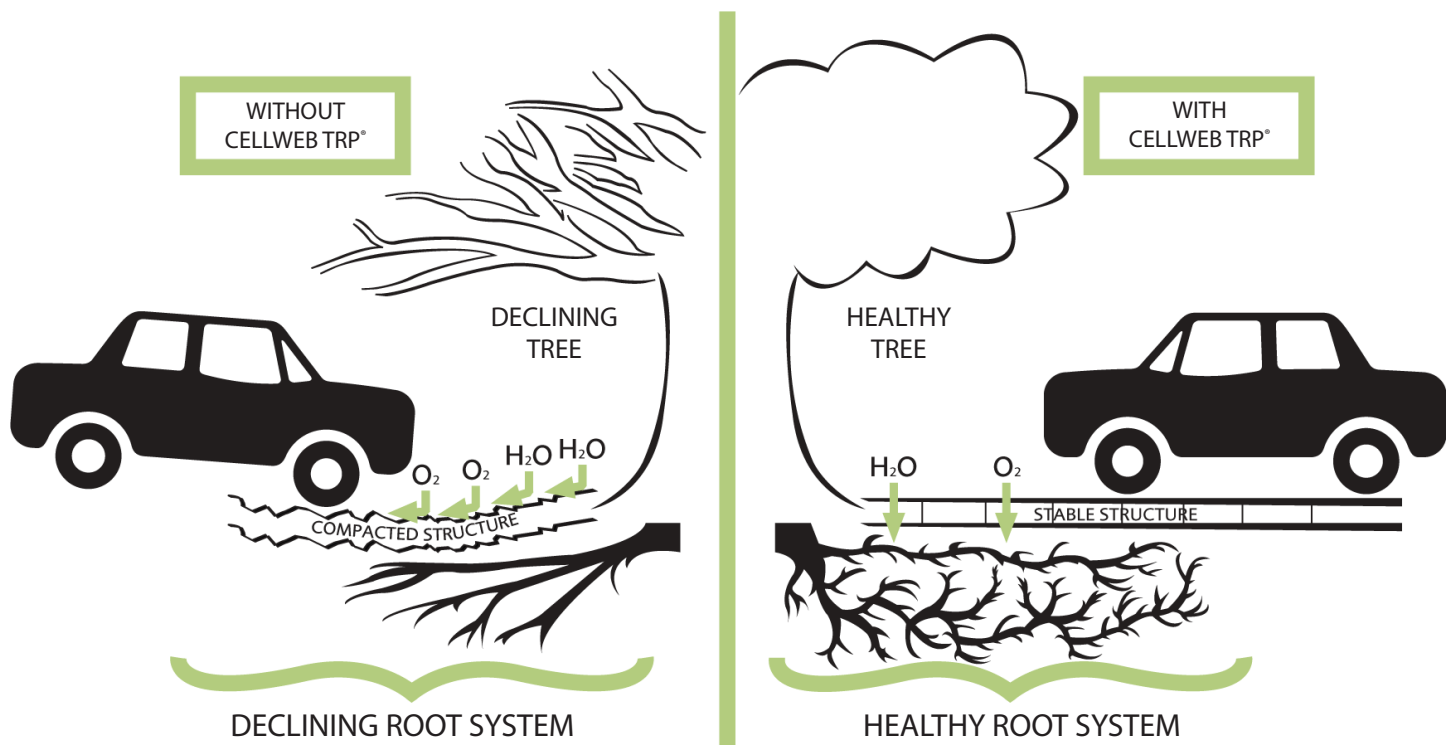
CellWeb TRP® is a cellular confinement system that confines aggregate materials and makes them stronger, thus increasing the bearing capacity of the sub base materials. Research shows that CellWeb TRP® acts as a stiff raft to distribute wheel loads and reduce their magnitude at the base of the construction, thus maintaining the soil bulk density at levels that are suitable for tree root growth.

### Water and Oxygen Transfer Through the CellWeb TRP® System

The CellWeb TRP® system is constructed using open aggregate infill and CellWeb TRP® has perforated cell walls. The pore spaces between the aggregate particles are greater than 0.1mm in diameter. This open structure is far more permeable than typical soils and allows the free movement of water and oxygen so that supplies to trees are maintained.

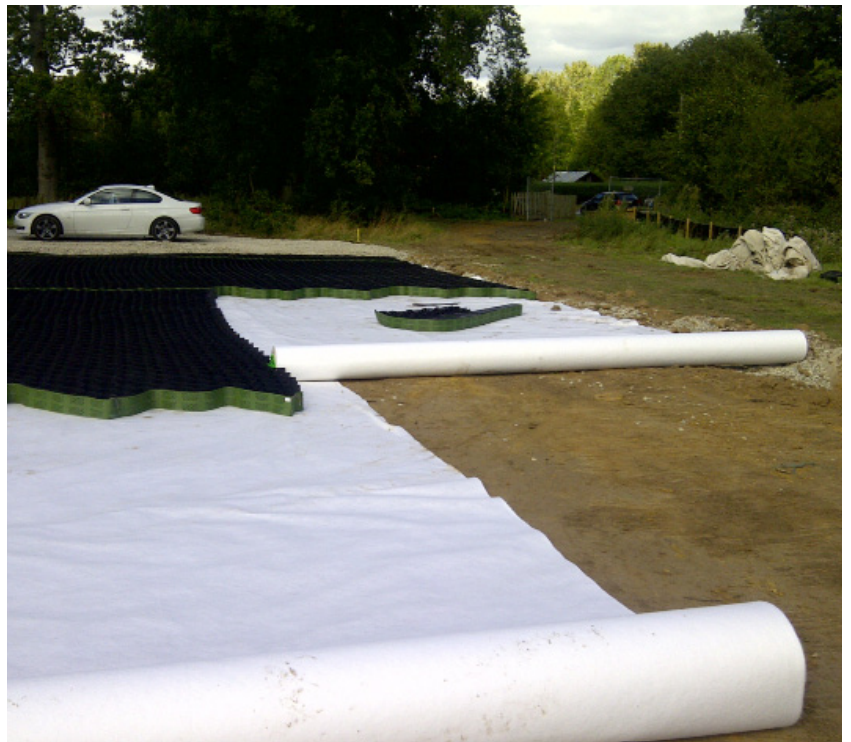
Harcourt Aboretum

The Treetex® geotextile used in the CellWeb TRP® system has two functions. Treetex® separates the sub base aggregates from the soil beneath and it traps oil within its structure and allows it to degrade aerobically within the pavement construction. The structure, thickness and weight of Treetex® creates the perfect environment for this to happen. Most importantly tests prove that Treetex® will absorb 1.7 litres of oil per square metre, this is 4 times more effective than standard geotextiles.

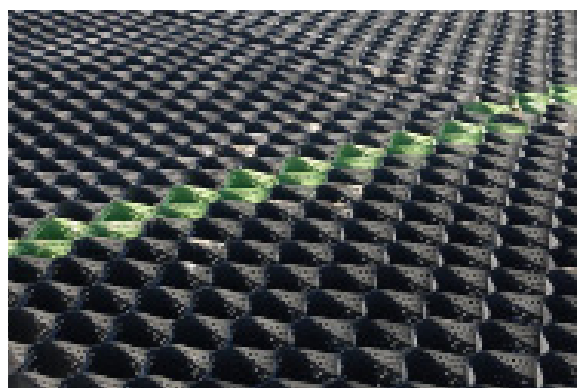
Woodcock Hall, Yorkshire

CellWeb TRP® is uniquely identifiable. It is manufactured with a bright green panel on each side. When installed the green panels are laid adjacent, creating a green band across the construction.

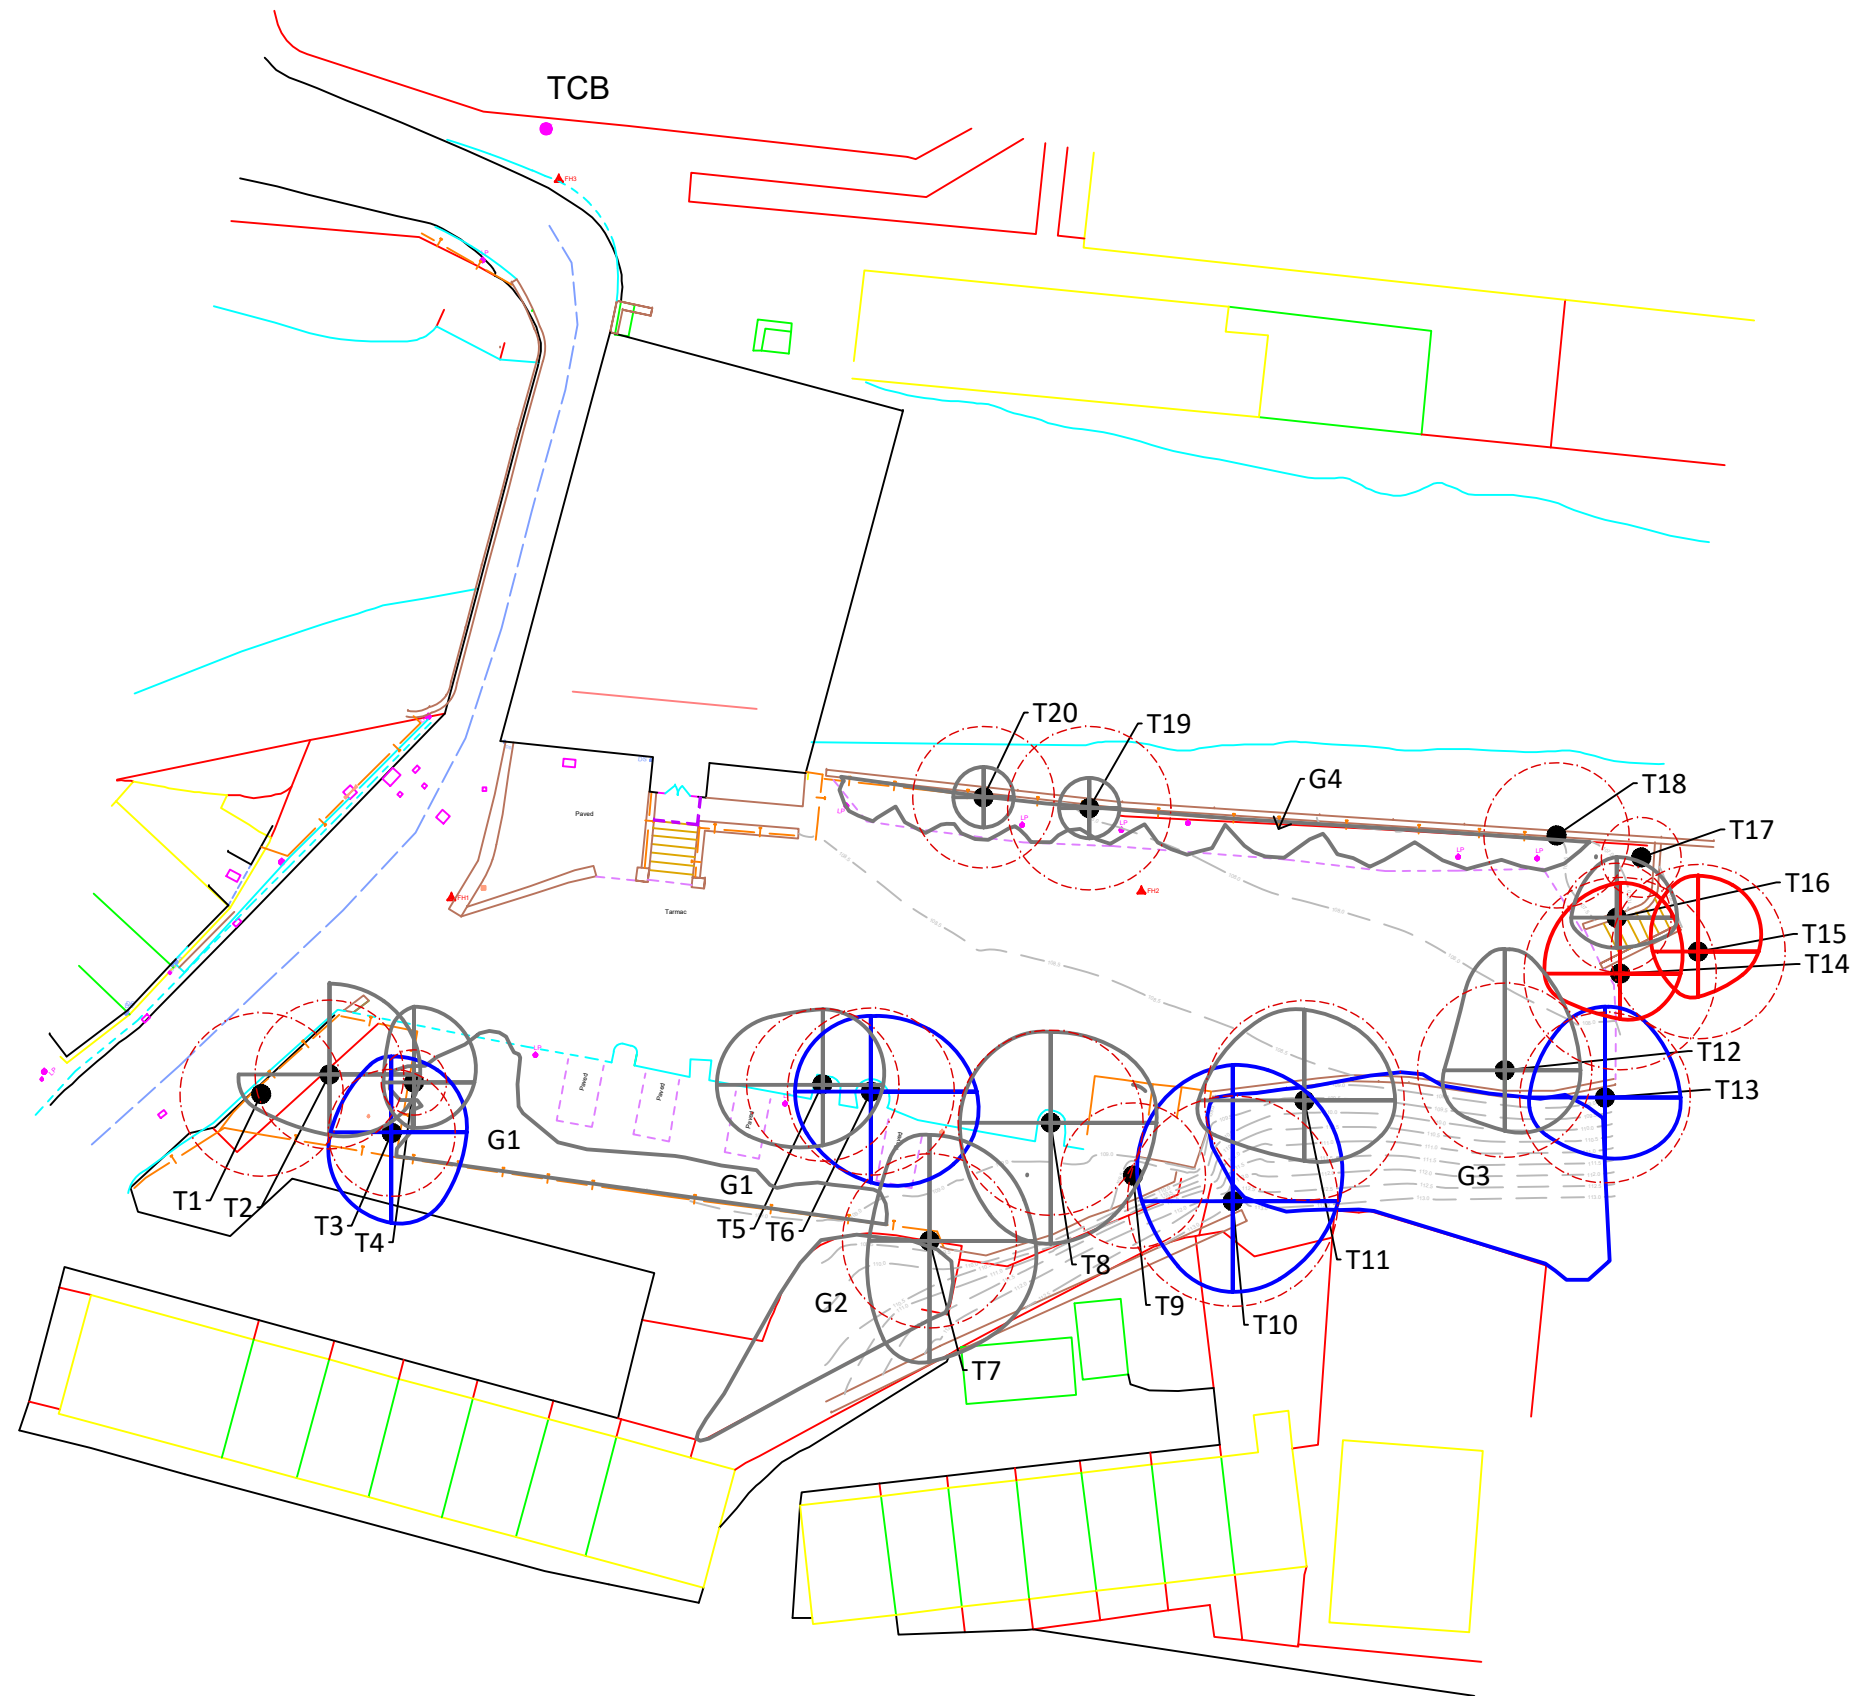
**Tree Protection Plan**

- 4.4 The below Implications Table details the Root Protection Area (RPA) in accordance with the British Standard 5837:2012 *Trees in relation to design, demolition and construction – Recommendations*. This is an area that should be left undisturbed in order to provide adequate rooting area for retained trees. This is also illustrated on the Site Plan of Appendix G.
