**1 and 3 Haslam Street,  
Bury,  
Manchester.  
BL9 6EQ**

**Preliminary Ecological Survey & Assessment  
in Respect of Bat Species and Nesting Birds.**

**Echo Calls Bat Surveys.**

**12<sup>th</sup> May 2026.**

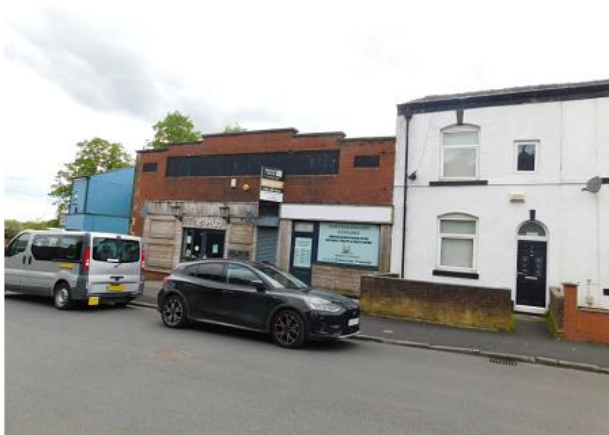
**PHOTO 1**  
**North-eastern Corner.**

- The eastern elevation of the complex had previously been the entrances into the retail shops, and during the current survey it was noticed that the majority of windows and timber notice boards were still present, however, these had been boarded up for some time. A close inspection of these timber covers and the areas of brick, both around and below them, using sight and also close focus binoculars, found neither any bat droppings, nor any other sign of bat occupation, and all these covers were judged to offer negligible bat roosting opportunity, (refer to **figs 2, 3 and 4**, and **photos 1 to 5**).

- Along the upper edge of the eastern elevation was a low brick parapet wall, and again a close inspection of this wall, and also the concrete coping stone along its top, found it to be well-sealed, and offering negligible bat roosting opportunity, (refer to **figs 2, 3 and 4**, and **photos 1 to 5**).

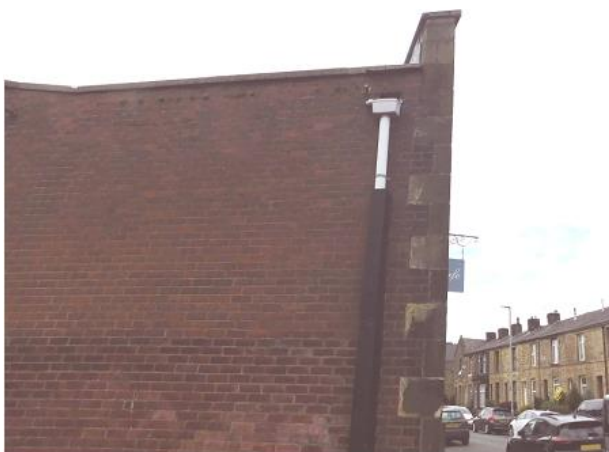
**PHOTO 5**  
**South-eastern View of Eastern Parapet Wall.**

The southern elevation was slightly curved, following the contour of Back Haslam Street, and an external survey found no apparent bat roosting opportunities, and therefore the elevation was judged to offer negligible bat roosting suitability, (refer to **figs 2, 3 and 4**, and **photos 5 to 14**).

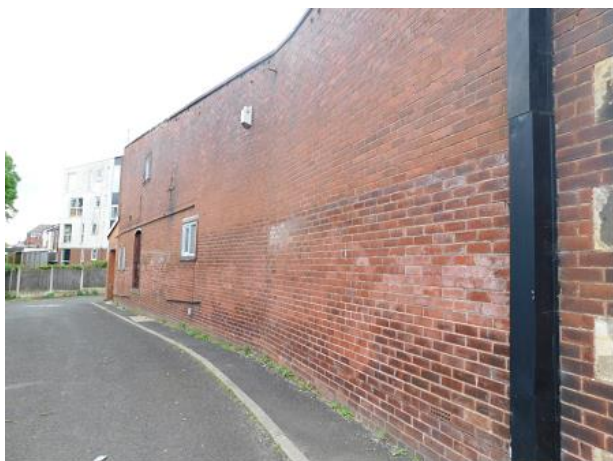
**PHOTO 7**  
**Eastern View Along Southern Elevation.**

- Positioned centrally along the southern elevation was an entrance porch, however, a full inspection of this found it to be boarded up internally, and externally closed off with a vertical metal grill. All parts of the wooden boarding, and also around the edges of the boards were searched using a bright torch, and an industrial endoscope camera, but neither bat droppings, any invertebrate or lepidopteran prey remains were found, nor was any bat fur grease or bat urine staining found, neither was any other evidence of bat occupation seen, and therefore the whole doorway was judged to offer negligible bat roosting suitability, (refer to **figs 2, 3 and 4**, and **photos 7 to 11**).

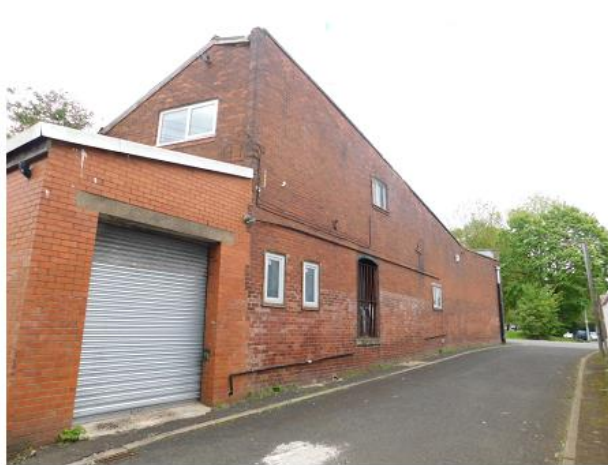
**PHOTO 10**  
**South-western Elevation.**

- Close to the western apex of the main roof, there was a gap beneath the soffits along the top roof edge, however, a search of the area using close focus binoculars, found no indication of bat droppings, or invertebrate prey remains, nor was there any indication of either bat urine staining or fur grease staining which would have indicated the passage of bats into the gap. The conclusion therefore was that the gap had negligible potential for bat roosting, (refer to **figs 2, 3 and 4**, and **photos 10, 11, 14 and 17**).

Attached to the western elevation of the complex was the single storied garage extension, and this was constructed entirely from brick, and was thought to be a fairly recent addition to the structure. It had a sloping roof of corrugated iron sheeting, mounted upon wooden beams and purlins, but although there was a false ceiling of plasterboard panels, the extension was uninsulated and unheated. There was a large roller shutter door in the southern elevation, but a close inspection of this, both internally and externally found neither droppings or any other evidence of bat usage. The extension was in a reasonable condition, being fairly sound and well maintained, however it would be very draughty, damp and cold throughout the year, and therefore the garage, was deemed unsuitable for either daytime roosting bats, or breeding bats. Also, as frost and inclement bad weather were both very likely to penetrate the interior of the garage in the colder months, it therefore did not offer the optimum humidity, and constant low temperatures that are required for hibernating bats, and as an interior search using a bright torch, close-focus binoculars, and an industrial endoscope camera, found neither bat droppings, any invertebrate or lepidopteran prey remains, nor any bat fur grease staining. Also, a search among all internal parts of the garage, using the Darkbeam LED ultraviolet flashlight, found no signs of bat urine staining, nor was any other evidence of bat occupation observed, and therefore the whole garage extension was judged to offer negligible bat roosting suitability, (refer to **figs 2, 3 and 4**, and **photos 10 to 22**).

- There were gaps between the soffit boarding at both the south-western and the north-western upper corners, and also there was a gap between the upper southern elevation and the soffit boarding, and all three of these locations were searched, first by using sight with a bright torch, and then using close-focus binoculars, and an industrial endoscope camera, but found neither bat droppings, any remains of invertebrate or lepidopteran prey, nor was any bat fur grease staining observed that would have indicated the passage of bats through the gaps. Also, a search of all parts of the walls both around and floor below these potential access points, using the Darkbeam LED ultraviolet flashlight, found no signs of bat urine staining, and therefore all of these potential opportunities were judged to offer negligible bat roosting suitability, (refer to **figs 2, 3 and 4**, and **photos 10 to 18**).

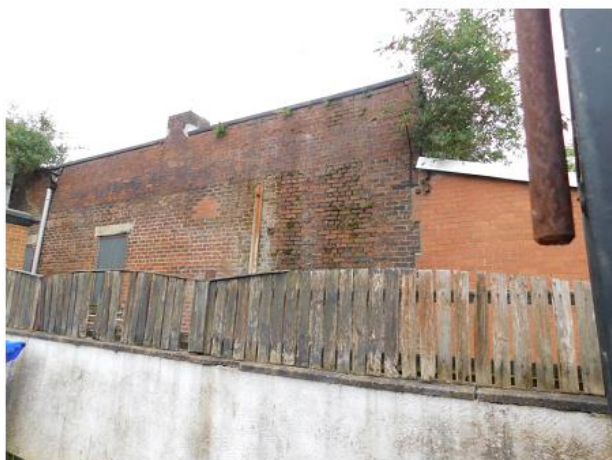
**PHOTO 21**  
**North-western Elevation**

A large part of the external northern elevation of the complex and its roof, could not be searched as it was attached to the aforementioned row of terraced houses along Haslem Street, however, the remainder of the elevation could be searched, and neither gaps nor lifted tiles were found, neither was there any other sign of bat usage or occupation discovered, (refer to **figs 2, 3 and 4**,

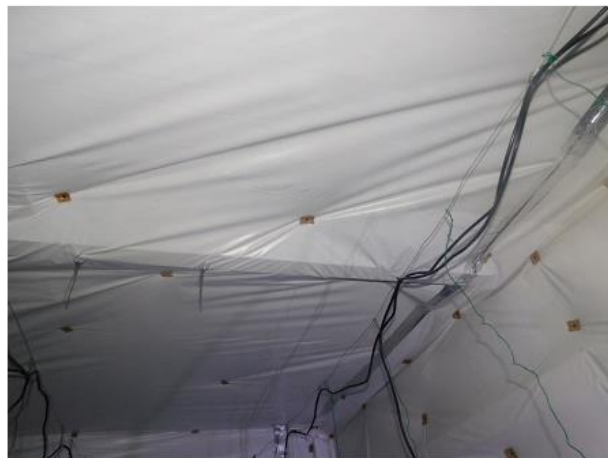
**PHOTO 24**  
**Underside of Eastern Cellar Roof.**

It was understood at the time of the survey, that the complex had ceased to be used for retail purposes around two years ago, and had only been used for incidental use since then. Although there were currently numerous pieces of furniture, machinery and other items, scattered around within the building interior, the overall structure was still in a reasonable condition, being fairly sound and sealed, both externally and internally. The structure was two storied, with a cellar beneath both parts, and also with easy access into the different parts of the roof void. The various roof voids were all insulated, and internally well sealed, with no indication of external access into the voids. Also, the cellars had no external access points, and therefore the roof voids and both parts of the cellar were deemed to offer negligible bat roosting suitability.

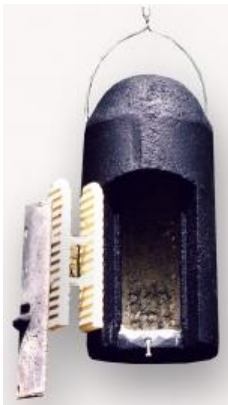
### Schwegler 1FD Bat Box

This Schwegler 1FD bat box has been developed specifically for smaller bats. The interior and the type and size of the entrance hole match the requirements of smaller species. It features a special layout inside the domed roof, an increased interior height, and two grooved internal wooden front panels with precise spacing between them.

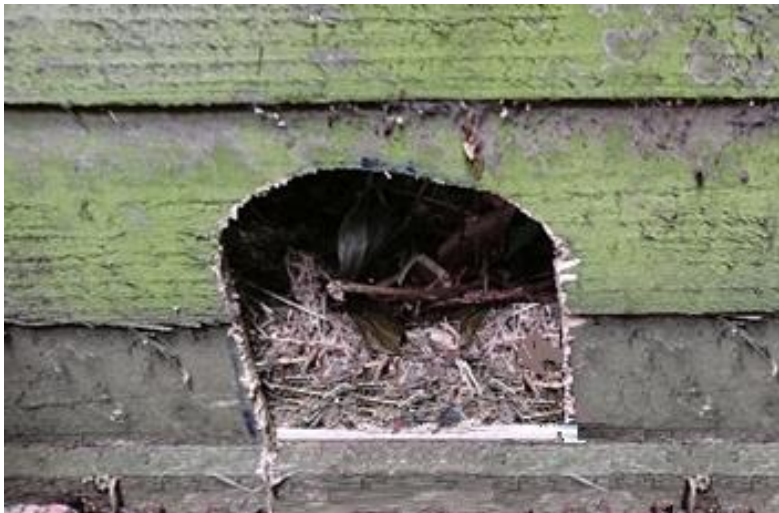
A 13cm-by-13cm square hole is sufficient for any hedgehog to pass through, no matter what the wall or fence is made from. This will be too small for pets and dogs to pass through to pursue hedgehogs.

- Remove a brick from the bottom of the wall.
- Cut a small hole in your fence if there are no gaps.
- Dig a channel underneath your wall, fence or gate, to obtain enough depth.

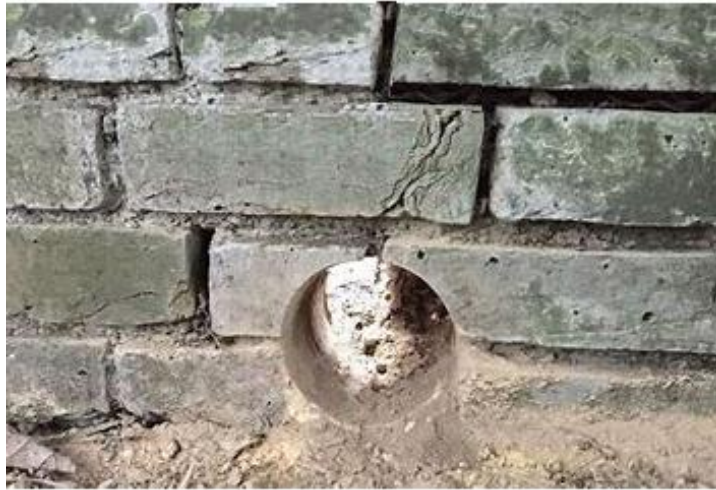
- A 13 cm diameter circular hole through brickwork creates a tunnel.

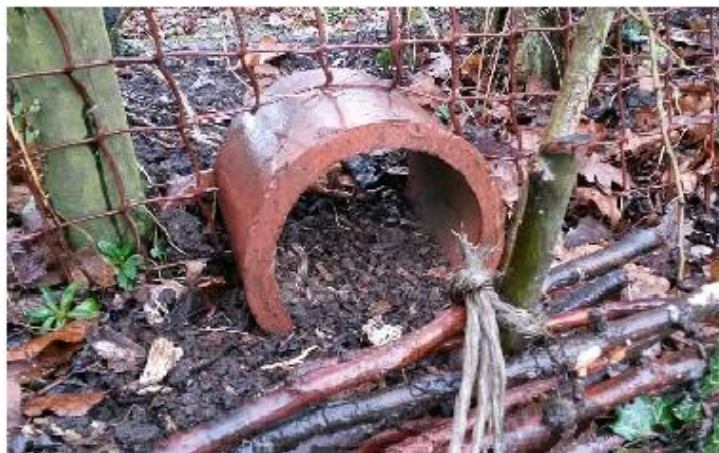
- Similarly, a 13cm diameter drainpipe would suffice through vertical fencing
