Pyramid Park, Bury  
Land Quality Statement

For  
Bury Council

Project No.  
14111

Date  
April 2024

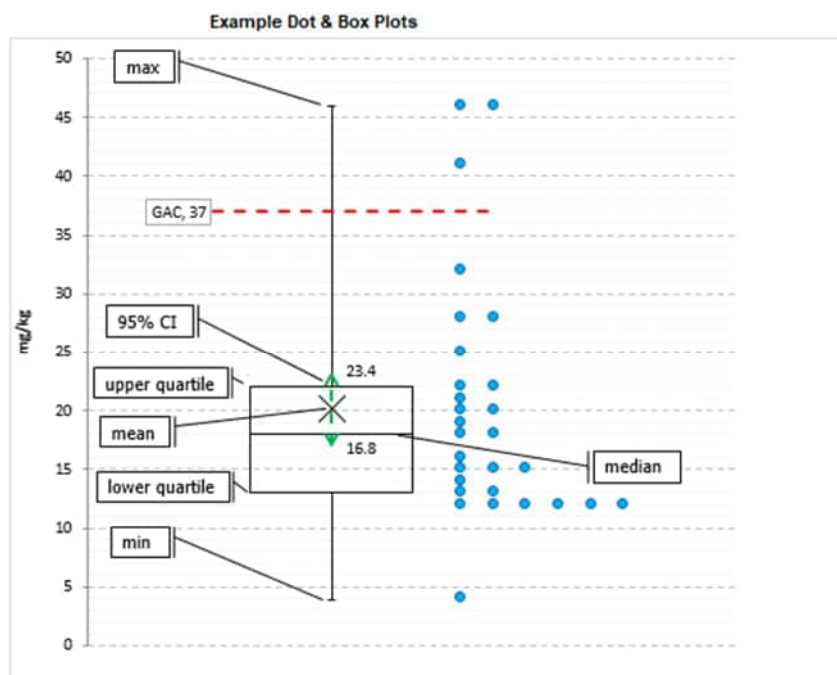
An example is shown below of dot and box plots and summary statistics from assessment of the soil sample analysis results. This summary aids in interpreting the results and checking that they 'make sense' in relation to the CSM. For example, if the mean and upper confidence interval are below the critical concentration, yet there are results that still exceed, are these results from the expected distribution, or is there a separate zone or soil layer which these results represent? Looking at all of the site information and always trying to better understand the CSM is essential to interpreting the results. It may be that insufficient information has been gathered in order to confidently answer the key questions posed.

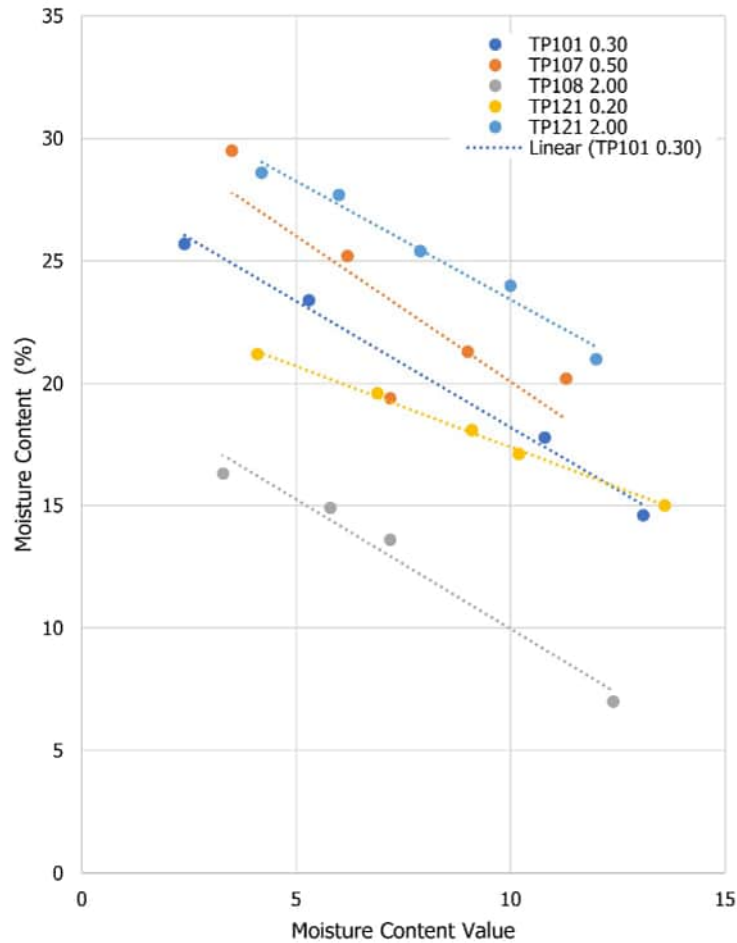
**MCV vs Moisture Content  
(Made Ground)**

- 6.3.22 Five Moisture Condition Value (MCV) relationship tests were undertaken on samples of the Made Ground. The results are presented in Figure 11a, Appendix 1.

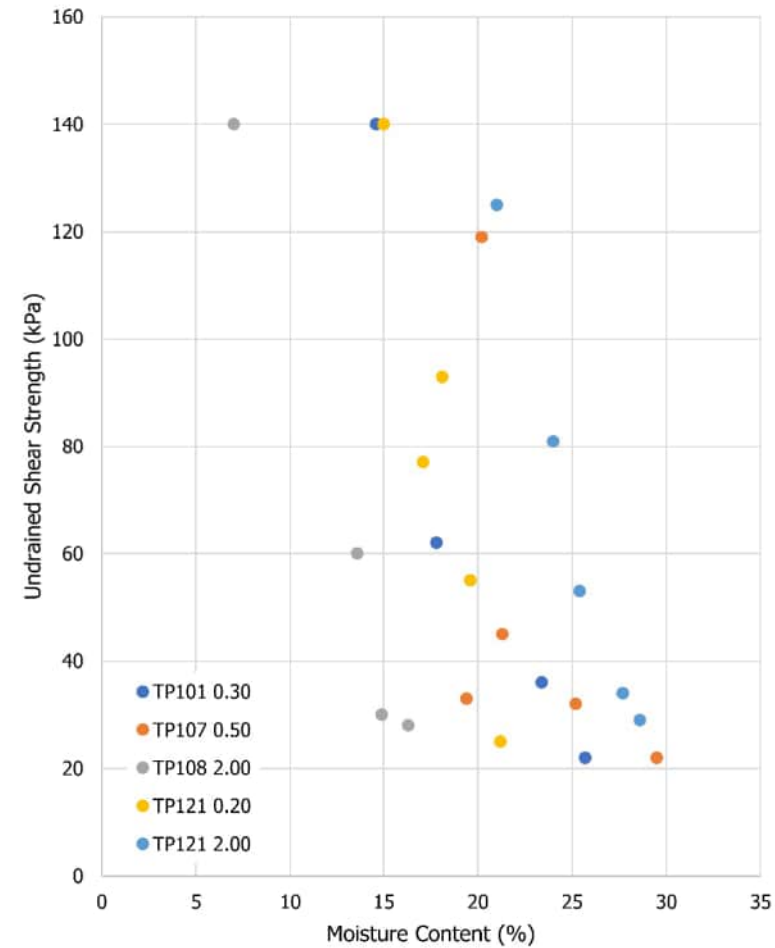
**Moisture Content vs Shear Vane Test  
(Made Ground)**

- 6.3.12 Twenty-three laboratory shear vane tests (HSV) were undertaken on five samples of Fine Made Ground at varying moisture contents. A plot of the recorded undrained shear strengths vs moisture content, presented in Figure 11a, Appendix 1, indicates that the undrained shear strength generally falls below 50kPa where the moisture content is above 20% although, three tests recorded undrained shear strengths below 50kPa where the moisture content was between 15% and 20%.
