## Three Buildings & Chimney Former Mondi Site, Holcombe Mill Bridge Street Ramsbottom

Level 1-2 Historic Building Recording  
[Report No. 4556](#)

**Level 1-2 Historic Building Recording**

**Report No. 4556**

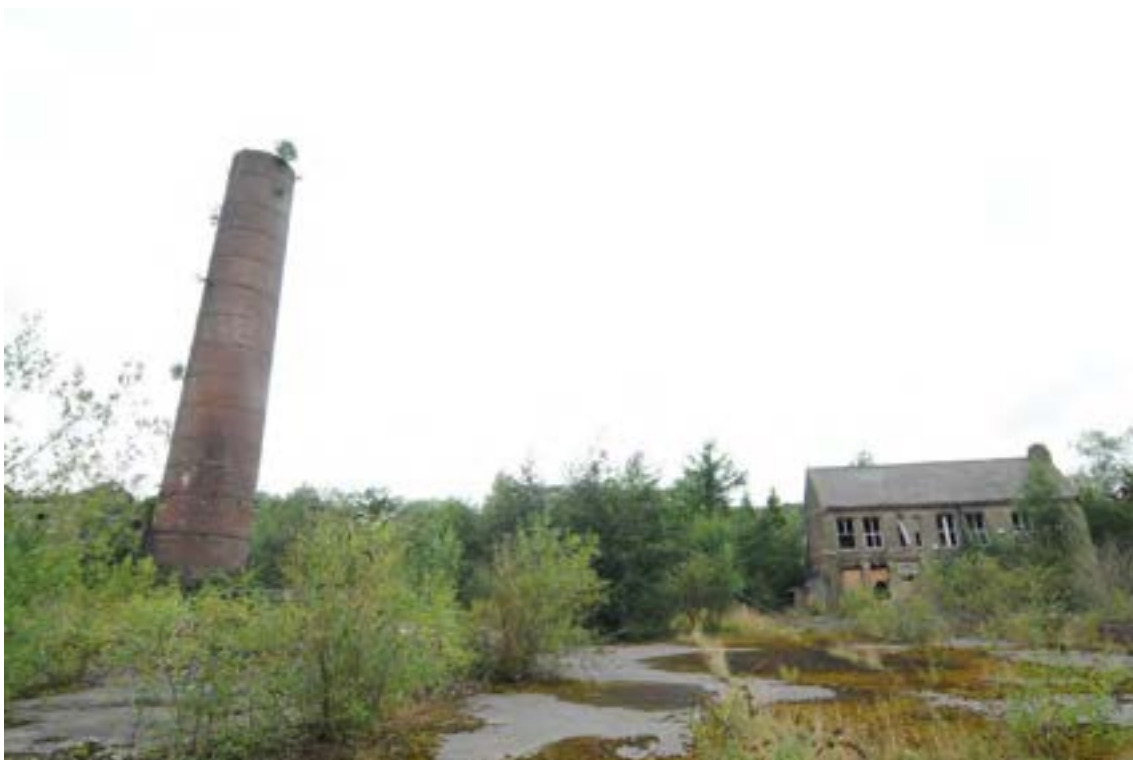
Photograph No : 1 Digital Ref: HOMI\_HBR\_0089 Direction: W  
Description: Westward view of site with Building A at north (right), Building B (centre, behind vegetation), Building C and Chimney at south (left)

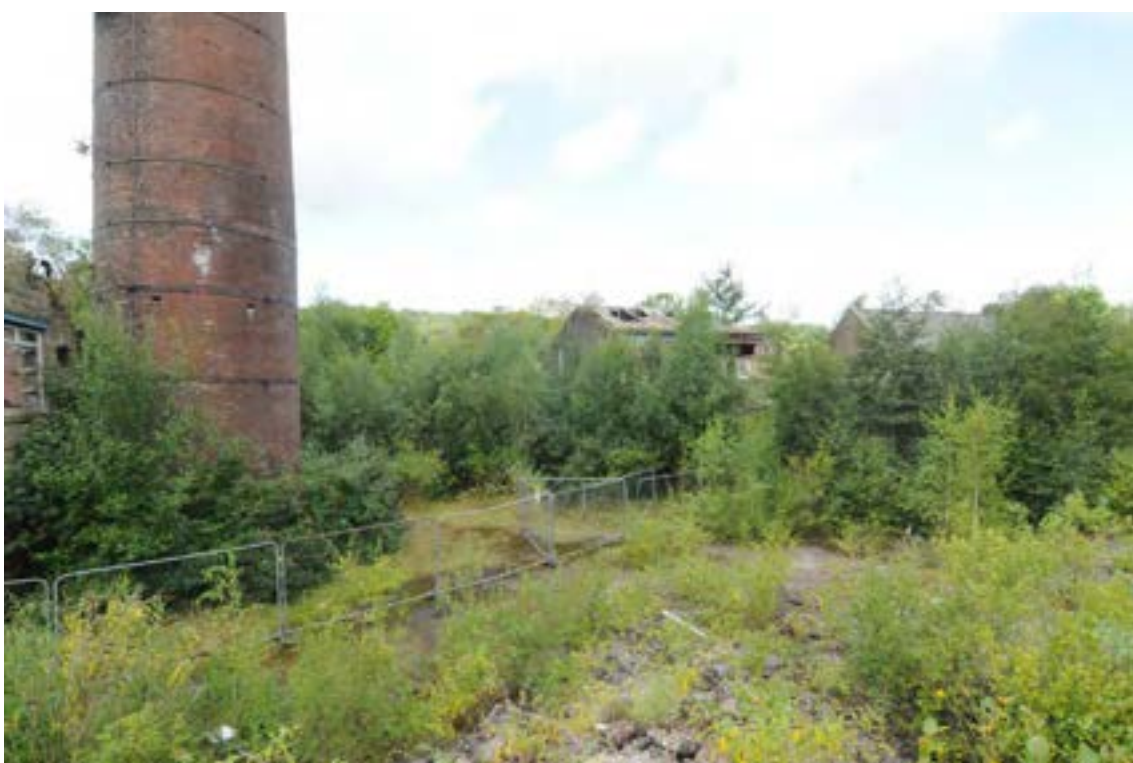
Photograph No : 2 Digital Ref: HOMI\_HBR\_0006 Direction: NW  
Description: NW view of site with Building A at north (right), Building B (centre), Building C and Chimney at south (left)

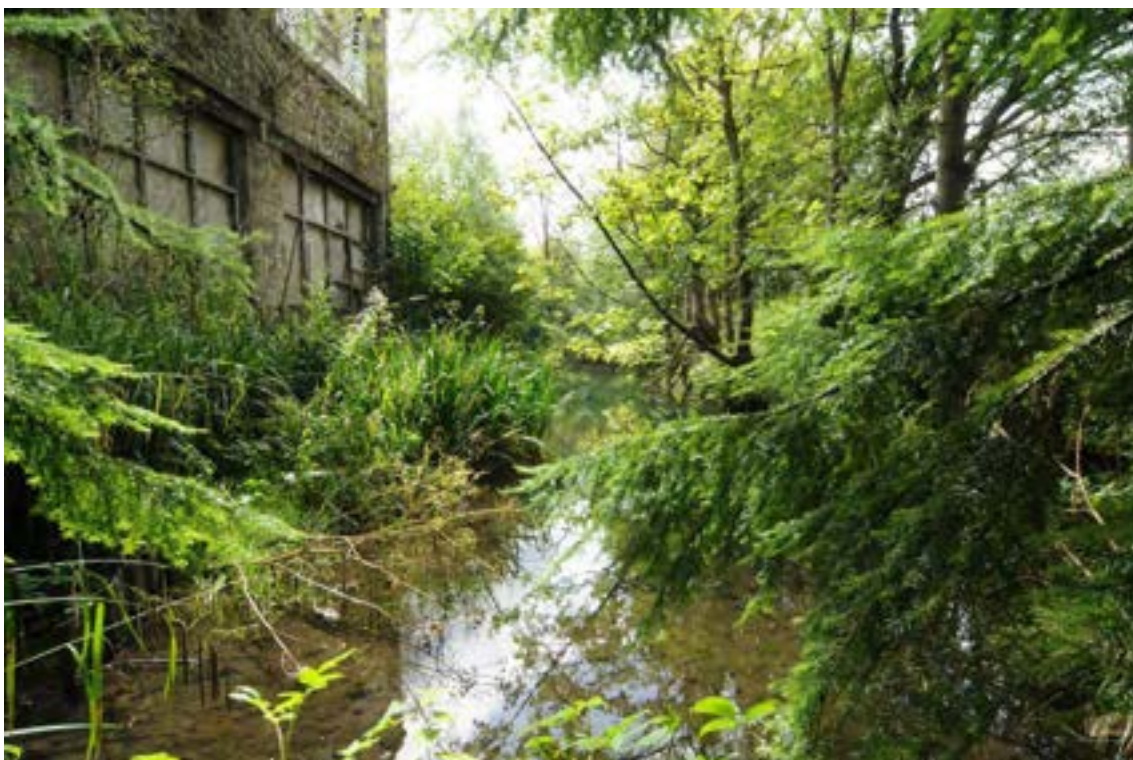
Photograph No : 3 Digital Ref: HOMI\_HBR\_0064 Direction: S  
Description: Remains of goit and west elevation of Building B

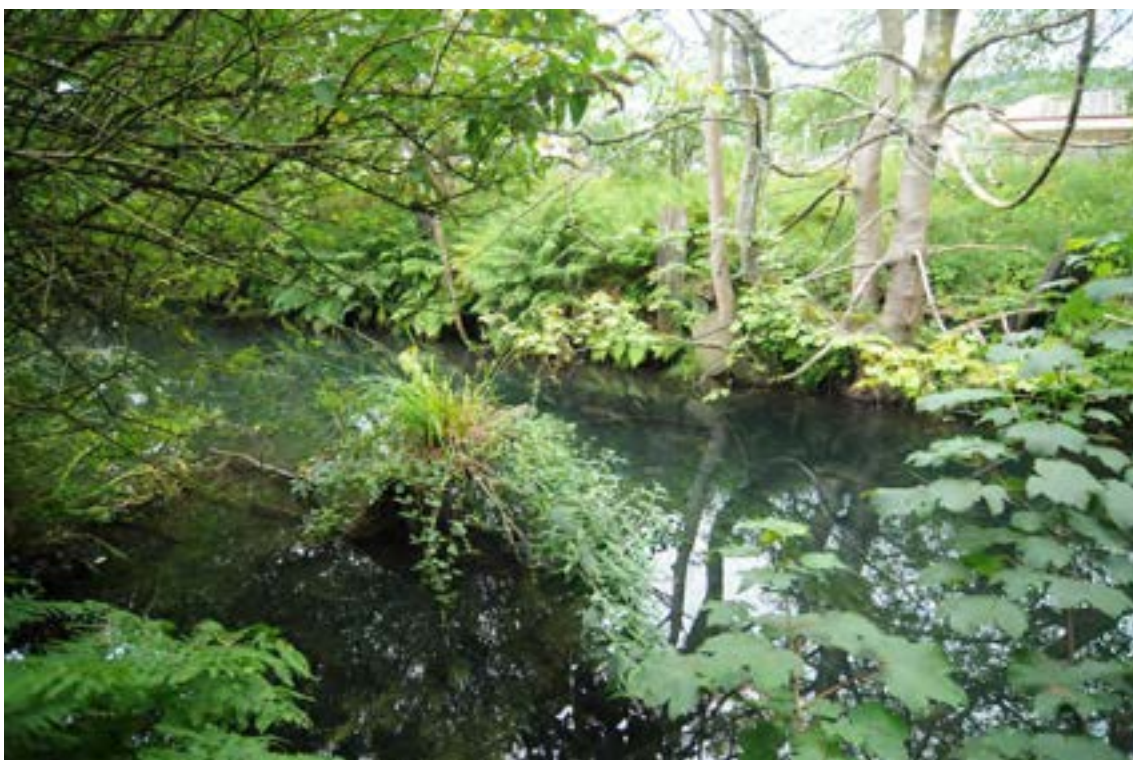
Photograph No : 4 Digital Ref: HOMI\_HBR\_0133 Direction: W  
Description: General view of goit with timber post on west bank

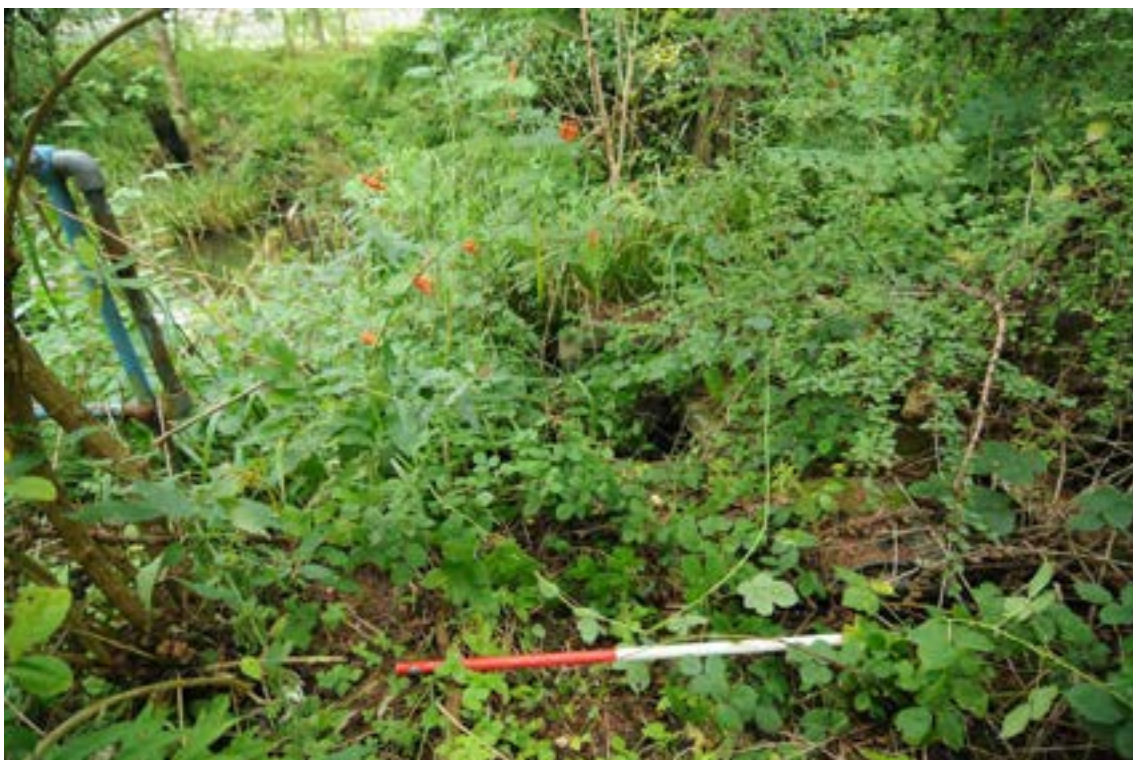
Photograph No : 5 Digital Ref: HOMI\_HBR\_0111 Direction: W  
Description: Sluice in goit

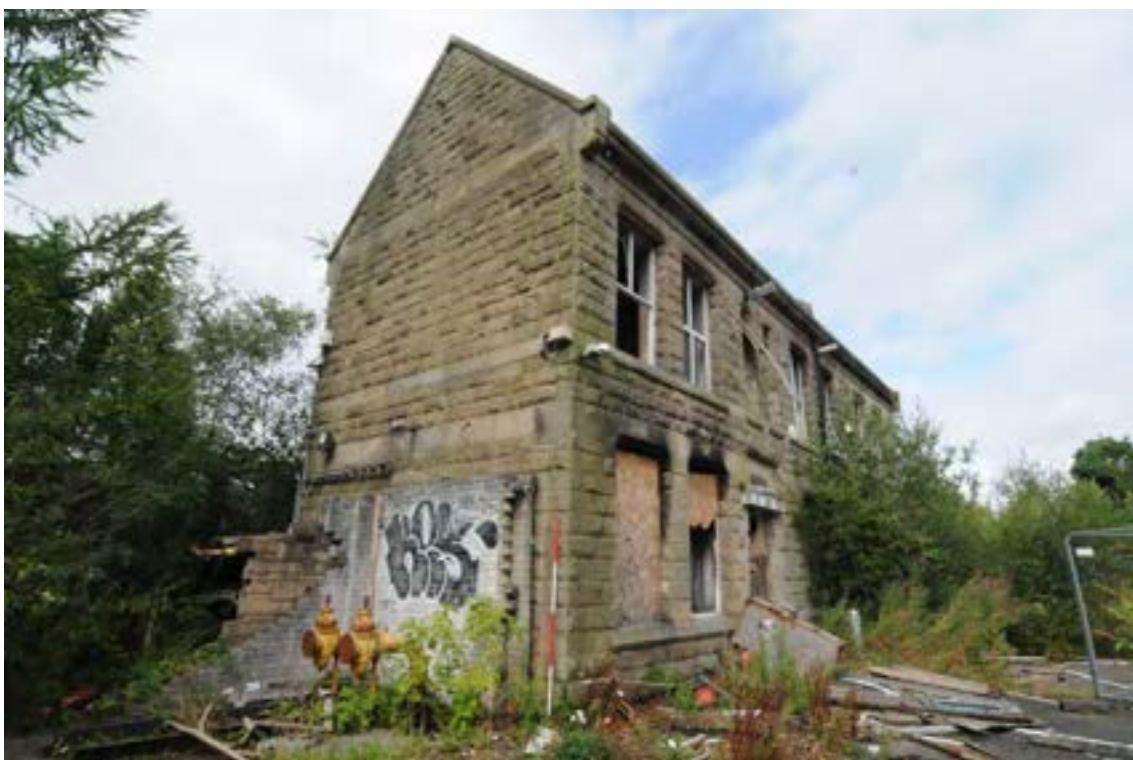
Photograph No : 6 Digital Ref: HOMI\_HBR\_0065 Direction: NW  
Description: South gable and east elevation of Building A

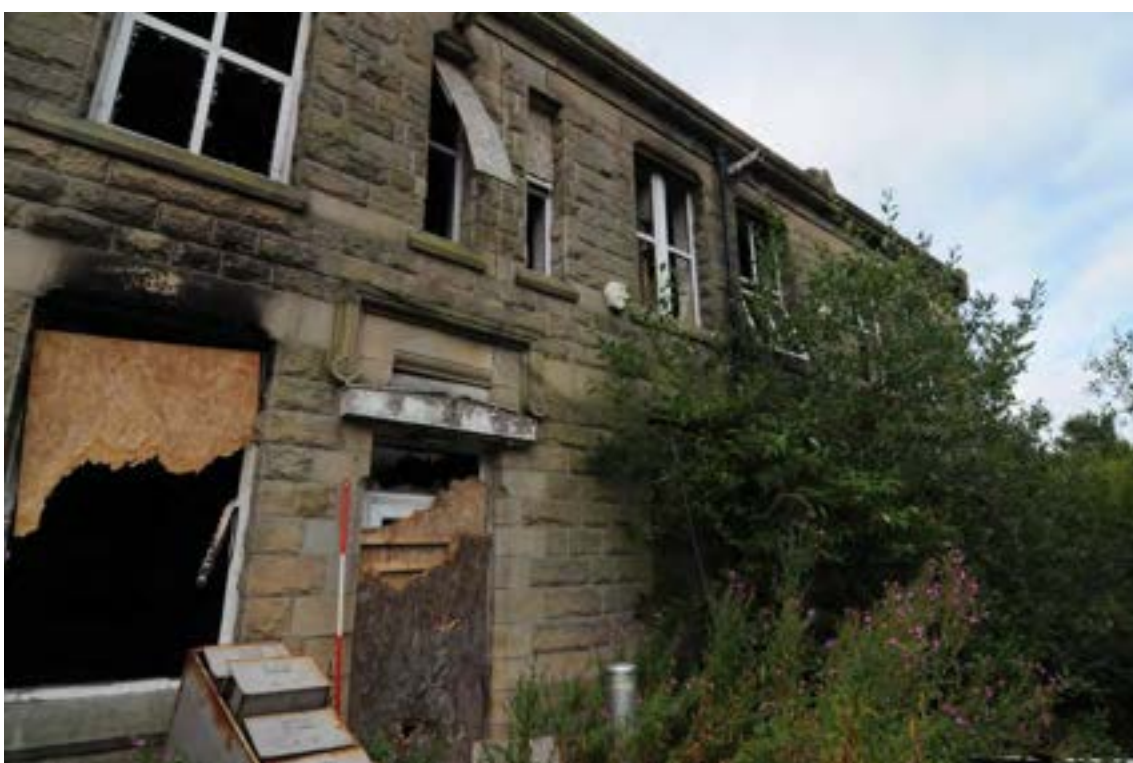
Photograph No : 8 Digital Ref: HOMI\_HBR\_0072 Direction: NW  
Description: East elevation of Building A

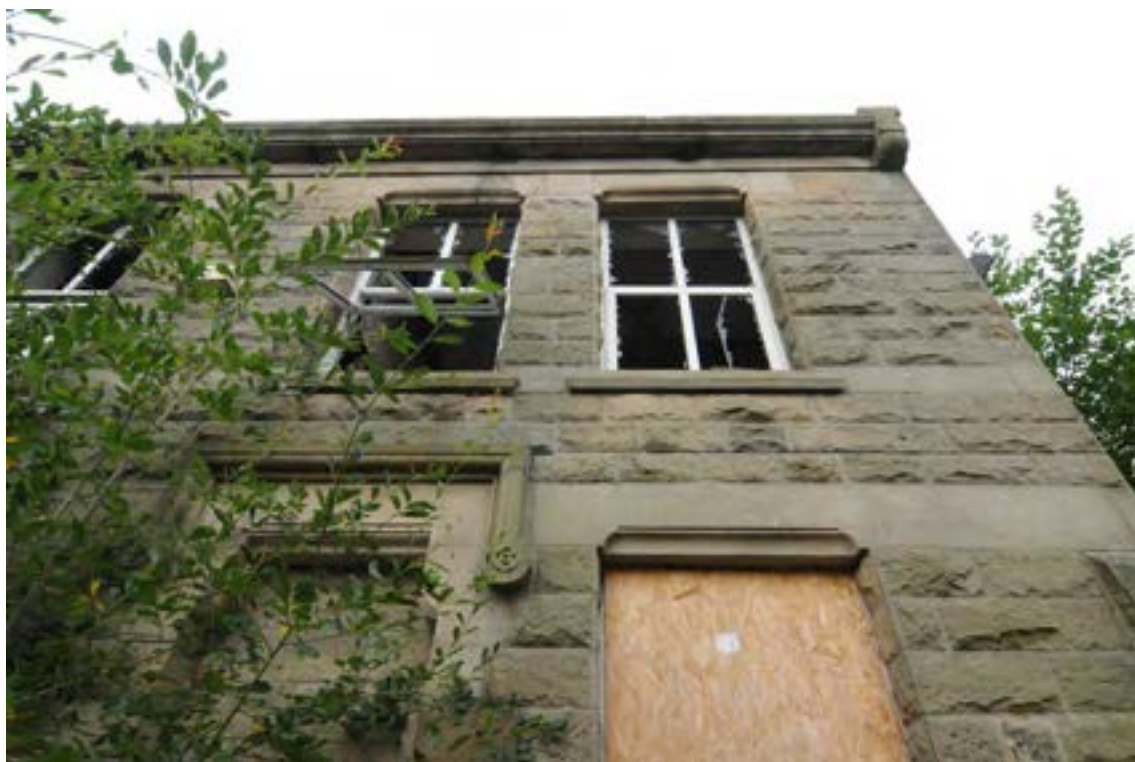
Photograph No : 12 Digital Ref: HOMI\_HBR\_0077 Direction: W  
Description: First floor of east elevation of Building A

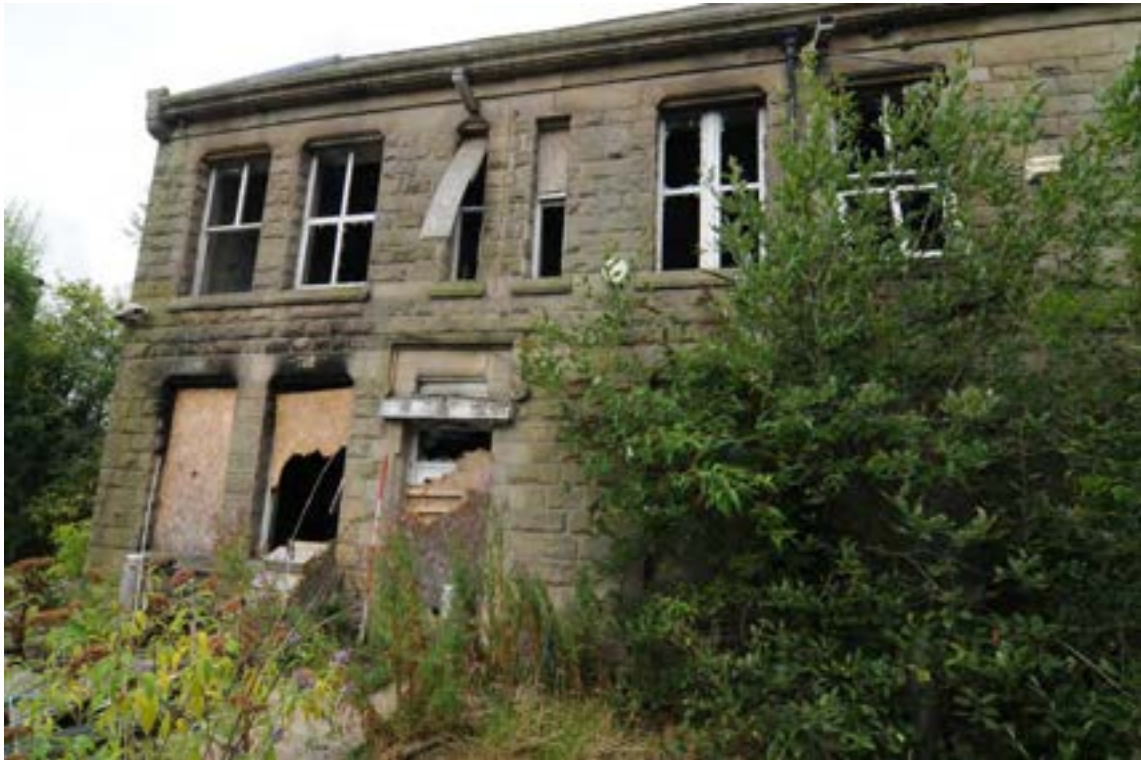
Photograph No : 15 Digital Ref: HOMI\_HBR\_0073 Direction: SW  
Description: Southern extent of east elevation of Building A

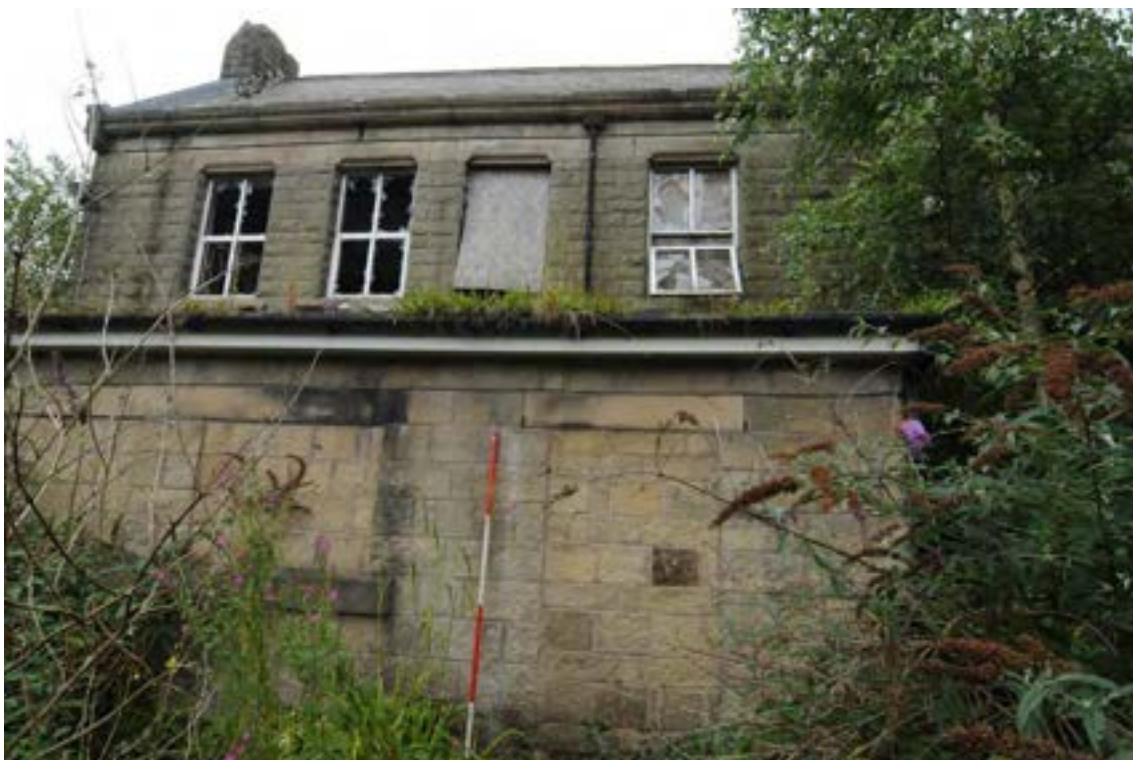
Photograph No : 17 Digital Ref: HOMI\_HBR\_0082 Direction: E  
Description: Blocked doorway in west elevation of single storey addition of Building A, first floor west elevation of Building A

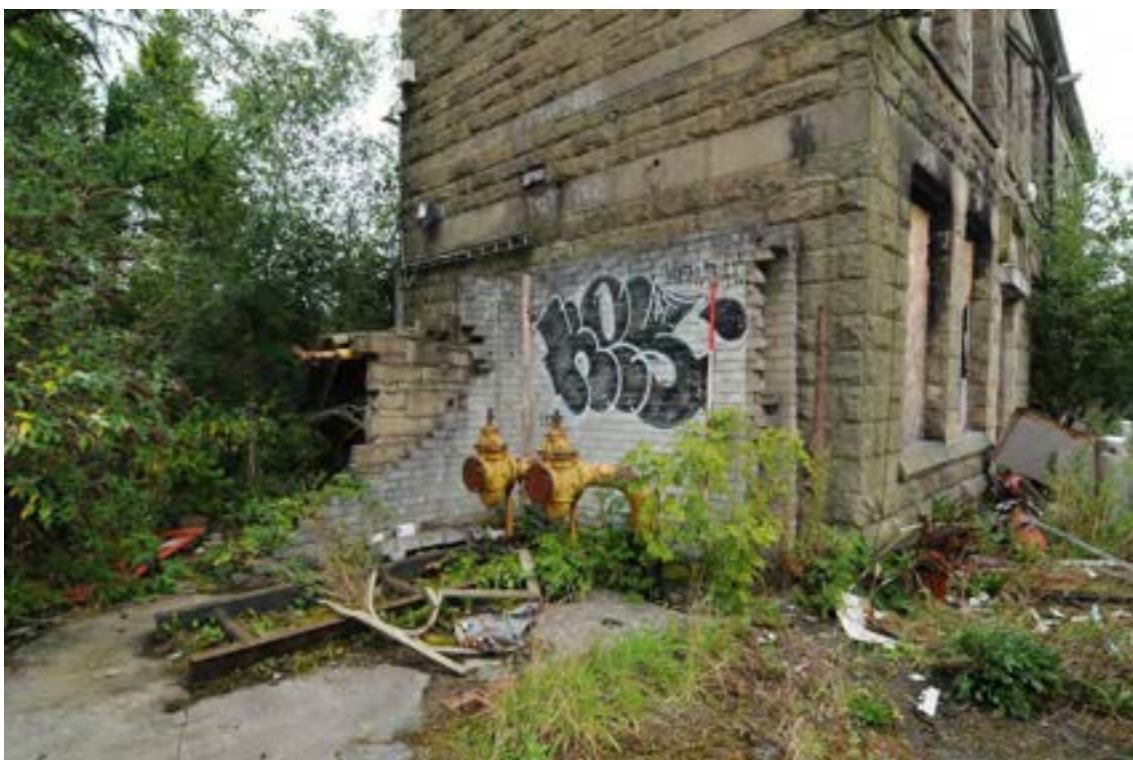
Photograph No : 18 Digital Ref: HOMI\_HBR\_0086 Direction: SW  
Description: Brick and stone addition at south gable of Building A with gas

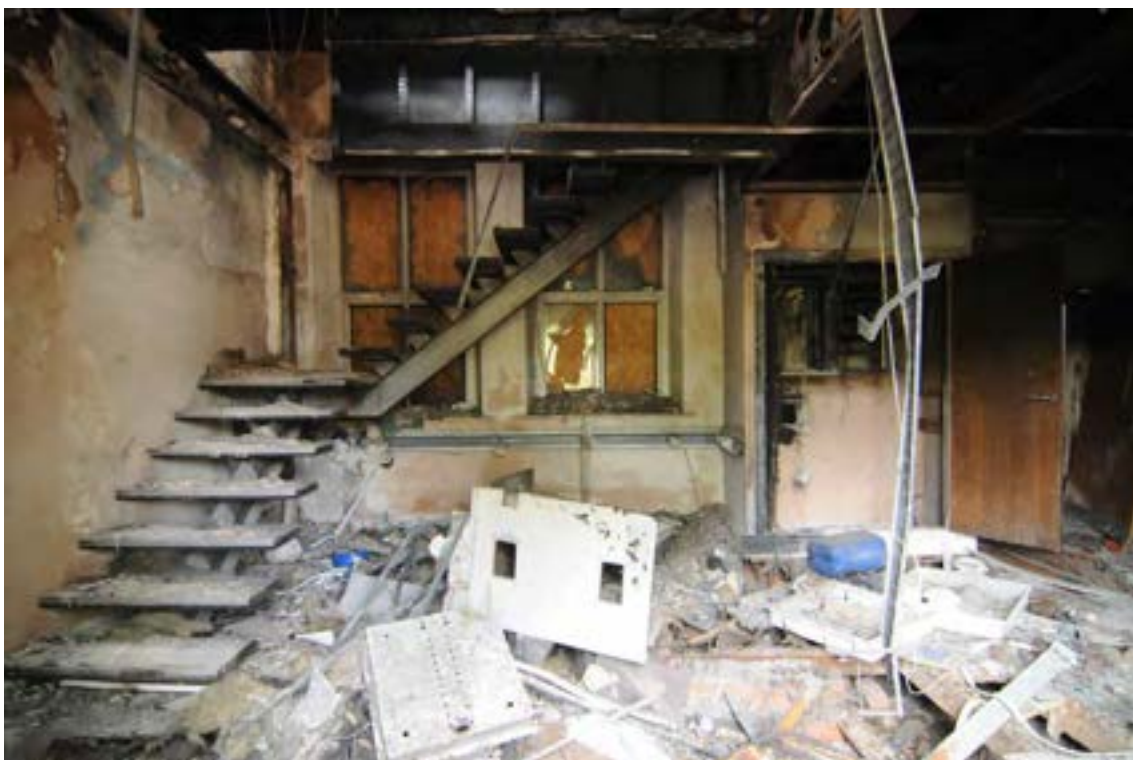
Photograph No : 19 Digital Ref: HOMI\_HBR\_0067 Direction: W  
Description: Internal ground floor of Building A with stairs in SW corner

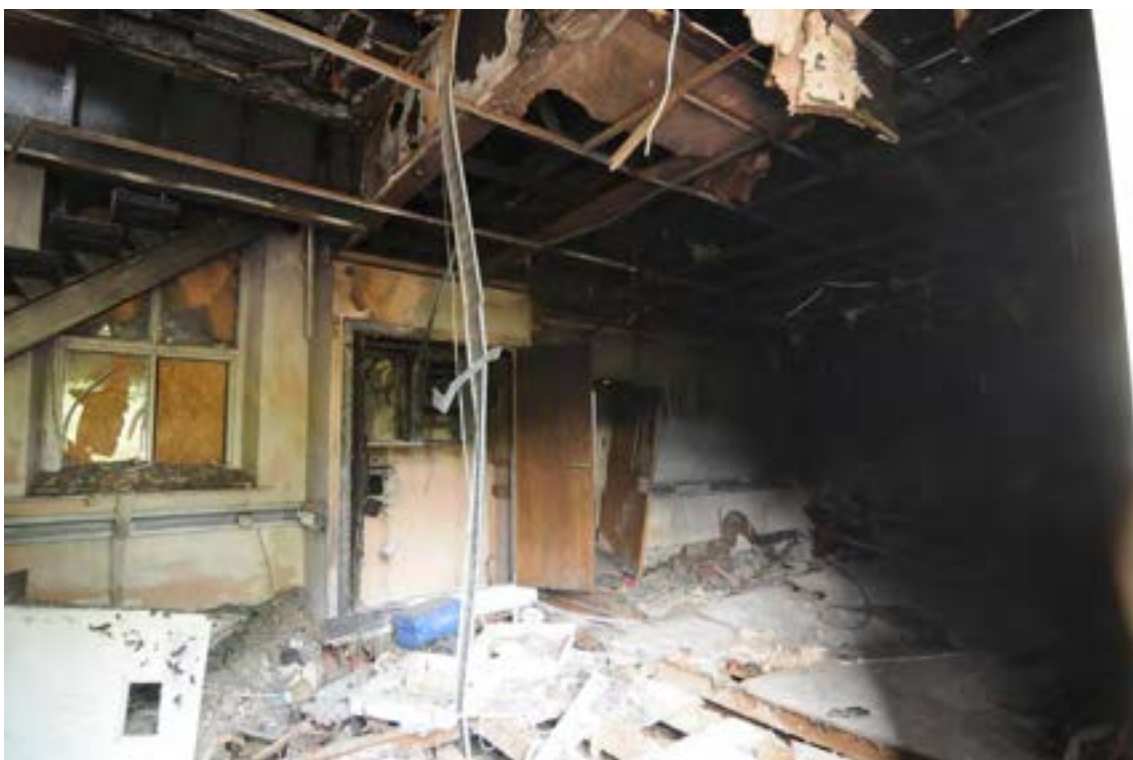
Photograph No : 20 Digital Ref: HOMI\_HBR\_0068 Direction: NW  
Description: General NW view of internal ground floor of Building A

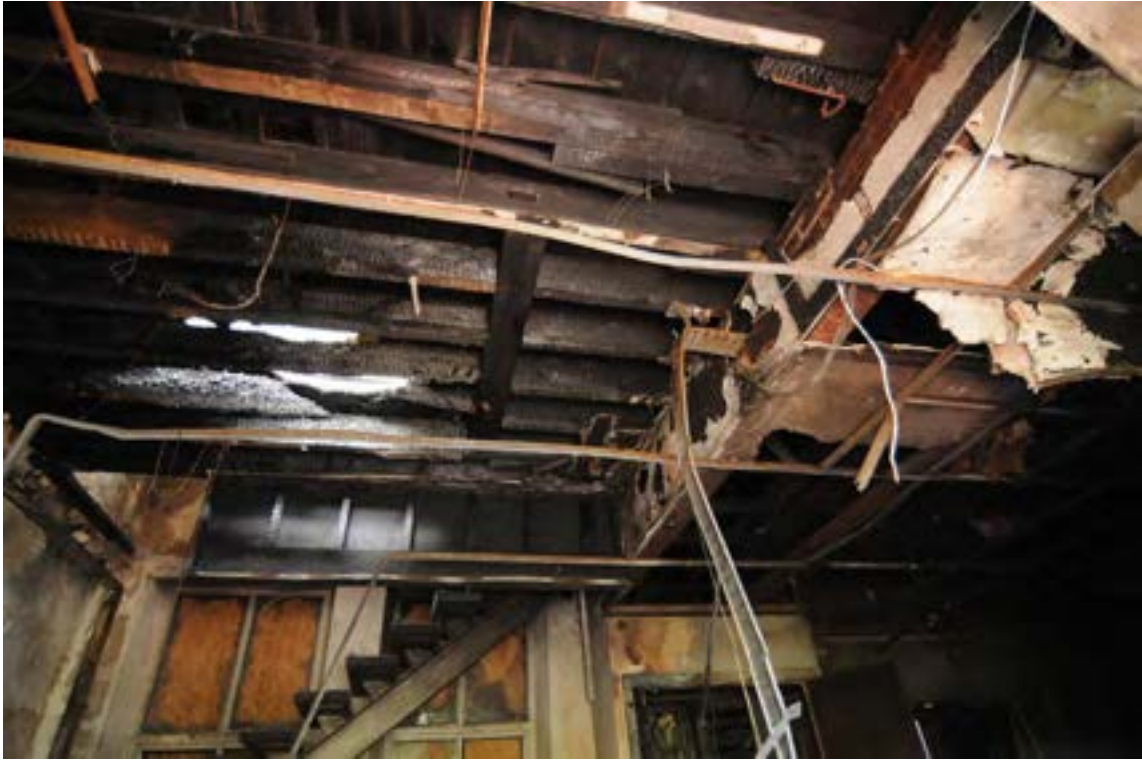
Photograph No : 21 Digital Ref: HOMI\_HBR\_0069 Direction: W  
Description: Ground floor ceiling timber beams in Building A

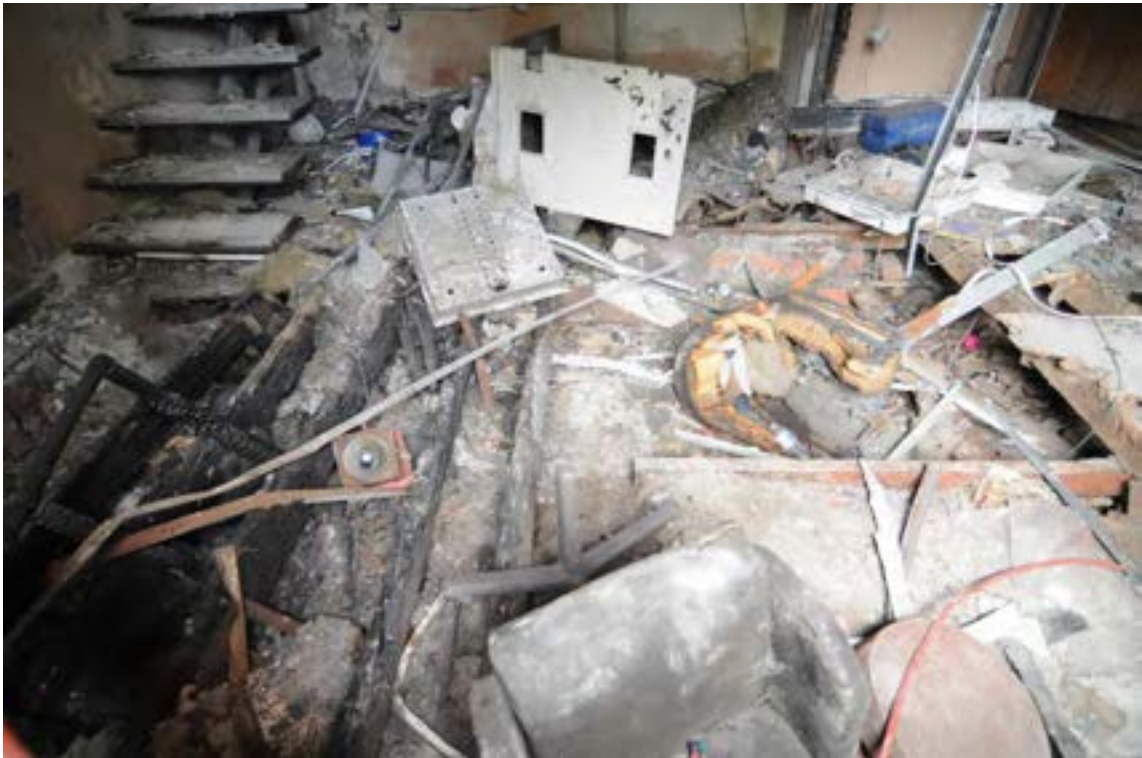
Photograph No : 22 Digital Ref: HOMI\_HBR\_0071 Direction: W  
Description: Ground in ground floor of Building A

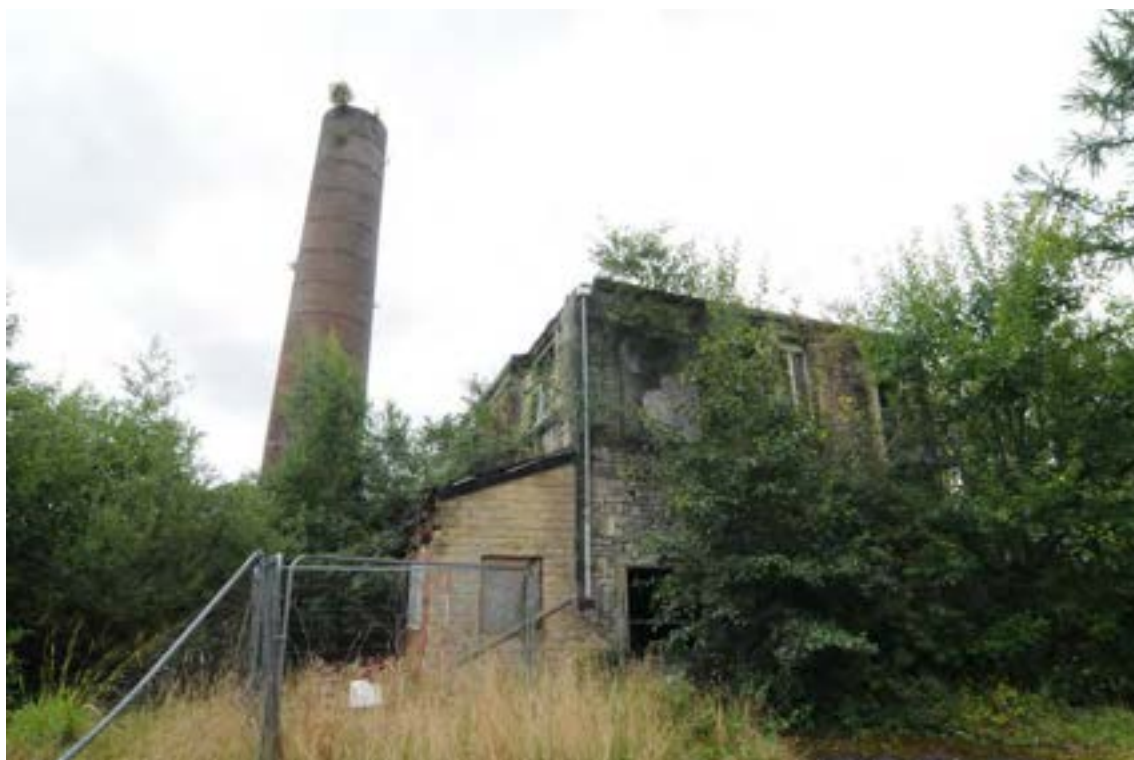
At the north elevation there was a wide door with an ashlar lintel and surrounds towards the east (fig. 4.6; **Photographs 26, 28, 41**). Directly above the first floor featured a brick blocked opening with a similar ashlar lintel and surrounds and a projecting cill. The centre of the first floor featured a two-light window with a wide ashlar mullion, flush ashlar lintel, projecting ashlar cill, and alternating jambs (**Photograph 42**). Metal stairs led to a door at the west (**Photograph 43**). The alternating jambs and ashlar lintel were smaller in size than those found elsewhere on the building, suggesting the door was not original.

Photograph No : 26 Digital Ref: HOMI\_HBR\_0041 Direction: S  
Description: North elevation of Building B with Chimney in background

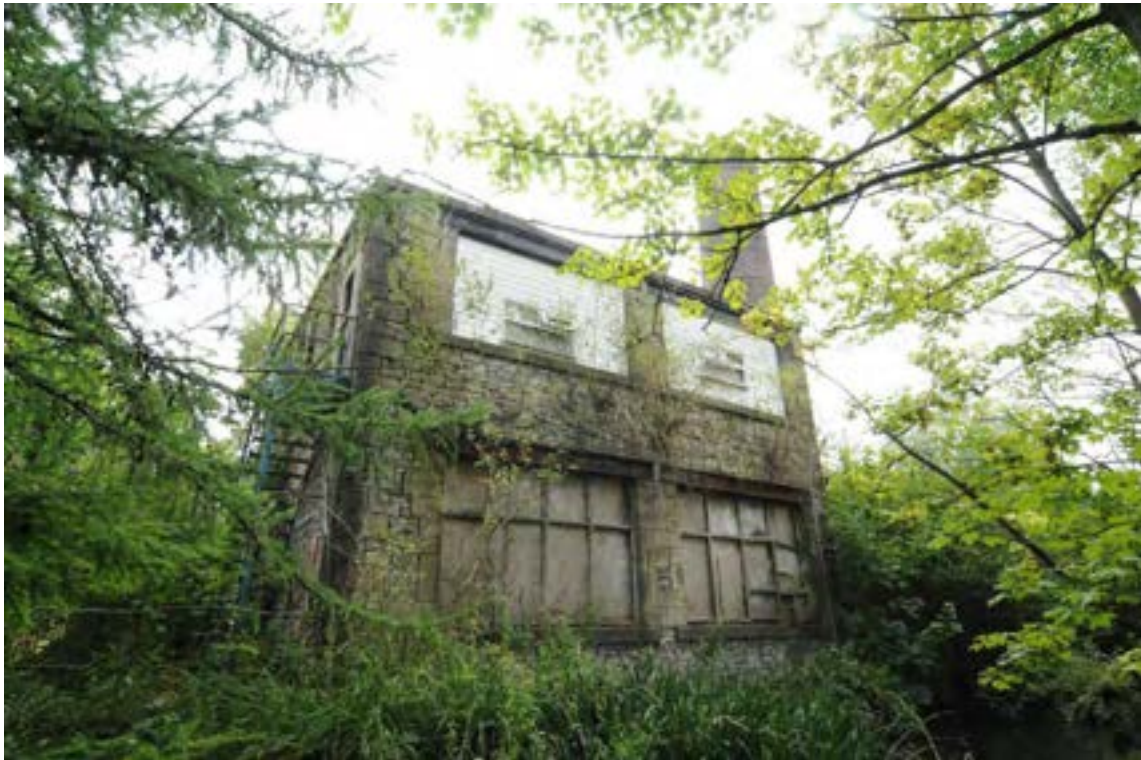
Photograph No : 27 Digital Ref: HOMI\_HBR\_0061 Direction: SE  
Description: West elevation of Building B with Chimney in background

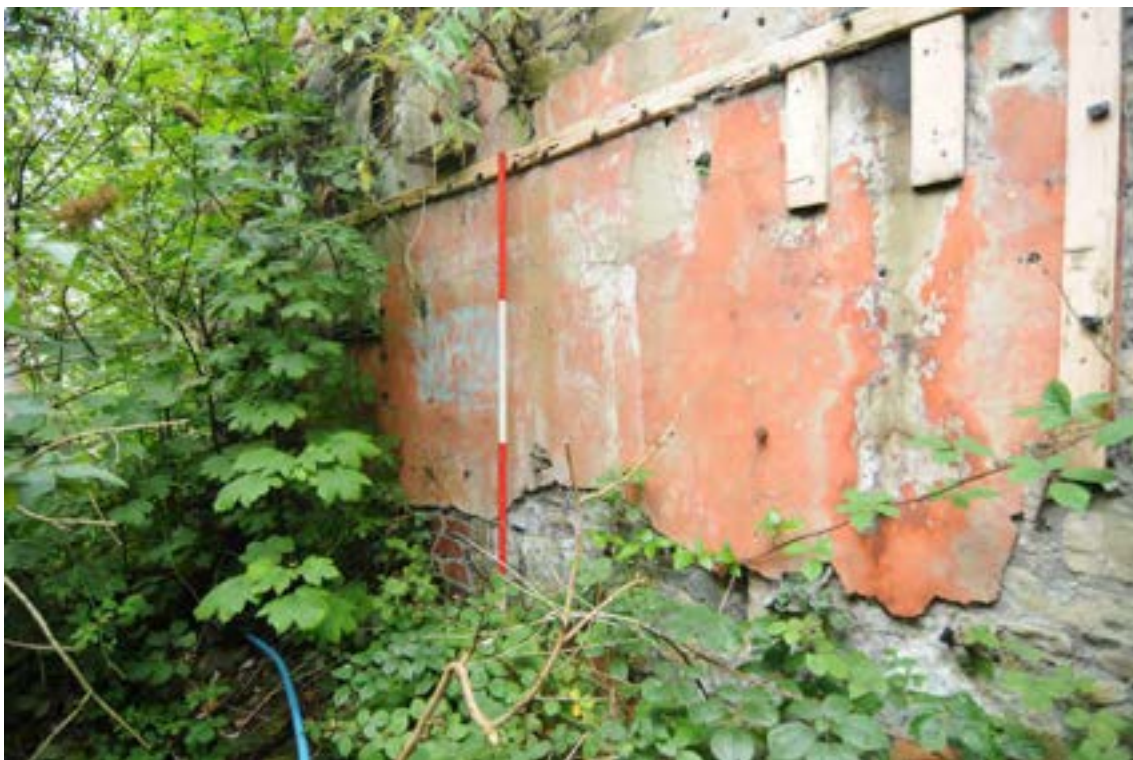
Photograph No : 36 Digital Ref: HOMI\_HBR\_0126 Direction: NW  
Description: Brick and stone beneath plaster in south gable of Building B

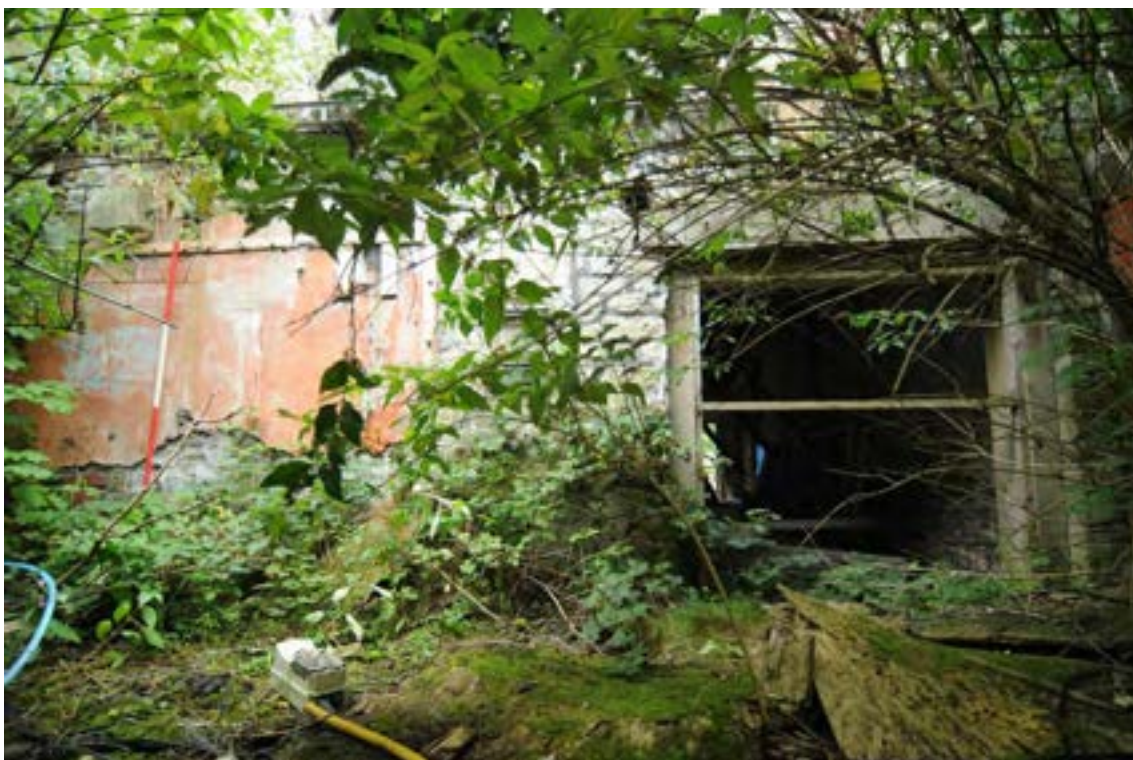
Photograph No : 37 Digital Ref: HOMI\_HBR\_0127 Direction: N  
Description: Fenestration in ground floor of south gable of Building B

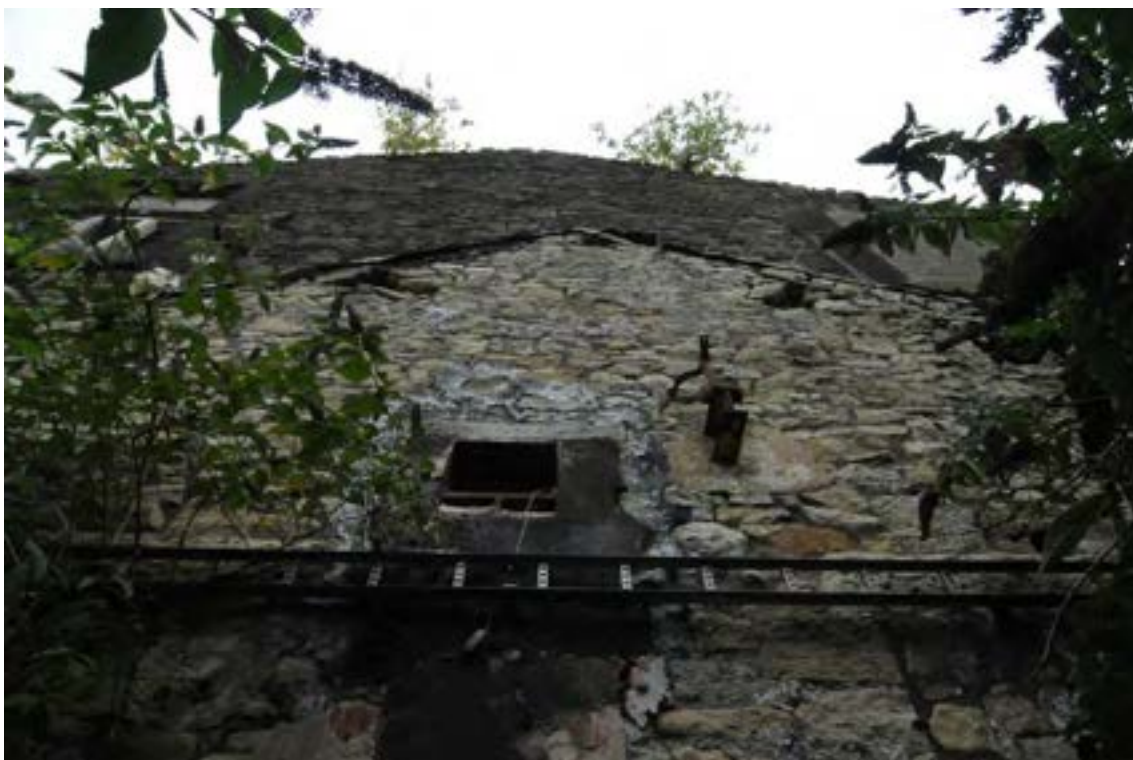
Photograph No : 39 Digital Ref: HOMI\_HBR\_0119 Direction: N  
Description: South gable of Building B with bearing box, steel I-beam, gable scar

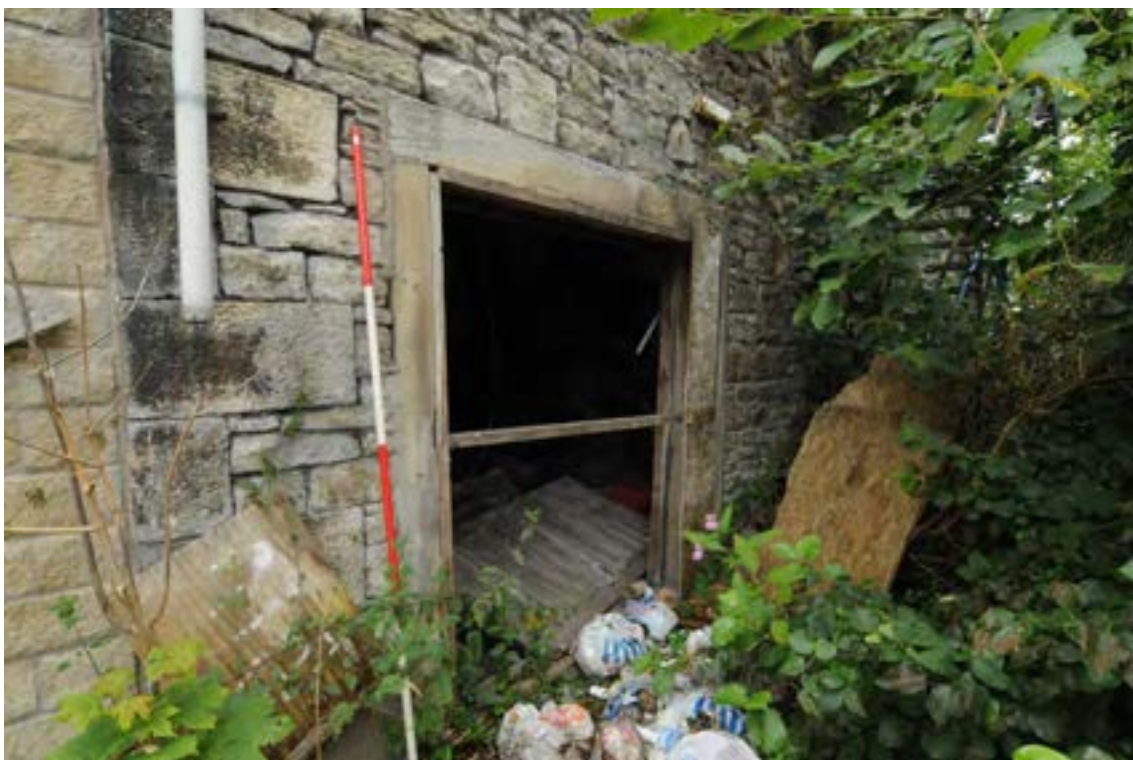
Photograph No : 41 Digital Ref: HOMI\_HBR\_0046 Direction: SW  
Description: Detail of ground floor fenestration in north elevation of Building B

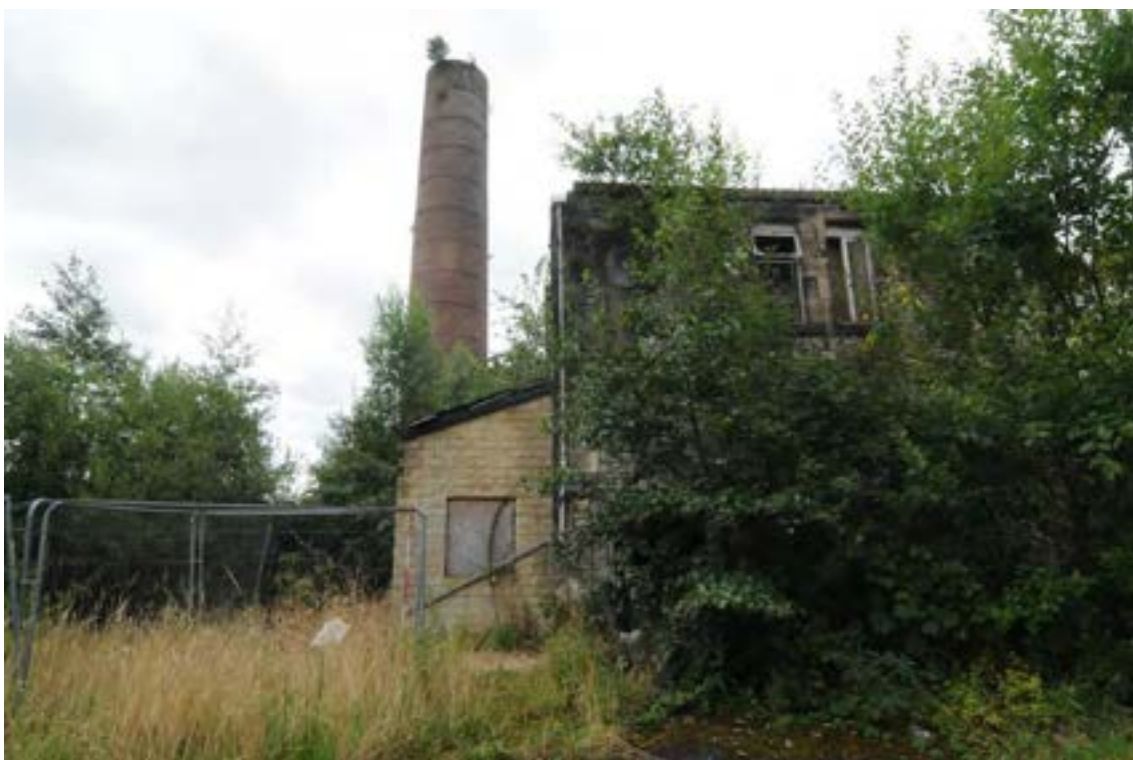
Photograph No : 42 Digital Ref: HOMI\_HBR\_0042 Direction: S  
Description: North elevation of Building B with Chimney in background

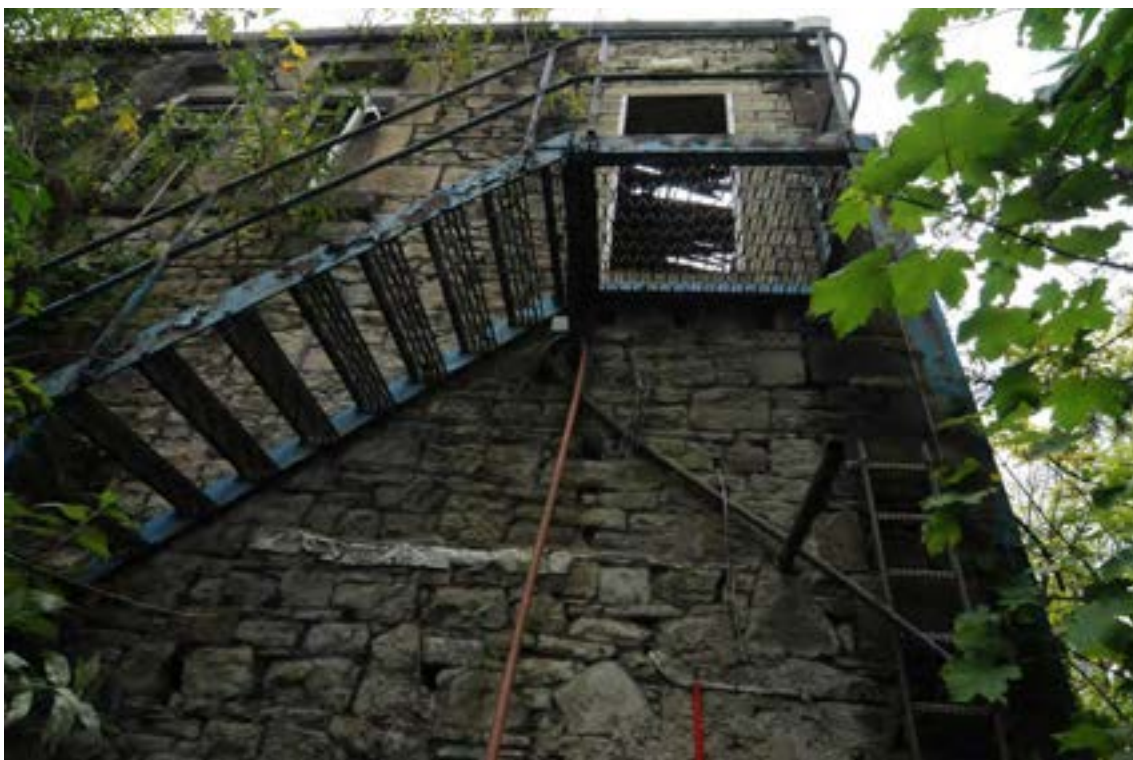
Photograph No : 43 Digital Ref: HOMI\_HBR\_0060 Direction: S  
Description: Ground and first floor of north elevation of Building B with fire escape

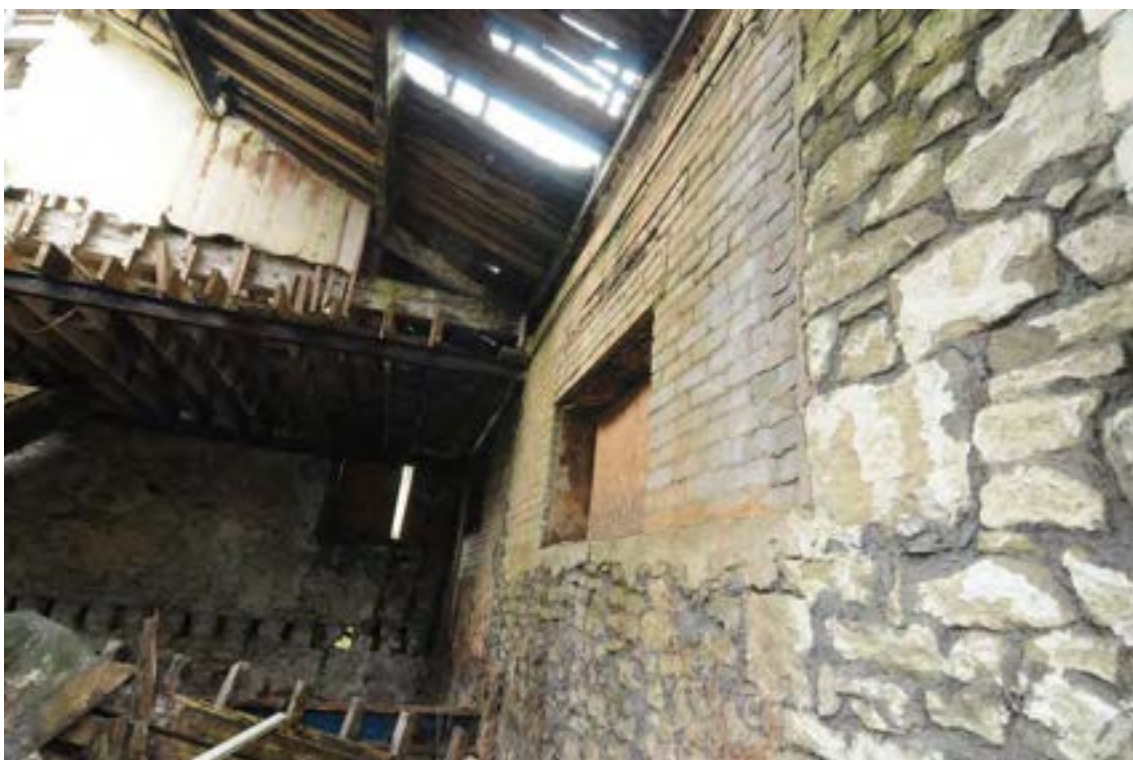
Photograph No : 44 Digital Ref: HOMI\_HBR\_0055 Direction: SW  
Description: Brick blocked fenestration at first floor in west wall of Building B

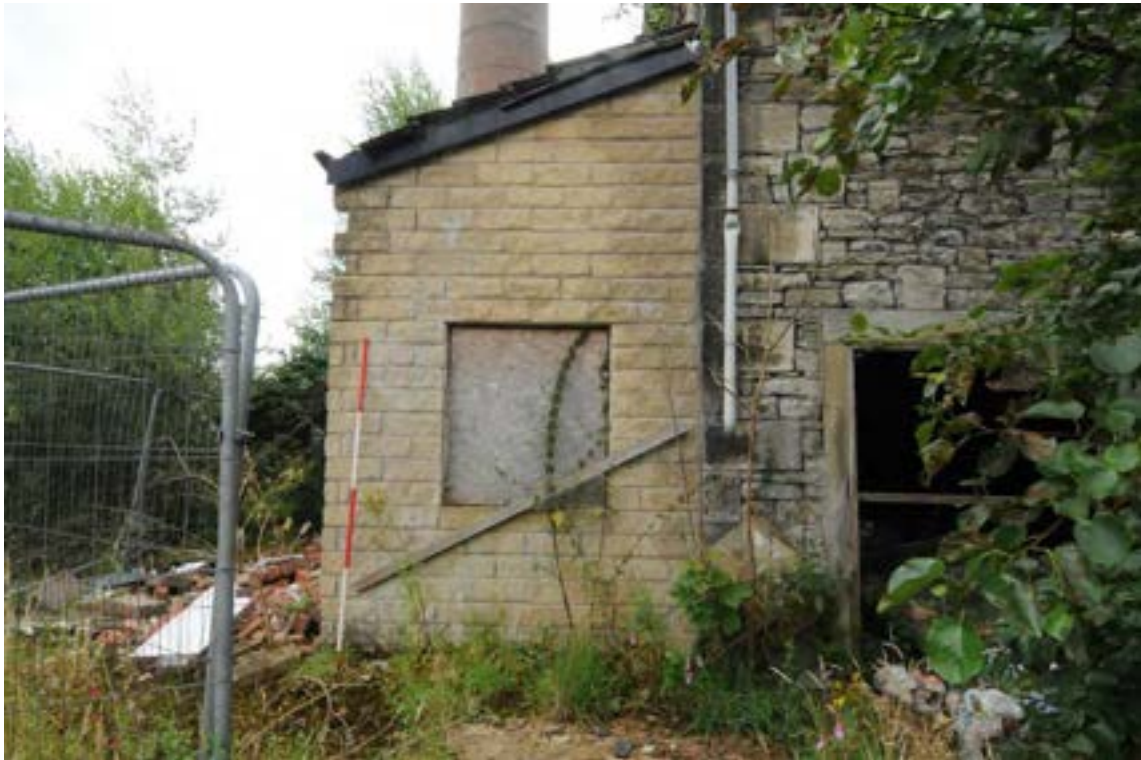
Photograph No : 47 Digital Ref: HOMI\_HBR\_0044 Direction: S  
Description: North elevation of addition of Building B with Chimney in background
