## Three Buildings & Chimney Former Mondi Site, Holcombe Mill Bridge Street Ramsbottom

Level 1-2 Historic Building Recording  
[Report No. 4556](#)

**Level 1-2 Historic Building Recording**

**Report No. 4556**

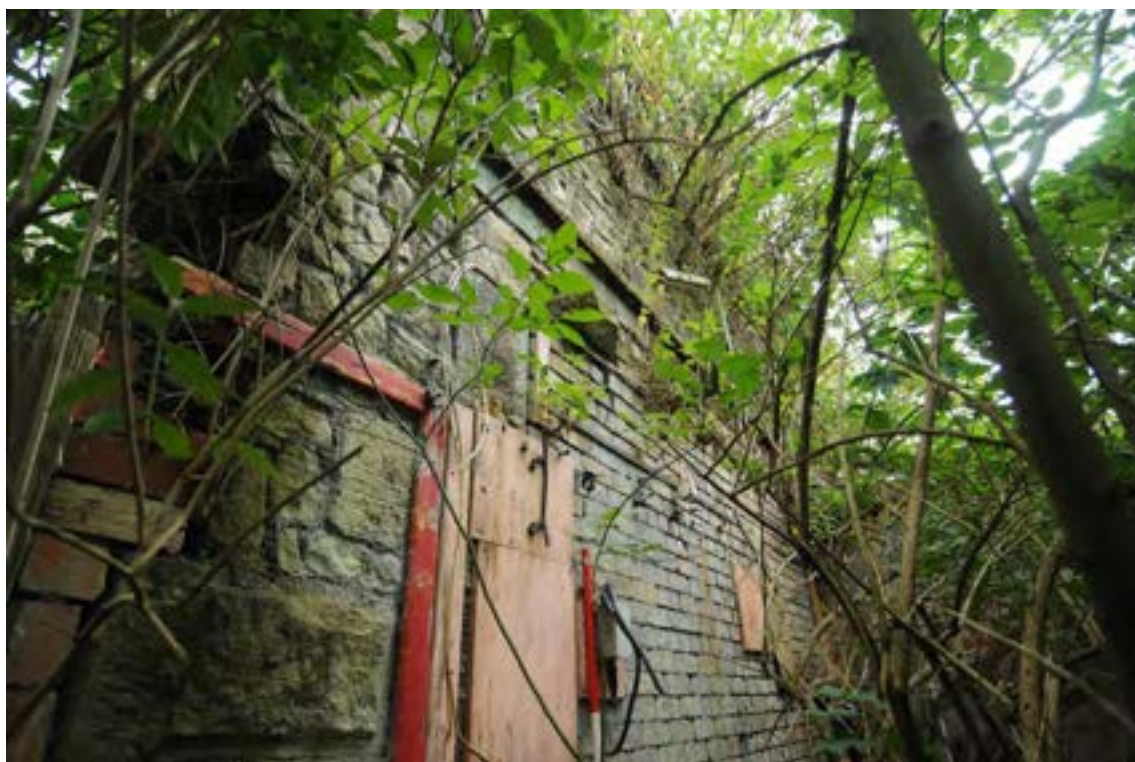
Photograph No : 50 Digital Ref: HOMI\_HBR\_0118 Direction: NW  
Description: Blocked fenestration in southern extent of east elevation of Building B with quoins at extent

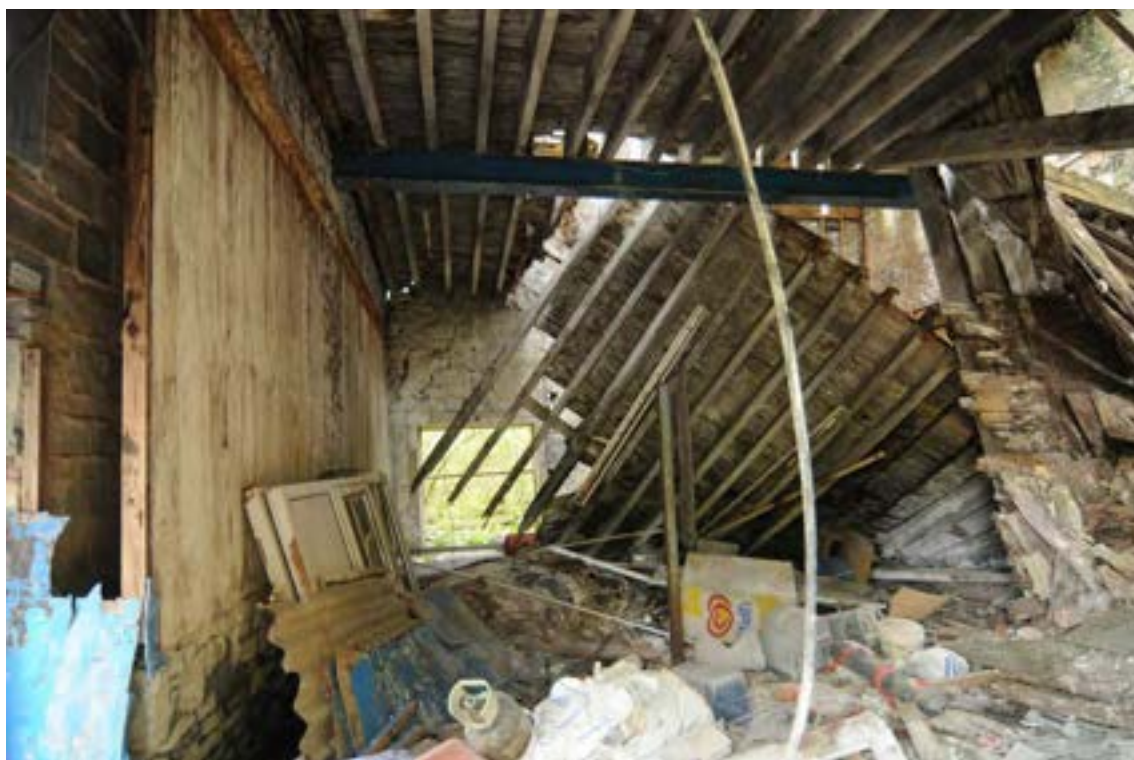
Photograph No : 52 Digital Ref: HOMI\_HBR\_0048 Direction: S  
Description: General southern view of internal area of Building B

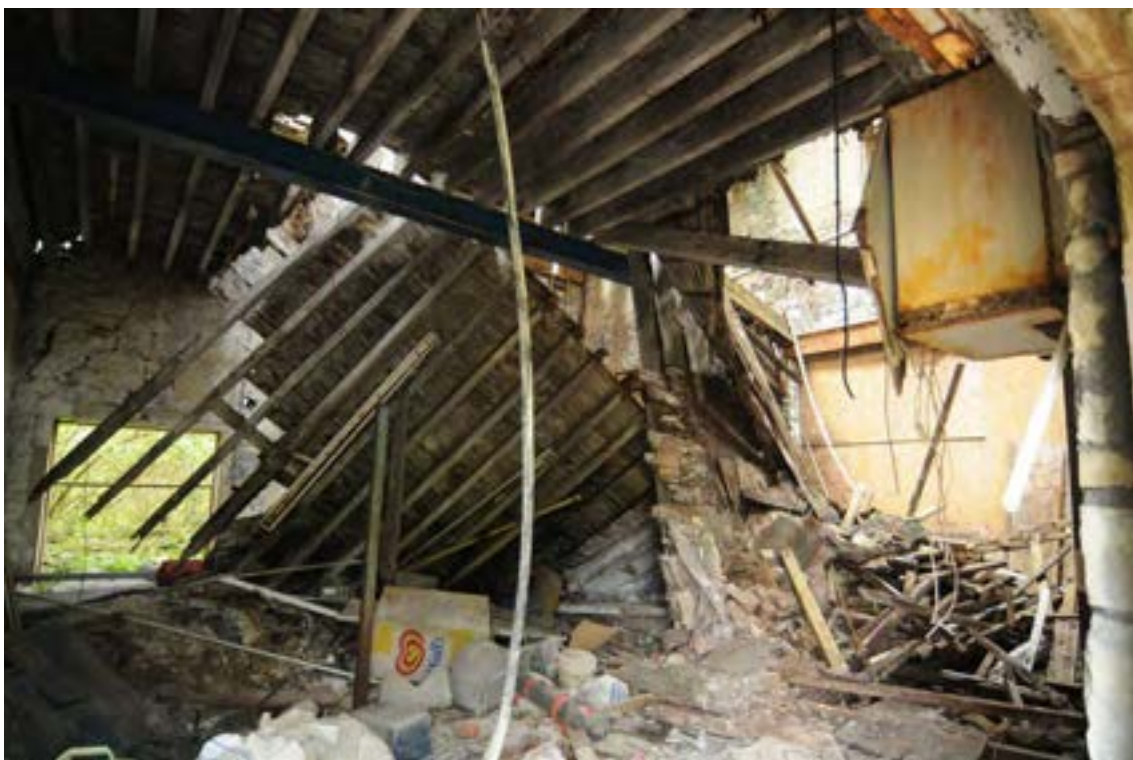
Photograph No : 53 Digital Ref: HOMI\_HBR\_0049 Direction: SW  
Description: General southern view of ground floor internal area of Building B

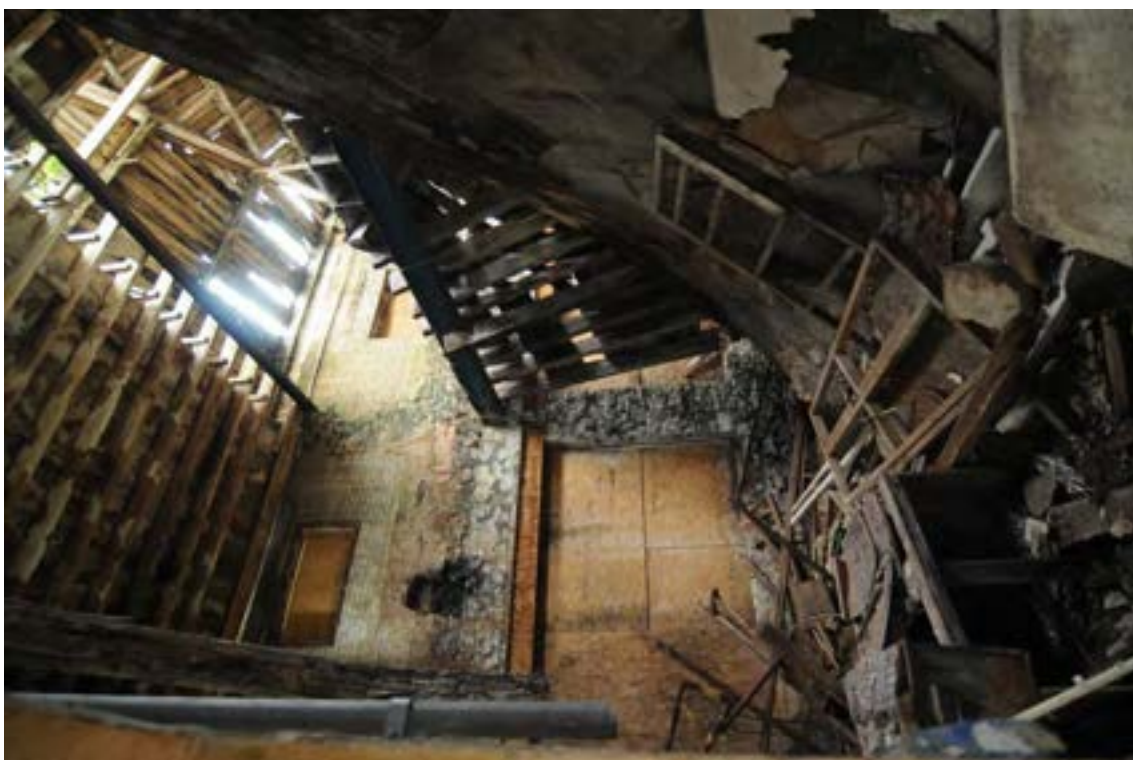
Photograph No : 54 Digital Ref: HOMI\_HBR\_0123 Direction: W  
Description: Ground and first floor of west wall of Building B

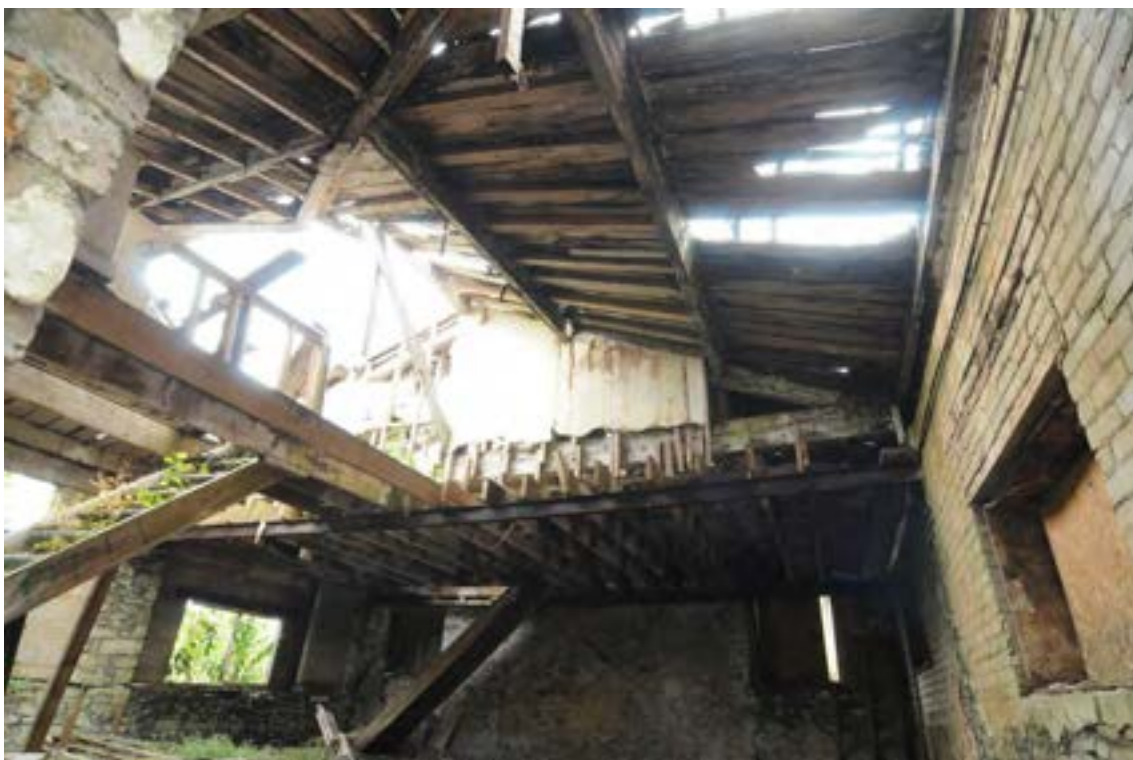
Photograph No : 55 Digital Ref: HOMI\_HBR\_0056 Direction: S  
Description: General southern view of first floor internal area of Building B

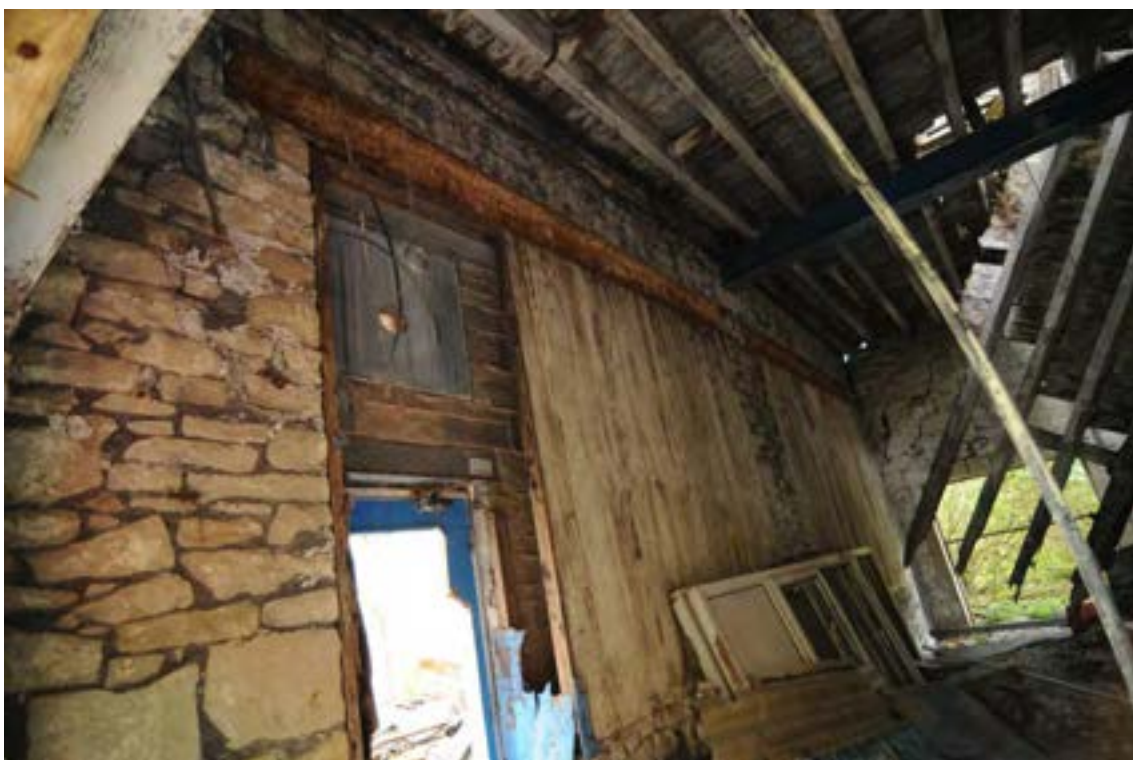
Photograph No : 56 Digital Ref: HOMI\_HBR\_0051 Direction: SE  
Description: Opening of east wall of Building B with façade wall beyond

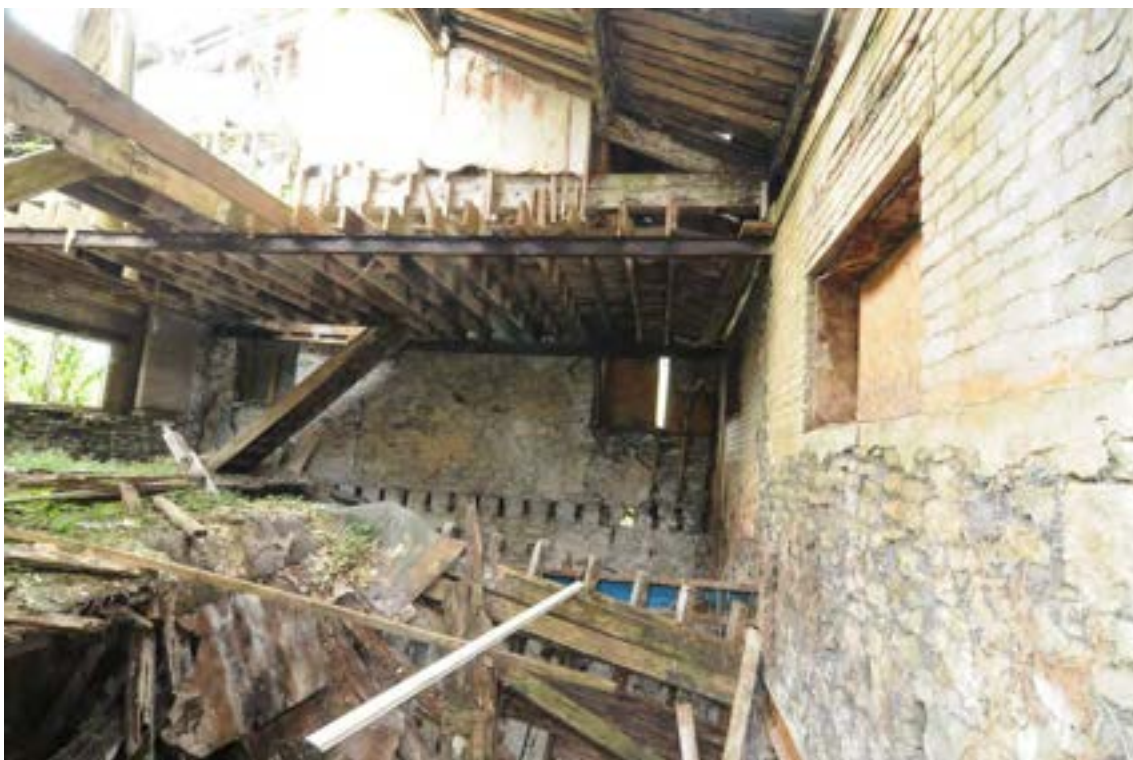
Photograph No : 57 Digital Ref: HOMI\_HBR\_0053 Direction: S  
Description: General southern view of first floor internal area of Building B

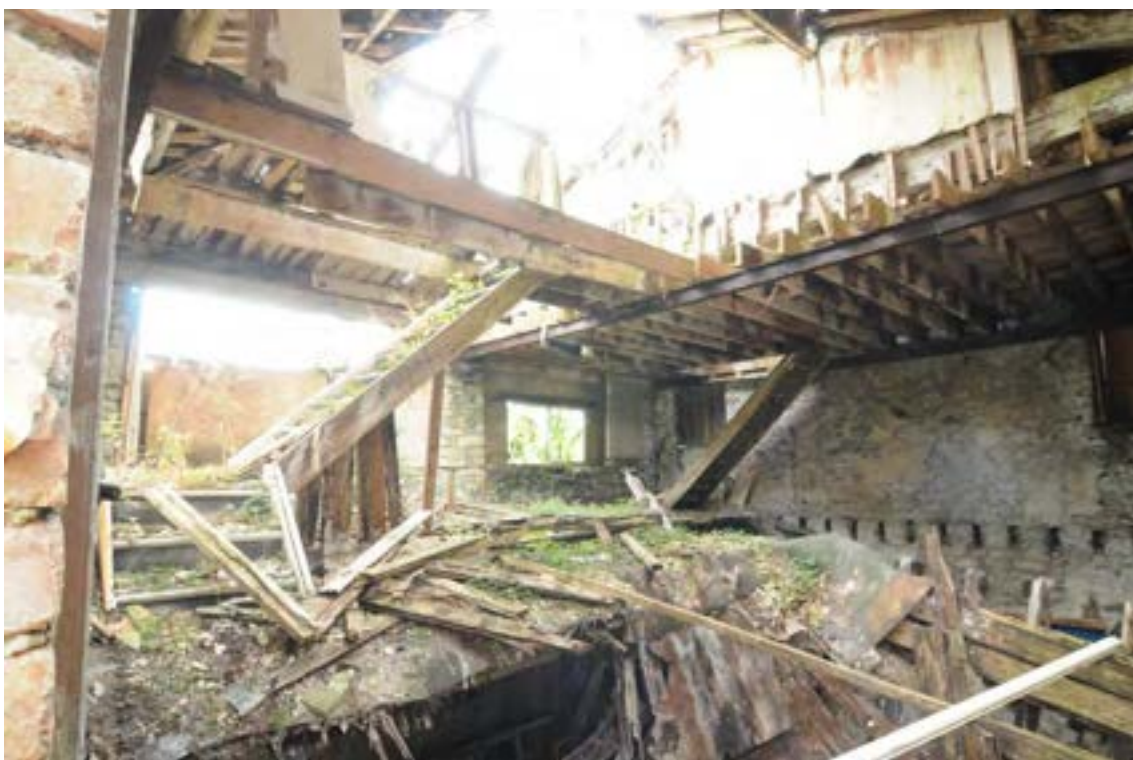
Photograph No : 58 Digital Ref: HOMI\_HBR\_0054 Direction: SE  
Description: General SE view of first floor internal area of Building B with stairs

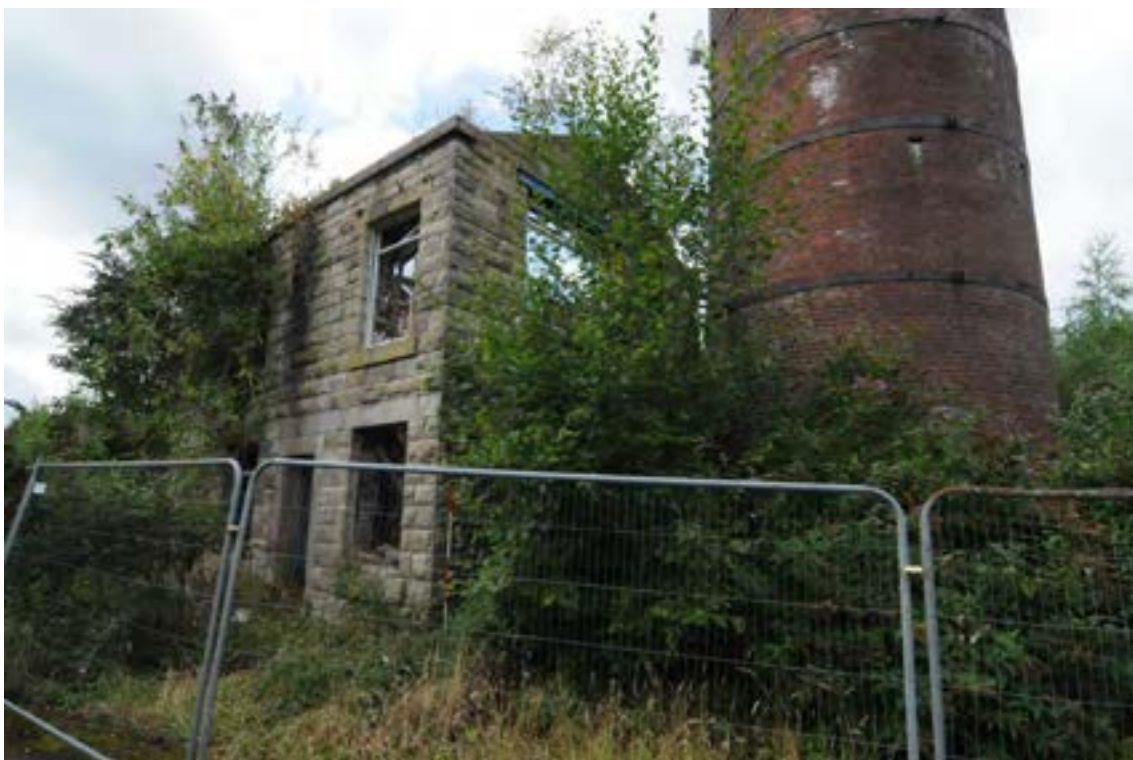
Photograph No : 61 Digital Ref: HOMI\_HBR\_0004 Direction: SW  
Description: East and north elevations of Building C and Chimney base

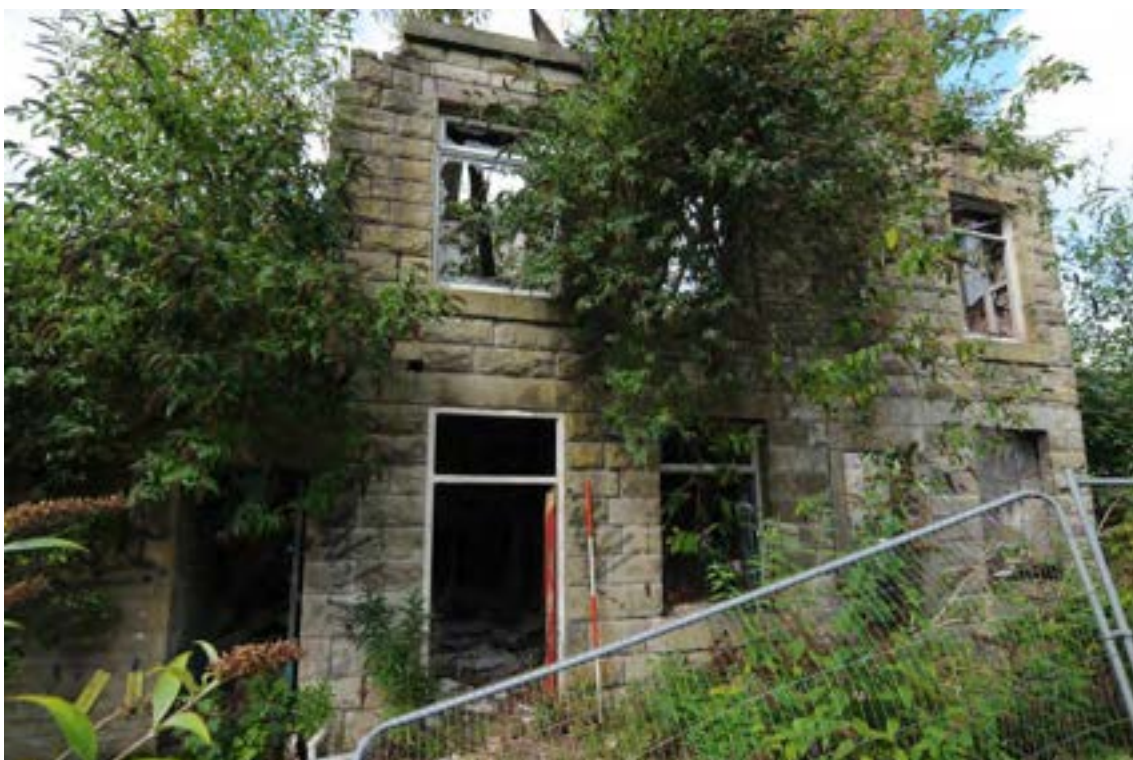
Building C was comprised of brick with coursed roughhewn grey sandstone façade at the principal east elevation and north elevation (**Photographs 62, 65 - 67**). Ashlar stones formed a band that continued from the ground floor fenestration to the north elevation, also found at the first-floor lintels, and at both floor fenestration cills (**Photographs 62, 66, 68 & 69**). The northern ground floor door had an ashlar architrave, whilst fenestration elsewhere had an ashlar margin at the surrounds (**Photograph 70**). The southern doorway appeared to have been opened at an earlier window as evident through cement infill at the former cill (**Photograph 71**). On the north elevation there was a door with an ashlar lintel at the west extent and a large window with a timber lintel and PVC framing towards the east (**Photograph 68**). At the ground floor level there was an area of cement appearing to block an earlier opening (**Photographs 72 & 73**). A steel I-beam was fitted below the door and joined to the chimney (**Photograph 74**). Two additional I-beams had been cut at the east (**Photograph 66**). Just above the ground level, the north elevation had a single small pipe opening (**Photograph 75**).

Photograph No : 62 Digital Ref: HOMI\_HBR\_0003 Direction: W  
Description: East elevation of Building C

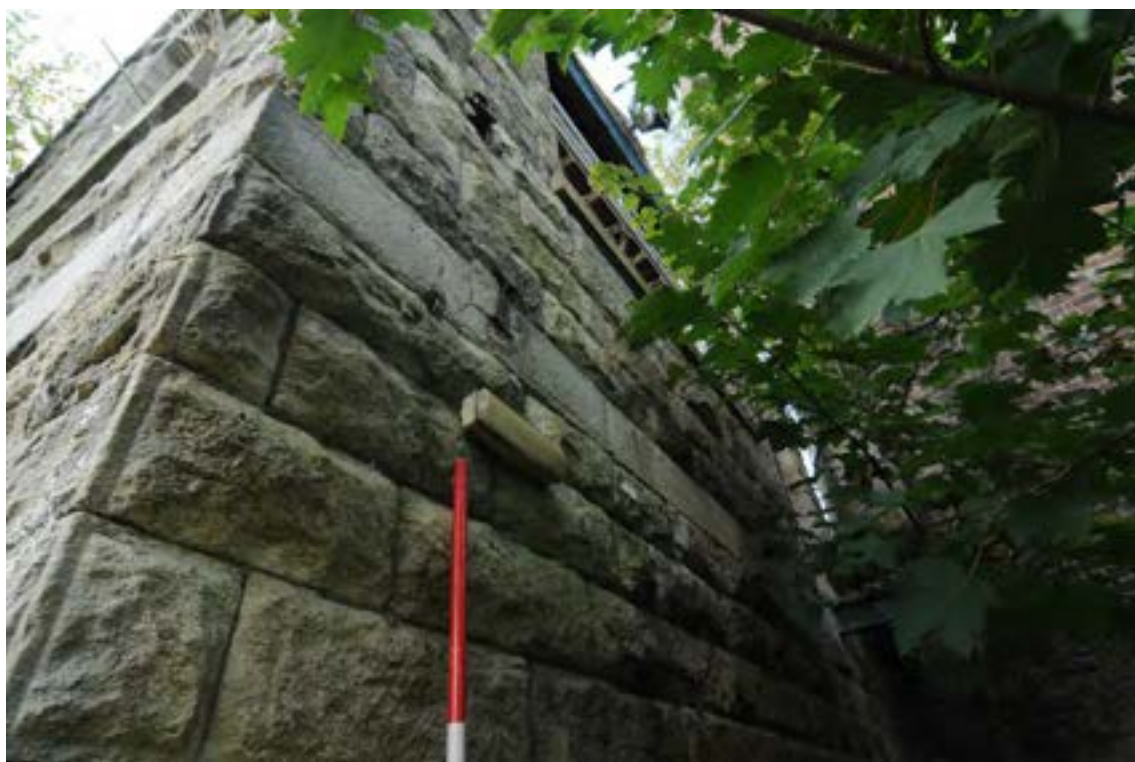
Photograph No : 66 Digital Ref: HOMI\_HBR\_0020 Direction: SW  
 Description: Detail of ashlar band in north elevation of Building C with large window on first floor

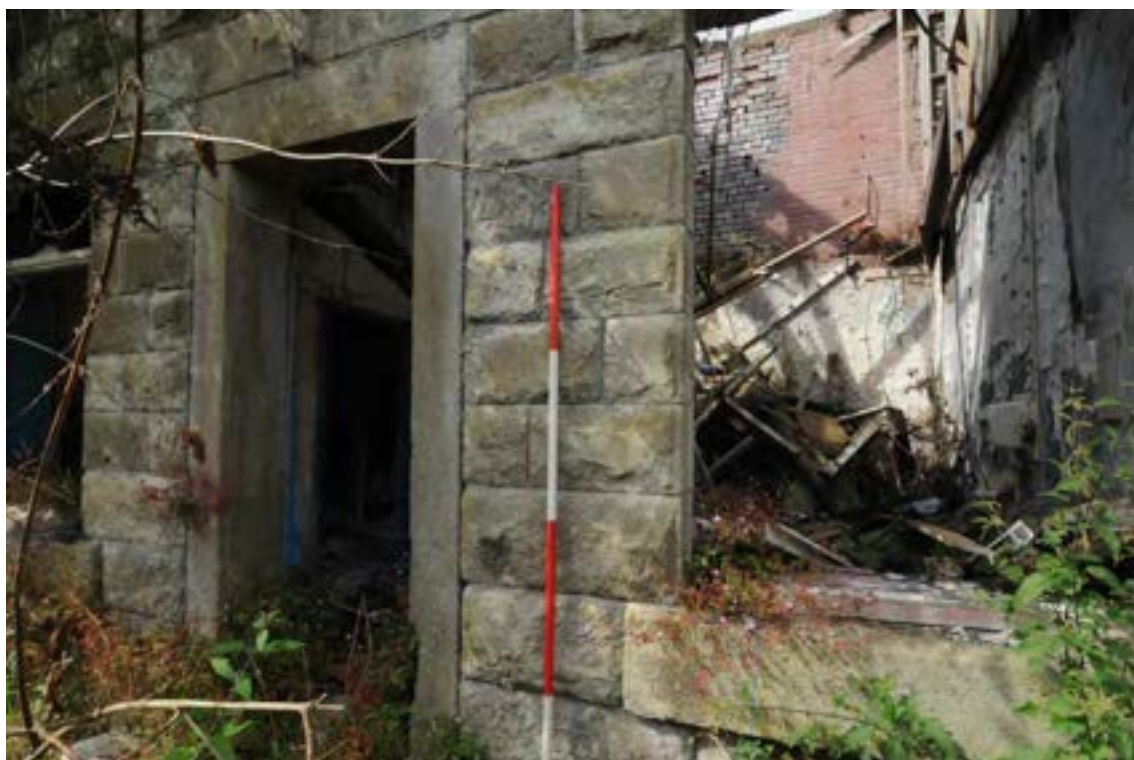
Photograph No : 70 Digital Ref: HOMI\_HBR\_0014 Direction: SW  
Description: SW view of east elevation of Building C and view into building

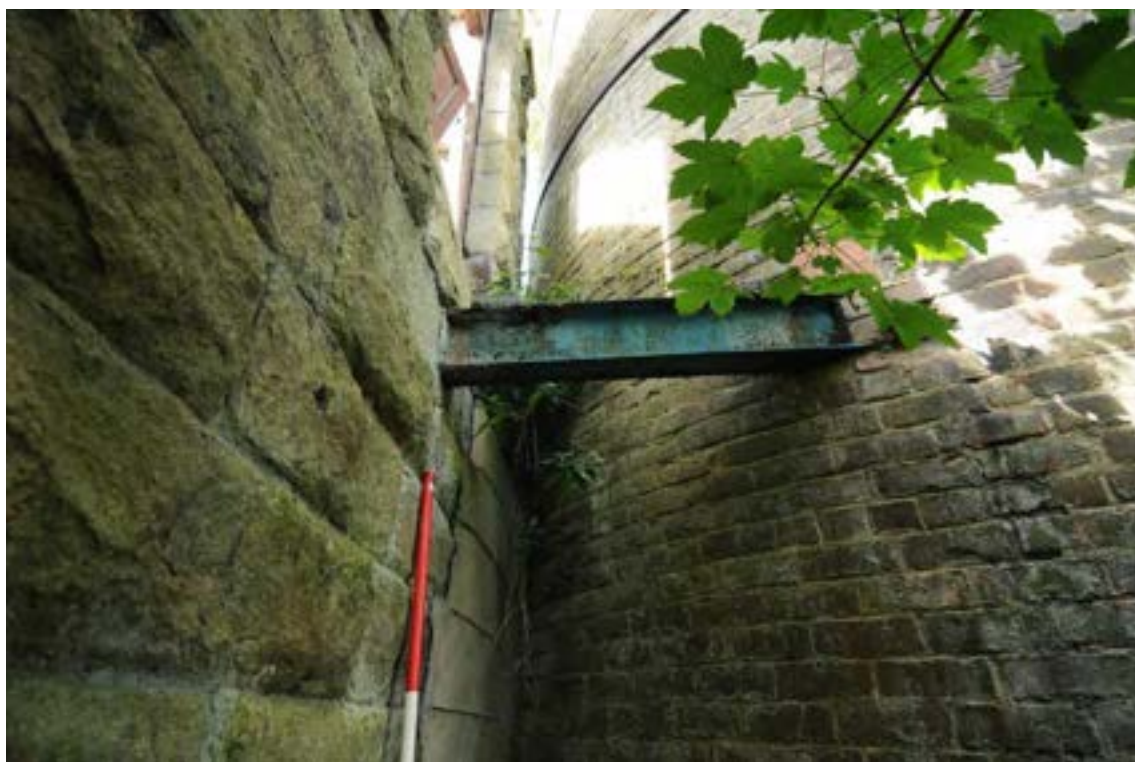
Photograph No : 74 Digital Ref: HOMI\_HBR\_0024 Direction: SW  
Description: Detail of steel I-beam between north elevation and chimney

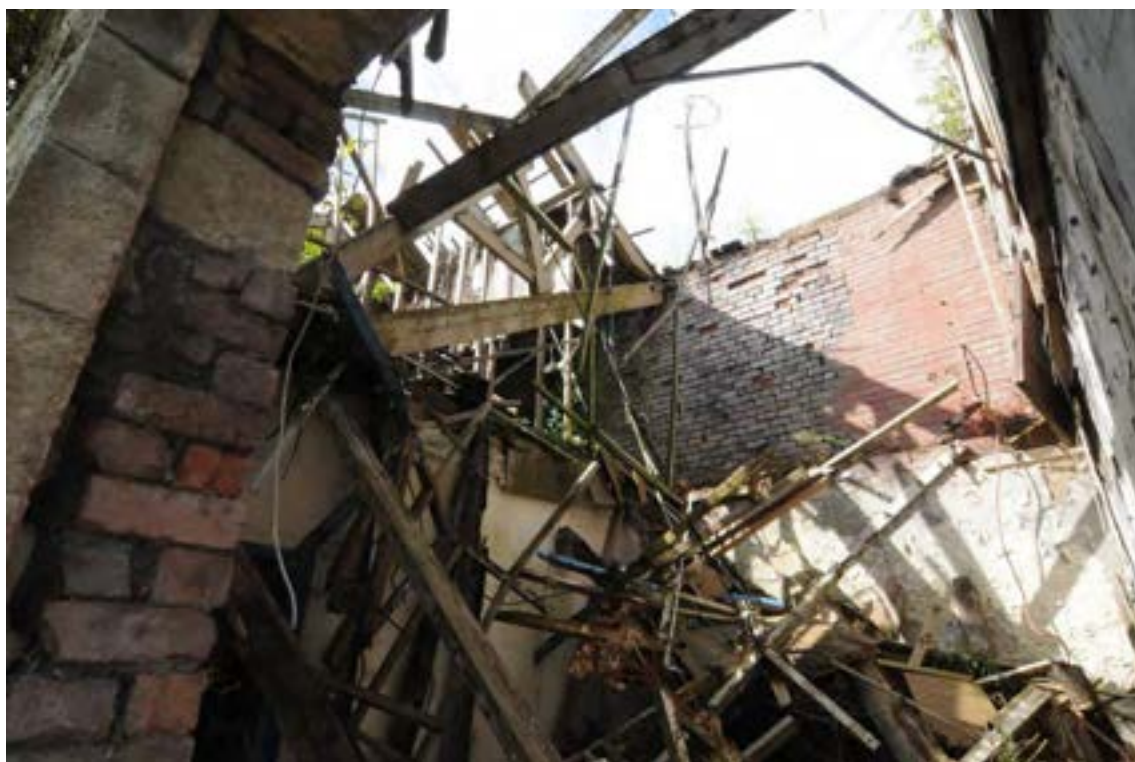
Photograph No : 82 Digital Ref: HOMI\_HBR\_0017 Direction: SW  
Description: SW view into ground and first floor of Building C

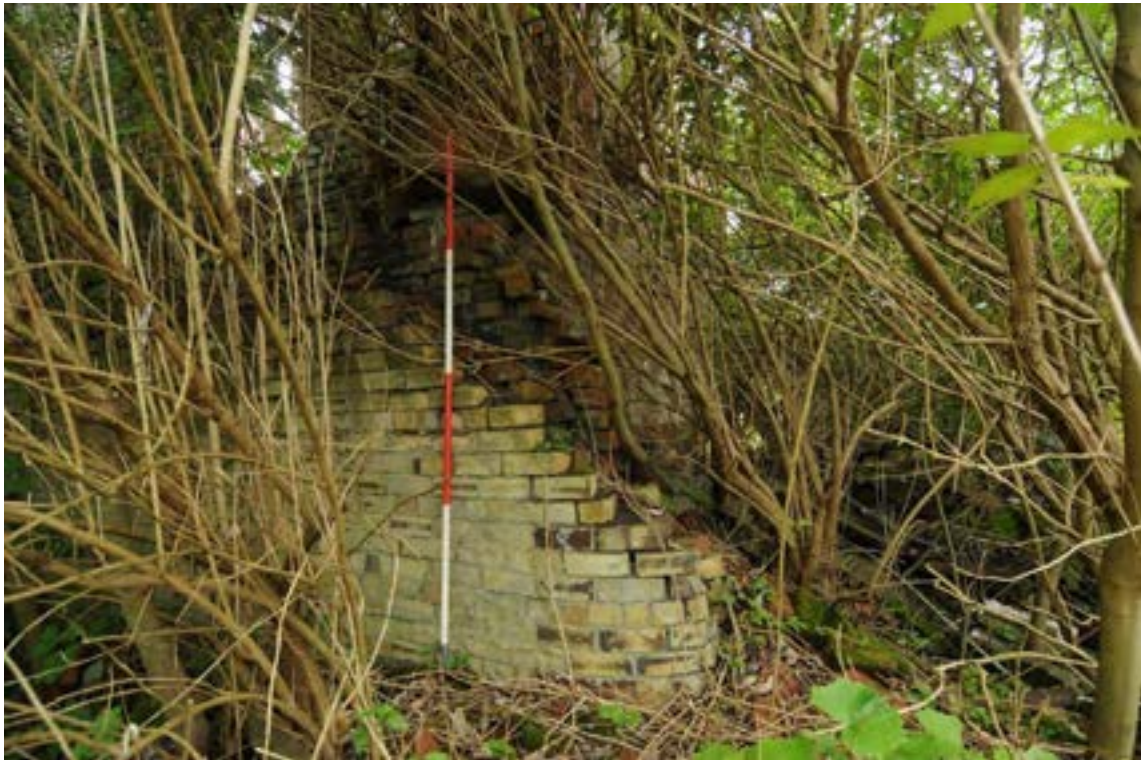
Photograph No : 87 Digital Ref: HOMI\_HBR\_0038 Direction: NE  
Description: Curve in brick at ground floor southern extent of west elevation of Building C

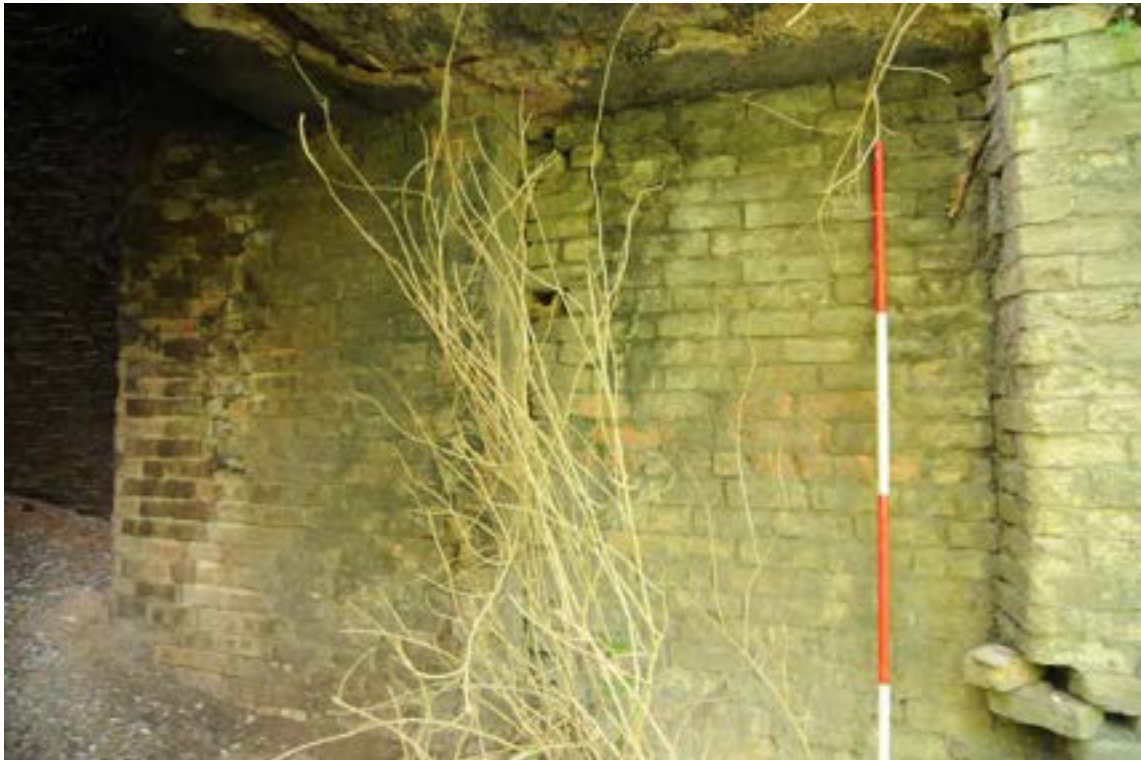
Photograph No : 89 Digital Ref: HOMI\_HBR\_0029 Direction: NE  
Description: Opening in south side of chimney and west elevation of Building C (right)

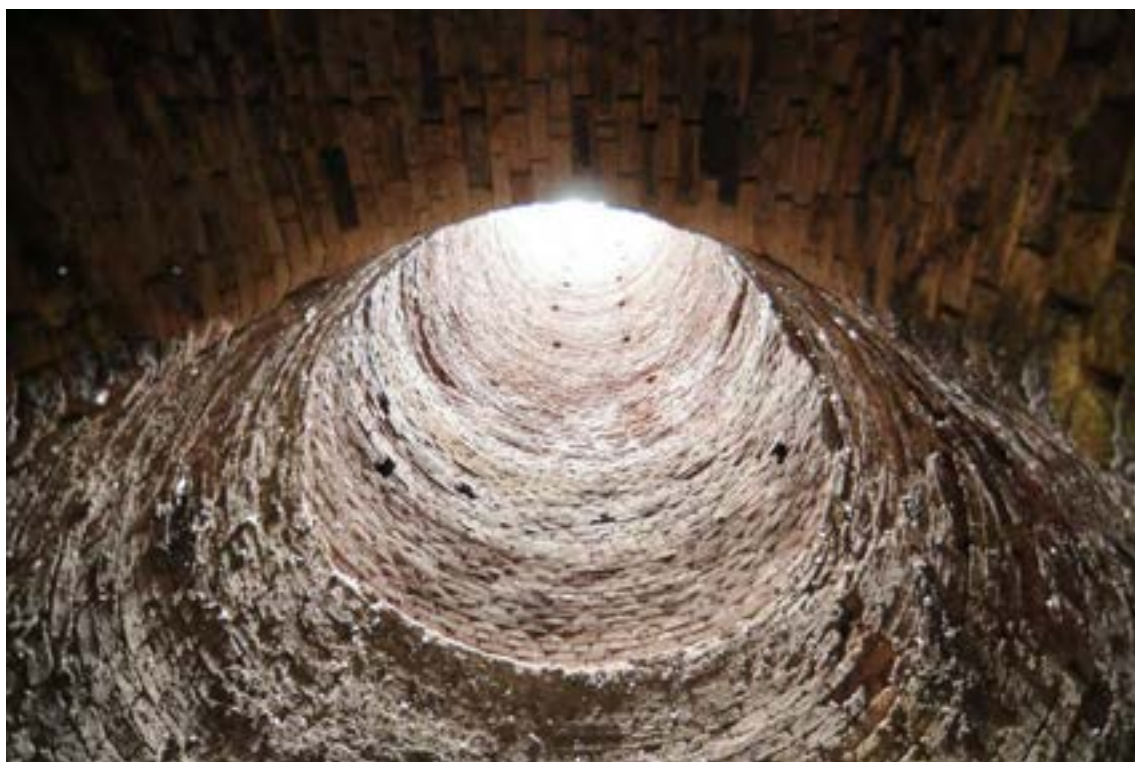
Photograph No : 92 Digital Ref: HOMI\_HBR\_0032 Direction: N  
Description: Internal view of chimney
