## Phase 1 GeoEnvironmental Desk Study

3 Sunningdale Avenue

Whitefield

**Report No. A6184/24/BDS**

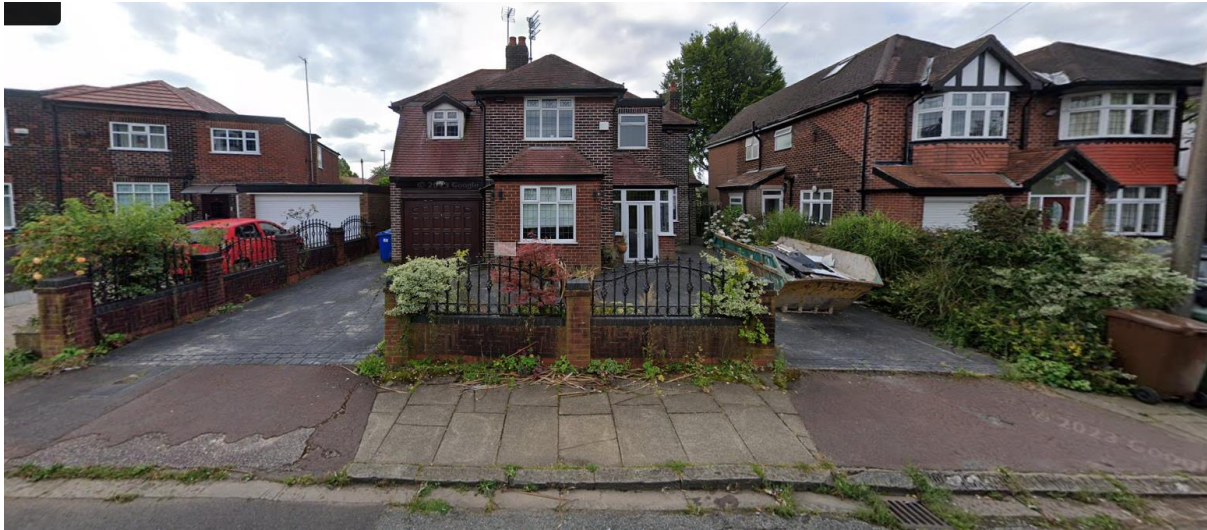
**Figure 3: Site Photograph**

- 2.4 The site is currently occupied with a two-storey domestic dwelling with an attached garage made of brick and. The front of the property is covered with hardstanding driveway. The rear of the property is covered with soft landscaping, shrubs, and majority tress in the eastern neighbour properties.

- 2.6 The general surrounding area comprises of residential dwellings.
- 2.7 A location plan is shown below as Figure 2, together with a recent site photograph as Figure 3 (overleaf).
