**Castledine  
Environmental**

**Phase 1 Land Contamination  
Risk Assessment  
for  
The Proposed Demolition and  
Rebuilding of a Dwelling including  
Basement and Ground Floor  
Extension to Rear and Single-Storey  
Extension to Front  
on the site of  
No.39 Bradshaw Road, Walshaw,  
Tottington, Bury BL8 3PW**

**Date: September 2024**

3788D P1 MK Projects - Bury

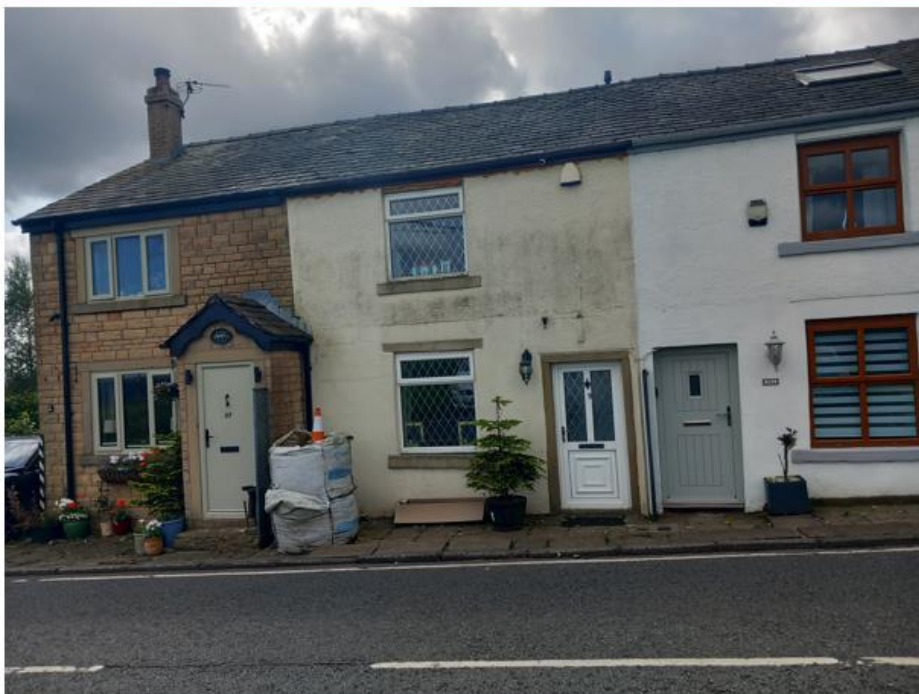
**Photo No.1: Facing SW from the opposite side of Bradshaw Road showing the front (NE) face of the dwelling**

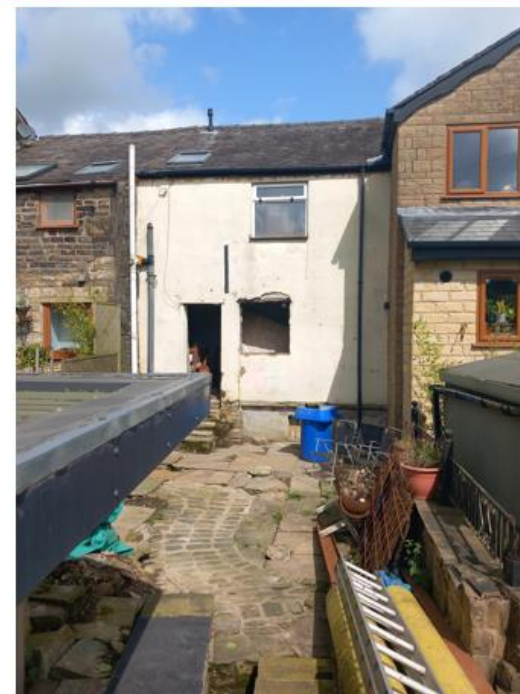
**Photo No.2: Facing slightly NE showing the rear (SW) face of the dwelling from the garden area**

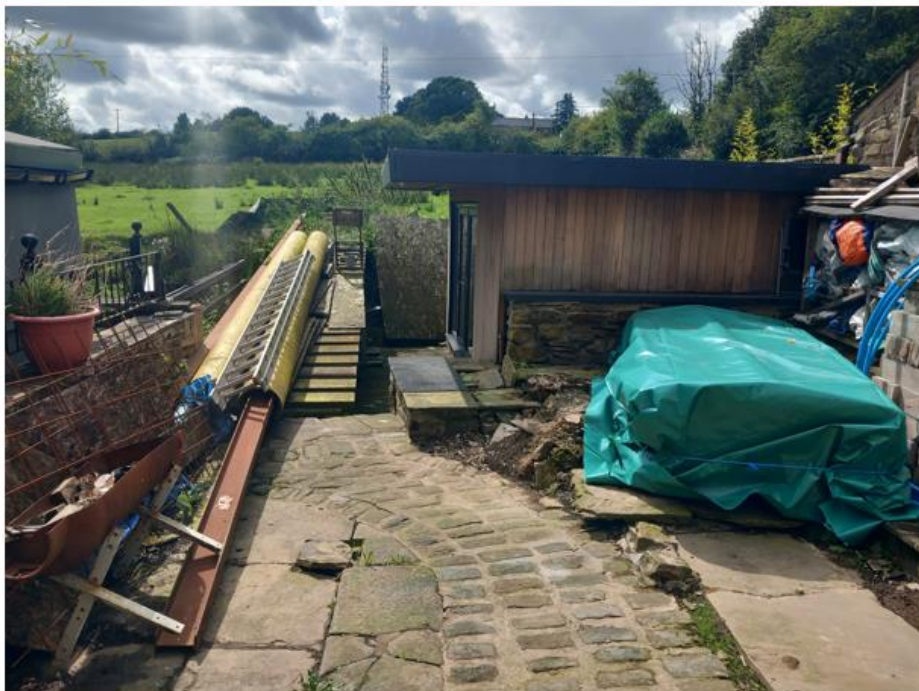
The rear garden area was seen to be terraced and wholly occupied by hardstanding (again, slabbed sandstone / millstone grit paving) with the only areas of exposed soil being small planting beds. A small summerhouse was also noted in the rear garden.

**Photo No.3: Facing slightly SW from the rear garden area showing the extent of the garden, hardstanding and summerhouse**

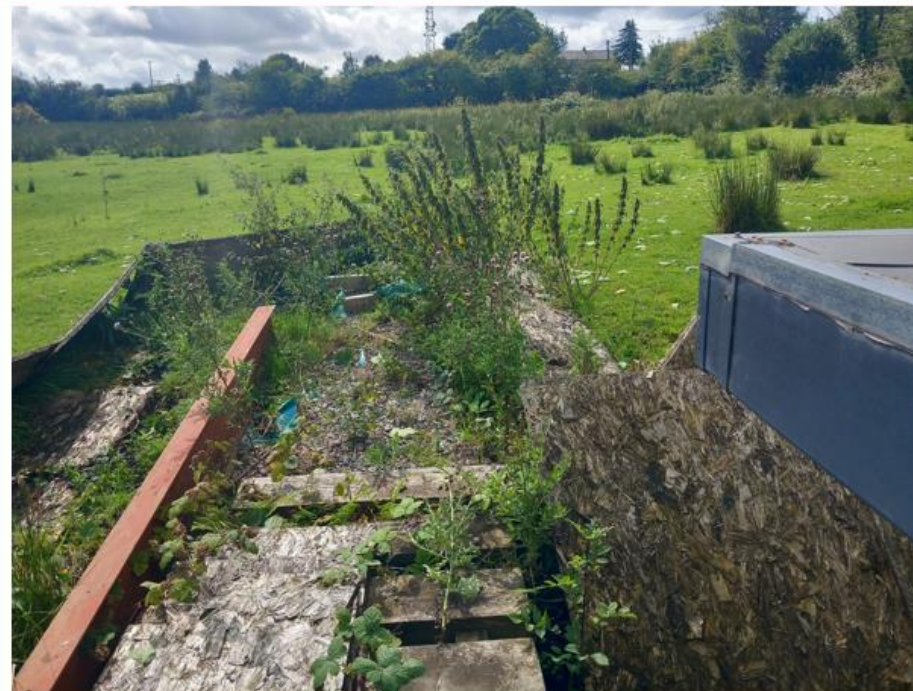
**Photo No.4: Facing slightly SW showing extent of site**

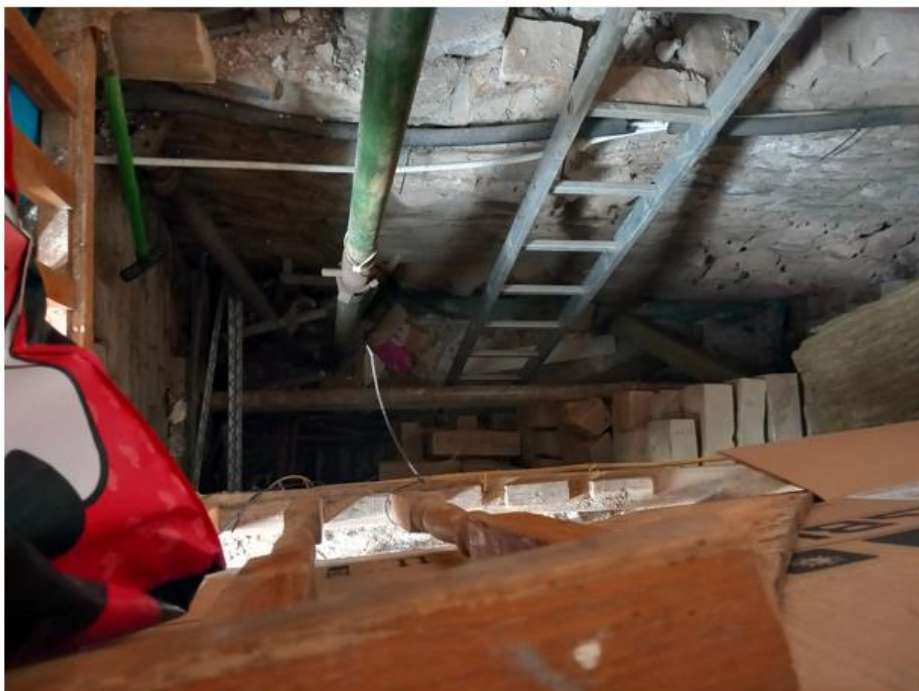
of old-building stone construction with slabbed paving at the base. The cellar was seen to be occupied by various construction materials, storage boxes and other, domestic items held in storage.

**Photo No.5: Looking directly down from the ground-floor level to the underlying basement in the SW extent of the dwelling**

- Upgrading the required cellar tanking measures with ground gas protection measures suitable to protect against carbon dioxide / methane
- Allowance for specific remediation or point testing, should the Watching Brief (inline with the below) indicate the need for such.

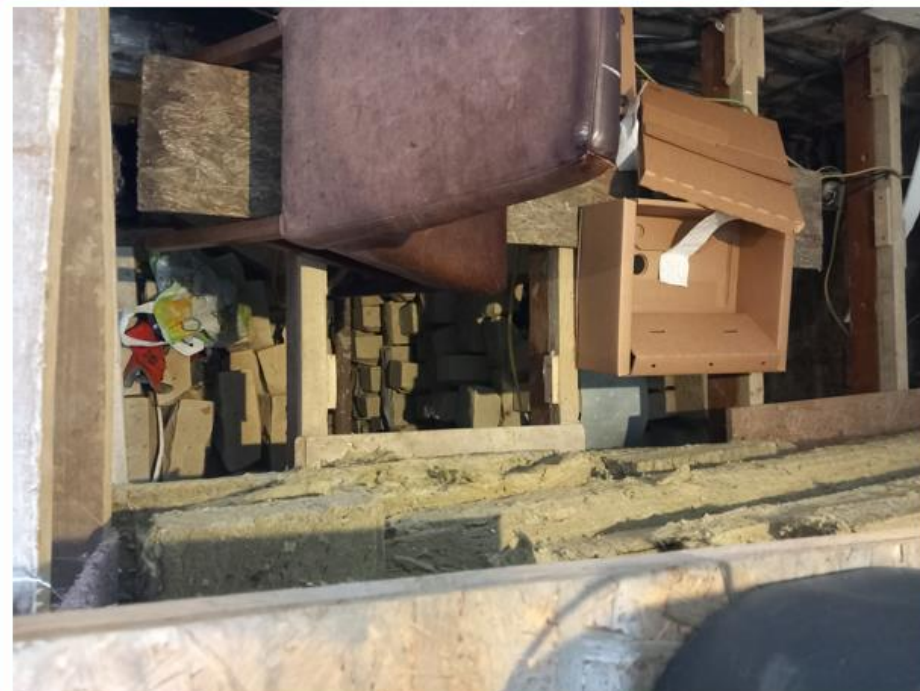
**Photo No.6: Looking directly down from the ground-floor level to the underlying basement in the SW extent of the dwelling**
