M-0544

Installation of New Balcony Support Frames

Pinfold Court, Whitefield, Manchester,  
M45 7NZ

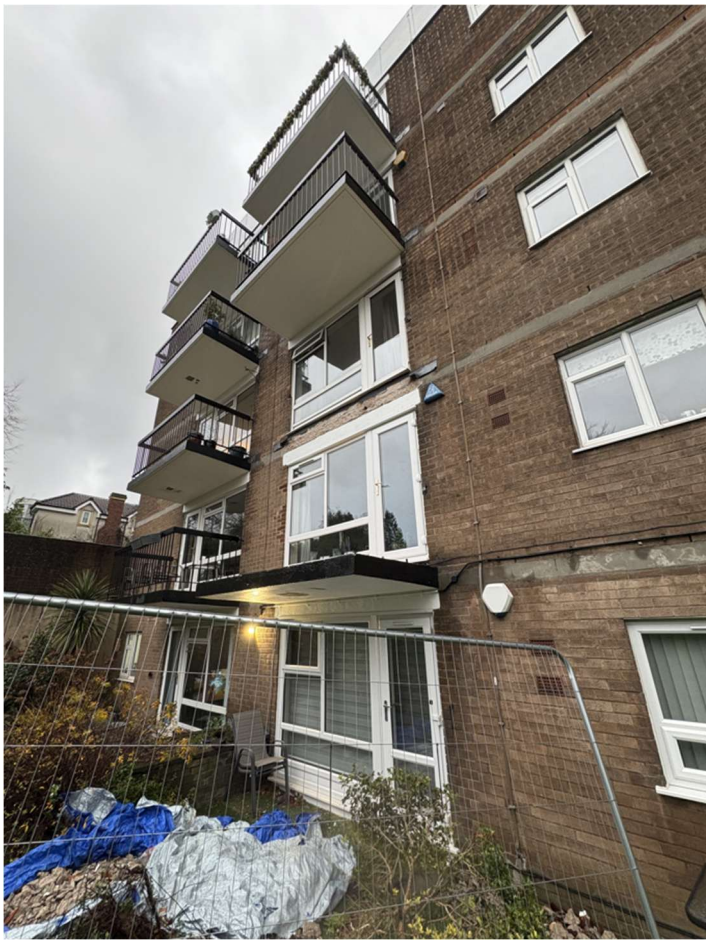
Photo of collapsed balcony

Last year one of the balconies of the west elevation suddenly collapsed. Fortunately nobody was using the balcony at the time.

The collapsed balcony was located along the west elevation of the property, facing Higher Lane and belonged to a second floor flat.

Following a review from the structural engineer it was concluded that there were a couple of structural issues with the balcony which need to be addressed i.e. inadequate reinforcement with the concrete balcony. As the fault on the balcony is shared with all the balconies it then means what ever is required to fix the collapsed balcony needs to be addressed to all of the balconies.

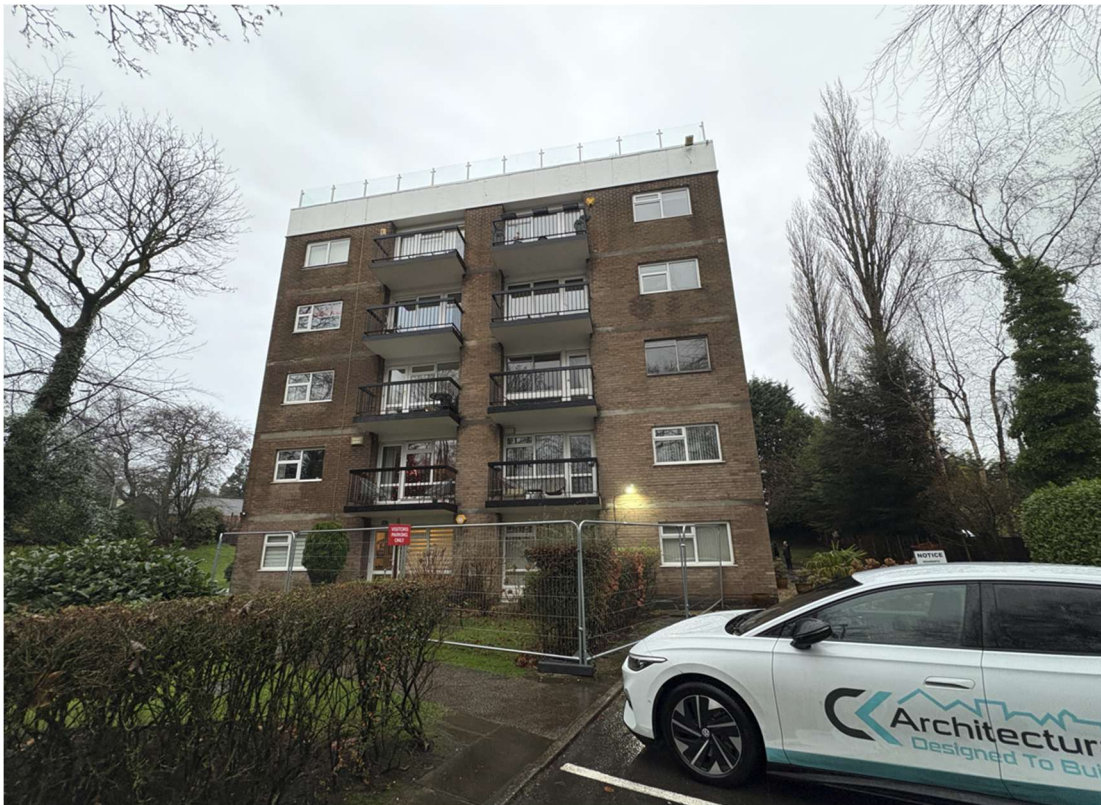
Photo of south elevation

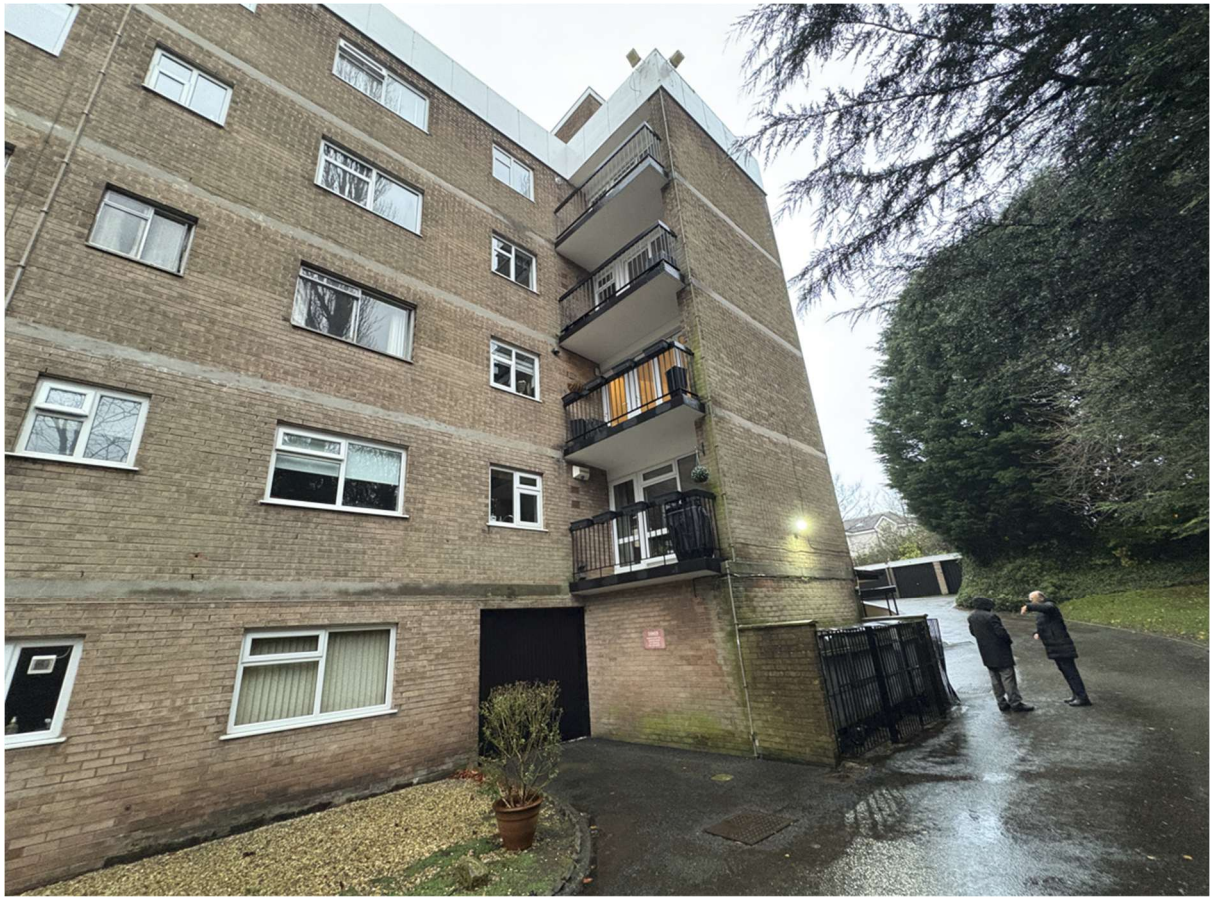
Photo of west elevation
