## **Former Police Station, Bury**

### **Combined Phase 1 Desk Study and Phase 2 Geo-Environmental Ground Investigation Report**

For: Bury Metropolitan Borough Council

Ref: 3842-01  
Job: 3842  
Rev: -  
By: AS

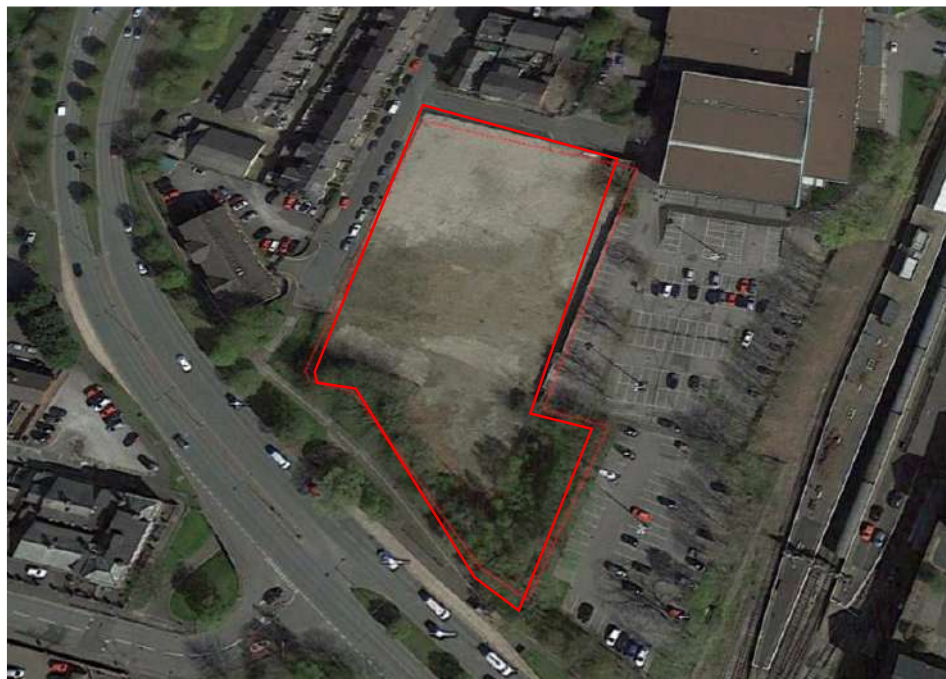
The site is a c. 0.7Ha site, located to the south of Lower Bank Street, Bury, at the approximate postcode BL9 0JW. The National Ordnance Survey grid reference for the centre of the site is 380096E, 410680N. The site currently comprises a vacant area of land. The site is bound by residential properties and Irwell Street to the west, Jubilee Way (A58) to the south, a car park to the east and Lower Bank Street to the north. Access to the site is off Lower Bank Street to the north. The site is shown on the below aerial image:

Figure 1; Aerial image dated April 2021.

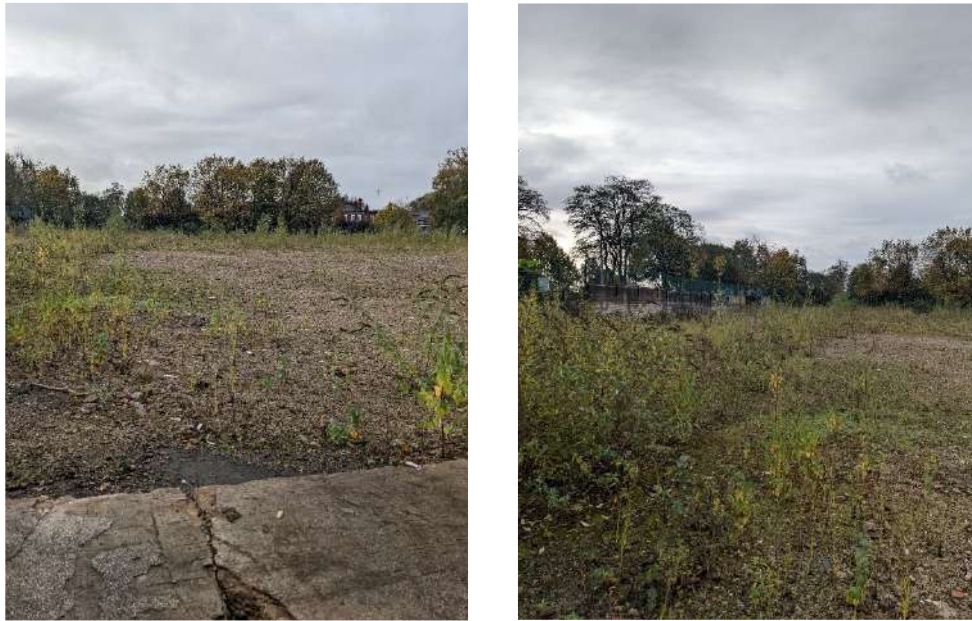
The site was noted to be a vacant parcel of land with fencing around all boundaries, with the exception of the eastern boundary which comprised a retaining wall. The ground underfoot was noted to be hardstanding throughout, comprising crush and cobbles of red brick and concrete. No buildings or features of note are present on-site. A concrete boulder has been placed at the site entrance to prevent unauthorised access.

*Figure 2: Photographs showing the site from the north looking south.*

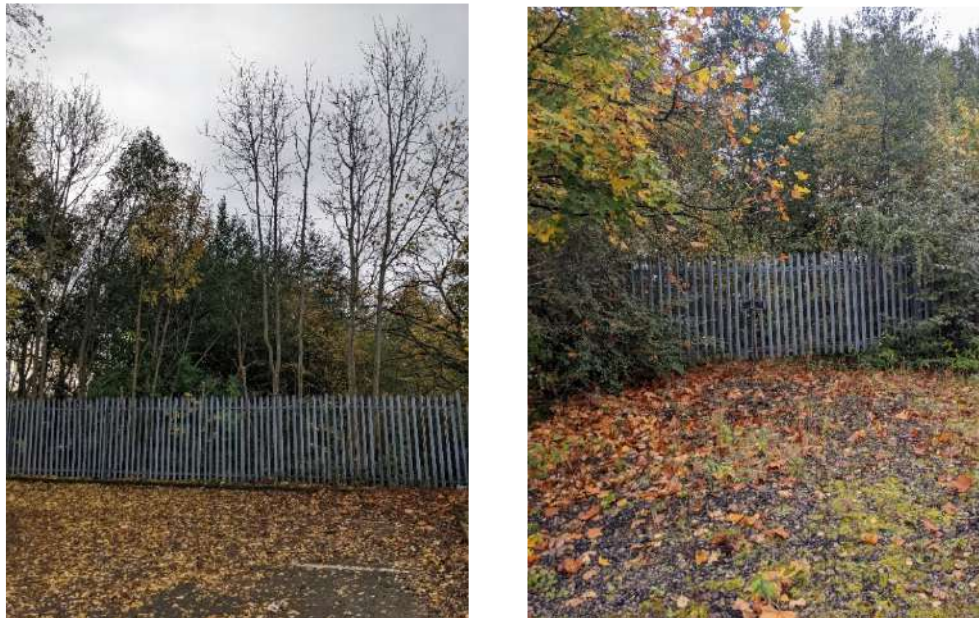
Dense vegetation and established trees were noted along the southern and eastern boundaries of the site, especially in the south-eastern corner of the site, where a gate has been placed.

*Figure 3: Photographs showing the established trees along the south-eastern site boundary, looking south from the adjacent off-site car park (left) and looking east (right).*

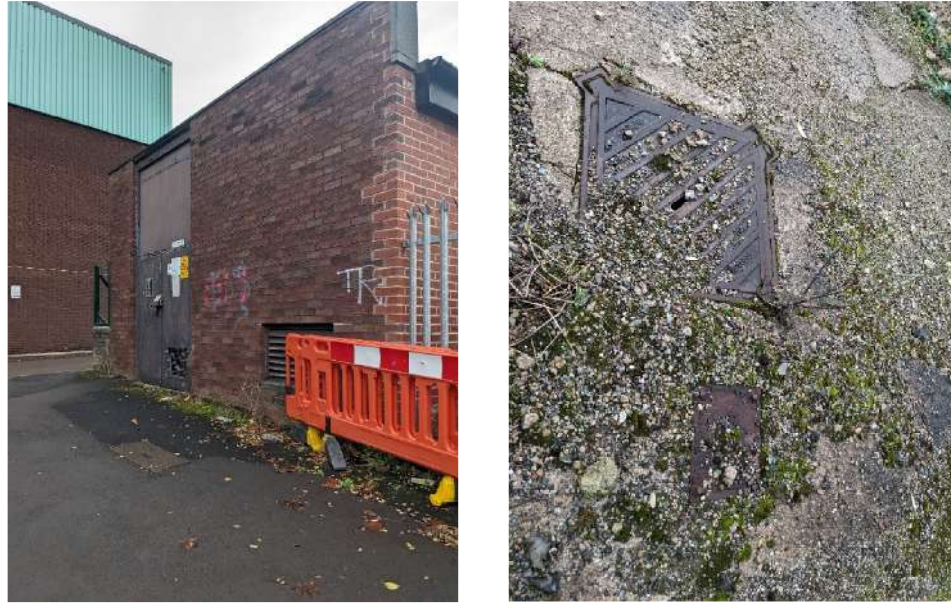
An off-site electricity sub-station was noted adjacent to the north-eastern site corner, with a corresponding overhead line and pole near the northern site boundary. Numerous manholes were noted along the northern site boundary near the site

entrance. Two electricity boxes were also noted off site, immediately adjacent to the fence delineating the western site boundary.

Figure 4: Photographs showing the off-site electricity sub-station near the north-eastern site corner (left) and manholes noted along the northern site boundary (right).

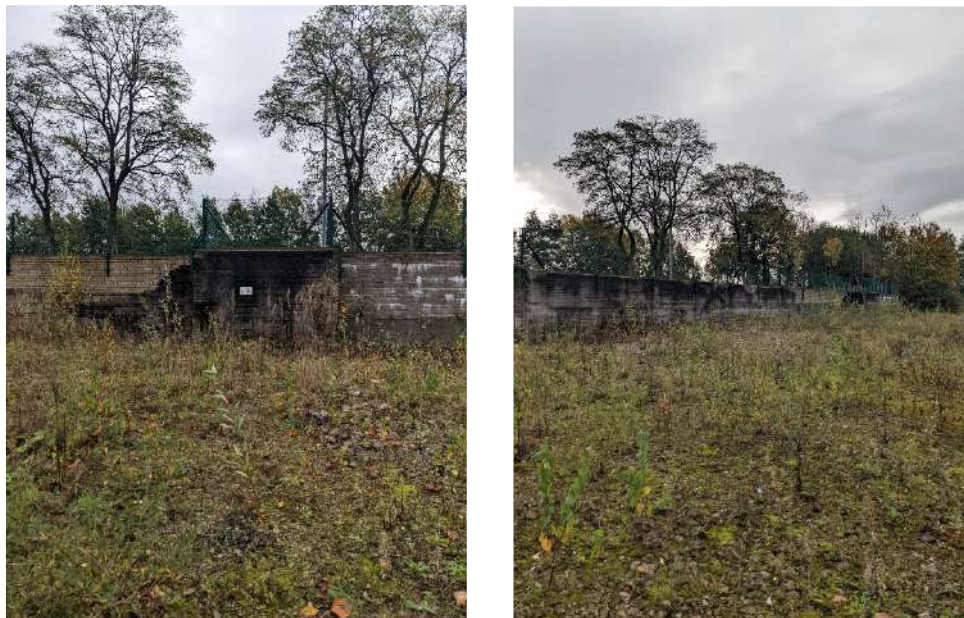
A brick and concrete retaining wall, approximately 3m tall was noted along the eastern site boundary, anticipated to have been constructed to allow the creation of the car parking to the east. The wall appears to be in good condition following the on-site demolition of the former police station.

Figure 5: Photographs showing the retaining wall along the eastern site boundary.

| Factors | Remarks | Considerations | Risk |
|---|---|---|---|
| <b>Retaining Wall</b> | A brick and concrete retaining wall is present along the eastern site boundary. It is approximately 3m tall and was noted to be in good condition. | The retaining wall will need to be inspected and remedial measures may need to be undertaken prior to development, subject to an assessment of the impact upon Third Party assets. | <b>Moderate</b> |

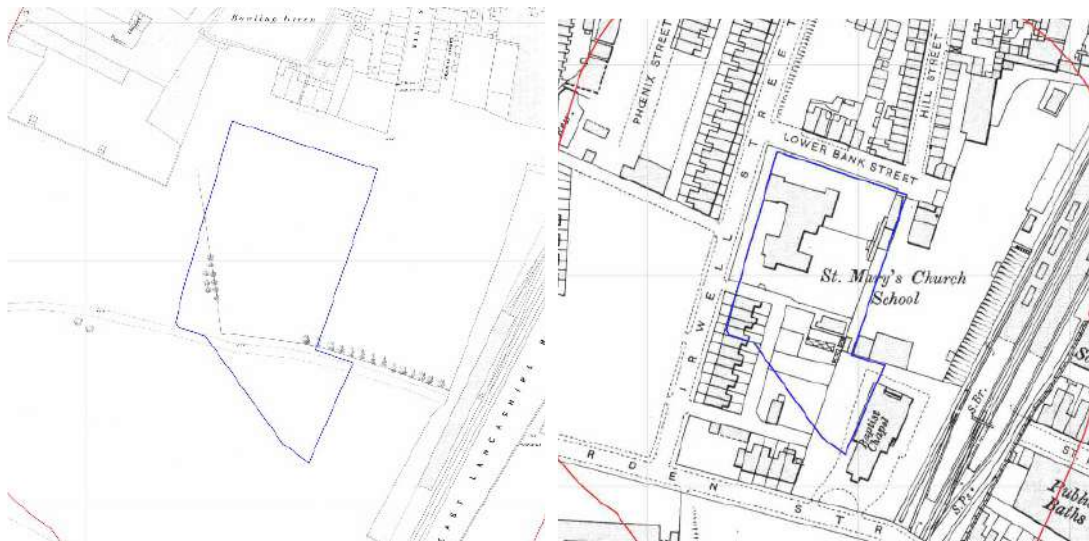
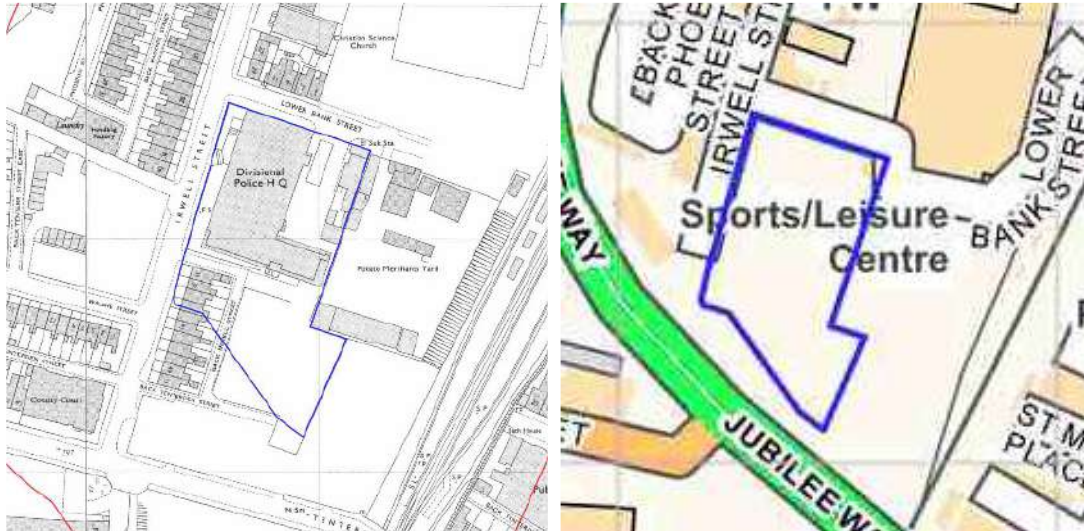
| Date | Site Feature |
|---|---|
| 2017 – 2022 | By 2017 the police station building is demolished, and the terraced house are no longer present, replaced by the Jubilee Way (A58). The site remained mostly unchanged since. |

Figure 6: Extracts of the OS historical maps dated 1849 (top left), 1910 (top right), 1973 (bottom left) and 2022 (bottom right).

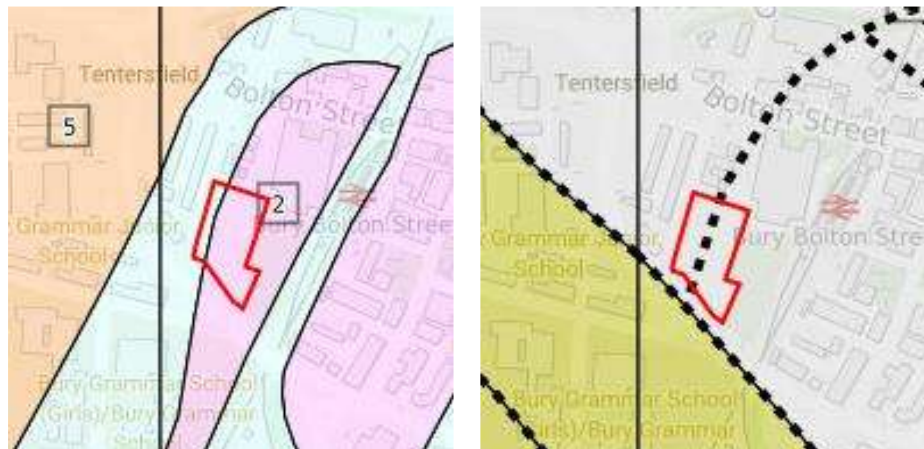
The BGS 1:50,000 Solid and Drift Geological Map of the area (Sheet No: 85 dated 2001) indicates that the site is underlain by Glaciofluvial Sheet Deposits across the majority of the site, which typically comprise **sand** and **gravel**, while the site section along the western site boundary lies an area of Glacial Till, typically comprising a heterogenous mixture of **clays**, **sands** and **gravels**. The site is underlain by bedrock of the Pennine Lower Coal Measures which comprises **mudstone**, **siltstone** and **sandstone**.

Figure 7: Extracts of the BGS 1:50,000 drift (left) and bedrock (right) geological map. Pink = Glaciofluvial Deposits, Blue = Glacial Till, Light Orange = River Terrace Deposits, Light Grey = Lower Pennine Coal Measures, Light Green = Cannel Rock

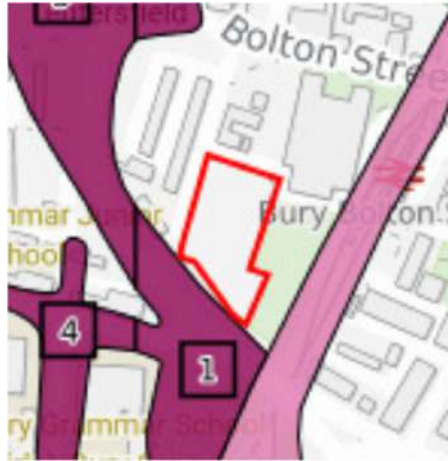
The BGS geological maps record Made Ground and worked ground within 500m of the site, the nearest noted 3m south of the site, pertaining to artificial ground, anticipated to be associated with the widespread historical and recent industrial activities in the area.

Figure 8: Extract showing the location of the Made Ground (dark purple) and worked ground (pink)

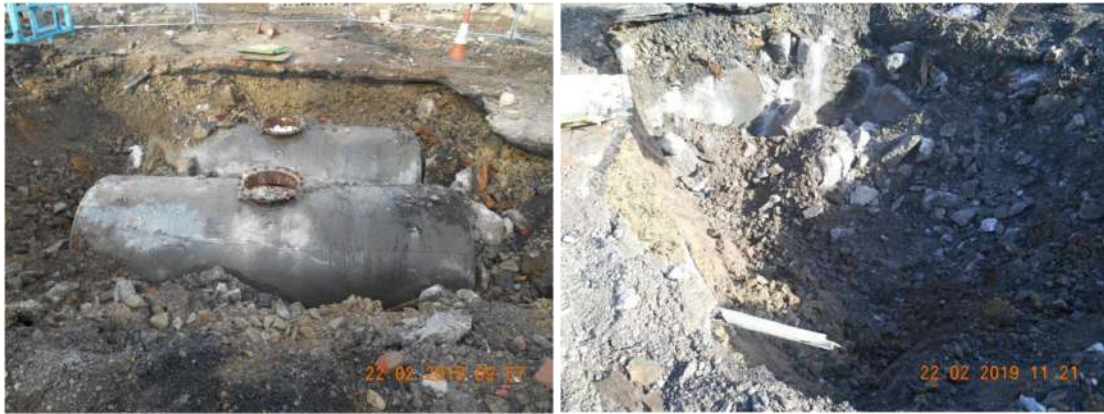
2 No. steel Underground Storage Tanks (USTs) were recorded in the central-northern site section, encased within a concrete cradle. The site investigation undertaken by E3P concluded that the tanks were suitable for safe lifting. Impacted liquid within the tanks was removed from site by a vacuum tanker for off-site disposal and the tank was safely removed from the site. On 5<sup>th</sup> March 2019, E3P undertook validation testing of the excavation around the where the USTs had been located. The testing included two samples per exposed face of the excavation and two from the base.

Figure 4 - E3P Photographs showing the tanks (left) and the exposed concrete cradle (right).

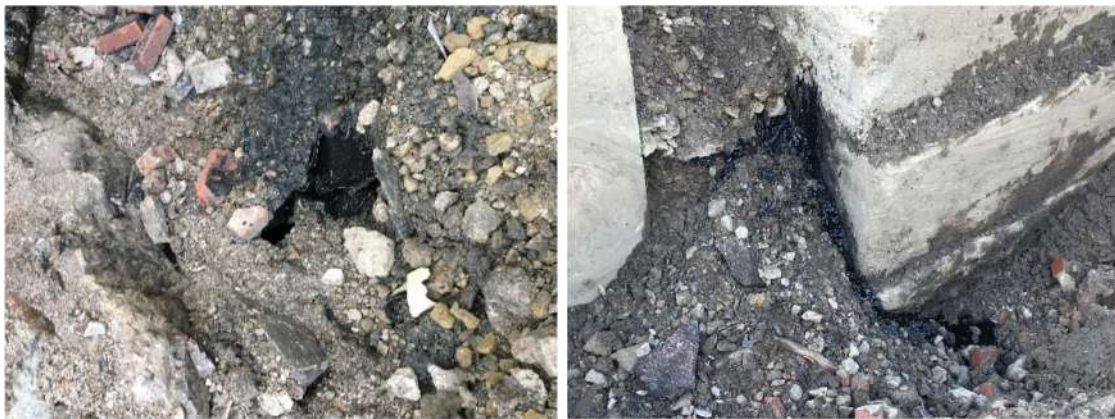
In order to determine if there was any evidence of wider hydrocarbon impact from the base of the UST cradle, two trial pits were excavated in down gradient locations. No significantly elevated concentrations were recorded in these sampling locations but a 'hydrocarbon type liquid' that was present in the ground to the south and down gradient of where the USTs had been located:

Figure 5 - E3P photos showing 'hydrocarbon liquid' down gradient of USTs.

From the above photos it can be seen that only a very small volume /area of impacted soils was found.

Based on the works undertaken E3P summarised that the hydrocarbon impact does not appear to have migrated off-site. Connell Bros were instructed to leave the residually impacted soils on-site. The excavated soils were tested and later disposed as Hazardous Waste.

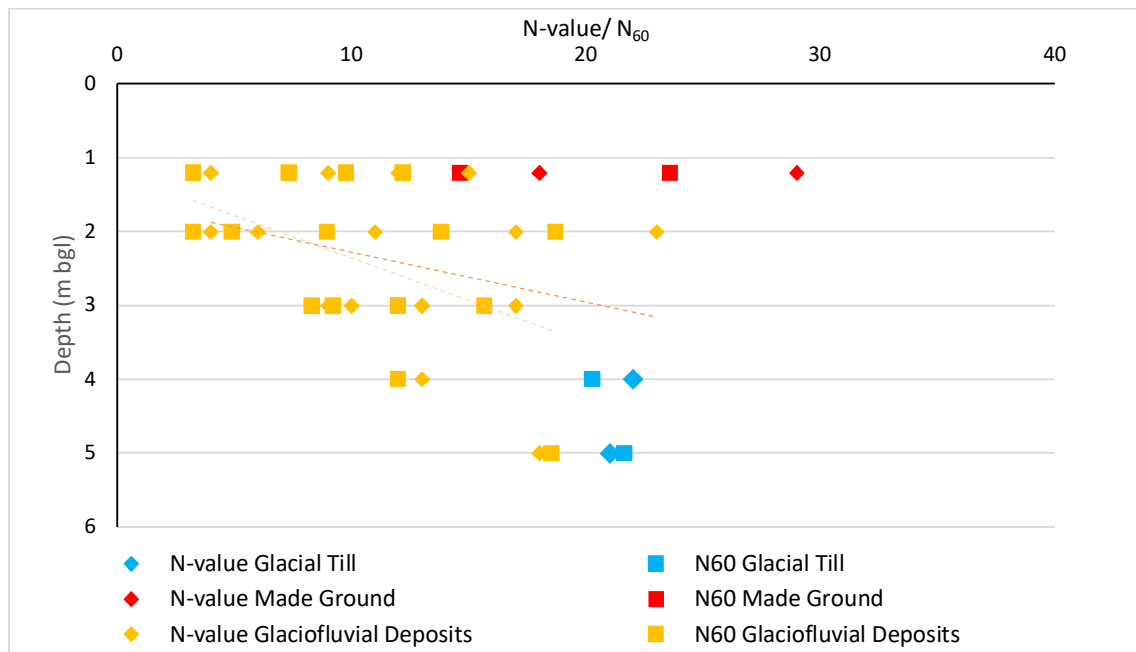
The following scatter graph shows that generally there is an increase in the N-values /  $N_{60}$  values recorded within the Glaciofluvial Deposits with depth. However, the N-values /  $N_{60}$  values are noted to be very variable.

For detailed, specific information pertaining to the Standard Penetration Tests (SPTs), refer to the dynamic sampling borehole logs contained within Appendix 9.

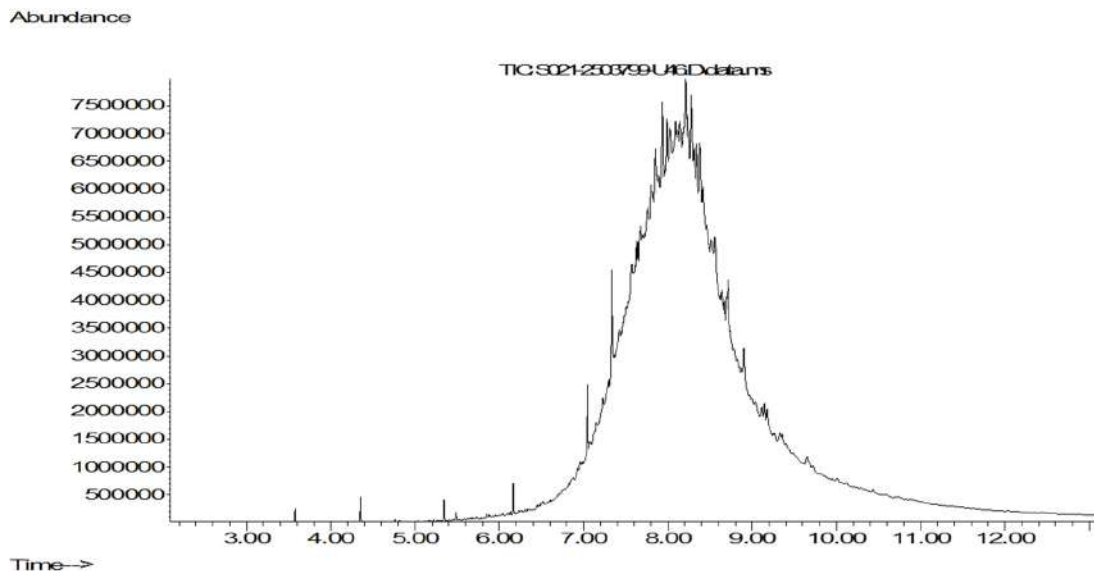
Forensic TPH analysis was undertaken, which gave the following chromatograph:

It can be seen that the sample is mostly represented by an Unresolved Complex Mixture (UCM), which is the large 'bump' in the centre of the graph, in the range C10 to greater than C40, with both aliphatic and aromatic product sources. The lab reported that *'The trace does not match the standard product profiles but is suggestive of lube oil from engine petrol'*.

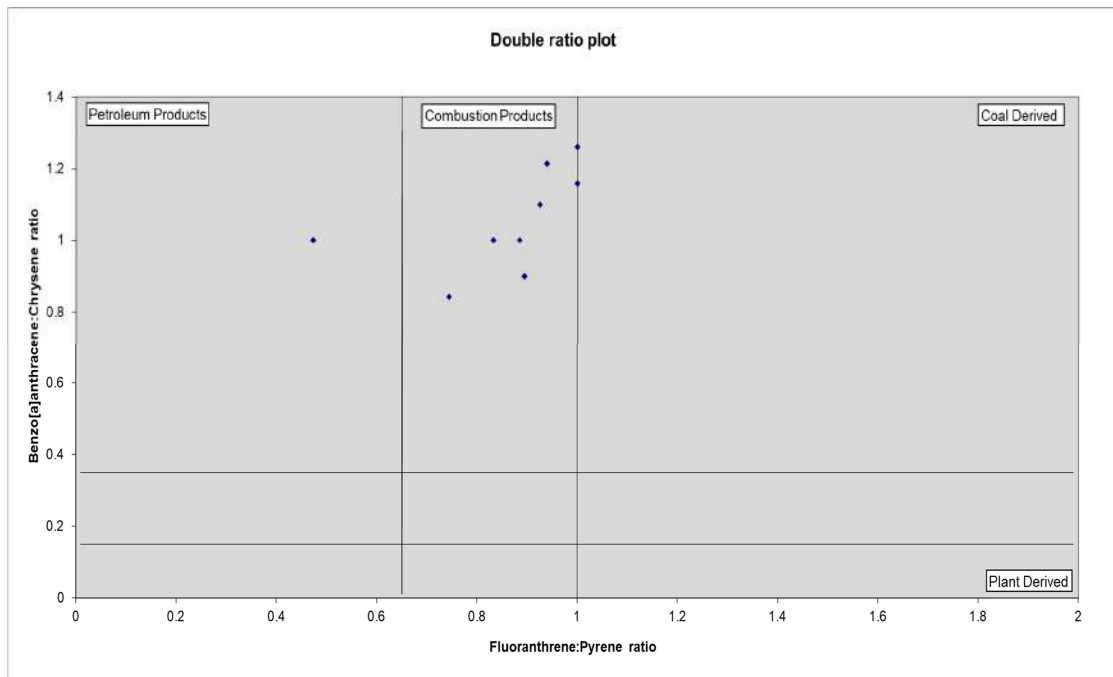
A Double Ratio Plot for all of the PAH compounds analysed across the site was produced to reveal the possible sources of the substances found on-site:

As seen above, the majority of the PAHs on-site are derived from combustion processes but could also stem specifically from the combustion of coal-derived materials, i.e., clinker. A single exception is noted within the results, signifying a petroleum product; this is unsurprising as it has been found in TP03 at 3.30m bgl, which is a sample targeted for its strong hydrocarbon odour, and where TPH exceedances have been found, as discussed above.

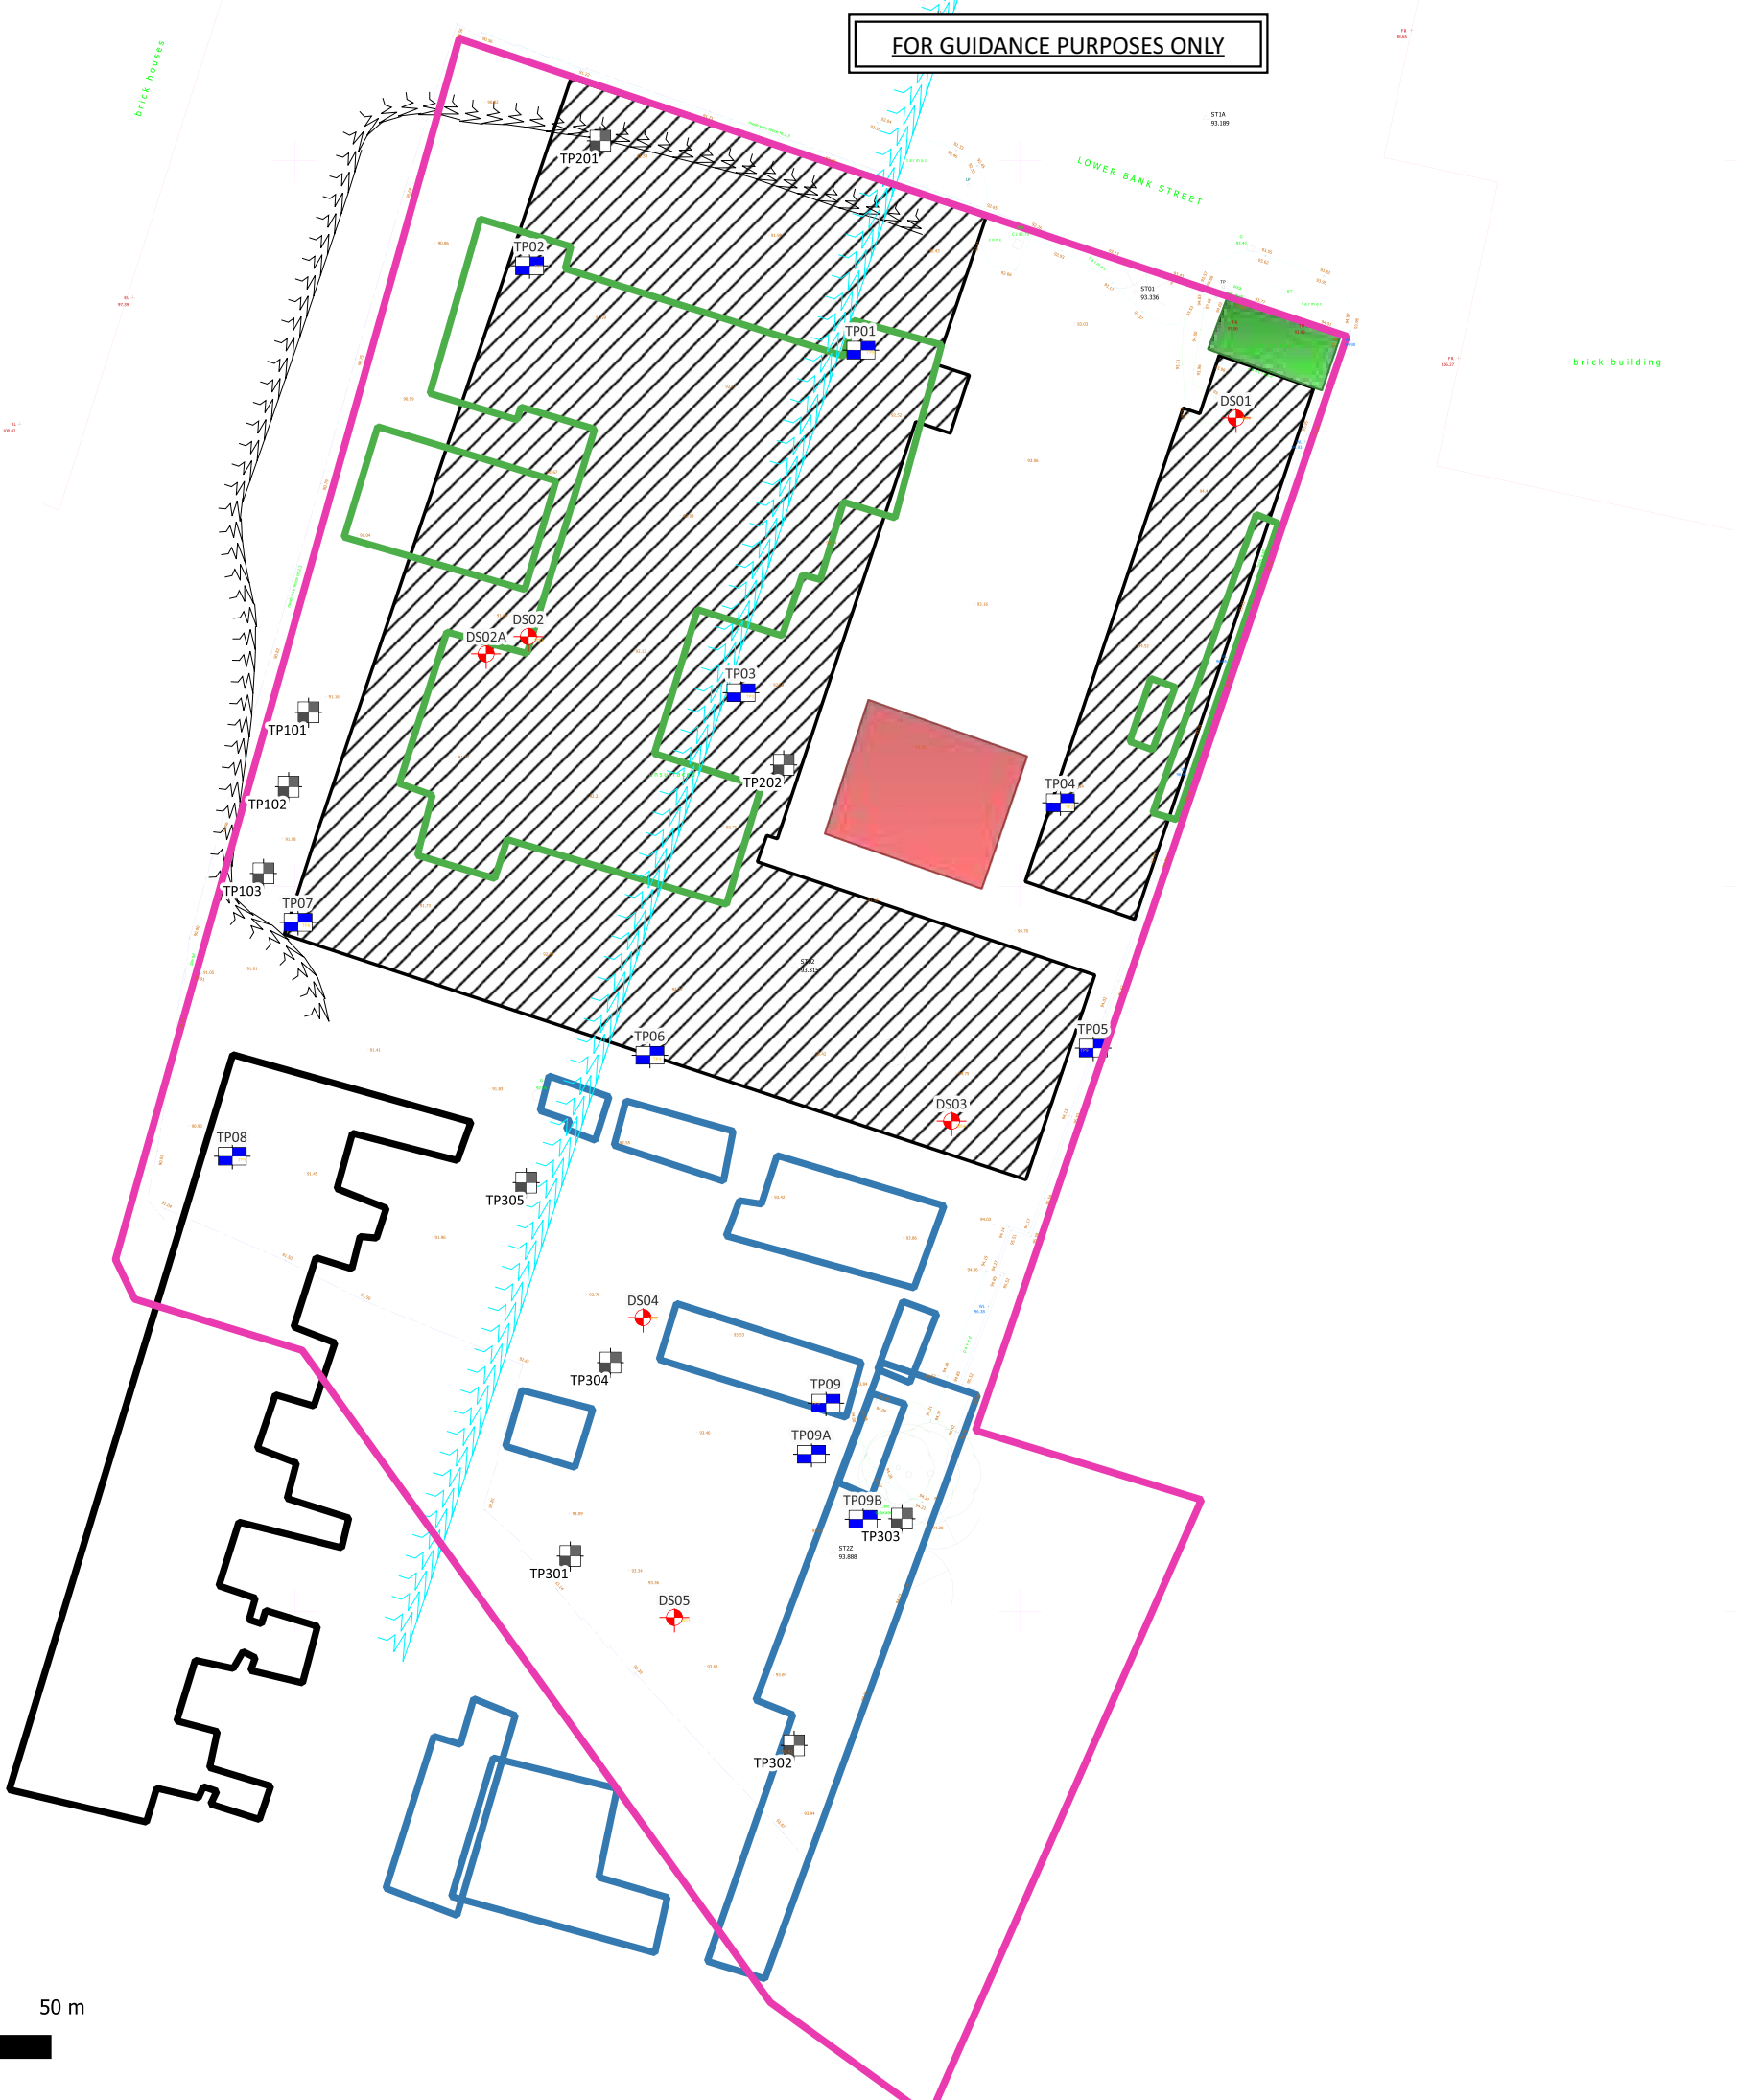
- Approximate Site Boundary
- Existing Electricity Sub-Station
- Area of Former Underground Storage Tanks
- Divisional Police HQ (1973 - 2017)
- Historical St. Mary's Church School (1891 - 1973)
- Historical Buildings of Unknown Use (1910s - 1950s)
- Historical Residential Dwellings (1900s - 1970s)
- Historical Slope (1890s)
- Geological Buried Channel
- E3P Trial Pits 2019
- IGE Trial Pits 2022
- IGE Dynamic Sample Holes 2022

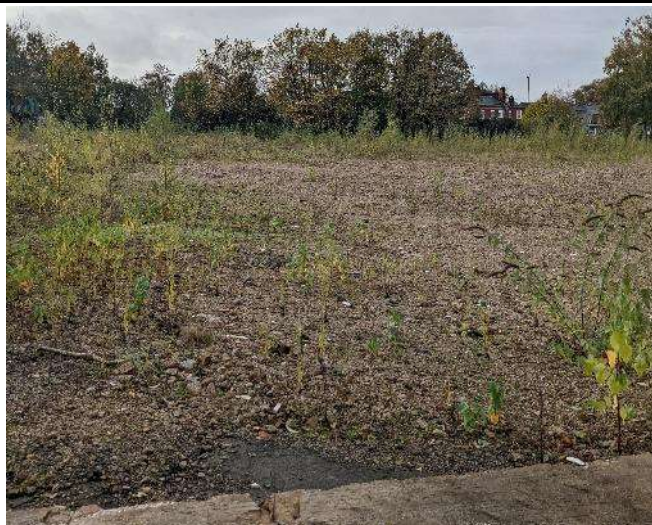
Figure 1 – The site with the concrete slab in the foreground, looking south.

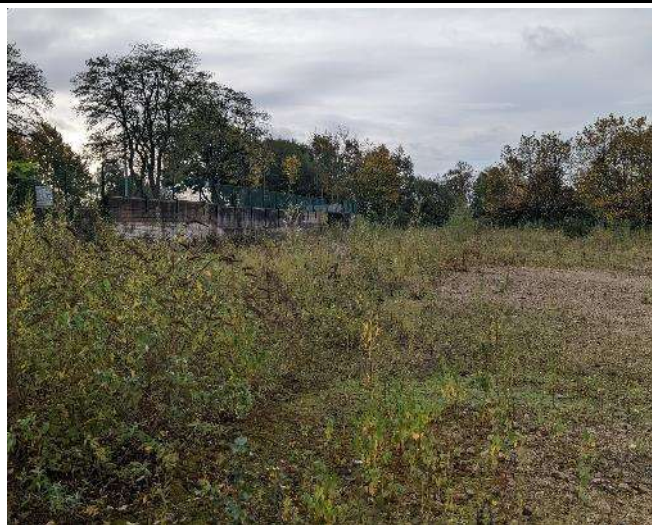
Figure 2 – The eastern site section with the retaining wall as seen from the north, looking south-east.

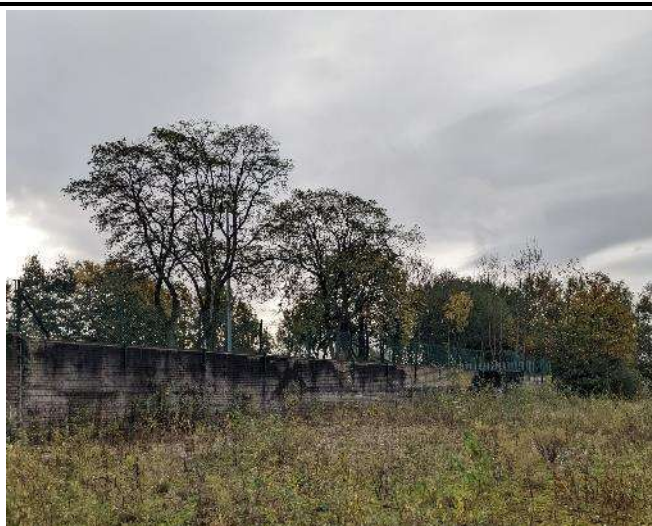
Figure 3 – The retaining wall along the eastern site boundary, looking south-east.

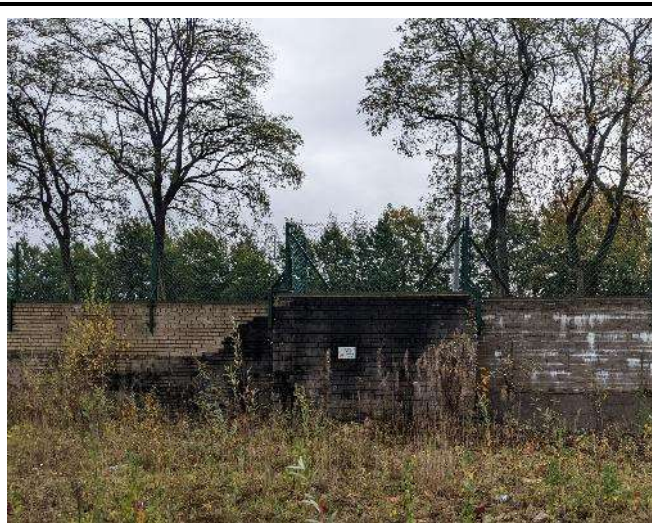
Figure 4 – The eastern retaining wall, looking east.

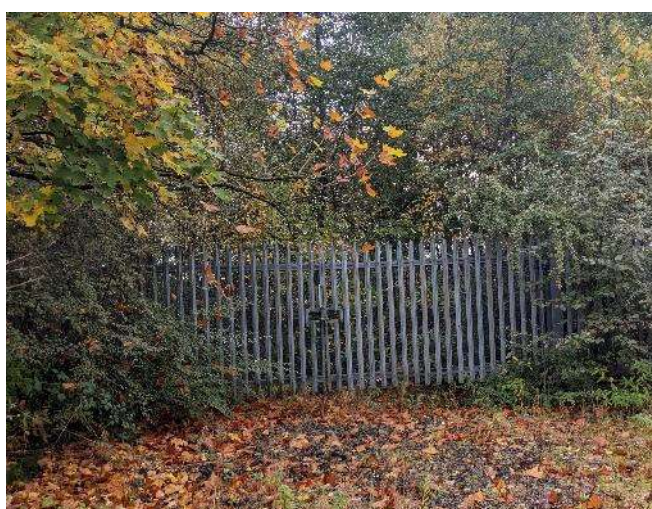
Figure 5 – The gated south-eastern site section, with dense vegetation and established trees, looking east.

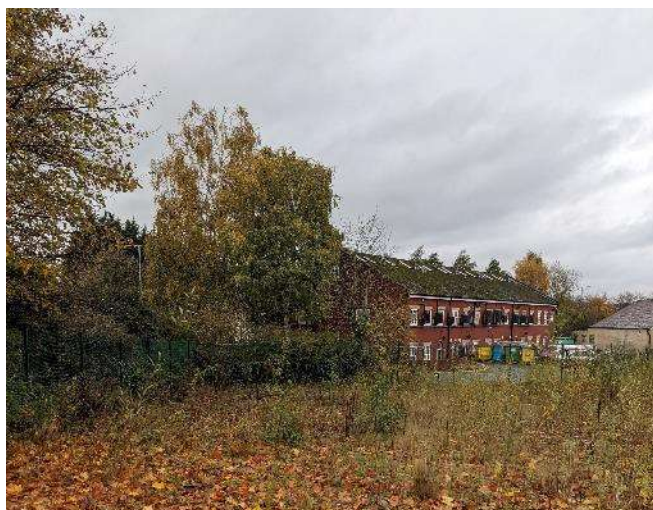
Figure 9 – The southwestern site section (old access road) with established trees along the southern site boundary, looking south-west.

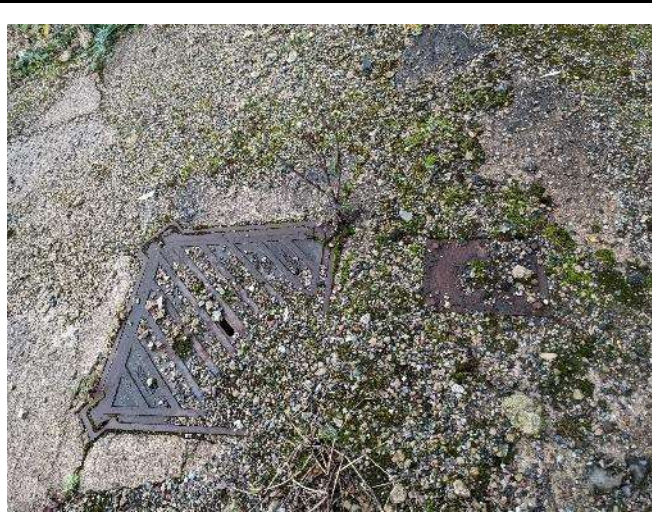
Figure 12 – Manholes along the northern site boundary, looking east.

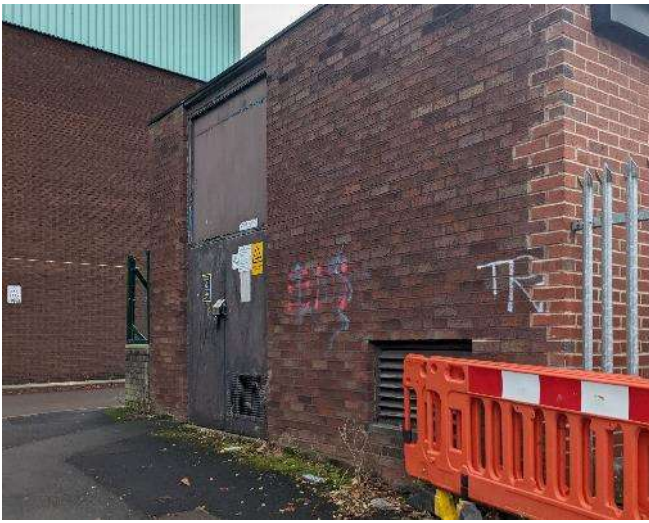
Figure 13 – An electricity sub-station adjacent to the northeastern site boundary, looking southeast.

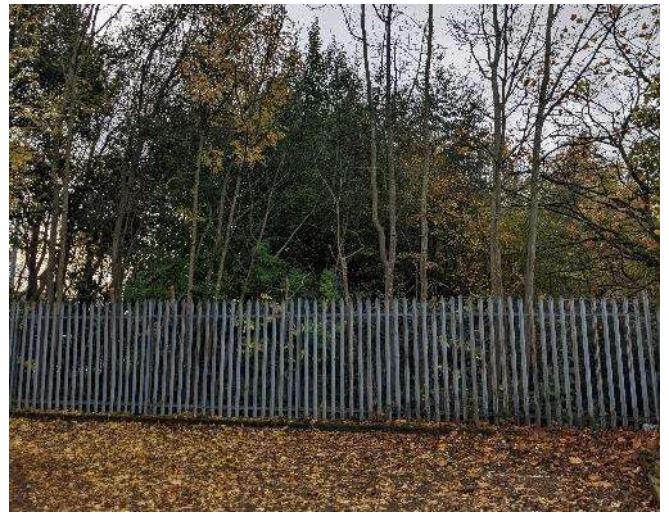
Figure 14 – The eastern site boundary with established trees, as seen from the adjacent off-site car park, looking south.

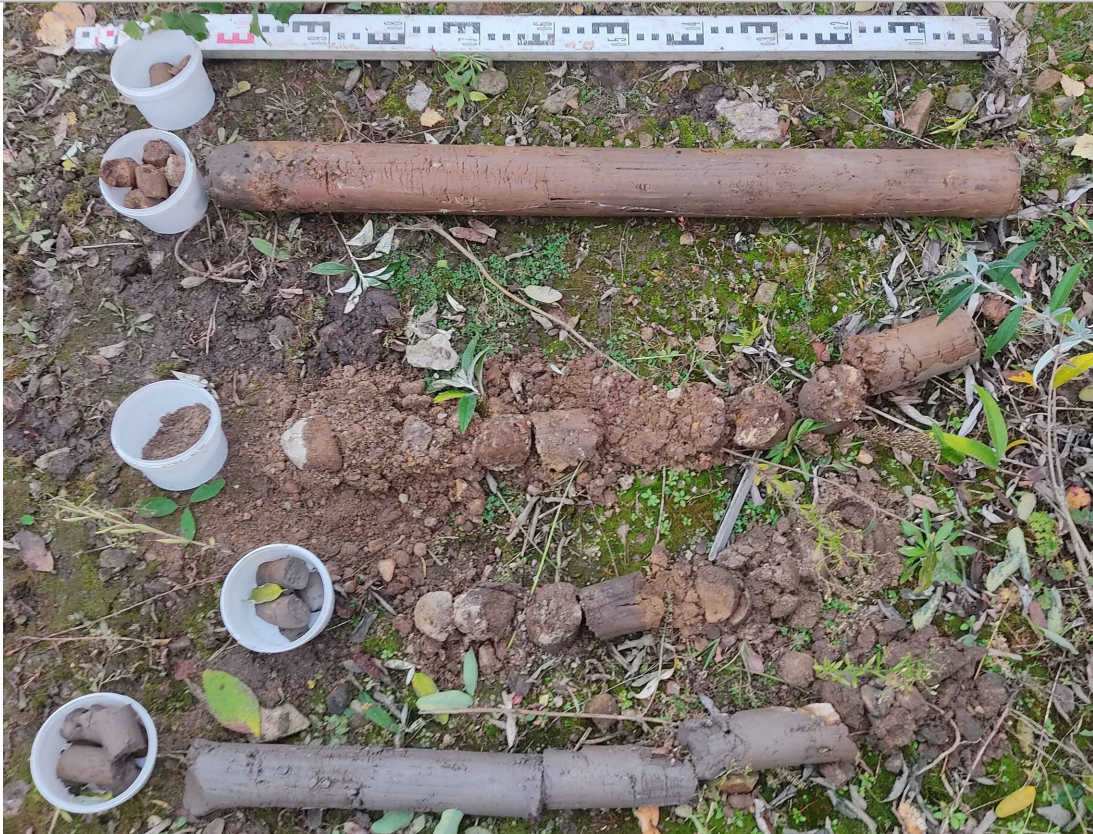
**Image 1.** DS01:  
Viewed right to left, top to bottom.  
1.20m - 2.00m bgl.  
2.00m - 3.00m bgl.  
3.00m - 4.00m bgl.  
4.00m - 5.00m bgl.

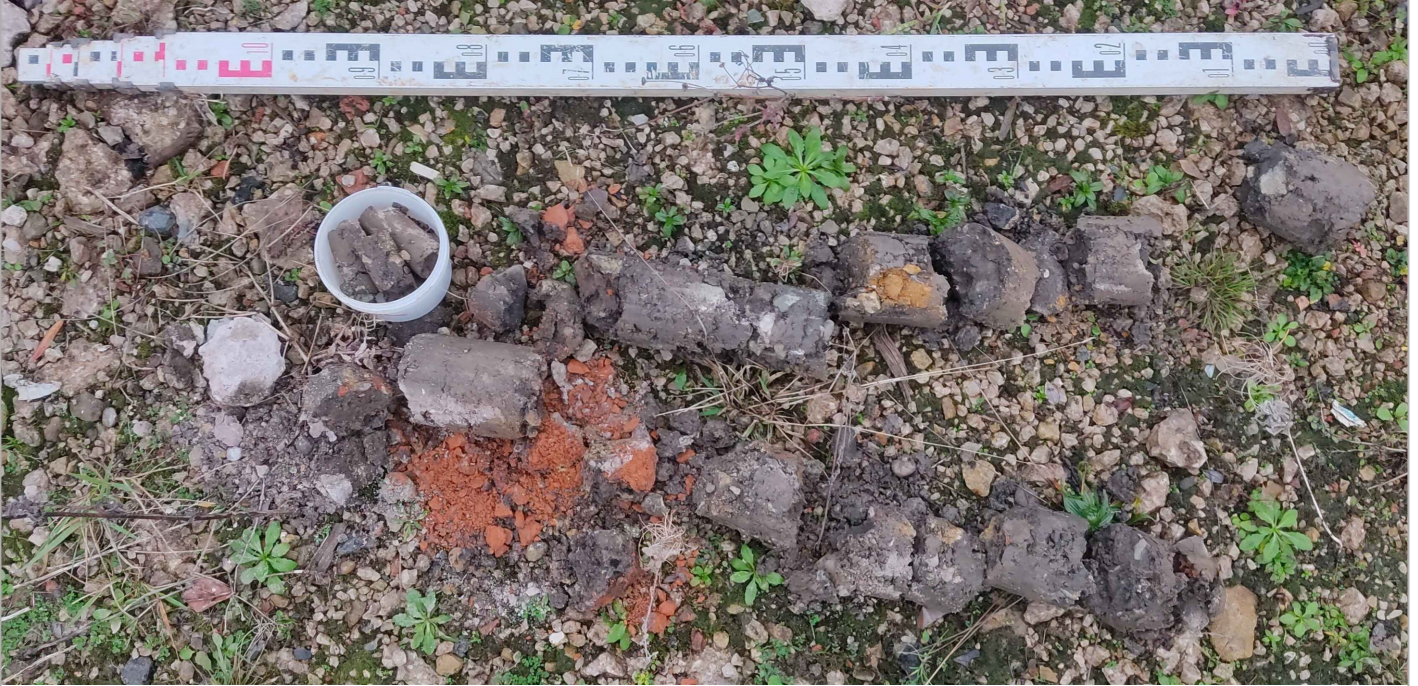
**Image 1.** DS02:  
Viewed right to left, top to bottom  
0.00m - 1.20m bgl.  
1.20m - 1.50m bgl.

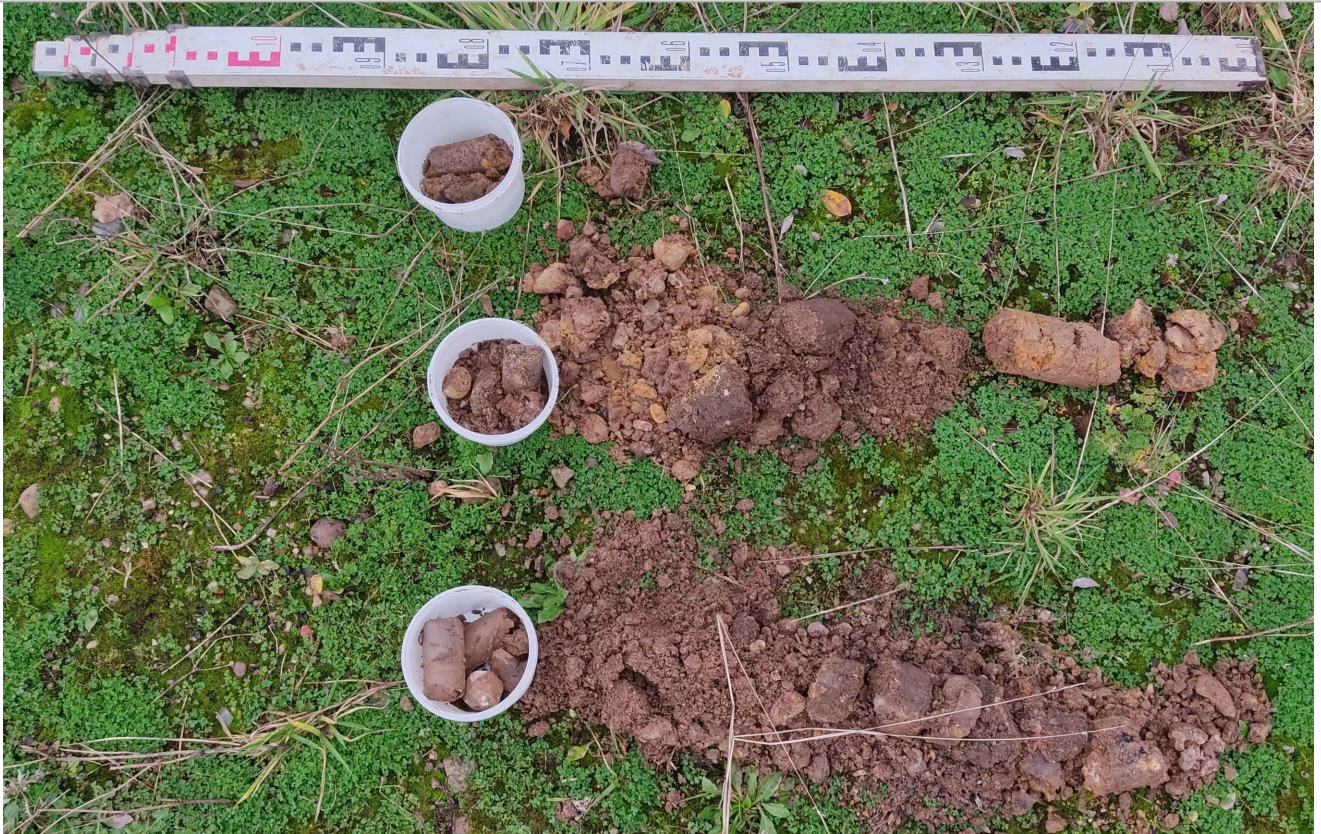
**Image 1.** DS02A:  
Viewed right to left, top to bottom.  
1.00m - 2.00m bgl.  
2.00m - 3.00m bgl.

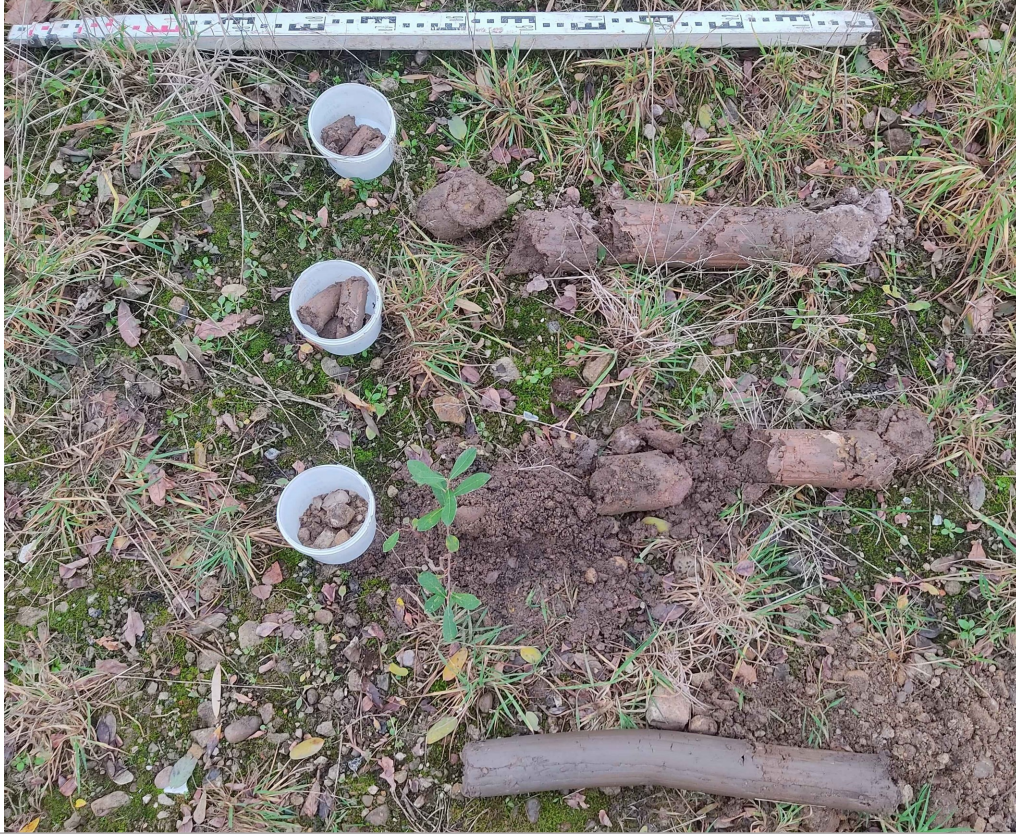
**Image 1.** DS03:  
Viewed right to left, top to bottom.  
1.20m - 2.00m bgl.  
2.00m - 3.00m bgl.  
3.00m - 4.00m bgl.

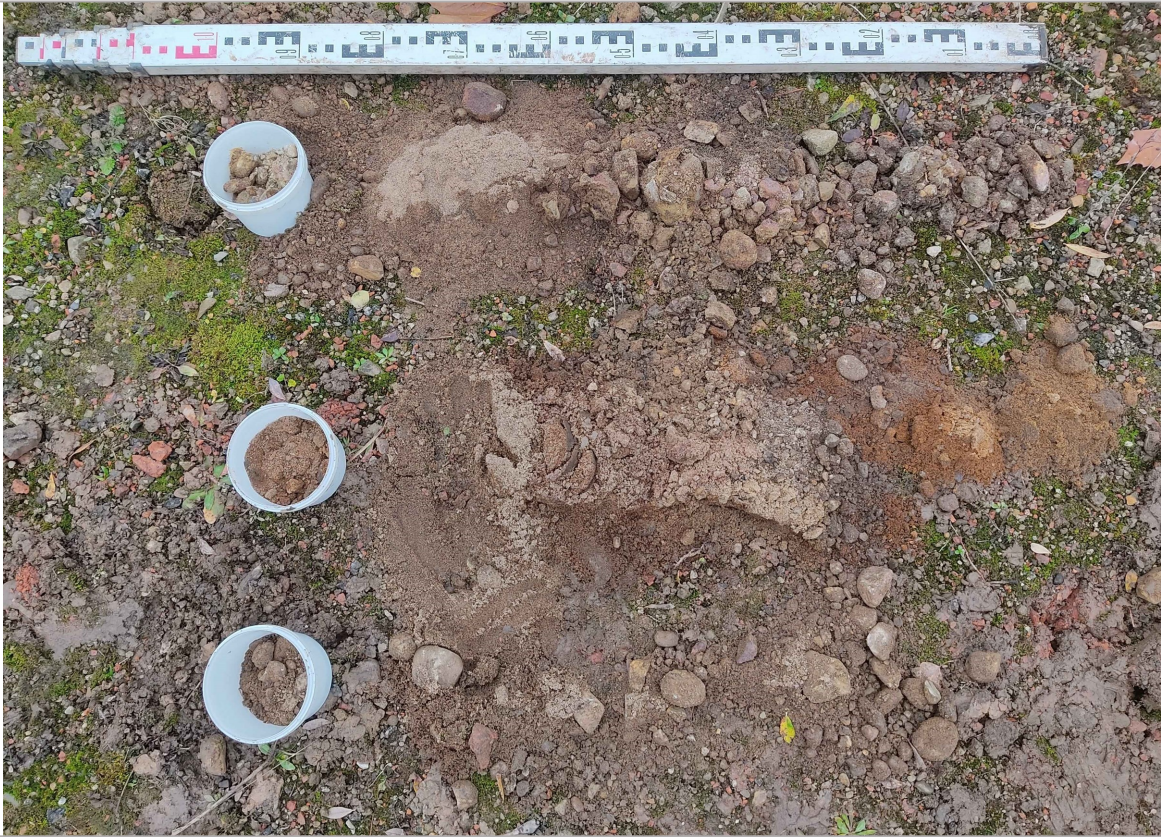
**Image 1.** DS04:  
Viewed right to left, top to bottom.  
1.20m - 2.00m bgl.  
2.00m - 3.00m bgl.  
3.00m - 4.00m bgl.
