## **Former Police Station, Bury**

### **Combined Phase 1 Desk Study and Phase 2 Geo-Environmental Ground Investigation Report**

For: Bury Metropolitan Borough Council

Ref: 3842-01  
Job: 3842  
Rev: -  
By: AS

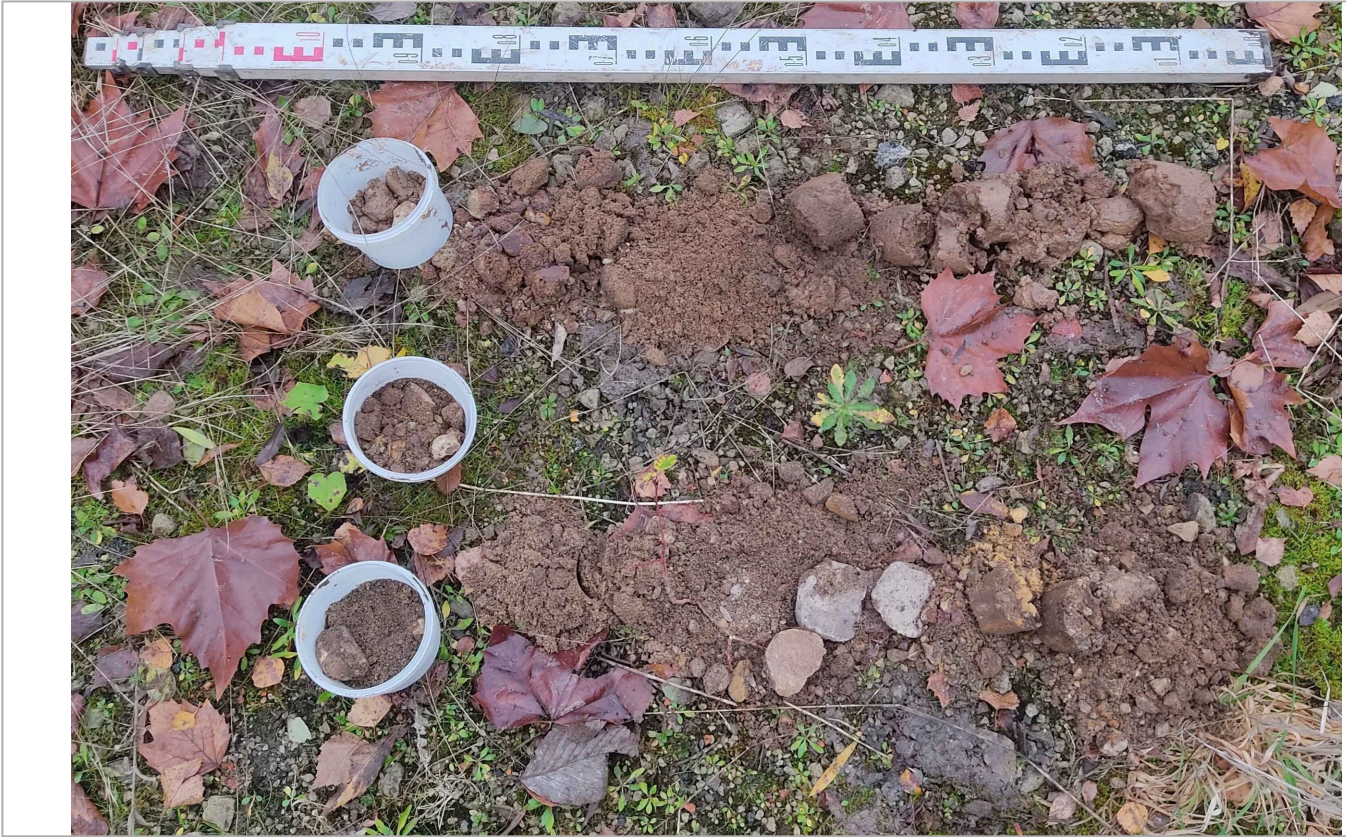
**Image 1.** DS05:  
Viewed right to left, top to bottom.  
1.20m - 2.00m bgl.  
2.00m - 3.00m bgl.
