# **SUPPLEMENTARY GROUND INVESTIGATION & CONTROLLED WATERS RISK ASSESSMENT**

**FORMER TEXACO FILLING STATION, BURY OLD ROAD, PRESTWICH**

**1<sup>ST</sup> APRIL 2024**

## **Eccles Associates Limited**

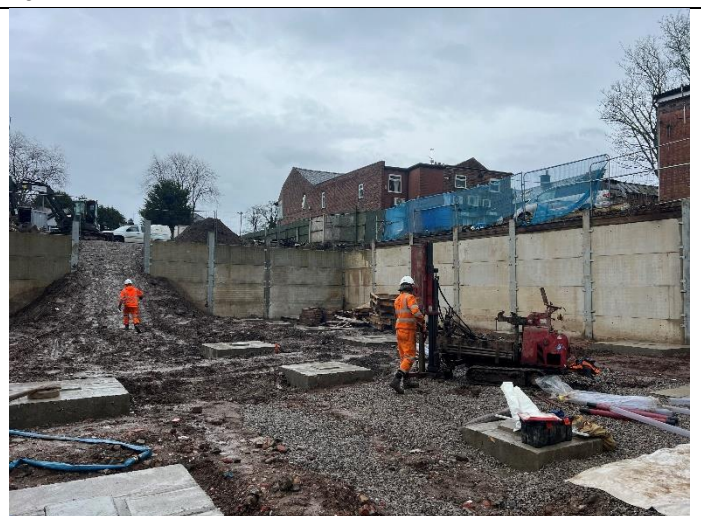
12: MW3 in progress
