**Our Ref:** 5237-G-LR001-Rev A

## **Site at Bury Market, Bury – Findings of Supplementary Rotary Borehole and Trial Pit Investigation**

ID GeoEnvironmental attended the site at Bury Market, Bury hereafter referred to as the 'site' between the 9<sup>th</sup> and 17<sup>th</sup> of December 2024, to conduct a supplementary phase of intrusive investigation. The findings of this supplementary phase of investigation should be read in conjunction with IDG's previous Geoenvironmental Appraisal Report Ref. 5237-G-R001 Rev A dated August 2022.

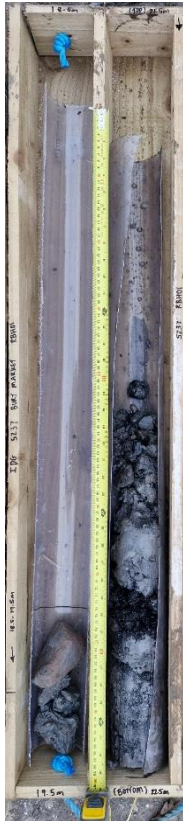
| <b>Photograph 1:</b><br><br>RBH01 – Core Runs 18.5 to 19.5m (left) and 21.5 to 22.5m (right) | | | |

Core recovery within RBH01 was generally poor between 16.5 – 21.0m bgl, with no recovery between 16.5 – 18.0m and 19.5 – 21.0m bgl. The poor recovery is considered likely to be the result of highly weathered bedrock in conjunction with partial washout by water used during coring. However, core recovery within RBH02 was generally good with between 49.33-100% core recovered.

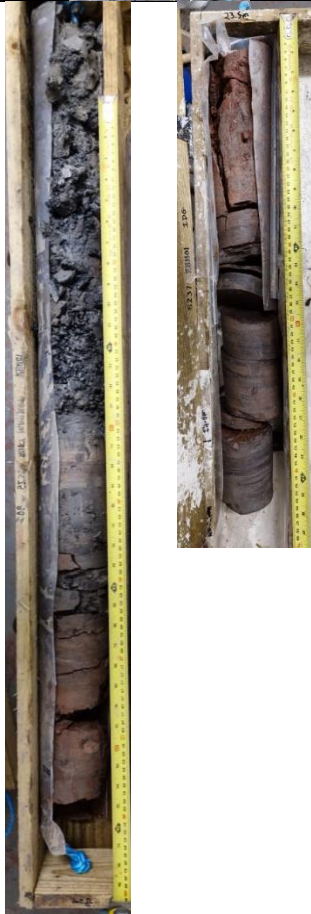
| <b>Photograph 2:</b><br><br>RBH01 – Core Run 22.5 to 24.0m<br><br>(Left Photo- 22.5 to 23.5m)<br>(Right Photo - 23.5 to 24.0m) | | | |

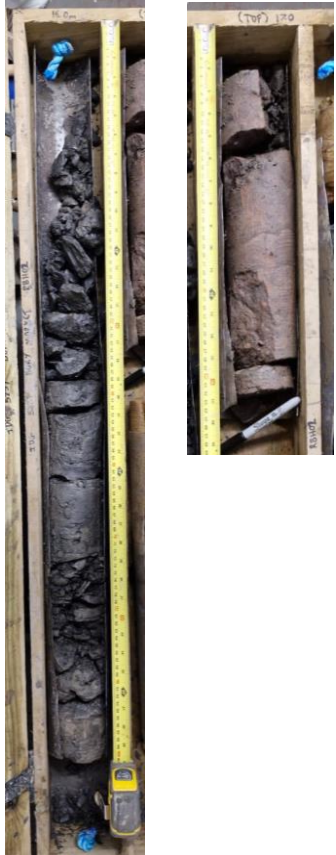
| <b>Photograph 3:</b><br><br>RBH02 – Core Run 16.0 to 17.5m<br><br>(Left Photo - 16.0 to 17.0m)<br>(Right Photo - 17.0 to 17.5m) | | | |

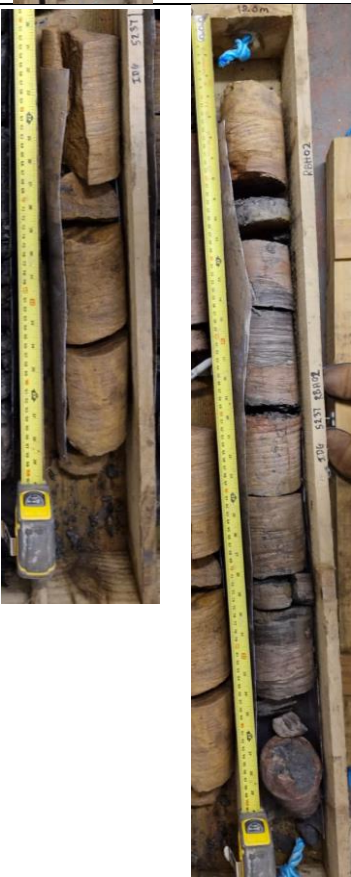
| <b>Photograph 4:</b><br><br>RBH02 – Core Run 17.5 to 19.0m<br><br>(Left Photo - 17.5 to 18.0m)<br>(Right Photo - 18.0 to 19.0m) | | | |

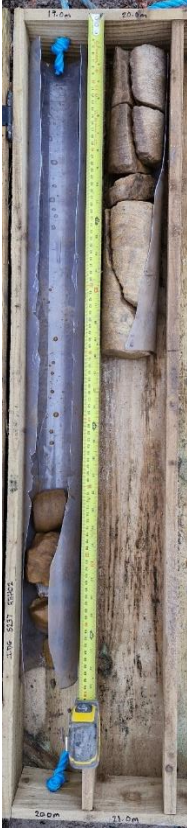
| <b>Photograph 5:</b><br><br>RBH02 – Core Run 19.0 to 20.5m | | | |

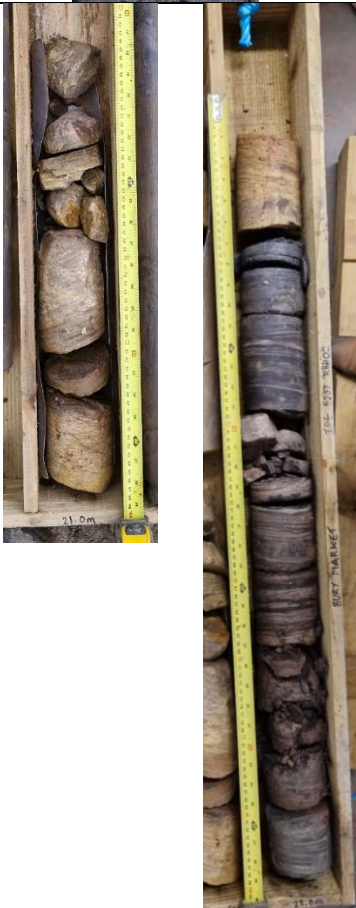
| <b>Photograph 6:</b><br><br>RBH02 – Core Run 20.5 to 22.0m<br><br>(Left Photo – 20.5 to 21.0m)<br>(Right Photo – 21.0 to 22.0m) | | | |

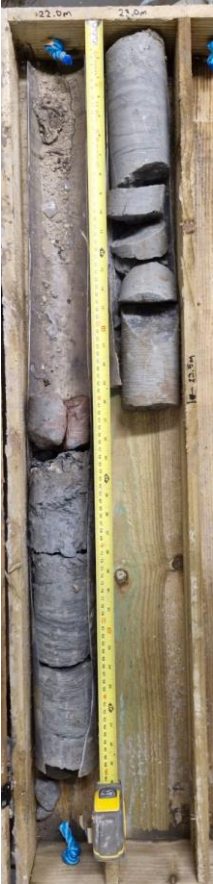
| <b>Photograph 7:</b><br><br>RBH02 – Core Run 22.0 to 23.5m | | | |
