# **BURY EMERGENCY DEPARTMENT, FAIRFIELD HOSPITAL, BURY**

## **PHASE 2 GROUND INVESTIGATION REPORT**

**Curtins Ref: 086745-CUR-XX-XX-T-GE-00006**

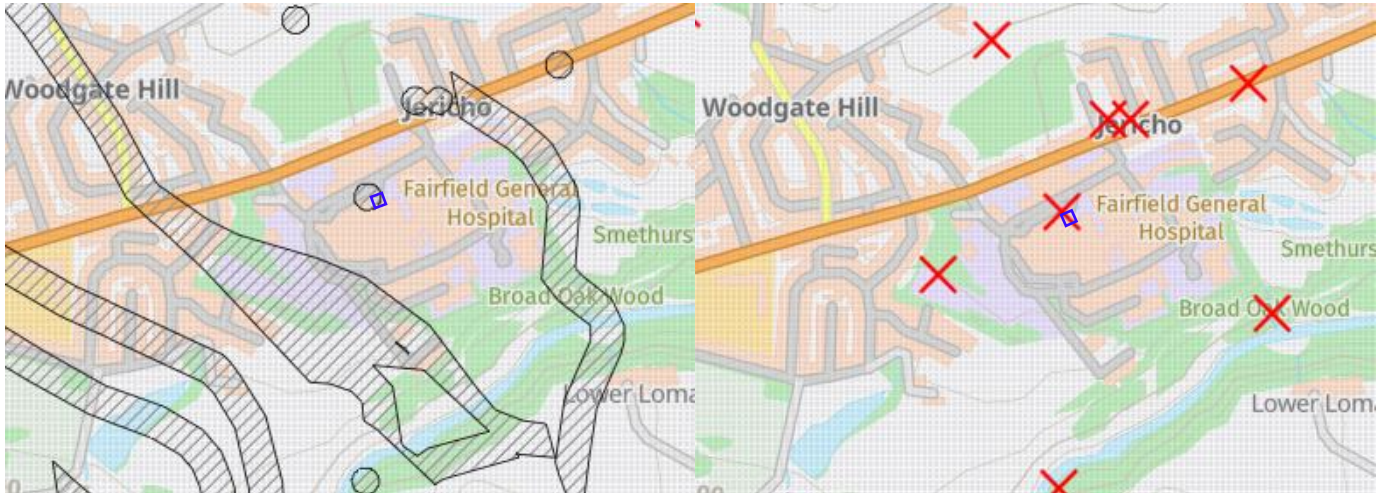
Figure 3 – Mining Remediation Authority Recorded Development High Risk Area (Left) Highlighted in Black Hatching. Mining Remediation Authority Recorded Mine Entries (right) Highlighted by Red X. Approximate Site Boundary in Red.

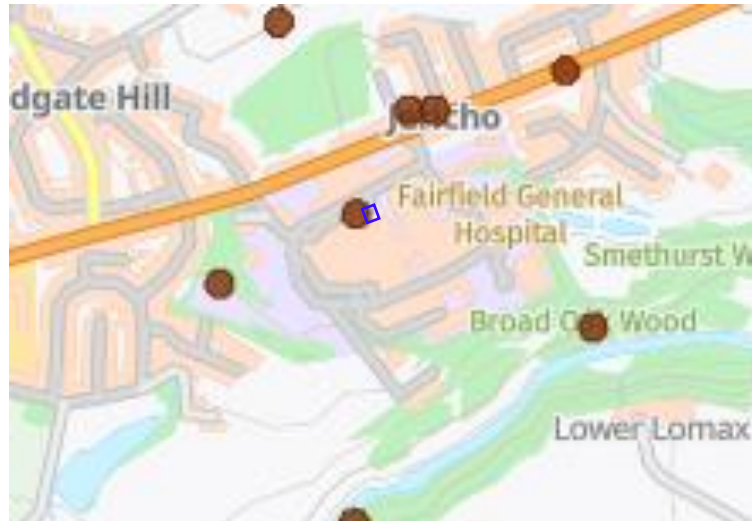
Figure 4 – Mining Remediation Authority Recorded Mine Entry Potential Zone of Influence in Brown.
