# The Engine Shed, Summerseat

## Phase 1 Preliminary Risk Assessment

**Job Number:** LKC 24 1175

**Client:** Mala NW Ltd

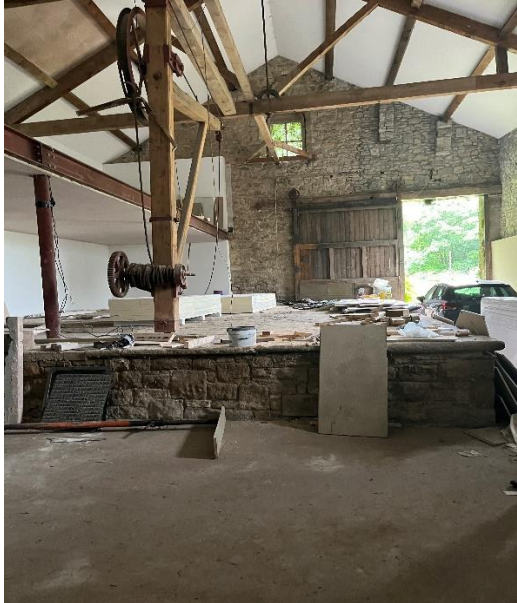
| <p><b>Photograph 1:</b> View inside building.</p> | <p><b>Photograph 2:</b> View along eastern site boundary looking S.</p> |

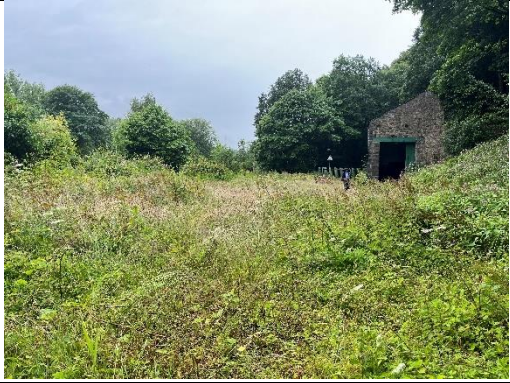
| <p><b>Photograph 3:</b> View across site looking N.</p> | <p><b>Photograph 4:</b> View of existing building from Rowlands Road..</p> |
