# ARBORICULTURAL IMPLICATIONS ASSESSMENT

PROPOSED DEVELOPMENT

THE OLD ENGINE SHED  
SUMMERSEAT

Author: C. Salisbury  
Date: 25 July 2024  
Ref: TRE/TOES/Rev A

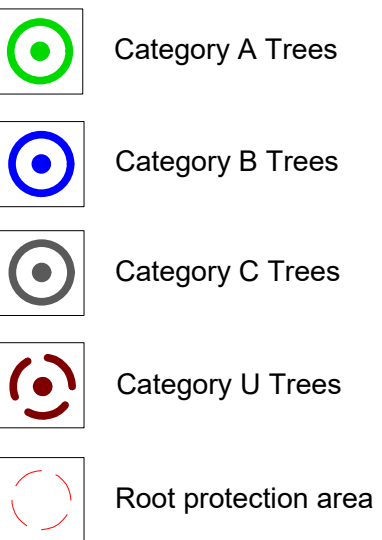
| Drawing Title:<br>BS5837 Plan | | |

- 3.1 Due to the proposed development and its associated infrastructure there are a number of locations where the proposals are in close proximity to the trees surveyed. The Site Layout Plan within appendix three identifies the trees in relation to the proposed development.
- 3.2 In order to fully assess the impact of the proposals an Impact Table has been created detailing each tree, which shows the proximity of the associated works to the tree.
- 3.3 This can then be assessed in accordance with BS 5837:2012 to determine whether the development will have a detrimental impact on the health of each tree. Once this has been determined remedial measures can be detailed to reduce the impact the proposals will have on the treescape.

- 5.1 The proposed parking is to be located on existing hard standing which is heavily compacted to the sites previous use. The proposed car parking will therefore have no detrimental impact on the adjacent woodland belts.
