# **Bat Survey Report and Method Statement European Protected Species (Bats)**

## **Reasonable Avoidance and Mitigation Measures**

**The Nurseries,  
Leigh Lane,  
Walshaw,  
Bury, BL8 1RL**

**13.02.2022**

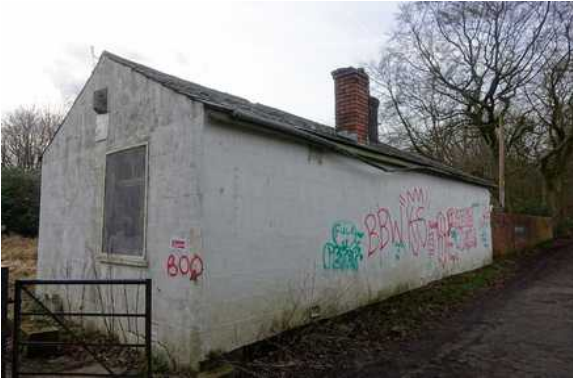
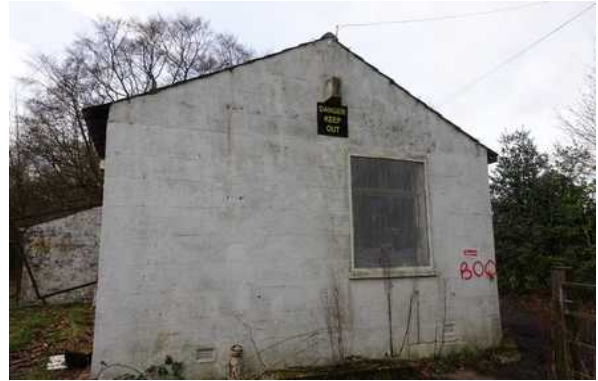
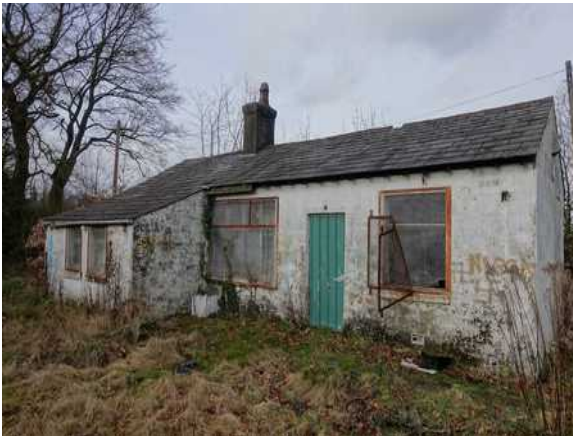
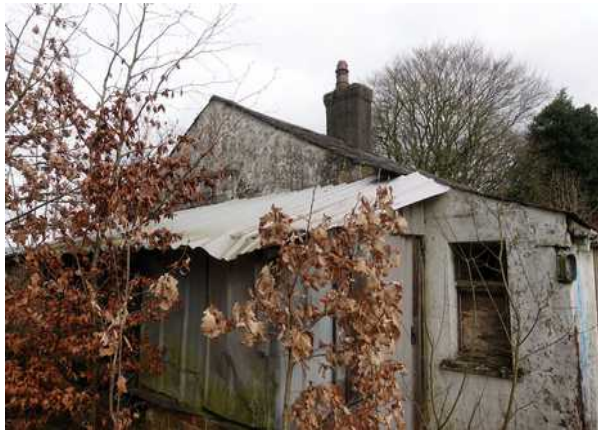
### Visual Inspection – Bungalow.

The property consists of a block built bungalow with a double pitched slate roof, a single storey extension is present on the southern facade and a leanto is present on the western gable. External walls are generally well pointed with no obvious cracks, gaps or crevices. Gaps were present on the eaves and gable ends, behind remaining fascia boarding and under missing ridge tiles and lifted roof slates.

The building was assessed as offering high roosting potential.

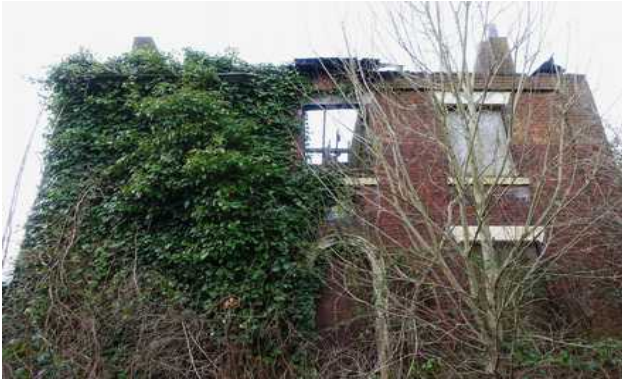
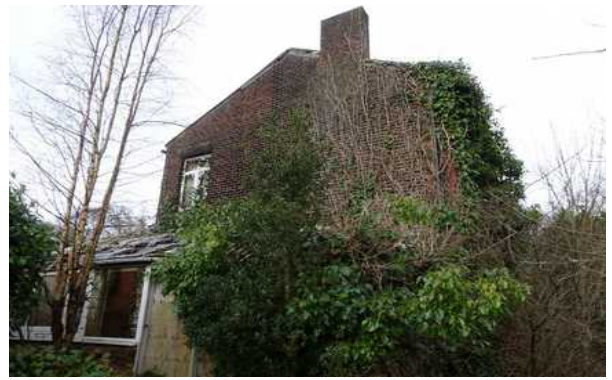
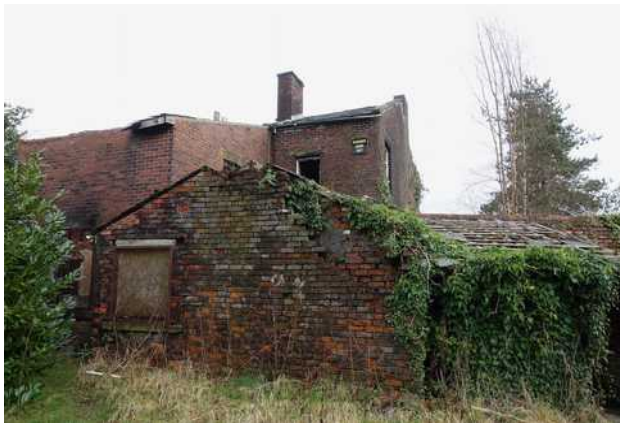
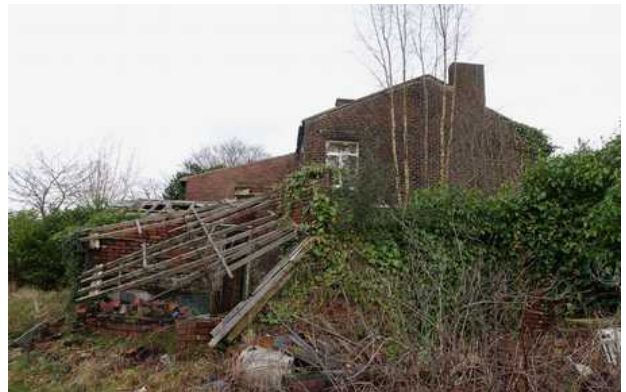
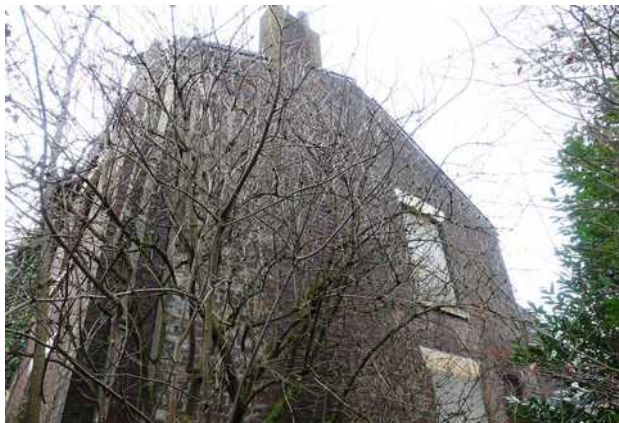
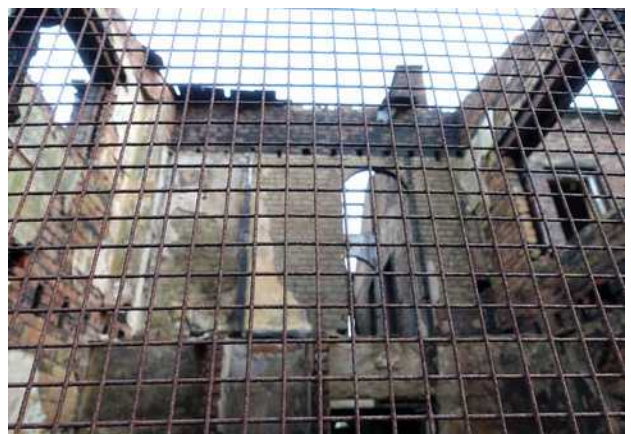
## The Main House

The main house consists of a two storey brick built detached house with single storey extensions present to the east and south facades. The property is in a poor condition with missing roof sections, areas of collapse and evidence of internal fire damage.

Gaps were present both on external walls and behind fascia boarding. The southern gable had gaps below roof slates. The building suffers from high levels of both weather and light penetration.

The building was assessed as offering moderate bat roosting potential.
