## Bat Roost Assessment

Former Mondi Site  
(Site 1)

Holcombe Mill  
Bridge Street  
Ramsbottom  
BL0 0BS

Ref: P.1202.19

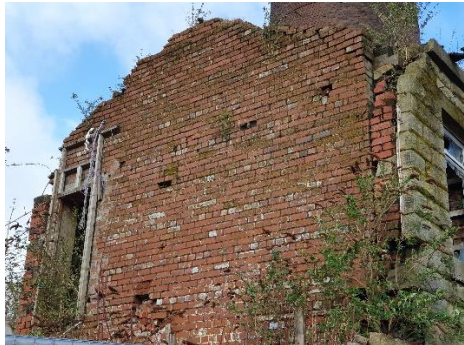
| Building | Photograph |
|---|---|
| | <p><b>B3 Southern elevation 2020</b></p> |

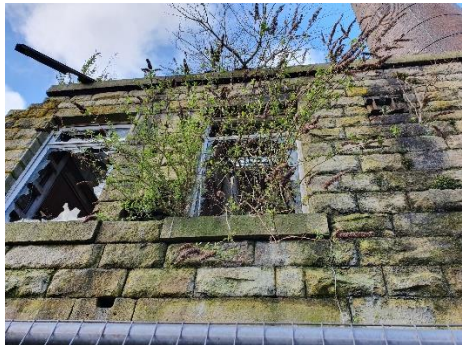
| Building | Photograph |
|---|---|
| | <p><b>B3 Buddleia around a first-floor window 2020</b></p> |

roof tiles. To the northern and southern aspects of the roof gaps were identified under the flashing. Vegetation including buddleia has colonised in sections of the building, including around door and window frames, short ephemeral vegetation has colonised on the ground floor window frames and moss was noted within the brickwork.

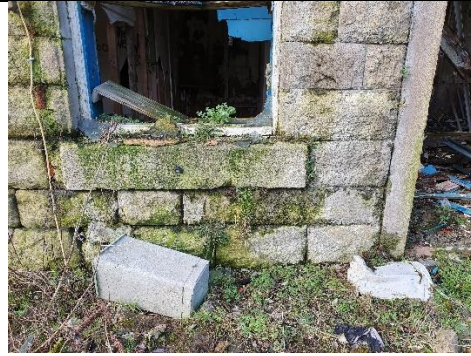
**B3 Visible gaps within stonework 2020**

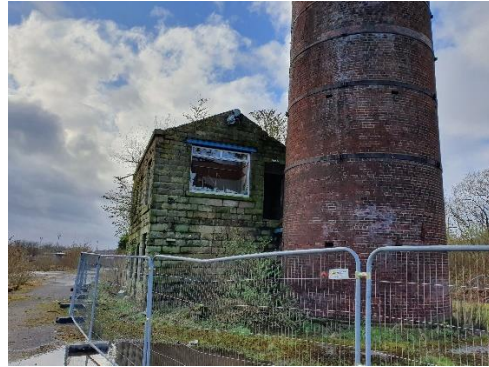
**B3 from the northern elevation 2020**

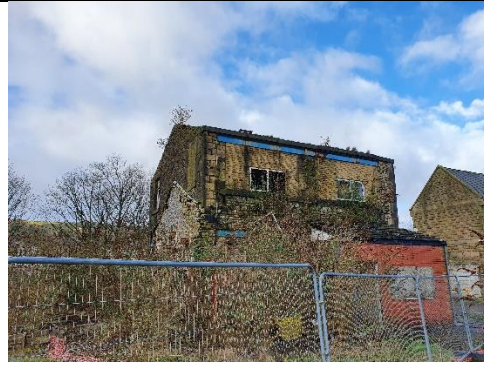
Building B2 is a two-storey building constructed from a mixture of cavity and solid brickwork and stone walls with a pitched roof. To the eastern elevation of the building there is a single storey brick extension with a sloped roof. Evidence of a single storey extension that has been demolished to the south elevation of the building was noted. The windows throughout the building were all uPVC frames with missing glass, the windows to the ground floor were all boarded over. The main entrance door is a wooden frame with missing glass panels.

**B2 eastern elevation with single storey extension in 2020**

2023, the building was assessed to continue to provide high suitability for bats, a nocturnal survey was undertaken in September 2023 and two further surveys will be undertake between May and August 2024 by Ascerta.

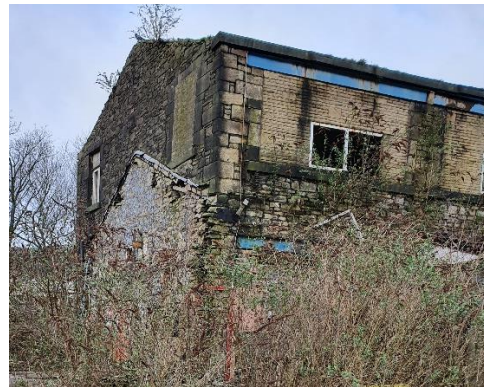
**B2, demolished section to the southern elevation in 2020**

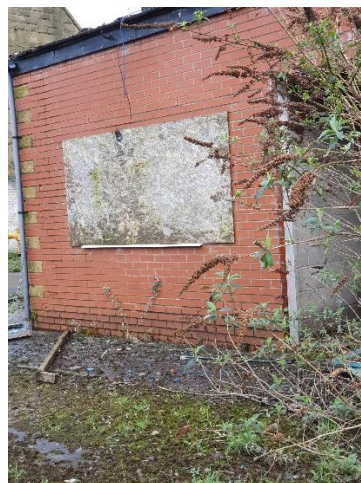
**B2 Ground floor boarded up window in 2020**

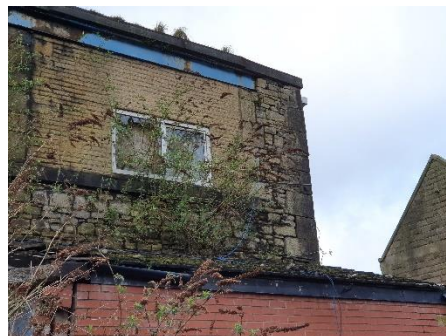
During the external inspection gaps and cracks were noted throughout the stonework, with small missing areas of mortar between the brickwork. A metal supporting beam was visible on the eastern elevation with gaps noted between the frame and brickwork within the walls.

**B2 Supporting beam to the eastern elevation in 2020**

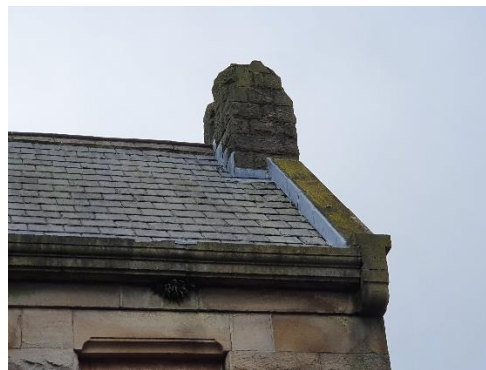
Small gaps were visible under the ridge line and under roof tiles. Gaps were also present within the flashing to the northern and southern elevations. To the eastern elevation gaps were noted under the overhanging areas of the stonework. All the windows and doors were boarded over with wooden panels, gaps were noted surrounding boarding at the windows on the eastern elevation.

B1 Visible gaps within the ridge line and surrounding flashing in 2020

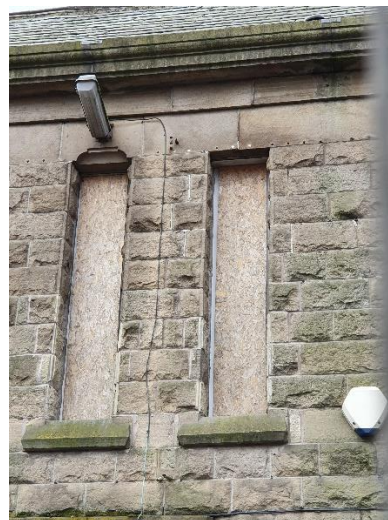
B1 Visible gaps beneath stone window ledge in 2020

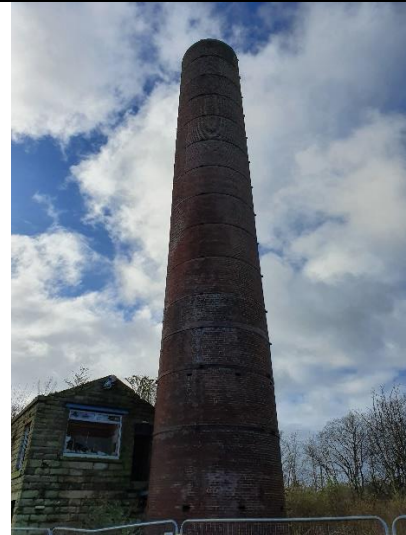
A chimney is present to the north of building B3 and is a solid brickwork constructed building. No windows or doors are present. The brick work is in a good condition, with acceptance to a few visible gaps and cracks with the aid of close focusing binoculars. Ventilation bricks were noted within the lower sections of the chimney. The building will be retained within the proposals and will not require nocturnal surveys for bats within the current planning application.
