## Phase 1 GeoEnvironmental Desk Study

**43 Hilton Lane**

**Prestwich**

**Report No. A4736/22**

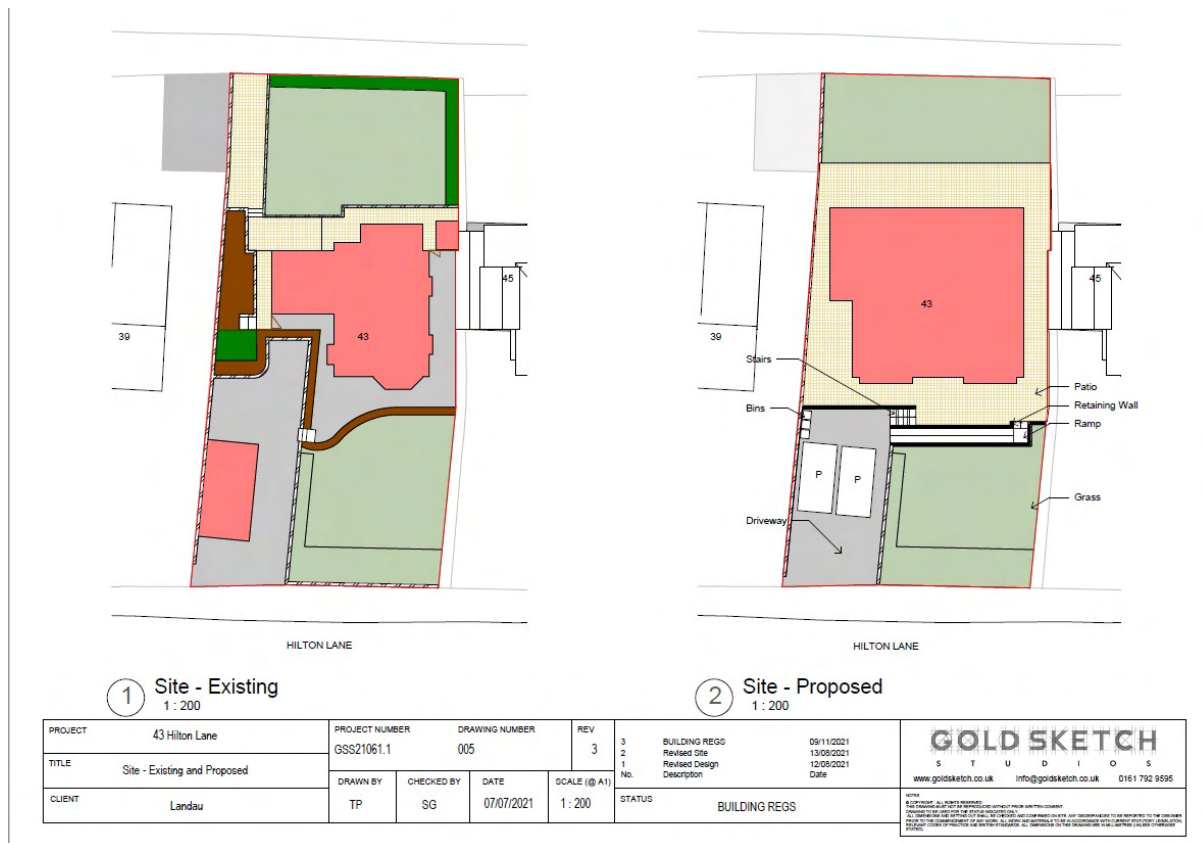
**Figure 2 Site Location Plan**

- 2.5 A current and proposed location plan is shown below as Figure 2, together with a recent site photograph as Figure 3 (overleaf).

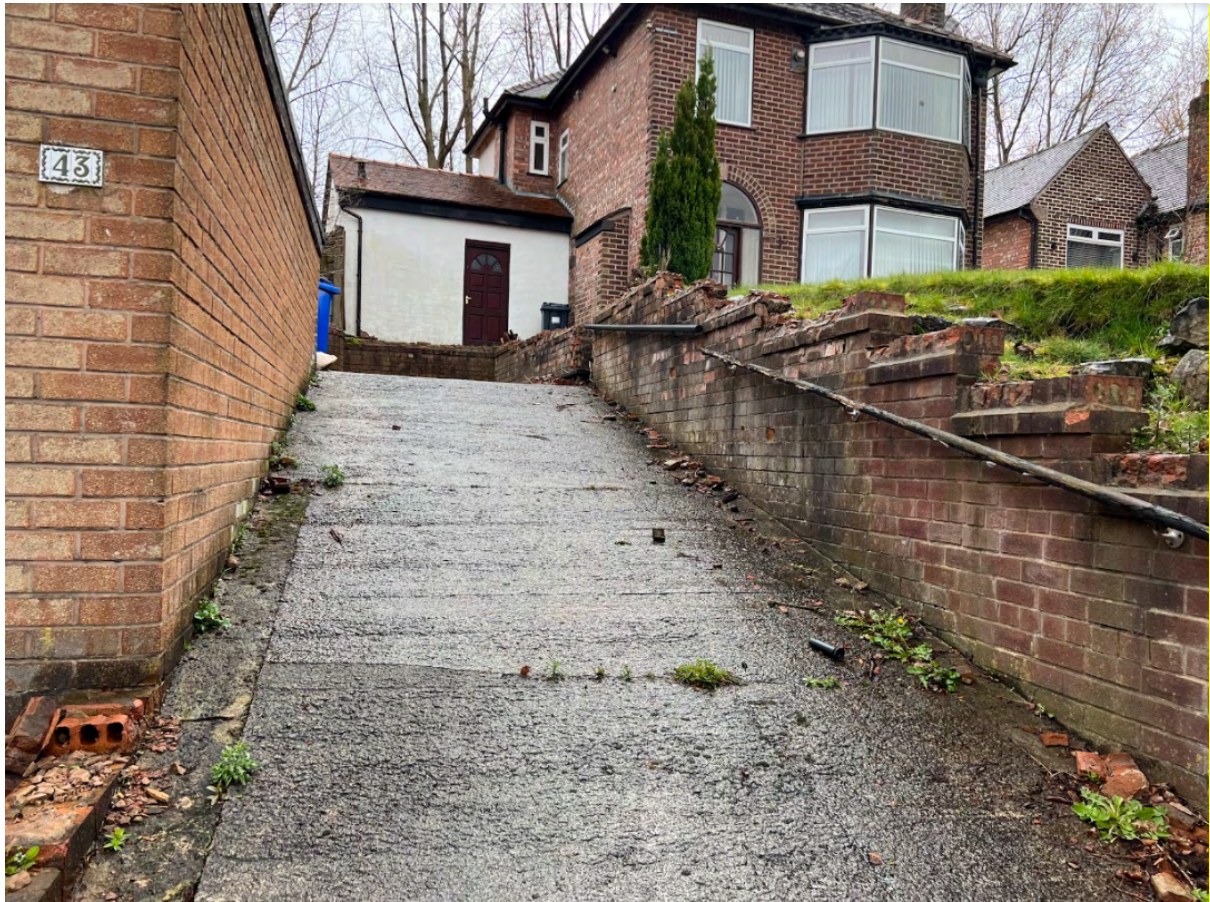
**Figure 3 Site Photograph**

- 2.2 The site is a near rectangular shaped parcel of land to the south of Hilton Lane, with Prestwich Golf Club located to the south. Access to the site is from a sloped driveway off Hilton Lane. The site is currently occupied by a detached dwelling, garage and associated gardens. The surrounding land use is of a similar suburban nature.

- 2.3 The site is currently occupied by a residential property along with associated garage, concrete car parking area and a grass garden.
- 2.4 The maximum dimensions of the proposed site are 36m northwest to southeast and 18m northeast to southwest. The site occupies an area of approximately 0.06 hectares.

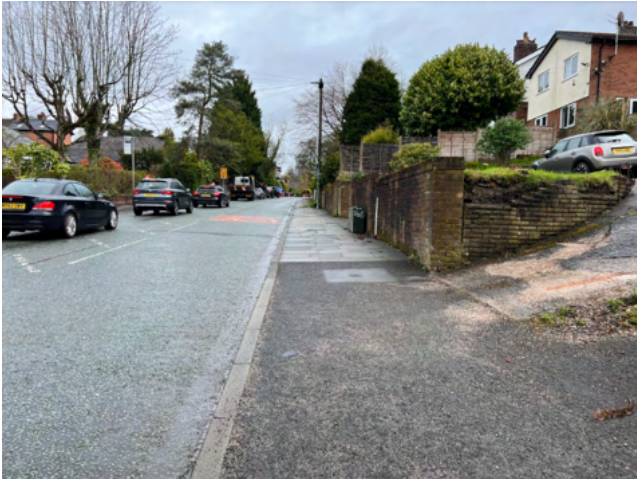
| <p><b>Plate 1 Viewing east showing site access via Hilton Lane, running parallel to the site.</b></p> | <p><b>Plate 2 Viewing south showing general overview of the site. Note the steep dipping slope away from the property.</b></p> |

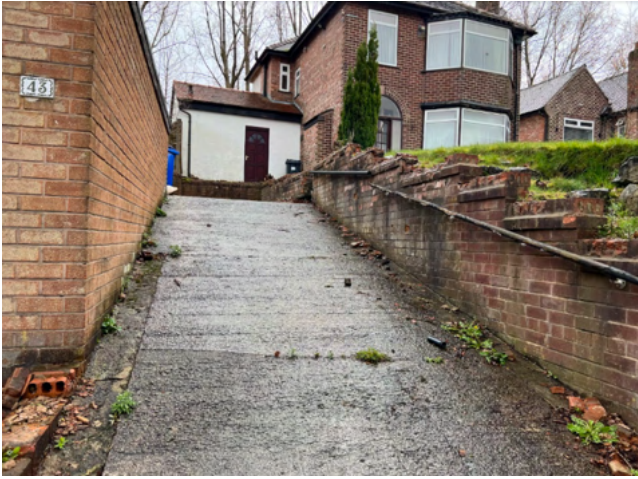
| Desk Study features checked during site visit | Feature and Information required | Present | Description / Comments |
|---|---|---|---|
| Ground Conditions | Is there any evidence of:<br><br>Mining, Mine entries<br><br>Subsidence<br><br>Landslip/slope erosion<br><br>Former investigation works | <del>Yes</del> /No<br><br><del>Yes</del> /No<br><br>Yes/ <del>No</del><br><br><del>Yes</del> /No | Slope erosion is observed as a result of onsite construction. |

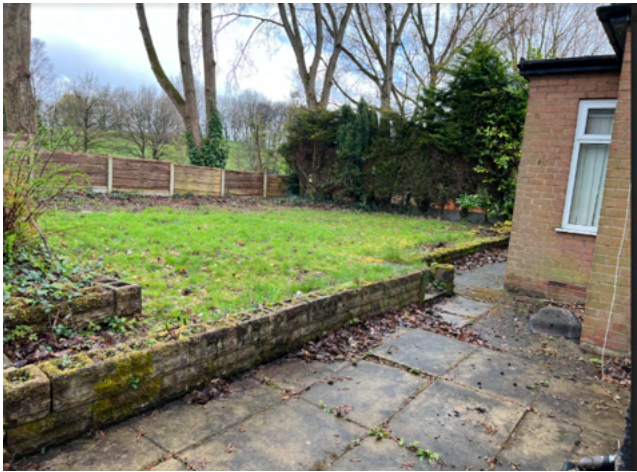
| <p><b>Plate 3 Viewing southwest showing view of the garden area along with pathed concrete slab area.</b></p> | <p><b>Plate 4 Viewing north showing raised area of redbrick along with wooden shed situated on the site.</b></p> |

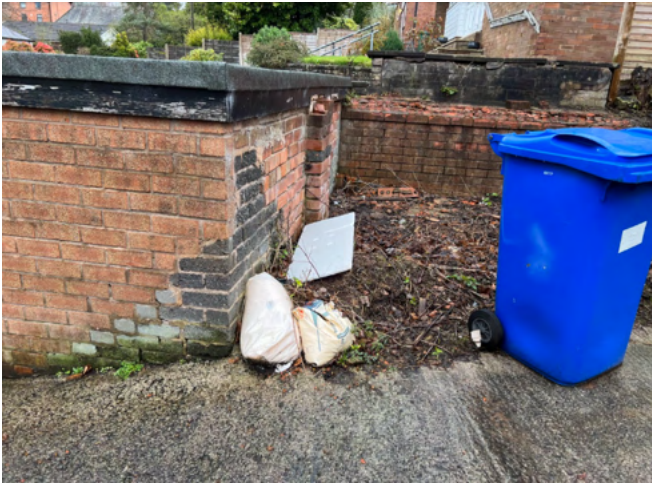
| <p><b>Plate 5 Viewing east showing small areas of litter and waste material present on the site.</b></p> | <p><b>Plate 6 Viewing south showing southern site boundary of a wooden fence.</b></p> |

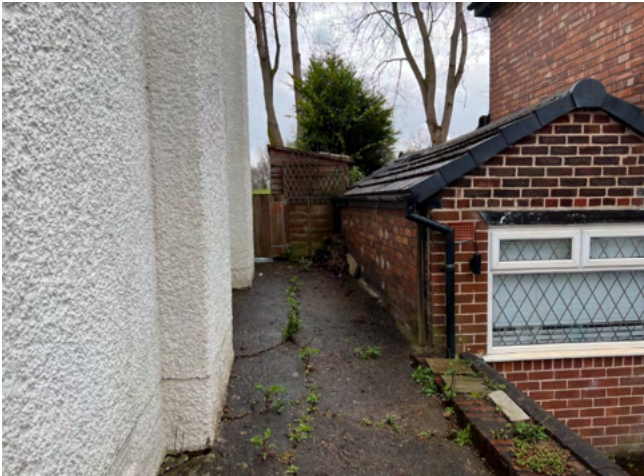
| <p><b>Plate 7 Viewing south showing the western boundary along with surrounding residential properties.</b></p> | <p><b>Plate 8 viewing south showing small brick garage located on site along with the sloped car parking area.</b></p> |
