## ARBORICULTURAL REPORT (BS 5837:2012)

FOR  
PROPOSED DEVELOPMENT

FORMER WATERSIDE PUB  
KAY STREET  
SUMMERSEAT  
BURY

November 2024

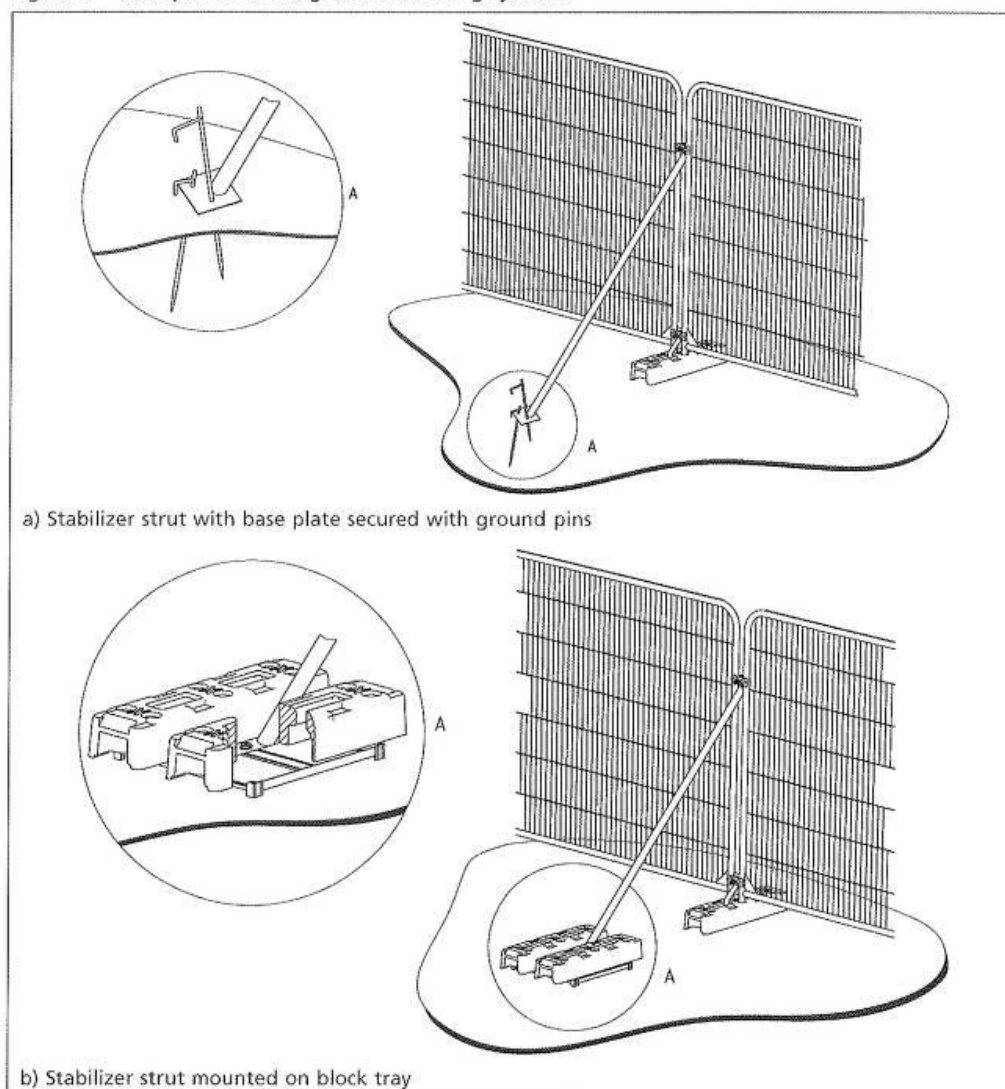
Figure 3 Examples of above-ground stabilizing systems

Figure 3(a): Type 2 Fencing (BS5837:2012 above-ground strut stabilising system with ground pins)

- 6.2.1 Construction Exclusion Zones (CEZs) shall be enclosed by Temporary Protective Fencing and/or, where necessary, Temporary Ground Protection. All fencing used on the site should fully comply with *BS 5837:2012 Trees in relation to design, demolition and construction – Recommendations*.

- 6.2.2 The fencing should be strong and suitable for local conditions. It should also take into account the degree of construction activity on the site.

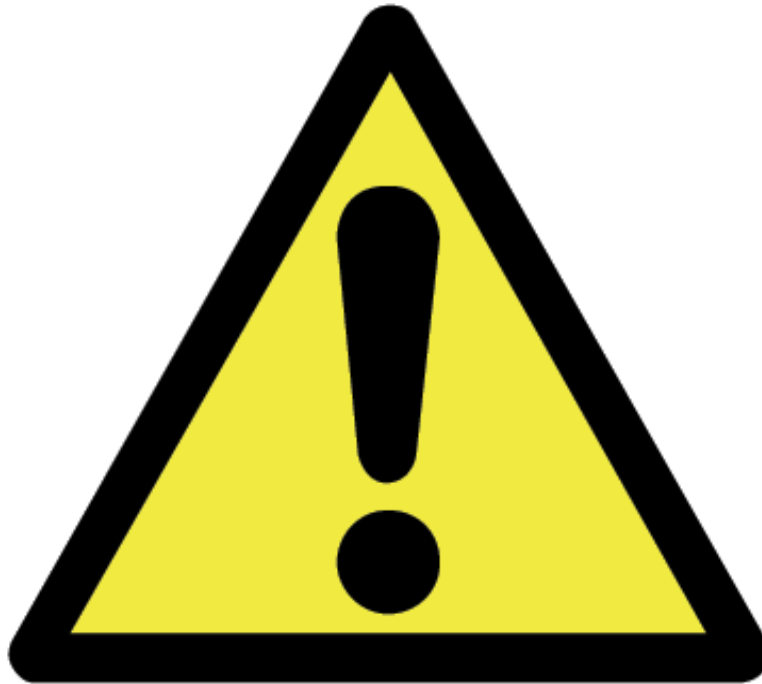
### **Site Notice For Protective Fencing**

# **TREE PROTECTION AREA KEEP OUT!**

TREES ENCLOSED BY THIS FENCE ARE PROTECTED BY PLANNING CONDITIONS AND ARE SUBJECTS OF A  
TREE PRESERVATION ORDER  
(TOWN & COUNTRY PLANNING ACT 1990)

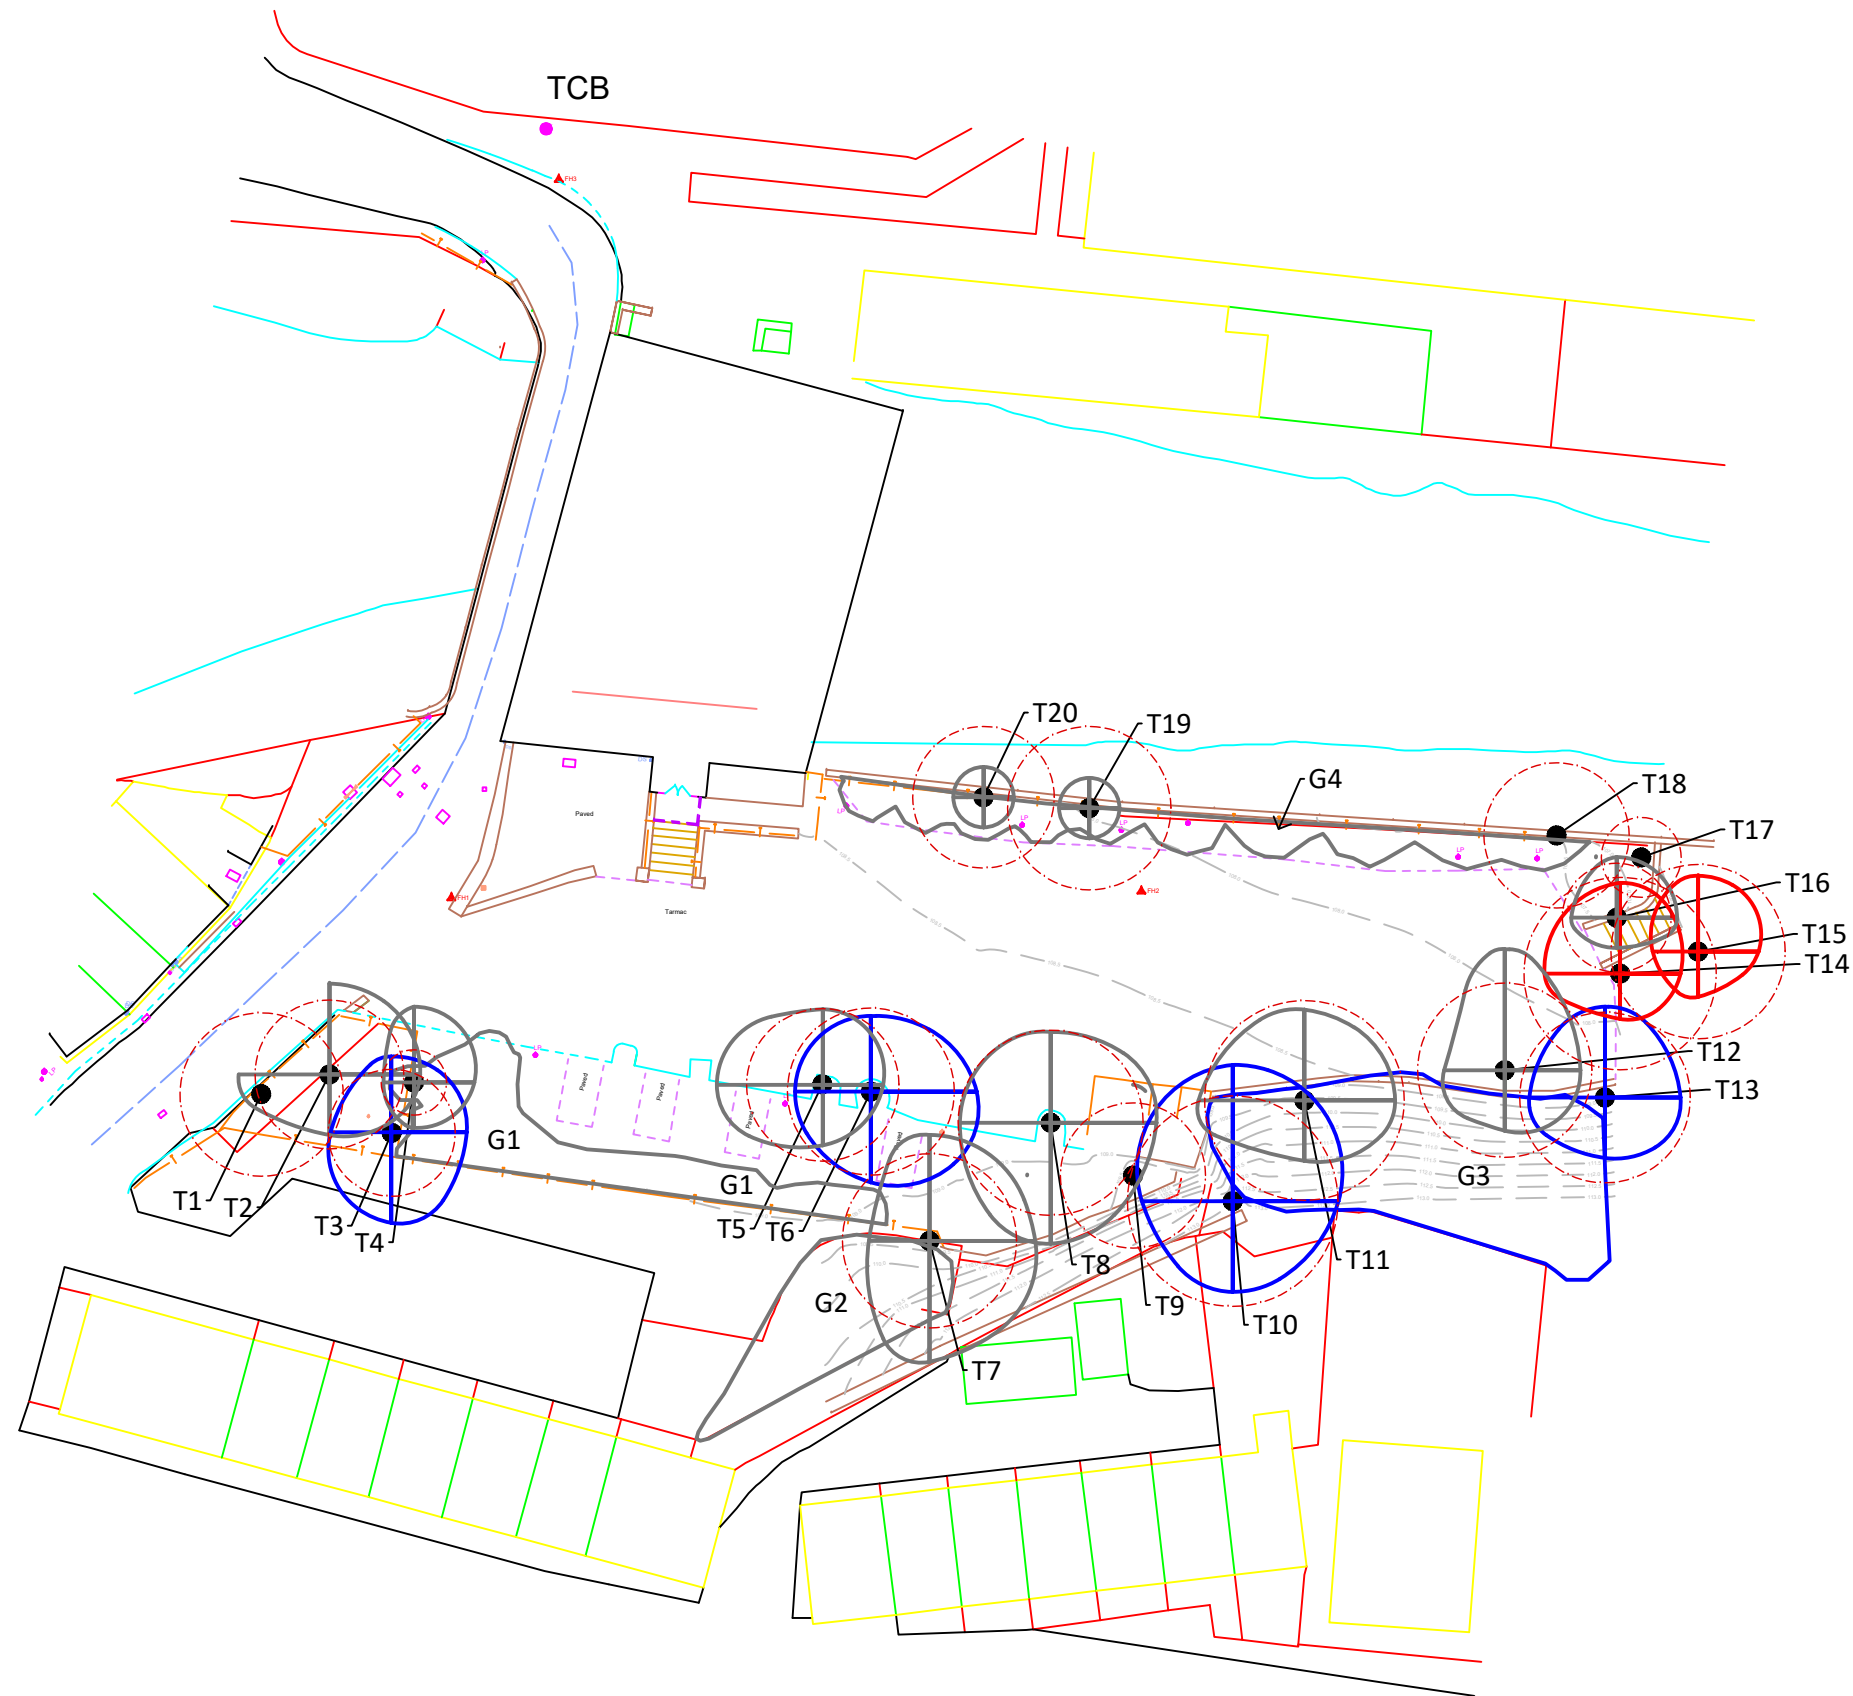
**Tree Protection Plan**

Root Protection Areas: Calculated inline with BS5837:2012 to show a circular RPA which does not take into consideration site conditions

- 4.1 The purpose of this section is to assess the implications, if any, the proposed development will have on the trees identified in the Tree Survey of 13<sup>th</sup> February 2023 carried out by DEP (see Appendix B & F) and advise on arboricultural measures, which would be likely to mitigate any damage resulting from the proposals.
- 4.2 The Site Layout Plan within Appendix F identifies the trees in relation to the proposed development.
