**Job title:** New Office Block, Bury

**Report type:** Supplementary Geo-  
Environmental Appraisal

| Document Control Form | |
|---|---|
| REPORT REFERENCE | GRO-21438-3875 |

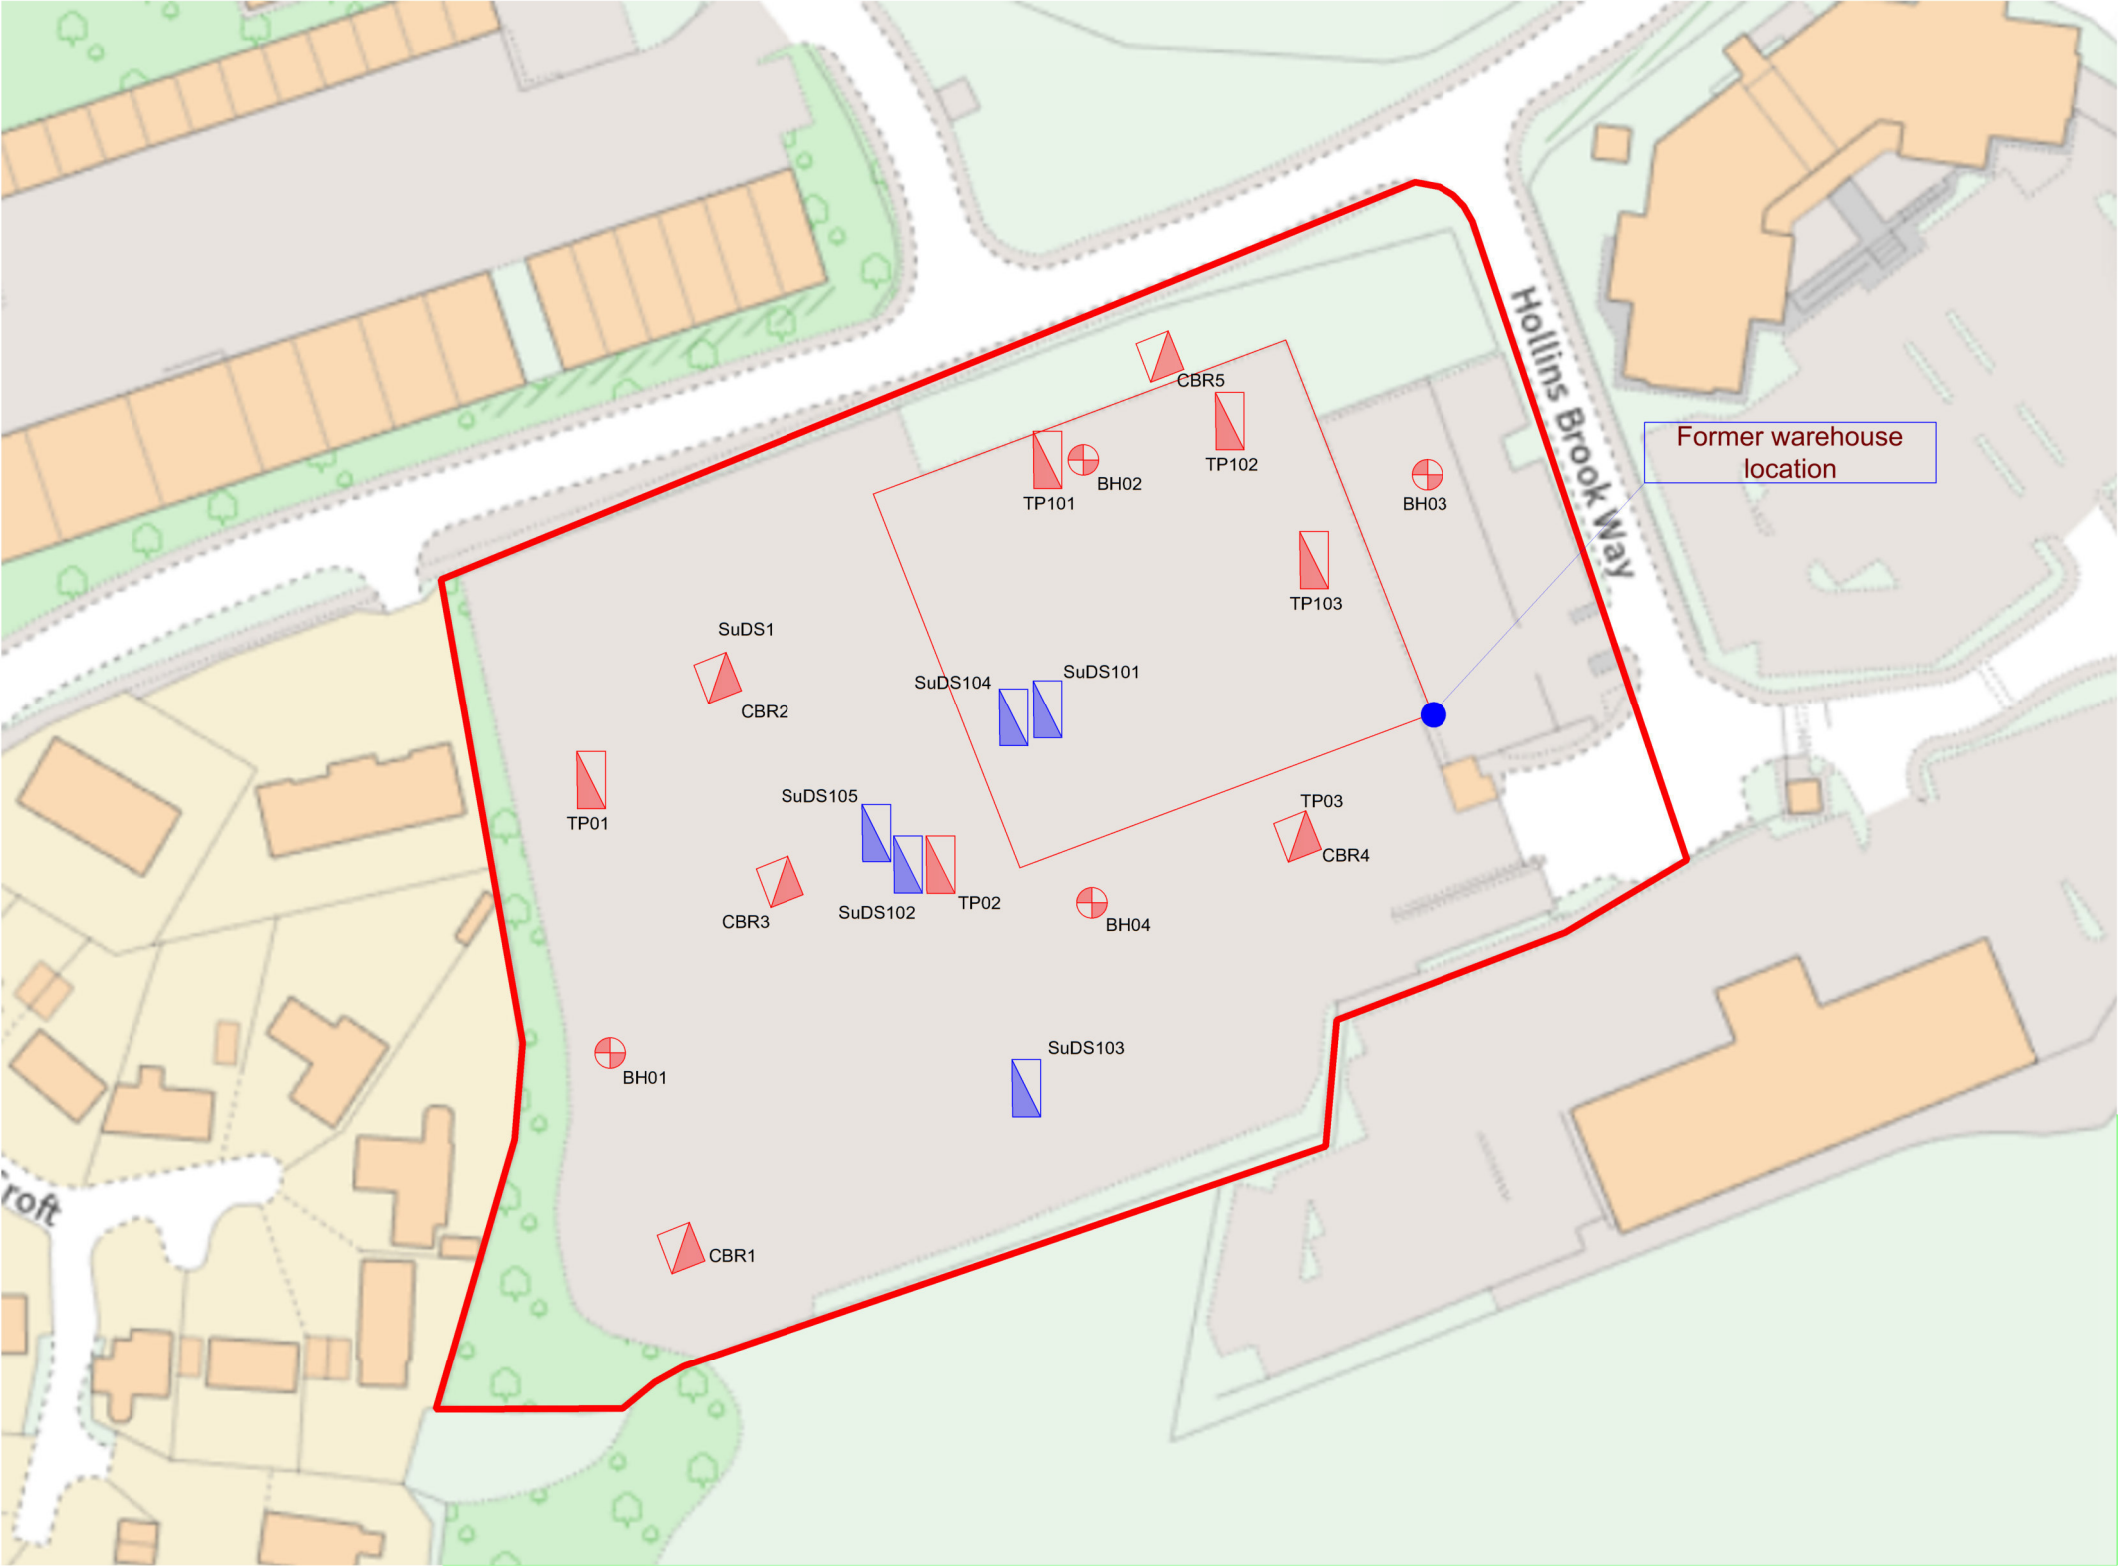
- 3 No. trial pits (TP101 to TP103) were excavated to a depth of 1.0m bgl using a JCB 3CX excavator.
- 5 No. soil percolation tests (SuDS101 to SuDS105) were undertaken at depths between 1.1m and 2.3m bgl.

The exploratory hole locations are presented on Groundtech Plan GRO-21438-P04\_1.1.

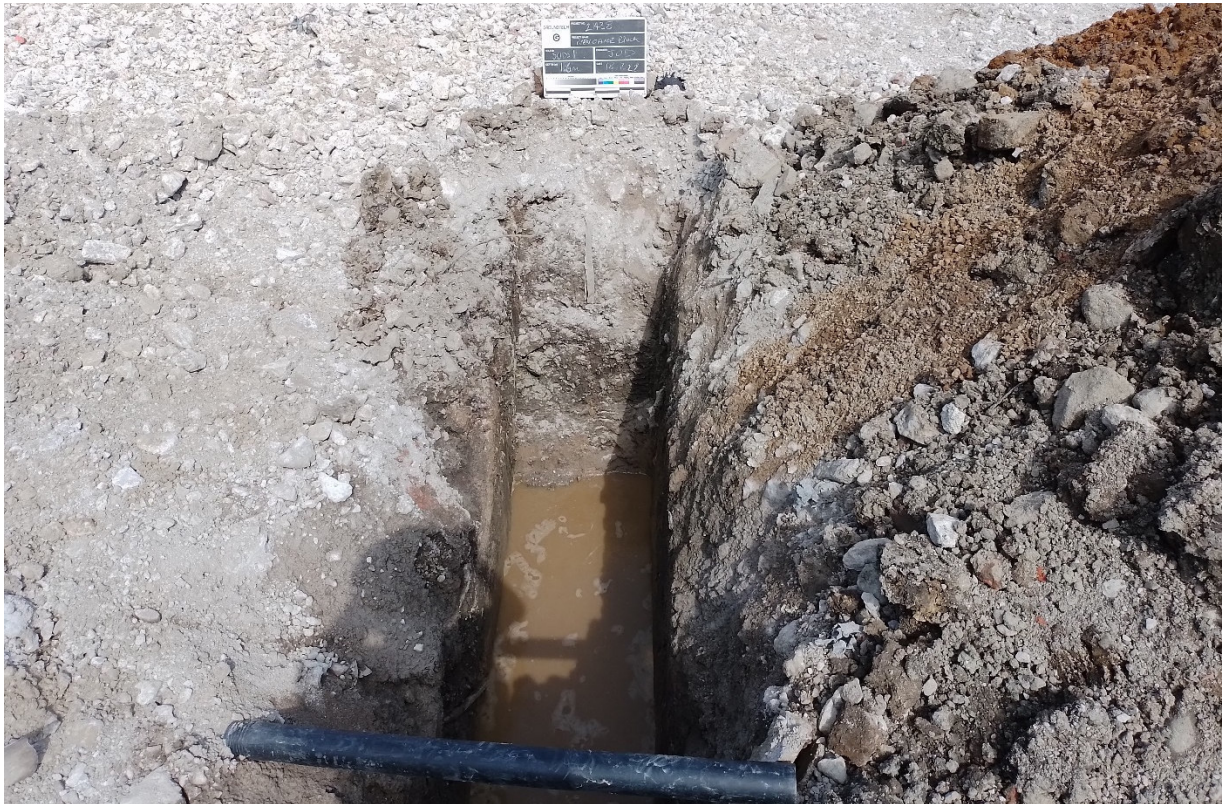
Photograph 1 – SuDS101

The natural strata tested at all locations comprised of slightly clayey occasionally silty gravelly Sand. The soil infiltration rates recorded generally indicate poor drainage conditions with the exception of the initial test undertaken at location SuDS103 which demonstrated a good soil infiltration rate.

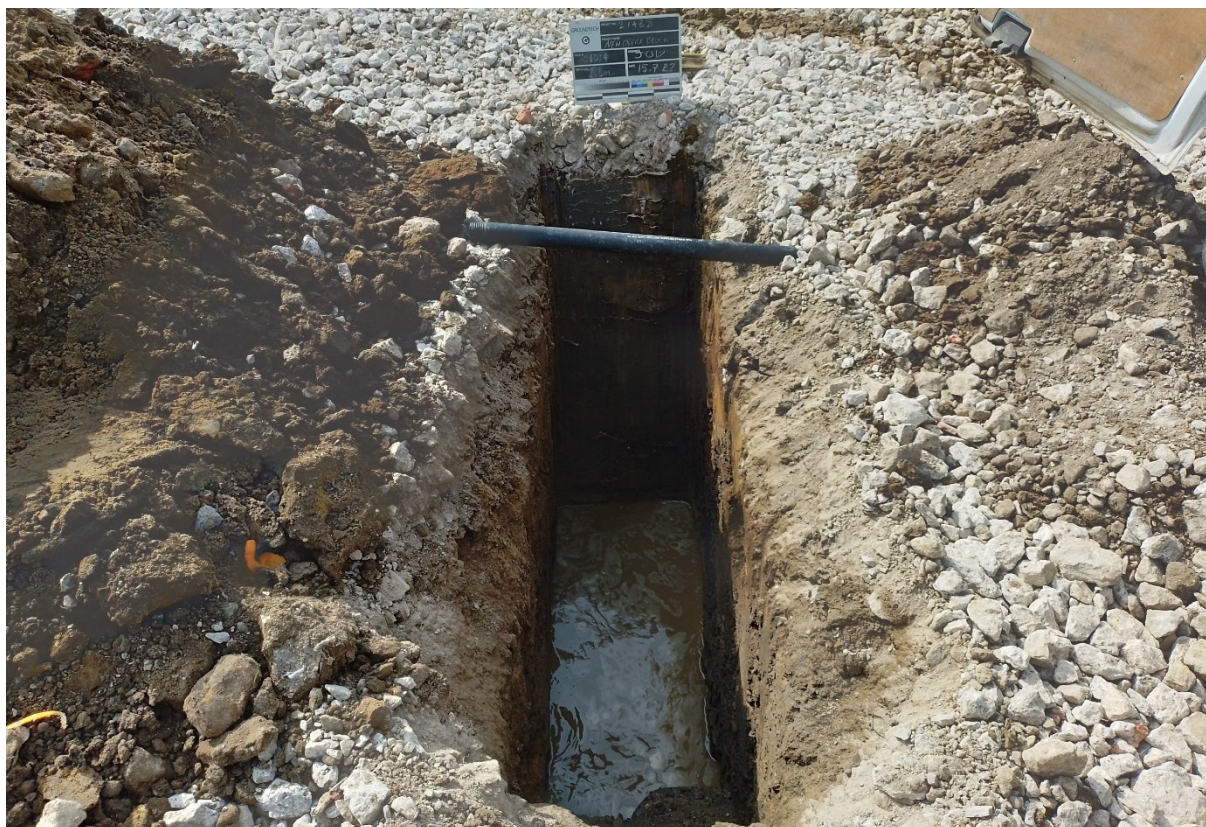
Photograph 4 – SuDS104

Groundwater was encountered in SuDS104 and SuDS105 at depths of 2.0m and 1.9m bgl respectively, within the natural Sand.

Groundwater was encountered at the base of the excavations at locations SuDS104 and SuDS105 and is likely contributing to the poor soil infiltration rates observed.
